Accident

| Aircraft Type and Registration: | Spitfire IXT, G-BMSB | |
| Date & Time (UTC): | 3 May 2025 at 1820 hrs | |
| Location: | Near Hythe, Kent | |

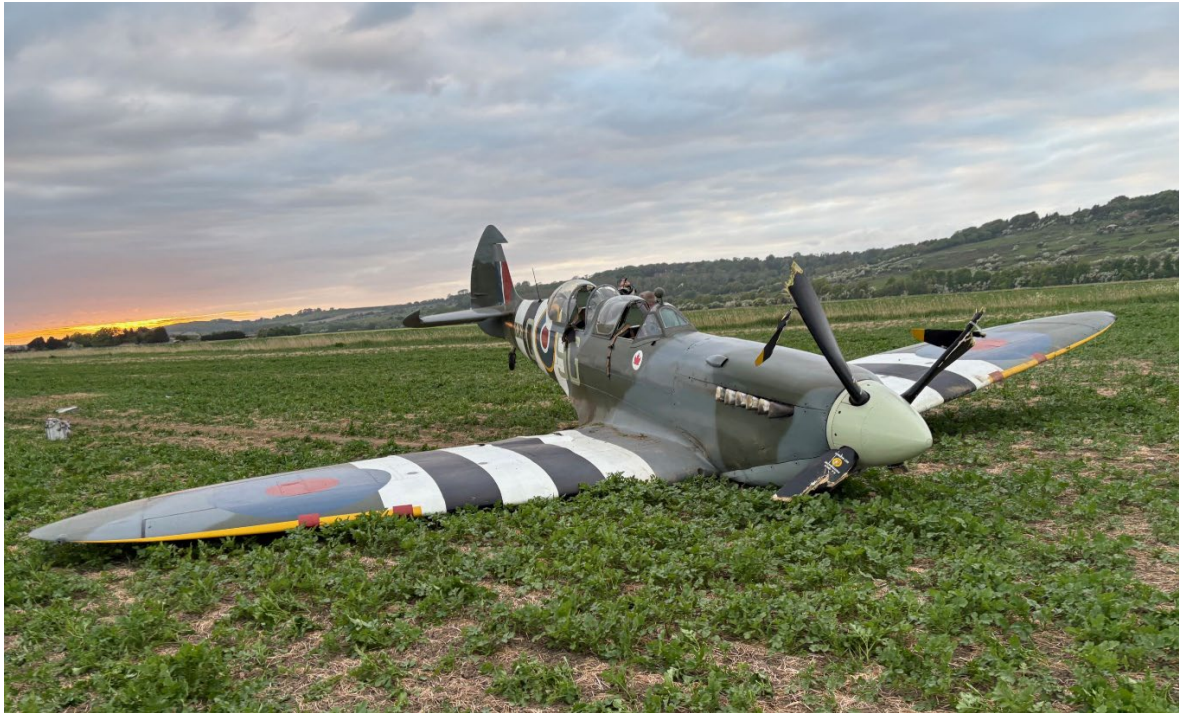
Figure 1
Spitfire Mk IX, G-BMSB

The aircraft had been flying for about 35 minutes when the pilot noticed a slight engine vibration. This was rapidly followed by a power loss. The pilot noted a distinct smell of fuel in the cockpit and suspected a fuel problem. He briefed his passenger and established a stable glide descent to carry out a wheels-up forced landing in a field. The aircraft landed on its underside and came to a stop (Figure 1). The passenger suffered minor injuries and the pilot was uninjured.

The aircraft was operating on a Safety Standards Acknowledgement and Consent (SSAC) passenger flight and was flying in formation with another Spitfire. It had been flying for about 35 minutes and was roughly two miles south of Lympne Castle in Kent, when the pilot noticed a slight engine vibration. He checked the engine temperatures, pressures and rpm, all of which appeared normal. However, within five seconds of the onset of the vibration, the engine rapidly lost power. It then briefly recovered, surged and appeared to lose power again. The engine started to backfire and the pilot observed dark coloured smoke emanating from the exhausts. He briefly experimented with moving the throttle to see if he could find a point where the engine would produce power, but this was unsuccessful. The pilot noted a smell of fuel in the cockpit so suspected a fuel problem. The aircraft rapidly lost airspeed and the pilot lowered the nose, chose a suitable area of open ground and made a gradual 10° right turn to line up and carry out a forced landing. He briefed his passenger, who remained calm throughout. He was in radio contact with the other Spitfire pilot who relayed a MAYDAY to Biggin Hill ATC on his behalf. He then concentrated on maintaining airspeed and energy throughout the descent but was able to establish the low fuel pressure warning light had illuminated so selected the boost pump ON. He also checked the magneto switches but neither action made any difference. He decided not to lower the landing gear. He made a slight heading adjustment to avoid overflying a caravan park and reduced the airspeed to 100 kt, closed the throttle and prepared for touchdown. He briefed his passenger to brace, gently rounded out and landed in the field. The aircraft remained upright and the pilot described how the aircraft came to a stop “surprisingly quickly”. The pilot and passenger vacated the cockpit unaided. The passenger suffered minor bruising and the pilot was uninjured. The aircraft sustained damage to its underside and propeller.

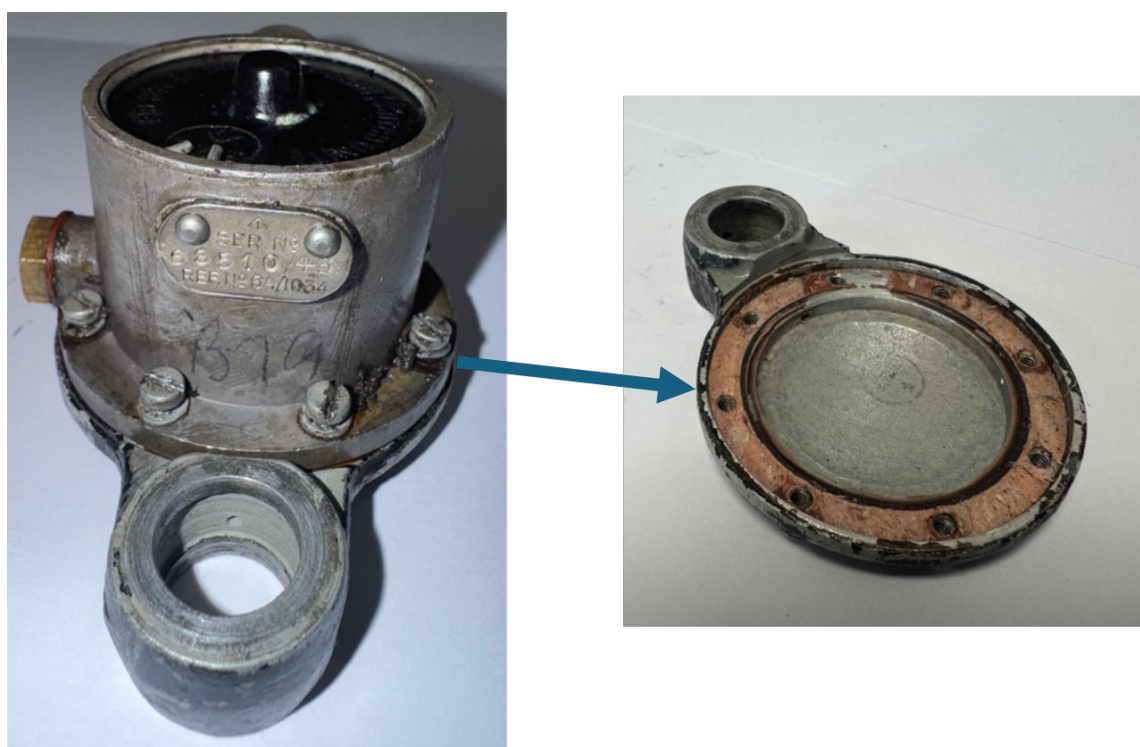
Figure 2

The aircraft was recovered to the operator's maintenance facility and examined. From the description given by the pilot, a substantial fuel leak within the engine bay was suspected. This was confirmed and a gasket fitted to the carburettor fuel low pressure switch assembly cover plate, was found to have degraded (Figure 2) probably due to ageing. The switch had developed an external leak at system pressure, because casement securing screws on the switch body had loosened off. Aging effects in elastomeric components, such as the gasket, include shrinking and hardening and it is possible that this resulted in the screws no longer being at the correct clamping torque. The fuel pressure switch was at least 70 years old and its last overhaul date was unknown.

Fuel pressure switch and degraded gasket

The leak allowed pressurised fuel to spray into the lower rear part of the engine bay, above and into the air filter box. The fuel was then being drawn into the air flow, affecting the fuel air mixture, so the engine was running extremely rich. This directly resulted in the engine vibration and power loss.

The engine lost power when a failed gasket in the fuel pressure warning switch, allowed pressurised fuel to spray into the engine bay and be drawn into the induction system. This led to an overly rich fuel mixture, resulting in the power loss.

As a result of this occurrence, the CAA issued Safety Notice (SN) SN-2025-009 '*Maintenance of historic piston and gas turbine airframe fuel/hydraulic system switches and components*', dated 9 June 2025. The SN informs historic aircraft operators and maintenance organisations of the importance of monitoring and maintaining the airworthiness of ageing tertiary fuel and hydraulic system switches and similar components.

It emphasises the need to have procedures in place to identify components that may be affected by age degradation or extended use and, to ensure that the aircraft maintenance programme includes provisions for regular inspection, periodic operational and functional checks, and calendar life limits, for such components.

The Civil Aviation Authority issued Safety Notice SN-2025-009 to inform historic aircraft operators and maintainers of the importance of monitoring and maintaining the airworthiness of ageing tertiary fuel and hydraulic system switches and similar components.
