## Accident

<b>Aircraft Type and Registration:</b>	Phoenix Wings Orca	
<b>No &amp; Type of Engines:</b>	8 electric motors	
<b>Year of Manufacture:</b>	2024 (Serial no: PW54)	
<b>Date &amp; Time (UTC):</b>	25 March 2025 at 1450 hrs	
<b>Location:</b>	Coombe Country Park, Warwickshire	
<b>Type of Flight:</b>	Commercial Operations (UAS)	
<b>Persons on Board:</b>	Crew - None	Passengers - None
<b>Injuries:</b>	Crew - N/A	Passengers - N/A
<b>Nature of Damage:</b>	Damaged beyond economic repair	
<b>Commander's Licence:</b>	Other	
<b>Commander's Age:</b>	23 years	
<b>Commander's Flying Experience:</b>	85 hours (of which 5 were on type) Last 90 days - 16 hours Last 28 days - 7 hours	
<b>Information Source:</b>	Aircraft Accident Report Form submitted by the pilot

## Synopsis

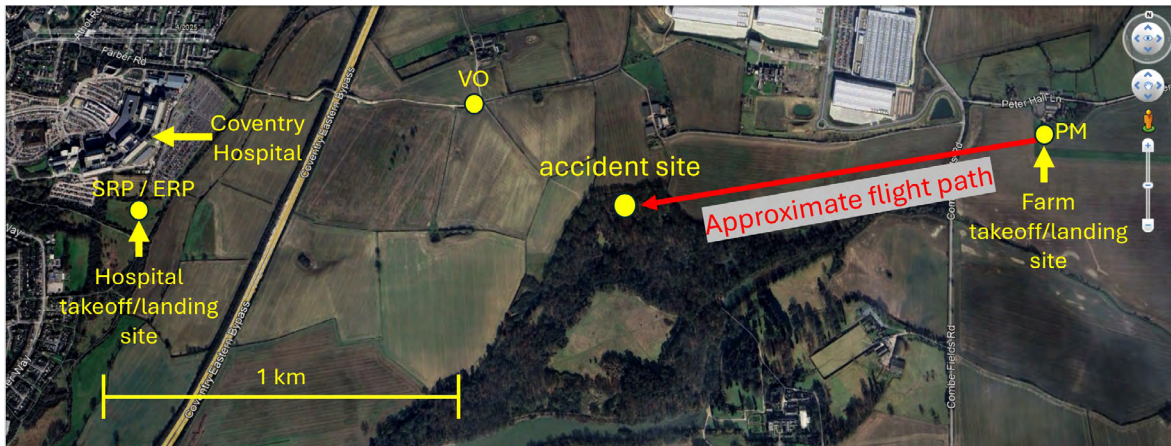
**Figure 1**

The aircraft was observed to follow the planned flight profile but as it approached approximately the halfway point the aircraft's motors suddenly stopped. The aircraft initially maintained altitude but subsequently stalled, before descending quickly and striking the ground within a wooded area (Figure 1). No persons were injured and there was no damage to property; the aircraft was damaged beyond repair.

Relative position of takeoff, landing and accident sites

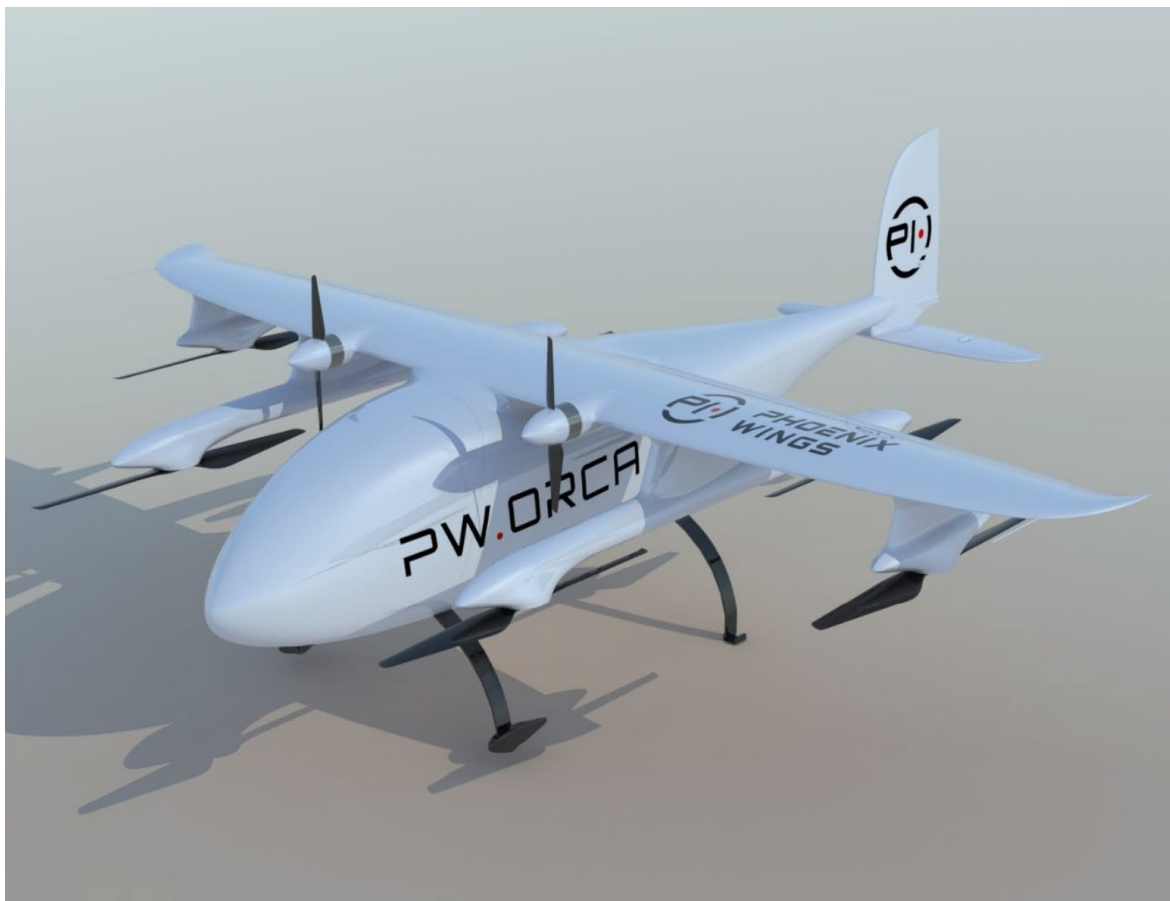
**Figure 3**

The aircraft (Figure 3) is an unmanned, electrically powered vertical takeoff and landing aircraft. It is equipped with eight propulsion motors. Six motors are installed under the wings, and these provide vertical takeoff and landing capability. Two motors are mounted at the front of the wings that provide propulsion during forward flight. The MTOW of the aircraft is 52 kg with a cruise speed of 60 kt and maximum range of 54 nm.

PW Orca  
(used with permission)
