AAIB Bulletin

10/2025

Published: 9 October 2025.

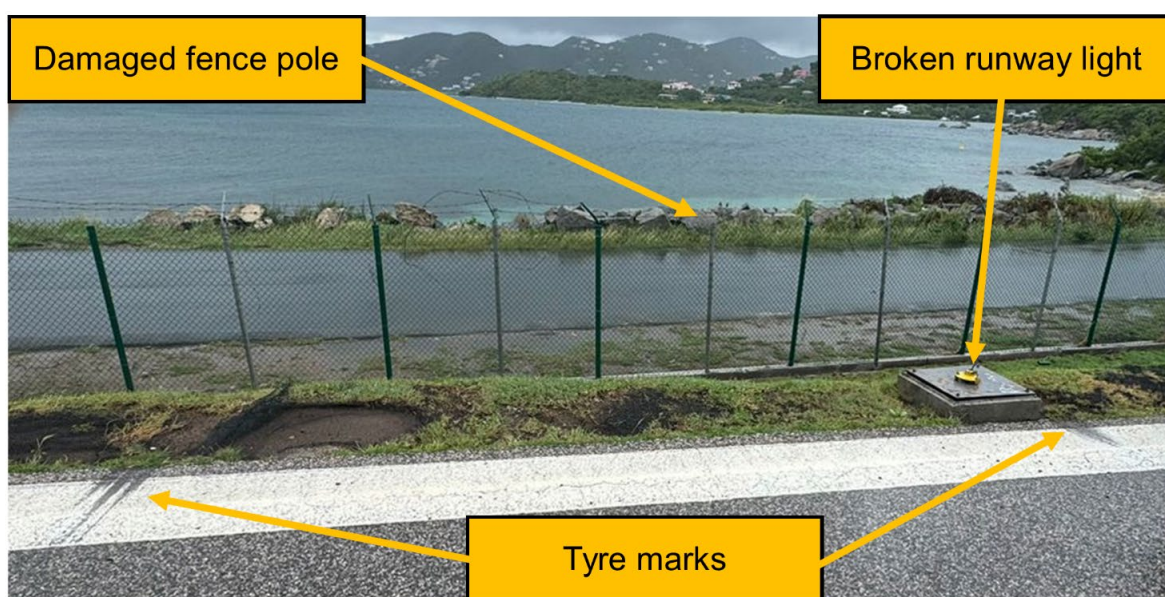
Figure 1

During an airfield inspection at TUPJ, which began at 1900 hrs Z on 6 November, it was found that a frangible light at the western edge of the Rwy 07 undershoot was missing. Tyre marks were also discovered on the extreme end of the runway. Based on the nature of the marks, their orientation and location, as well as the track between them, it was determined they were made by an aircraft rather than a ground vehicle (Figure 1). The airfield boundary fence in the Rwy 07 undershoot had also sustained damage. The barbed wire support arm on one fence pole was missing and the wire had been severed in that location (Figures 1 & 2).

Observations from the inspection of Rwy 07 undershoot

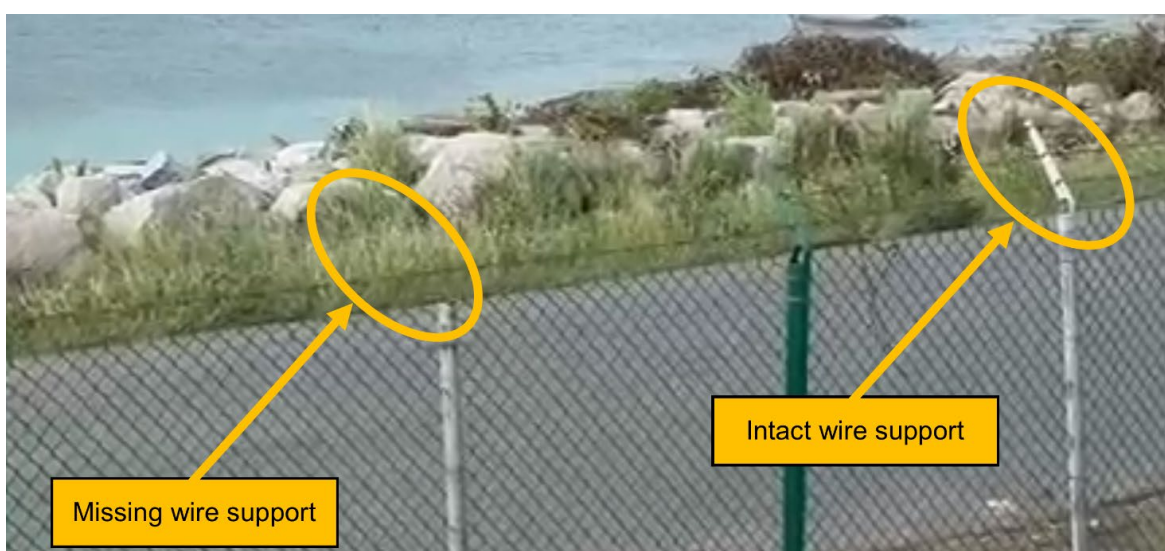
Figure 2

Broken fence pole with barbed wire support arm missing

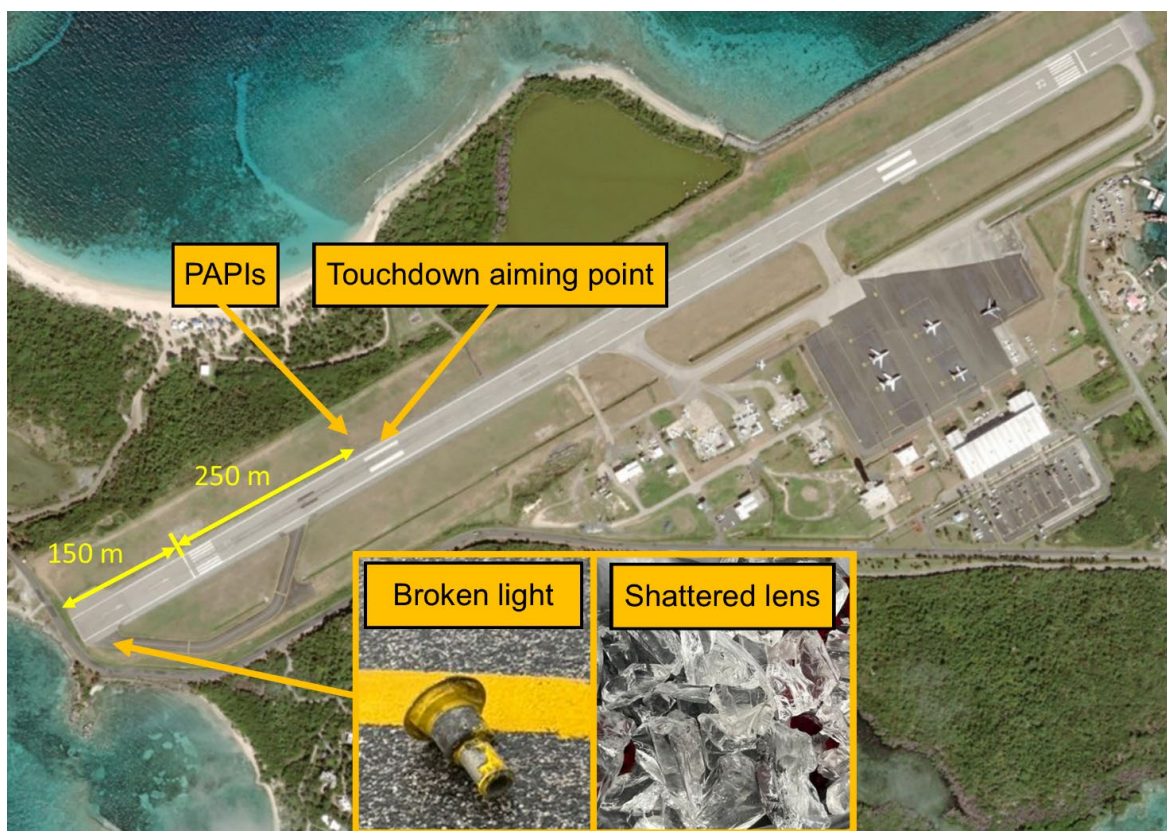
Figure 3

The body and shattered lens from the missing runway light were found at the edge of taxiway Alpha (Figure 3).

Airfield overview showing location of damage light (satellite image ©2025 Maxar)

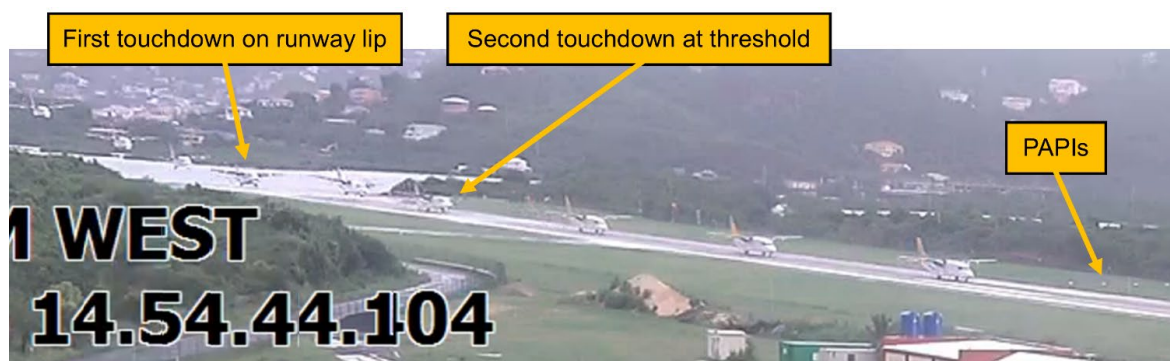
Figure 4

To determine how the damage might have occurred, the airfield authorities reviewed CCTV footage from 6 November. They found that when N915GD made its approach to Rwy 07 at 1854 hrs Z it initially touched down in the undershoot at the edge of the runway pavement, bounced once and then landed off its second touchdown (Figure 4).

Composite CCTV imagery of N915GD's approach (local time recorded on CCTV footage)

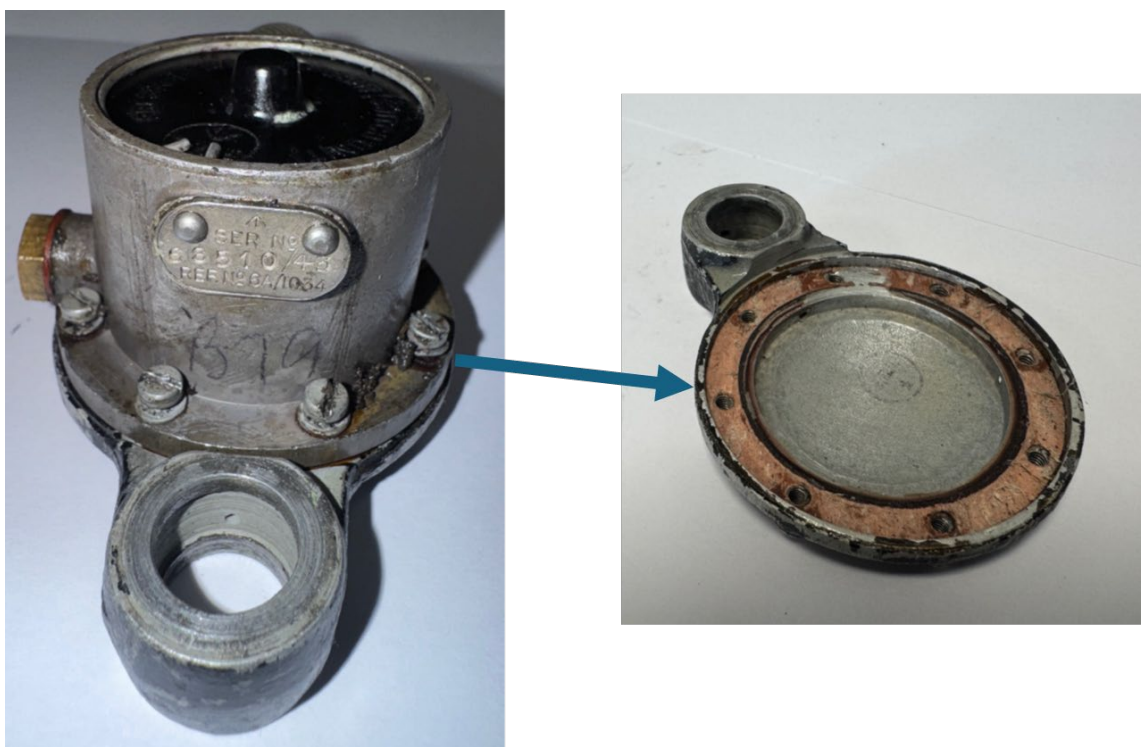
Figure 2

The aircraft was recovered to the operator's maintenance facility and examined. From the description given by the pilot, a substantial fuel leak within the engine bay was suspected. This was confirmed and a gasket fitted to the carburettor fuel low pressure switch assembly cover plate, was found to have degraded (Figure 2) probably due to ageing. The switch had developed an external leak at system pressure, because casement securing screws on the switch body had loosened off. Aging effects in elastomeric components, such as the gasket, include shrinking and hardening and it is possible that this resulted in the screws no longer being at the correct clamping torque. The fuel pressure switch was at least 70 years old and its last overhaul date was unknown.

Fuel pressure switch and degraded gasket

The leak allowed pressurised fuel to spray into the lower rear part of the engine bay, above and into the air filter box. The fuel was then being drawn into the air flow, affecting the fuel air mixture, so the engine was running extremely rich. This directly resulted in the engine vibration and power loss.

The engine lost power when a failed gasket in the fuel pressure warning switch, allowed pressurised fuel to spray into the engine bay and be drawn into the induction system. This led to an overly rich fuel mixture, resulting in the power loss.

As a result of this occurrence, the CAA issued Safety Notice (SN) SN-2025-009 '*Maintenance of historic piston and gas turbine airframe fuel/hydraulic system switches and components*', dated 9 June 2025. The SN informs historic aircraft operators and maintenance organisations of the importance of monitoring and maintaining the airworthiness of ageing tertiary fuel and hydraulic system switches and similar components.

It emphasises the need to have procedures in place to identify components that may be affected by age degradation or extended use and, to ensure that the aircraft maintenance programme includes provisions for regular inspection, periodic operational and functional checks, and calendar life limits, for such components.

The Civil Aviation Authority issued Safety Notice SN-2025-009 to inform historic aircraft operators and maintainers of the importance of monitoring and maintaining the airworthiness of ageing tertiary fuel and hydraulic system switches and similar components.

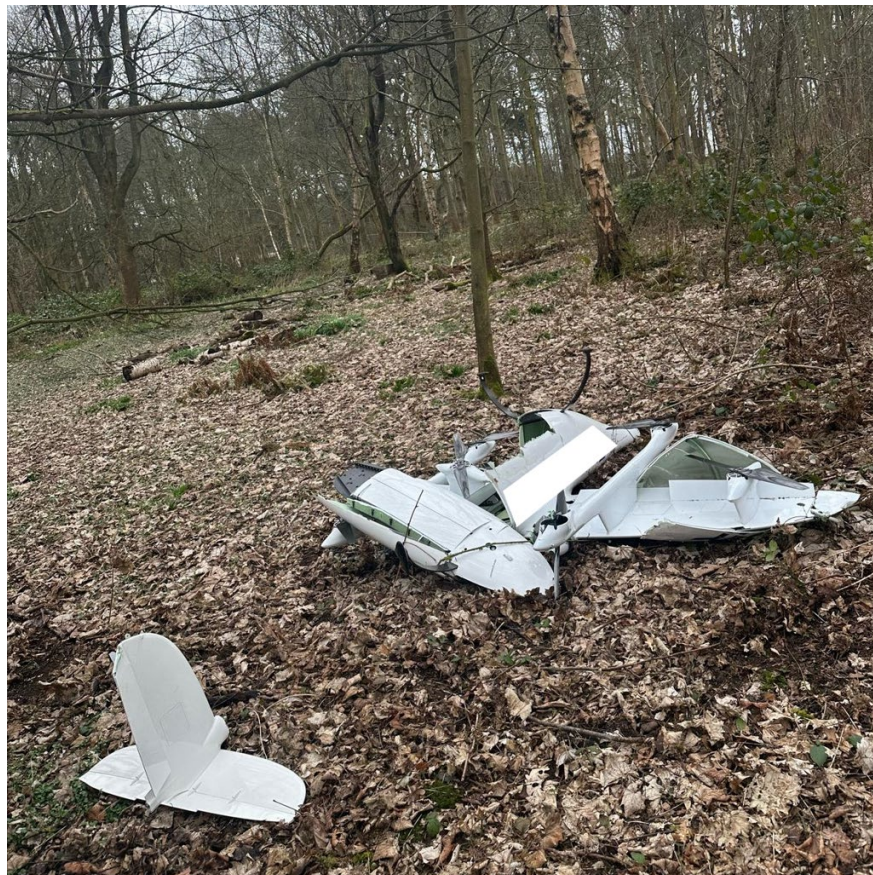
**Figure 2**

The aircraft struck the ground in a wooded area (Figure 2) which was accessible to the public. Approximately 250 m from the accident site was an outdoor activity centre.

Aircraft wreckage

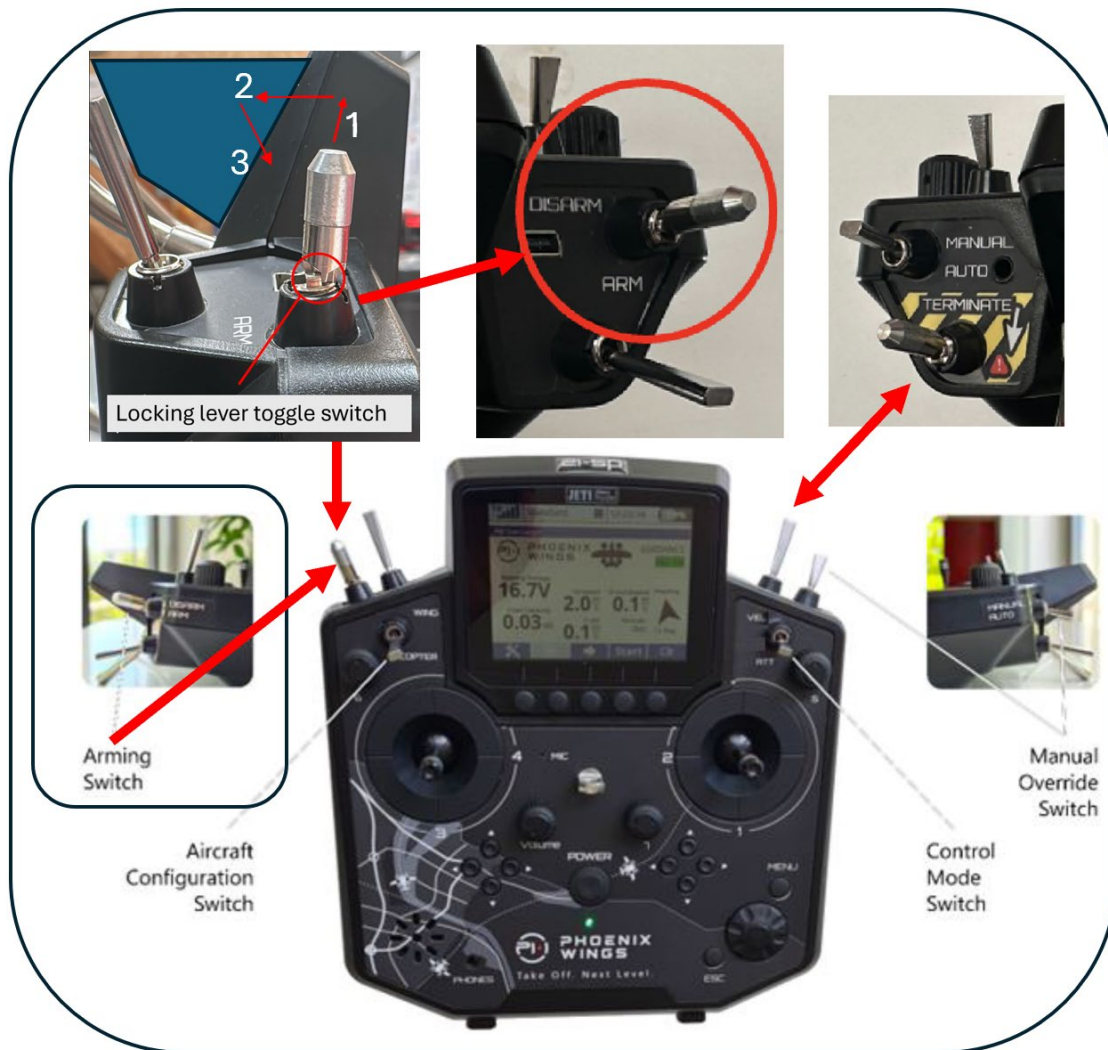
Figure 4

The cause of the accident was identified as a software bug in combination with a loss of synchronisation between the Remote Pilot (RP) and the Safety Remote Pilot (SRP), whereby the SRP's hand controller had remained set to the DISARM position when the aircraft had taken off. When the aircraft came within range of the SRP's controller, this resulted in power being removed from the aircraft's electric propulsion motors, leading to the aircraft stalling, its emergency parachute system being disabled, and a subsequent uncontrolled descent from a height of 60 m.

RP controller showing DISARM and ARM switch
