**Accident**

| <b>Aircraft Type and Registration:</b> | 1) Discus B, G-DJMD<br>2) Standard Cirrus, G-DCTB |
| <b>Date &amp; Time (UTC):</b> | 25 May 2024 at 1400 hrs |
| <b>Location:</b> | Hinton-in-the-Hedges Airfield, Northamptonshire |

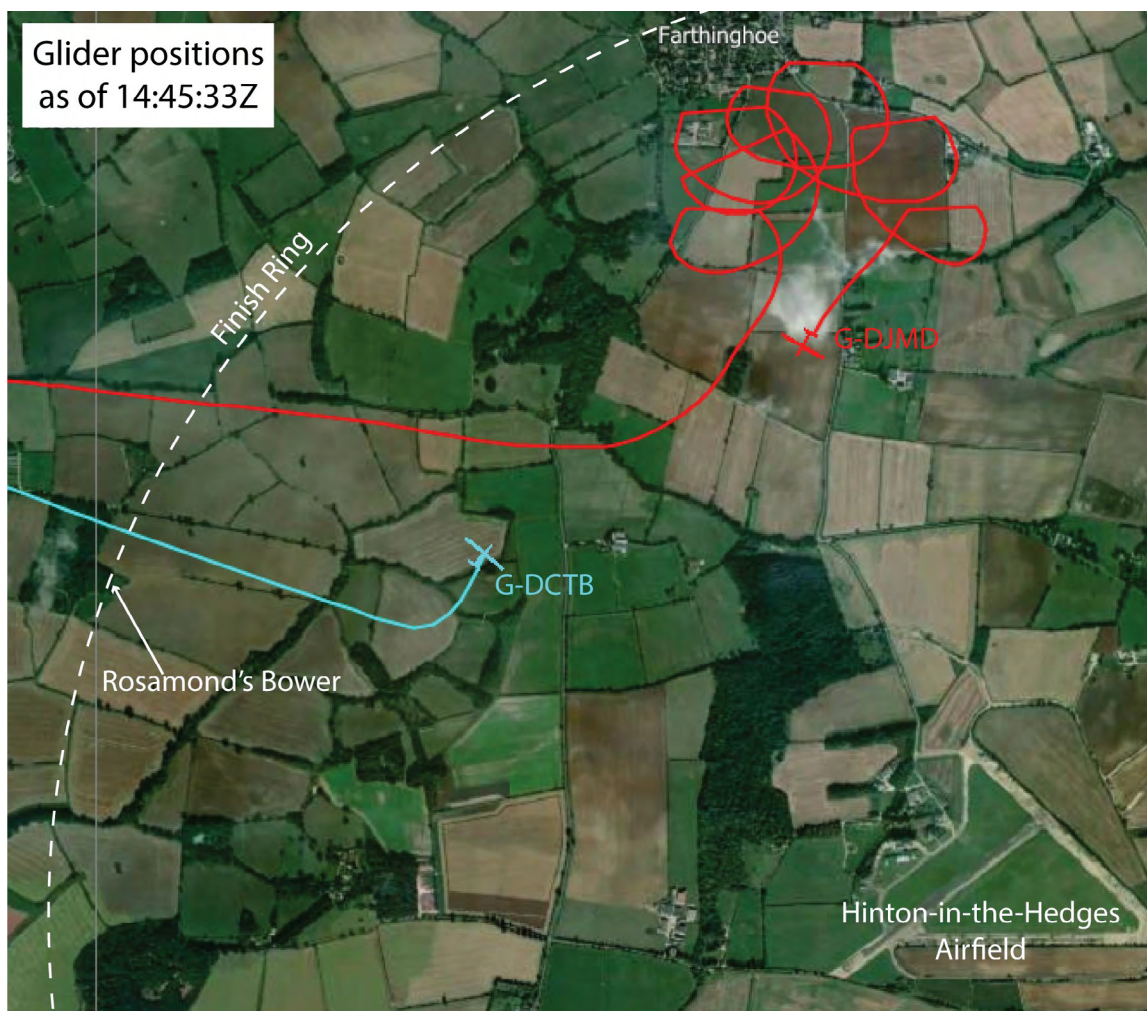
**Figure 2**

Relative positions of G-DJMD and G-DCTB as they positioned to join downwind

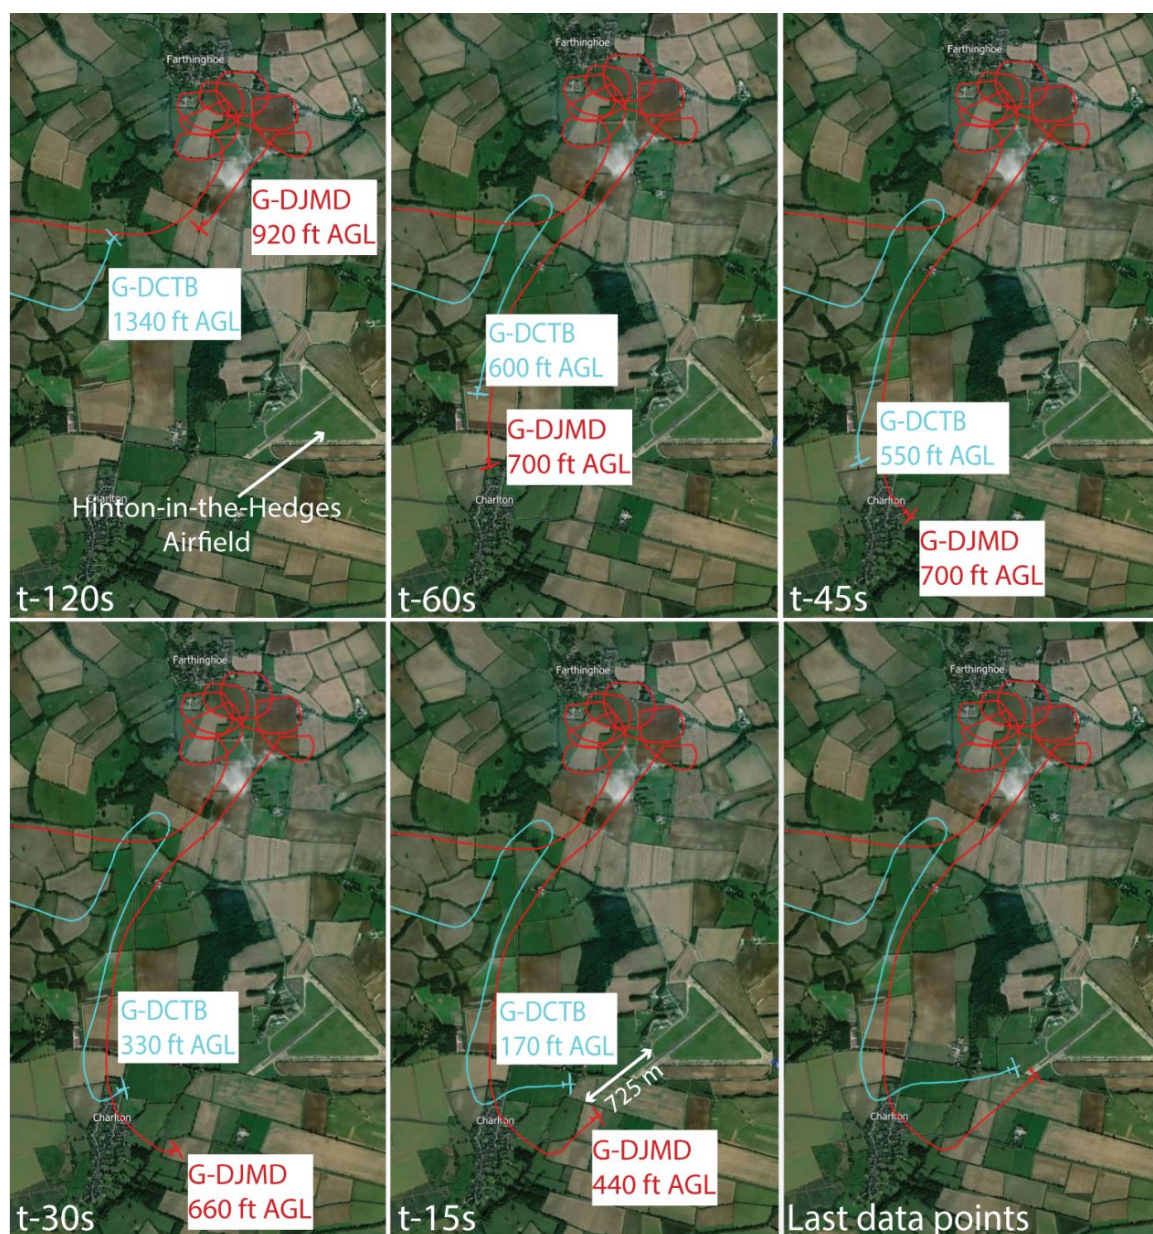
**Figure 3**

Relative positions of G-DJMD and G-DCTB over the last 120 seconds prior to the accident

Witness evidence and recorded data showed that the two gliders were on converging flight paths at an angle of approximately 30°. This created a challenging visual detection scenario with the added possibility that cockpit structure and pilot seat positions may have created blind spots. It could not be determined whether the pilots received FLARM alerts indicating the presence of the other glider, but no evasive manoeuvre was observed before the collision and so the investigation concluded that neither pilot visually detected the other glider in time to take effective avoiding action.

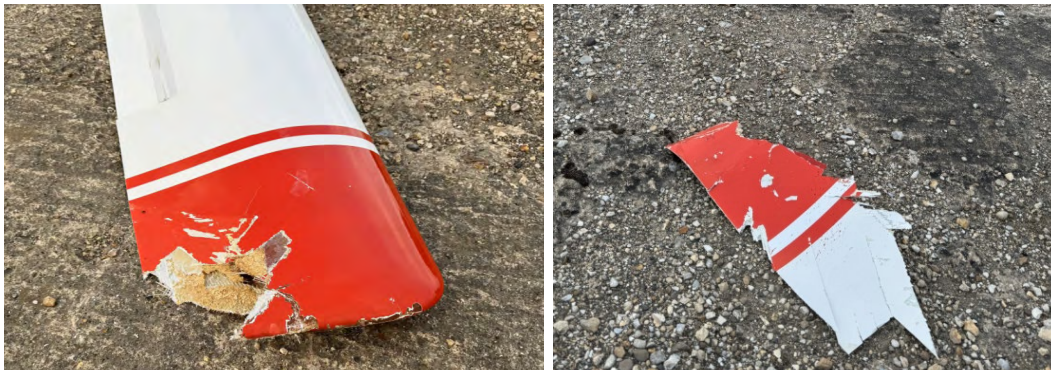
**Figure 6**

The right wingtip had impact damage; a section of the underside wingtip skin had become detached and was found approximately 40 m further back in the debris field (Figure 6).

G-DCTB right wingtip damage, and underside wingtip skin section

The right wingtip of G-DCTB contacted G-DJMD's canopy frame and canopy transparency in mid-air, causing the transparency to flex and fracture into multiple fragments. The location of the majority of G-DJMD's canopy fragments were found at the beginning of the debris field and paint transfer marks matching that of G-DCTB's wingtip were found on G-DJMD's canopy frame and transparency.

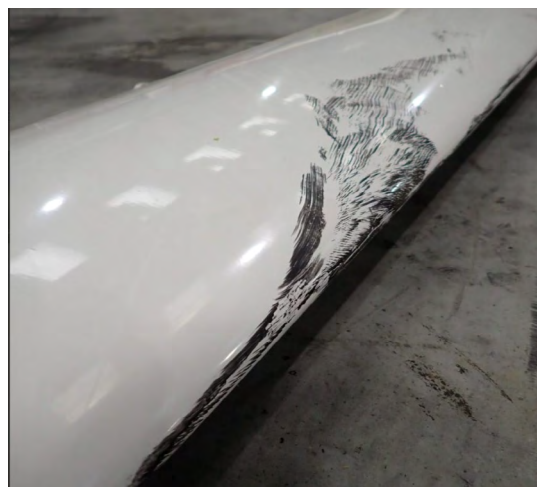
**Figure 7**

The right wing's leading edge was covered with heavy black marking, that extended to both upper and lower surfaces (Figure 7).

G-DCTB leading edge marks

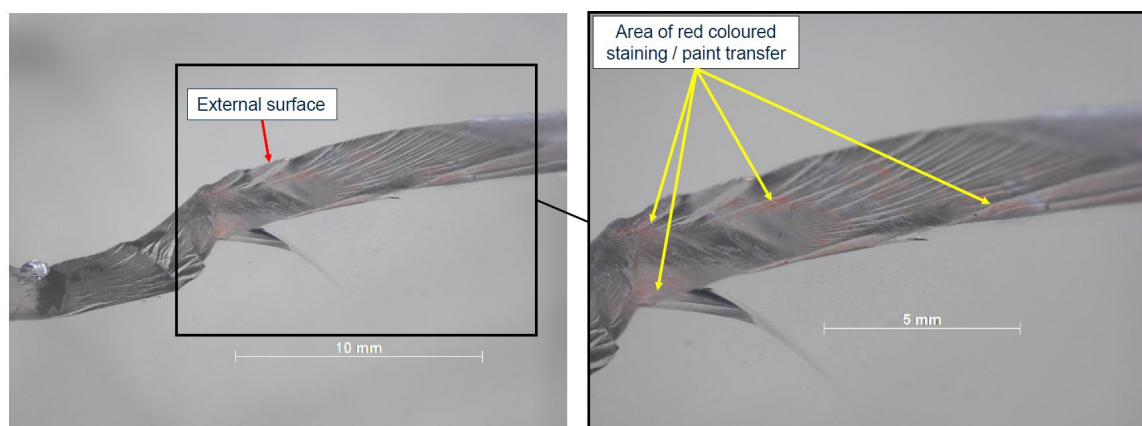
**Figure 9**

The analysis showed visible 'scarp' features (feather patterns) typical of brittle fracture on the edges of the fragments. This indicates the canopy failed from being distorted, rather than from an impact load. There was evidence of red paint transfer on fracture surfaces of two of the fragments (Figure 9) which were retrieved from the farthest part of the debris field.

Red paint transfer on canopy fragment fracture face

Crack initiation was likely to have been from at or near the window aperture, running through an area of red paint deposit. The fracture direction ran aft and upwards, before returning to the front of the canopy (Figure 10). The two areas of red paint transfer indicate pressure being broadly applied to the canopy between these points before the canopy flexed and broke, and the paint was then able to transfer onto the fracture surfaces.

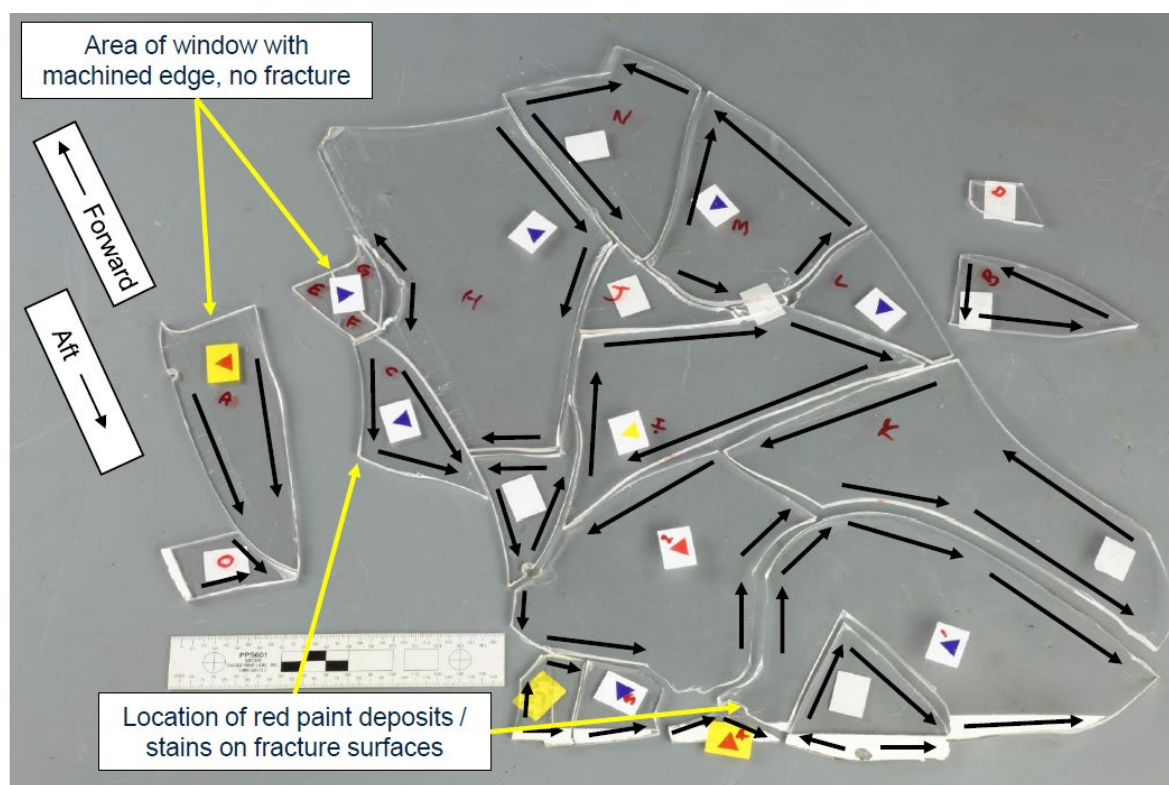
**Figure 10**

Canopy fragment reconstruction and fracture directions
