Abbreviated Dust Monitoring Report

Monitoring Period: 01 September 2025 to 28 September 2025

Project:	Grenfell Tower
Document Ref:	EEMC-DMR-201/101 – Grenfell Tower Rev 04
Period:	01 September 2025 to 28 September 2025

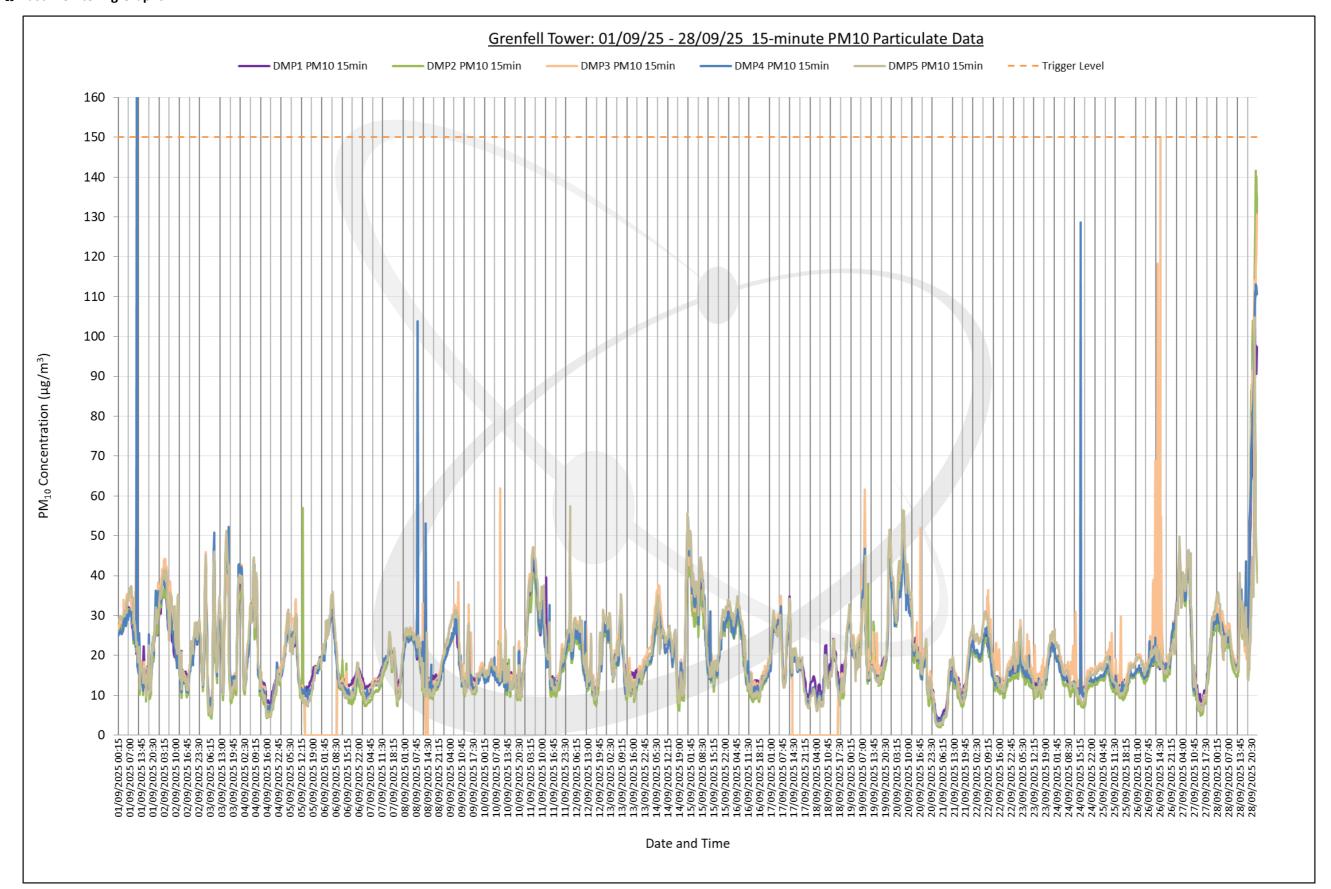
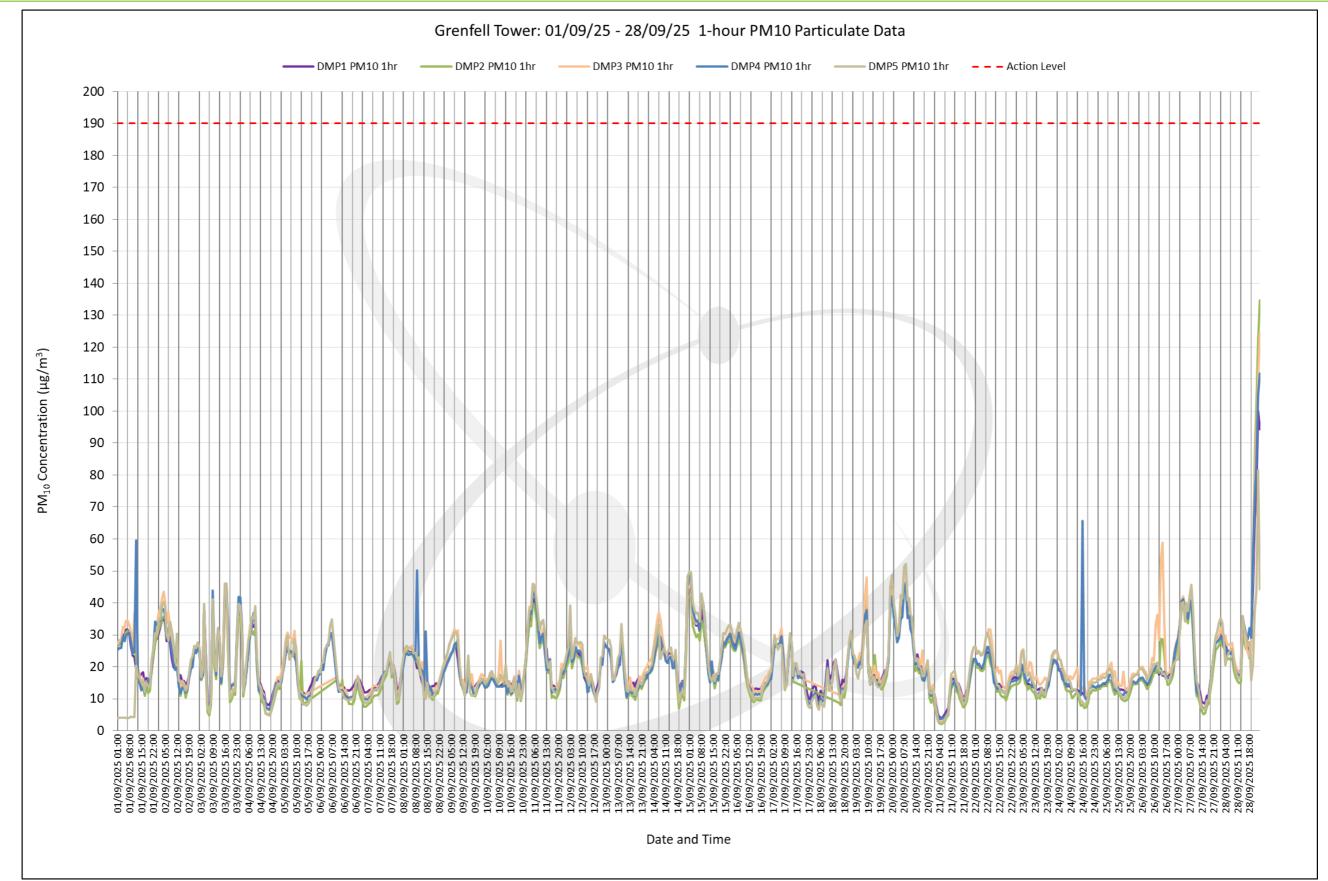
7. PM₁₀ Dust Monitoring Graphs

Time and Date of Exceedance	Measured Level of Exceedance (μg/m³)	Particle Size	Alert Level (15 mins) (μg/m³)	Monitoring Location	Cause of Exceedance	
28/09/25 23:00	80.5			DMP2		
28/09/25 23:15	76.9			DMP2	Outside site working hours.	
28/09/25 23:30	80.3			DMP2	Given the:	
29/09/25 00:00	77.9	PM _{2.5}	75	DMP2	 High humidity readings, Only the PM_{2.5} being elevated Similar exceedances from all monitors It is very likely that these exceedances were caused by the foggy weather and are not representative of any site works*. 	
26/09/25 14:45	150.1	DNA	150	DMP3	RBKC works directly under monitor	
01/09/25 11:15	187.4	PM ₁₀	150	DMP4	Not site related.

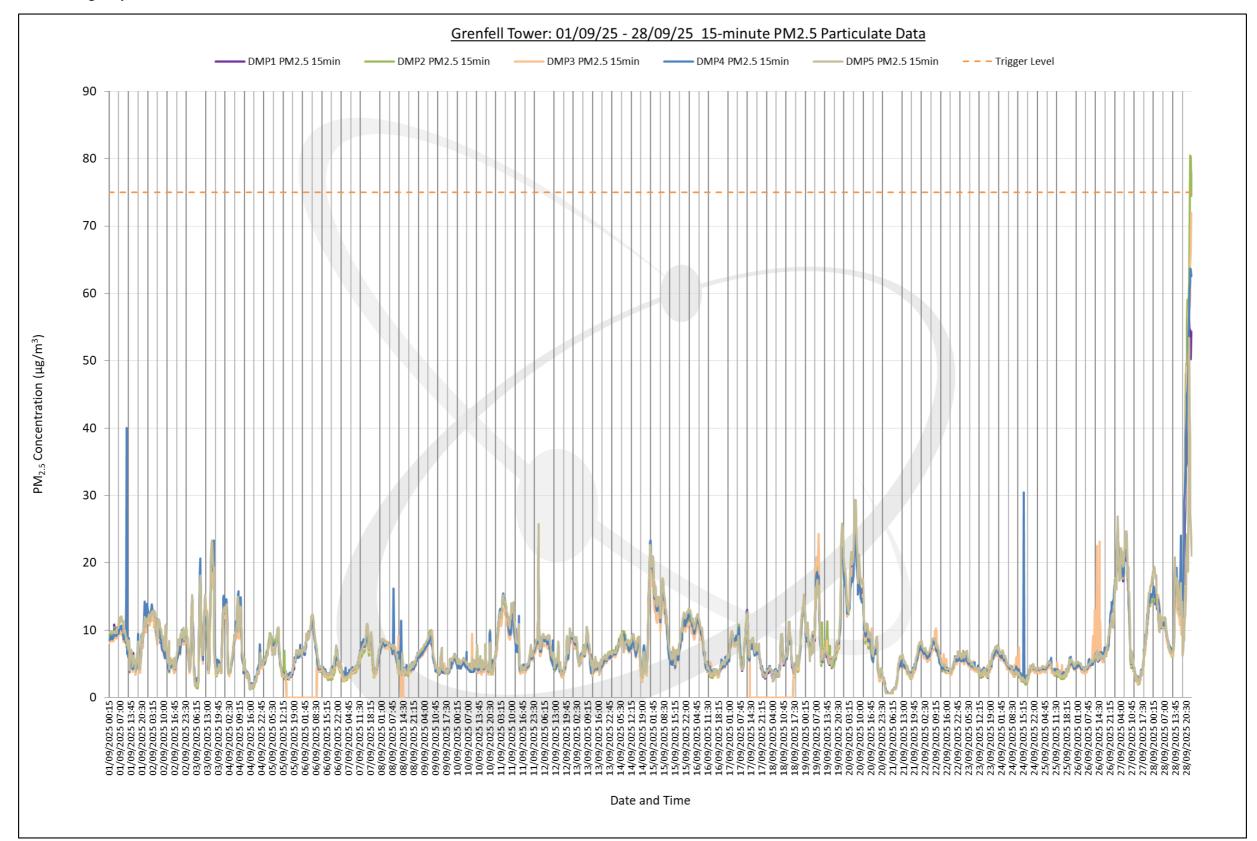
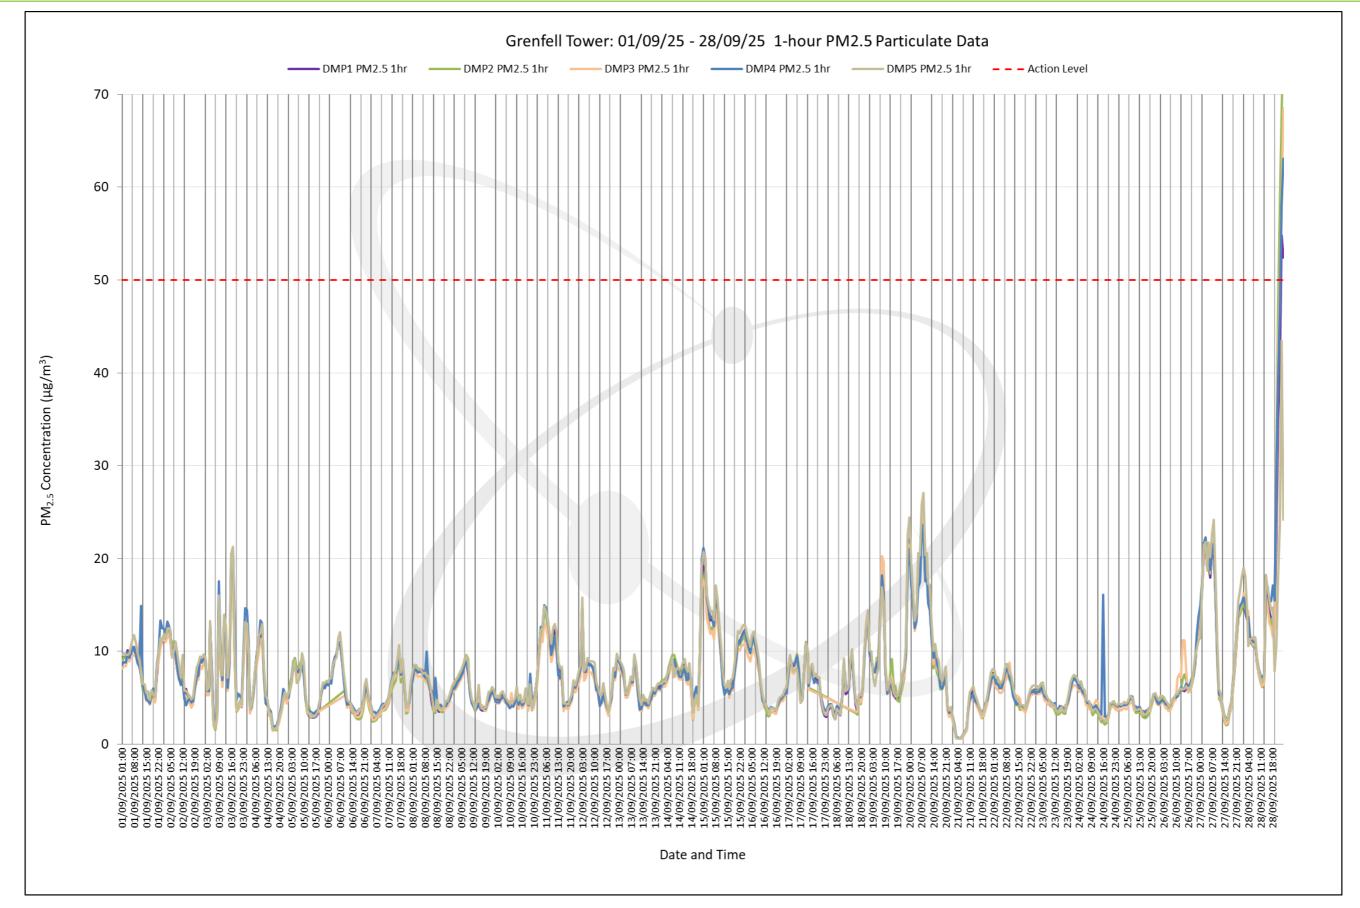
8. PM_{2.5} Dust Monitoring Graphs

- There were no exceedances of either the 15 minute PM_{10} 150 (µg/m³) or the 15 minute $PM_{2.5}$ 75 (µg/m³) Amber Trigger levels at DMP1.
- There were <u>no exceedances</u> of the 15 minute PM_{10} 150 ($\mu g/m^3$) and <u>four (4) exceedances</u> of the 15 minute PM_{2.5} 75 ($\mu q/m^3$) Amber Trigger levels at **DMP2.**
- There was one (1) exceedance of the 15 minute PM₁₀ 150 (μ g/m³) and no exceedances of the 15 minute PM_{2.5} 75 (μ g/m³) Amber Trigger levels at **DMP3.**
- There was one (1) exceedance of the 15 minute PM_{10} 150 (µg/m³) and no exceedances of the 15 minute $PM_{2.5}$ 75 (µg/m³) Amber Trigger levels at **DMP4.**
- There were no exceedances of either the 15 minute PM_{10} 150 (µg/m³) or the 15 minute $PM_{2.5}$ 75 (µg/m³) Amber Trigger levels at DMP5.

^{*}Foggy weather can affect PM_{2.5} due to a combination of; stagnant air, low wind and an increase in humidity. It can also be explained due to a phenomena known as-pollutant fog. This is due to an increased humidity, causing a false reading of water droplet molecules on the light scattering sensor. Increased humidity can cause aerosols to absorb water and therefore grow in size. This is known as 'hygroscopic growth'.

- There were <u>no exceedances</u> of the 1 hour PM₁₀ 190 (μ g/m³) and <u>two(2) exceedances</u> of the 1 hour PM_{2.5} 50 (μ g/m³) Red Action Alert levels at **DMP1**.
- There were <u>no exceedances</u> of the 1 hour PM₁₀ 190 (μ g/m³) and <u>three (3) exceedances</u> of the 1 hour PM_{2.5} 50 (μ g/m³) Red Action Alert levels at **DMP2**.
- There were <u>no exceedances</u> of the 1 hour PM₁₀ 190 (μ g/m³) and <u>two (2) exceedances</u> of the 1 hour PM_{2.5} 50 (μ g/m³) Red Action Alert levels at **DMP3**.
- There were <u>no exceedances</u> of the 1 hour PM₁₀ 190 (μ g/m³) and <u>two (2) exceedances</u> of the 1 hour PM_{2.5} 50 (μ g/m³) Red Action Alert levels at **DMP4.**
- There were <u>no exceedances</u> of either the 1 hour PM_{10} 190 (µg/m³) or the 1 hour $PM_{2.5}$ 50 (µg/m³) Red Action Alert levels at **DMP5**.
