# Rail Accident Report

Pedestrian struck by a train at Bourneview footpath crossing, London Borough of Croydon, 23 January 2025

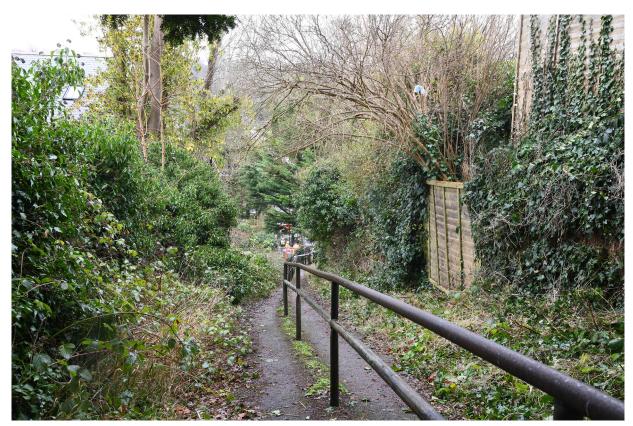
Figure 3: Approach to Bourneview crossing from Valley Road.

- 12 In common with many footpath crossings, Bourneview crossing does not have any active protection, such as lights, to warn users of approaching trains, or barriers, to restrict access over the crossing. Crossing users on foot are expected to stop, look and listen for approaching trains, and to make their own decision about whether or not it is safe to cross.
- 13 The approach to Bourneview crossing from Valley Road (the one used by the pedestrian) is down a footpath, approximately 80 metres long, which forms a public right of way (figure 3). Although this path has a solid surface, at the time of the accident this was encroached on and overhung by vegetation, giving it the general appearance of a muddy path. The path slopes down from the road to the railway, between two residential gardens.

- 75 The design and construction of the crossing could have made it more obvious to pedestrians that they were entering a potentially hazardous area. This is a possible causal factor.
- The approach to Bourneview crossing along the path from Valley Road (paragraph 13) has a semi-rural appearance. On the slightly muddy and sloped surface, which has some protruding tree roots, the main risk that a pedestrian was likely to perceive was one of slips or trips. Although signs are fitted at the kissing gate which marks the railway boundary (paragraph 16), these are some distance to the left of a user's eyeline. The fence line and gate themselves are also old and unimposing and potentially do not give the user strong visual cues that they are entering a change of environment and approaching an operational railway.

- Given the nature of the surfaces, it may be that users approaching the crossing would be looking downwards and watching their step, to avoid slipping or tripping, rather than looking up at the signs at the gate and decision point. In the case of the pedestrian involved in this accident, their gaze was probably downwards on approach to the crossing while looking at their phone (paragraph 54). In addition, their lower height (paragraph 56) meant that the level crossing signage would have been above their eyeline and so may not have been as obvious to them. As there are no markings on the ground, nor substantial changes in the colour, texture or surface of the path, there is nothing to alert a user who is distracted and looking down that they are approaching the railway or to prompt them to look up.

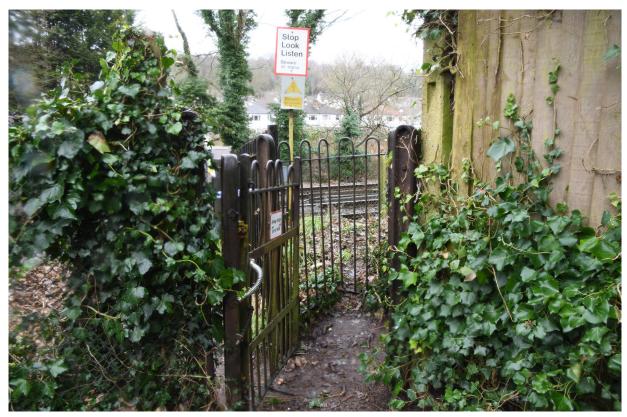
Figure 4: The kissing gate on the Valley Road side of the crossing.

- 17 The gate leads users through the railway boundary into a corridor around 4 metres long, enclosed with metal fencing approximately 1.25 metres tall. RAIB has determined that the fenced corridor inside the gate on the Valley Road side of the crossing (the approach used by the pedestrian involved in the accident) is about 4.15 metres long, and that it ends about 2 metres from the nearest running rail of the Up Caterham line (figure 5).

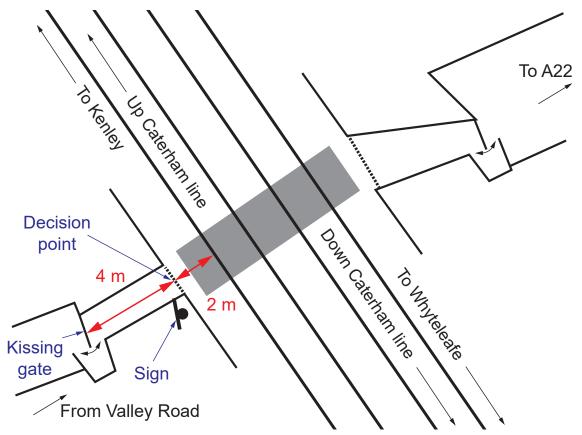
Figure 6: Layout of the crossing.

- The position where the fenced corridor ends is the 'decision point' for pedestrians crossing from this side (figure 6). This is the notional point at which pedestrian users are expected to decide whether it is safe to cross the railway. A decision point is also located 2 metres from the nearest rail on the Bourne View side of the crossing, for pedestrians crossing in the other direction.

- 21 The distance between the decision points on either side of the railway is known as the 'traverse distance'. RAIB measured this distance to be 9 metres (Network Rail's risk assessment placed the Valley Road side decision point 1.9 metres from the nearest rail, so calculated the traverse distance as 8.9 metres).

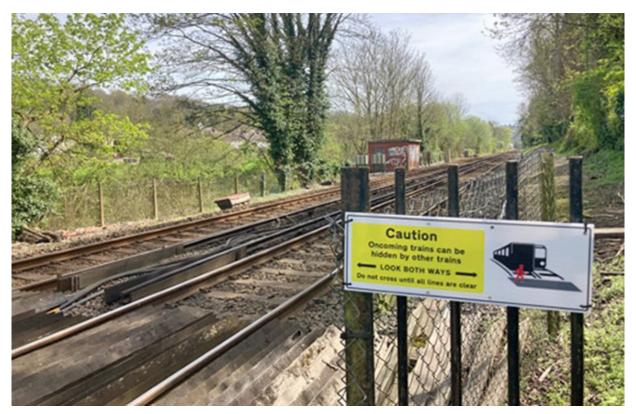
Figure 7: View from the decision point of trains approaching from Whyteleafe.

20 On the day of the accident, RAIB measured the sighting distances (the distances at which approaching trains can be seen by crossing users) in each direction from the decision points on each side of the railway. On the Valley Road side, a user standing at the decision point can see for around 850 metres towards Whyteleafe (the direction from which the train involved in the accident approached). Beyond this point, the railway passes under a bridge and curves to the right from the user's point of view (figure 7). Looking from this decision point in the other direction, the railway curves to the left and users can see for around 275 metres towards Kenley station.

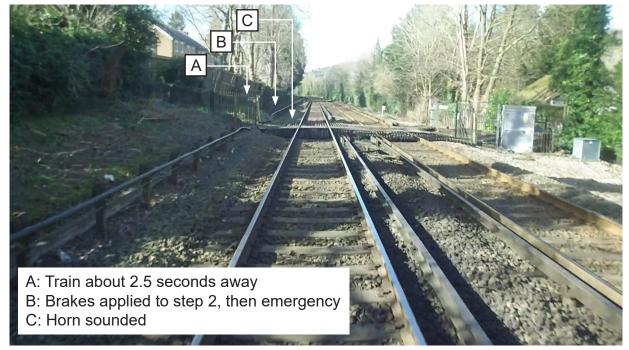
Figure 8: The positions of the pedestrian as the train approached.

- Shortly afterwards, when the train was about 35 metres from the crossing, the pedestrian can be seen between the end of the fence and the nearest rail (figure 8). The driver moved the train's brake control through step 3 (full service braking) and into the emergency braking position.

- Images from the train's FFCCTV system show that the pedestrian was at this stage walking at a steady pace, looking ahead and down at a glowing object, almost certain to be the illuminated screen of a mobile phone in their hands. They had their coat hood pulled up over their head.

44 The train driver began sounding the train's warning horn around 0.5 seconds after the emergency brake application, when the train was about 15 metres from the crossing and travelling at 53 mph (85 km/h). The pedestrian briefly looked up, apparently in response to the horn, but they did not have time to react or move out of the train's path. They were struck by the left-hand front corner of the train (in the direction of travel) and sustained fatal injuries. There is no evidence to suggest that the pedestrian was aware of the approaching train before the warning horn was sounded.
