# ***AAIB Bulletin***

# ***11/2025***

| Boeing 737-8K5 | G-TAWB | 16-Dec-24 | 3 |

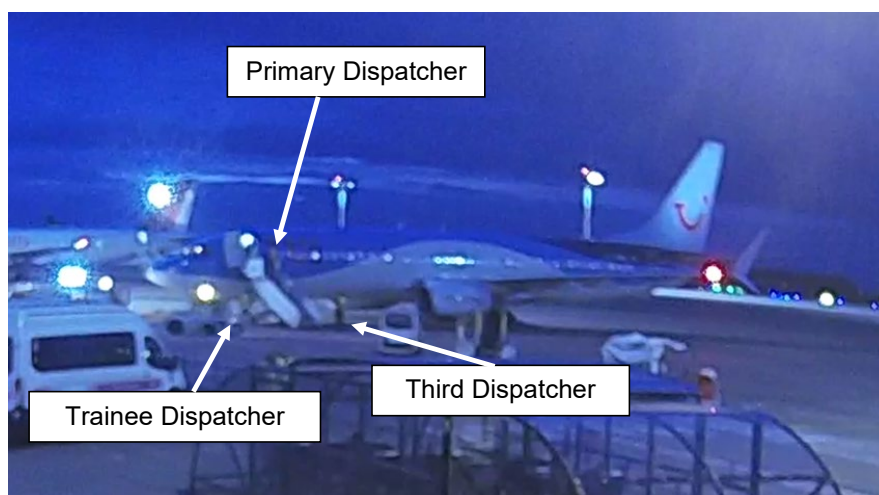
**Figure 5**

SCCM could not position herself back into the aircraft before the gap was sufficient for her to fall between the steps and the aircraft. He saw her try to hang onto the door, but she was unable to do so. The trainee dispatcher did not see the steps move or the fall as he had his back to the aircraft.

A screenshot of the CCTV showing the position of the dispatchers when the steps were moved

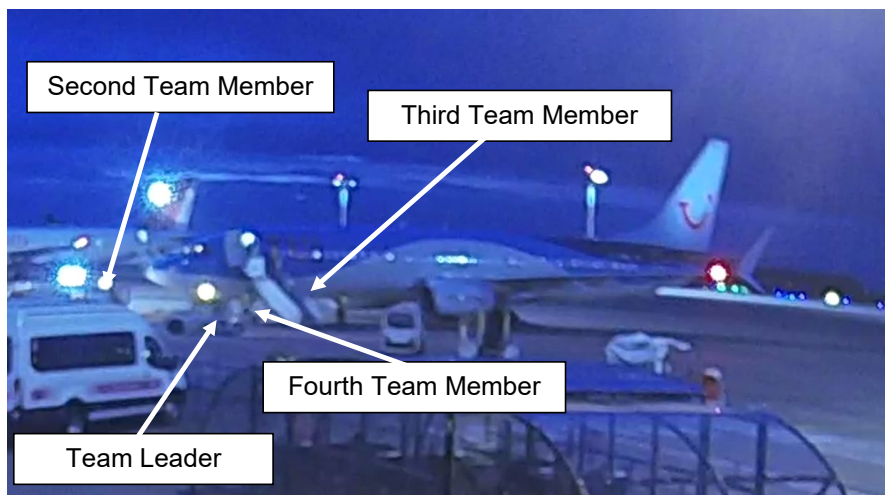
**Figure 6**

The fourth member of the ramp team had also completed nearly four years on the ramp at the airport. He was intended to be on the headset with the flight deck for the pushback so once the rear steps had been removed, he commenced his walkaround of the aircraft in preparation. He waited by the front of the aircraft for the boarding to be complete and around five minutes later saw a dispatcher releasing the stabilisers of the front steps. He understood this to be the dispatcher from the aircraft and therefore the door closure must be complete. He then moved under the steps on the nose side of the aircraft and together with his colleague began to push the steps once the brake was released. He heard a sound and turned around to see the SCCM laying on the ramp.

A screenshot of the CCTV showing the position of the ramp team when the steps were moved

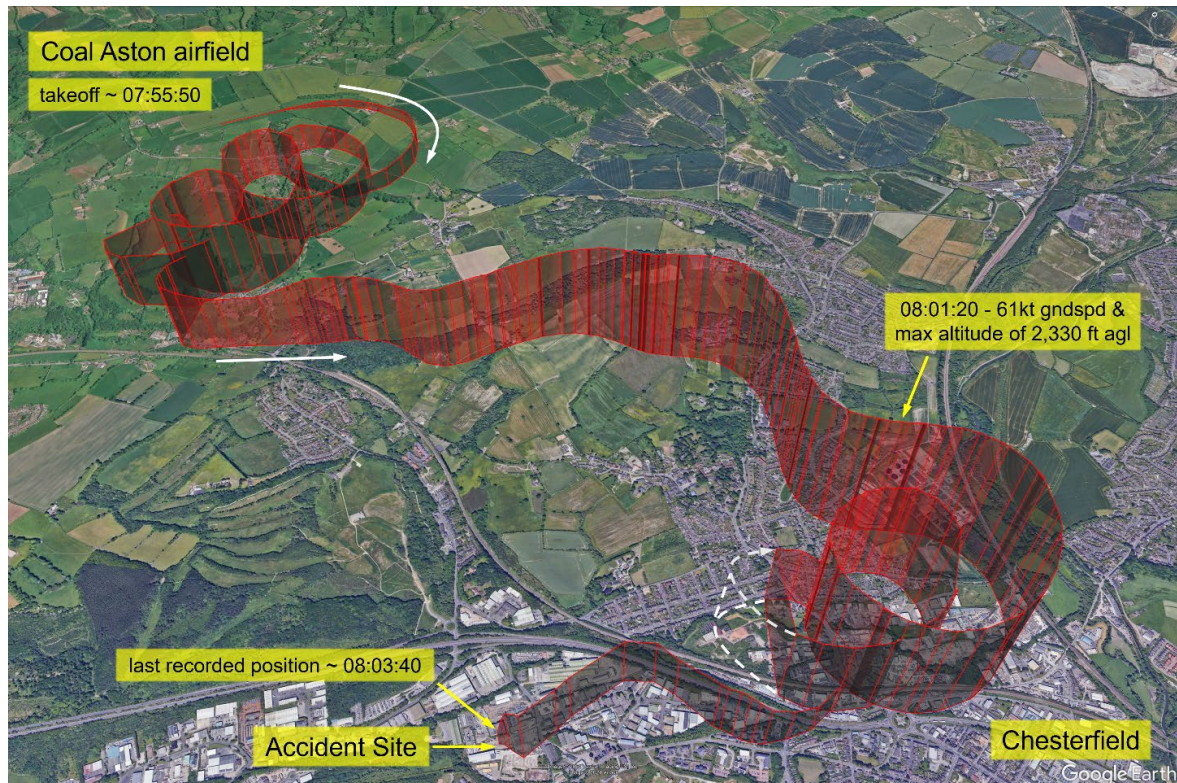
**Figure 1**  
GPS track of the flight

The aircraft was fitted with an ADS-B Out avionics device and its broadcasts of GPS position were recorded on ground stations that were in line of sight of the aircraft. Figure 1 illustrates the recorded track of the aircraft from Coal Aston airfield to a point approximately 400 ft above the accident site just under eight minutes later.

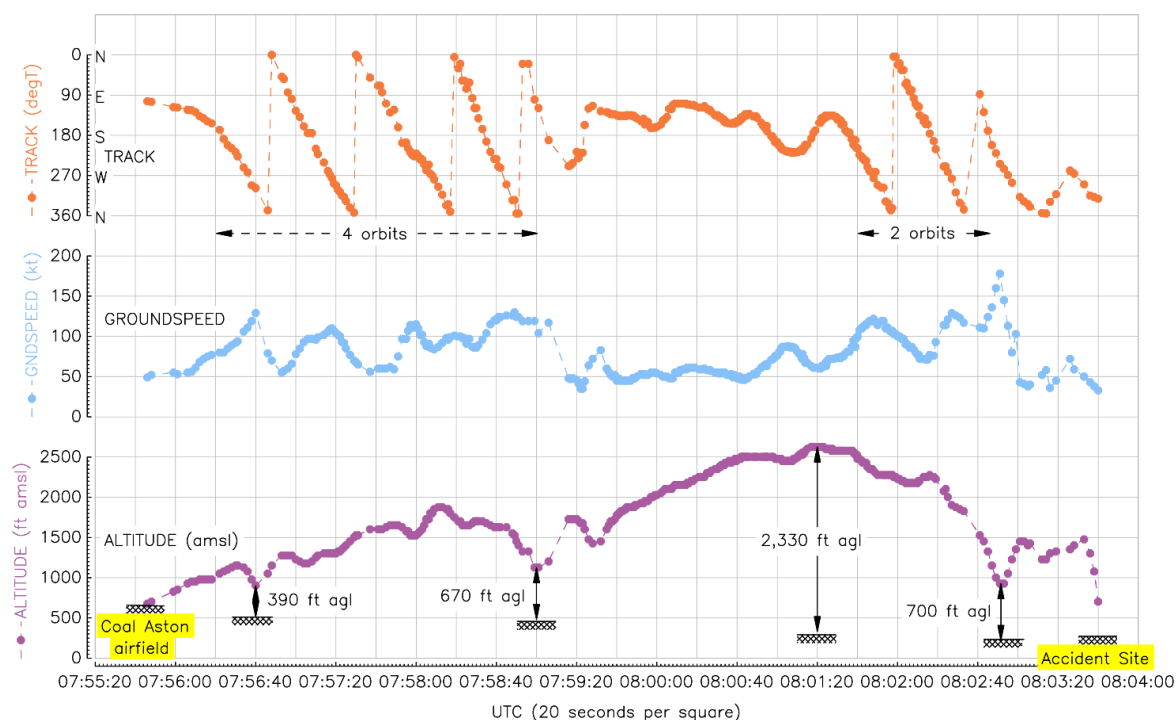
**Figure 2**

Figure 2 plots altitude and data derived from the GPS positions. Both figures show the aircraft initially climbing and descending in a series of right orbits to the south of the airfield. During the first orbit the aircraft descended to about 390 ft agl and then climbed away at over 3,000 ft/min. On the fourth orbit the aircraft descended to about 670 ft agl at a similar rate. Groundspeed varied between 50 and 130 kt. The aircraft then headed towards Chesterfield, on lower ground to the south, in a series of turns and climbing to a maximum altitude for the flight of 2,330 ft agl.

GPS derived data for accident flight with some ground elevations illustrated

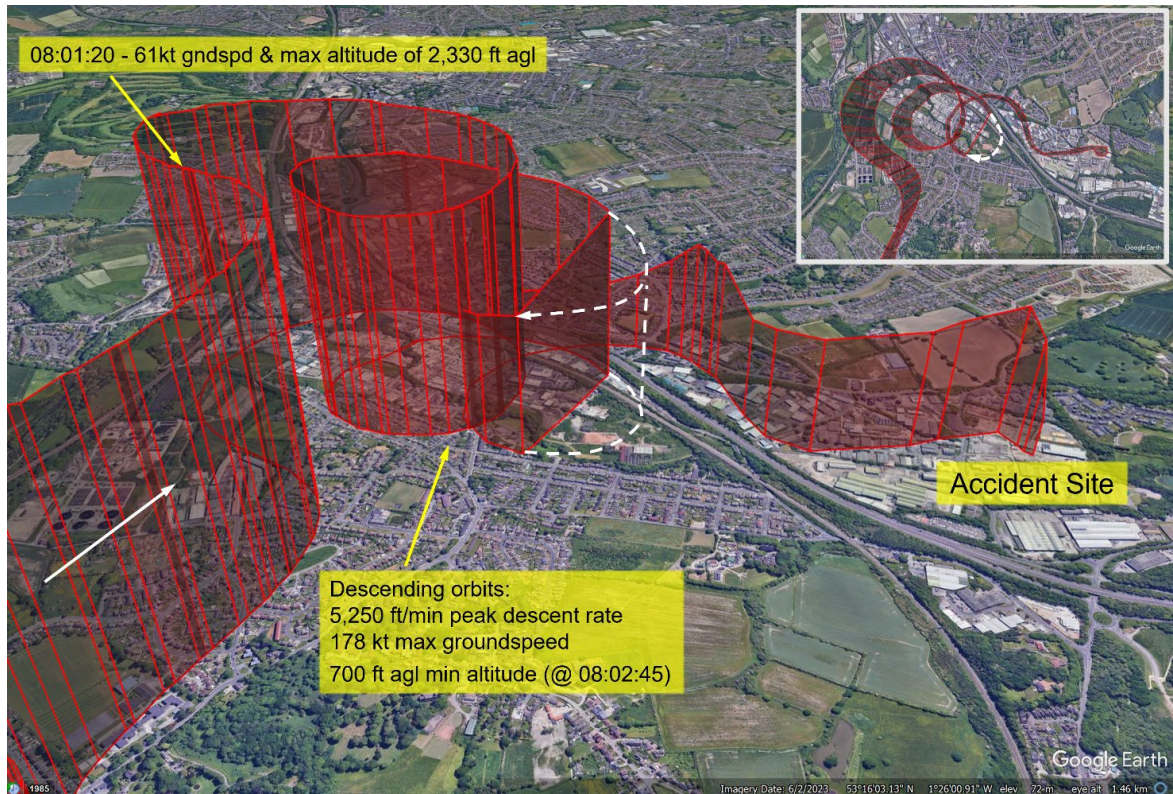
**Figure 3**

GPS track of aircraft over Chesterfield with descending orbits highlighted

Upon reaching Chesterfield, the pilot made two descending right-hand orbits. During these manoeuvres, the aircraft accelerated to a groundspeed of 178 kt with a peak descent rate of 5,250 ft/min. The aircraft then climbed from a low point of approximately 700 ft agl to just over 1,200 ft agl. A witness in the area observed an aircraft emerging from the clouds, turning towards the industrial estate, and then climbing at a steep angle until it disappeared back into clouds. It is likely that, on gaining visual contact with the ground after the descending orbits and being confronted with a built-up area and rising terrain, the pilot attempted to increase separation by initiating a rapid climb.

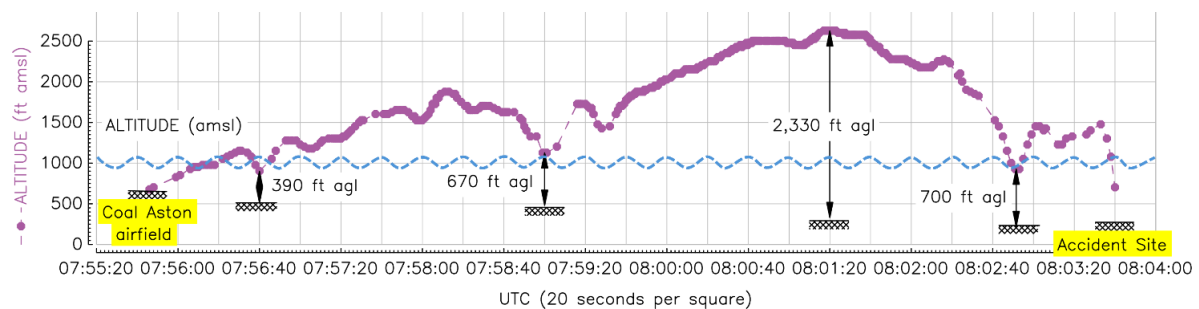
**Figure 10**

Witness observations of the aircraft appearing below cloud near Coal Aston and Chesterfield are consistent with recorded data and a cloud base of approximately 1,000 ft amsl as detailed by the Met Office aftercast (Figure 10).

Aircraft altitude (extract from Figure 2) against a 1,000 ft amsl cloud base
