## Abbreviated Vibration Monitoring Report

Monitoring Period: 29 September 2025 to 02 November 2025

| <b>Project:</b> | Grenfell Tower |
| <b>Document Ref:</b> | EEMC-VMR-201/102 – Grenfell Tower Rev 02 |

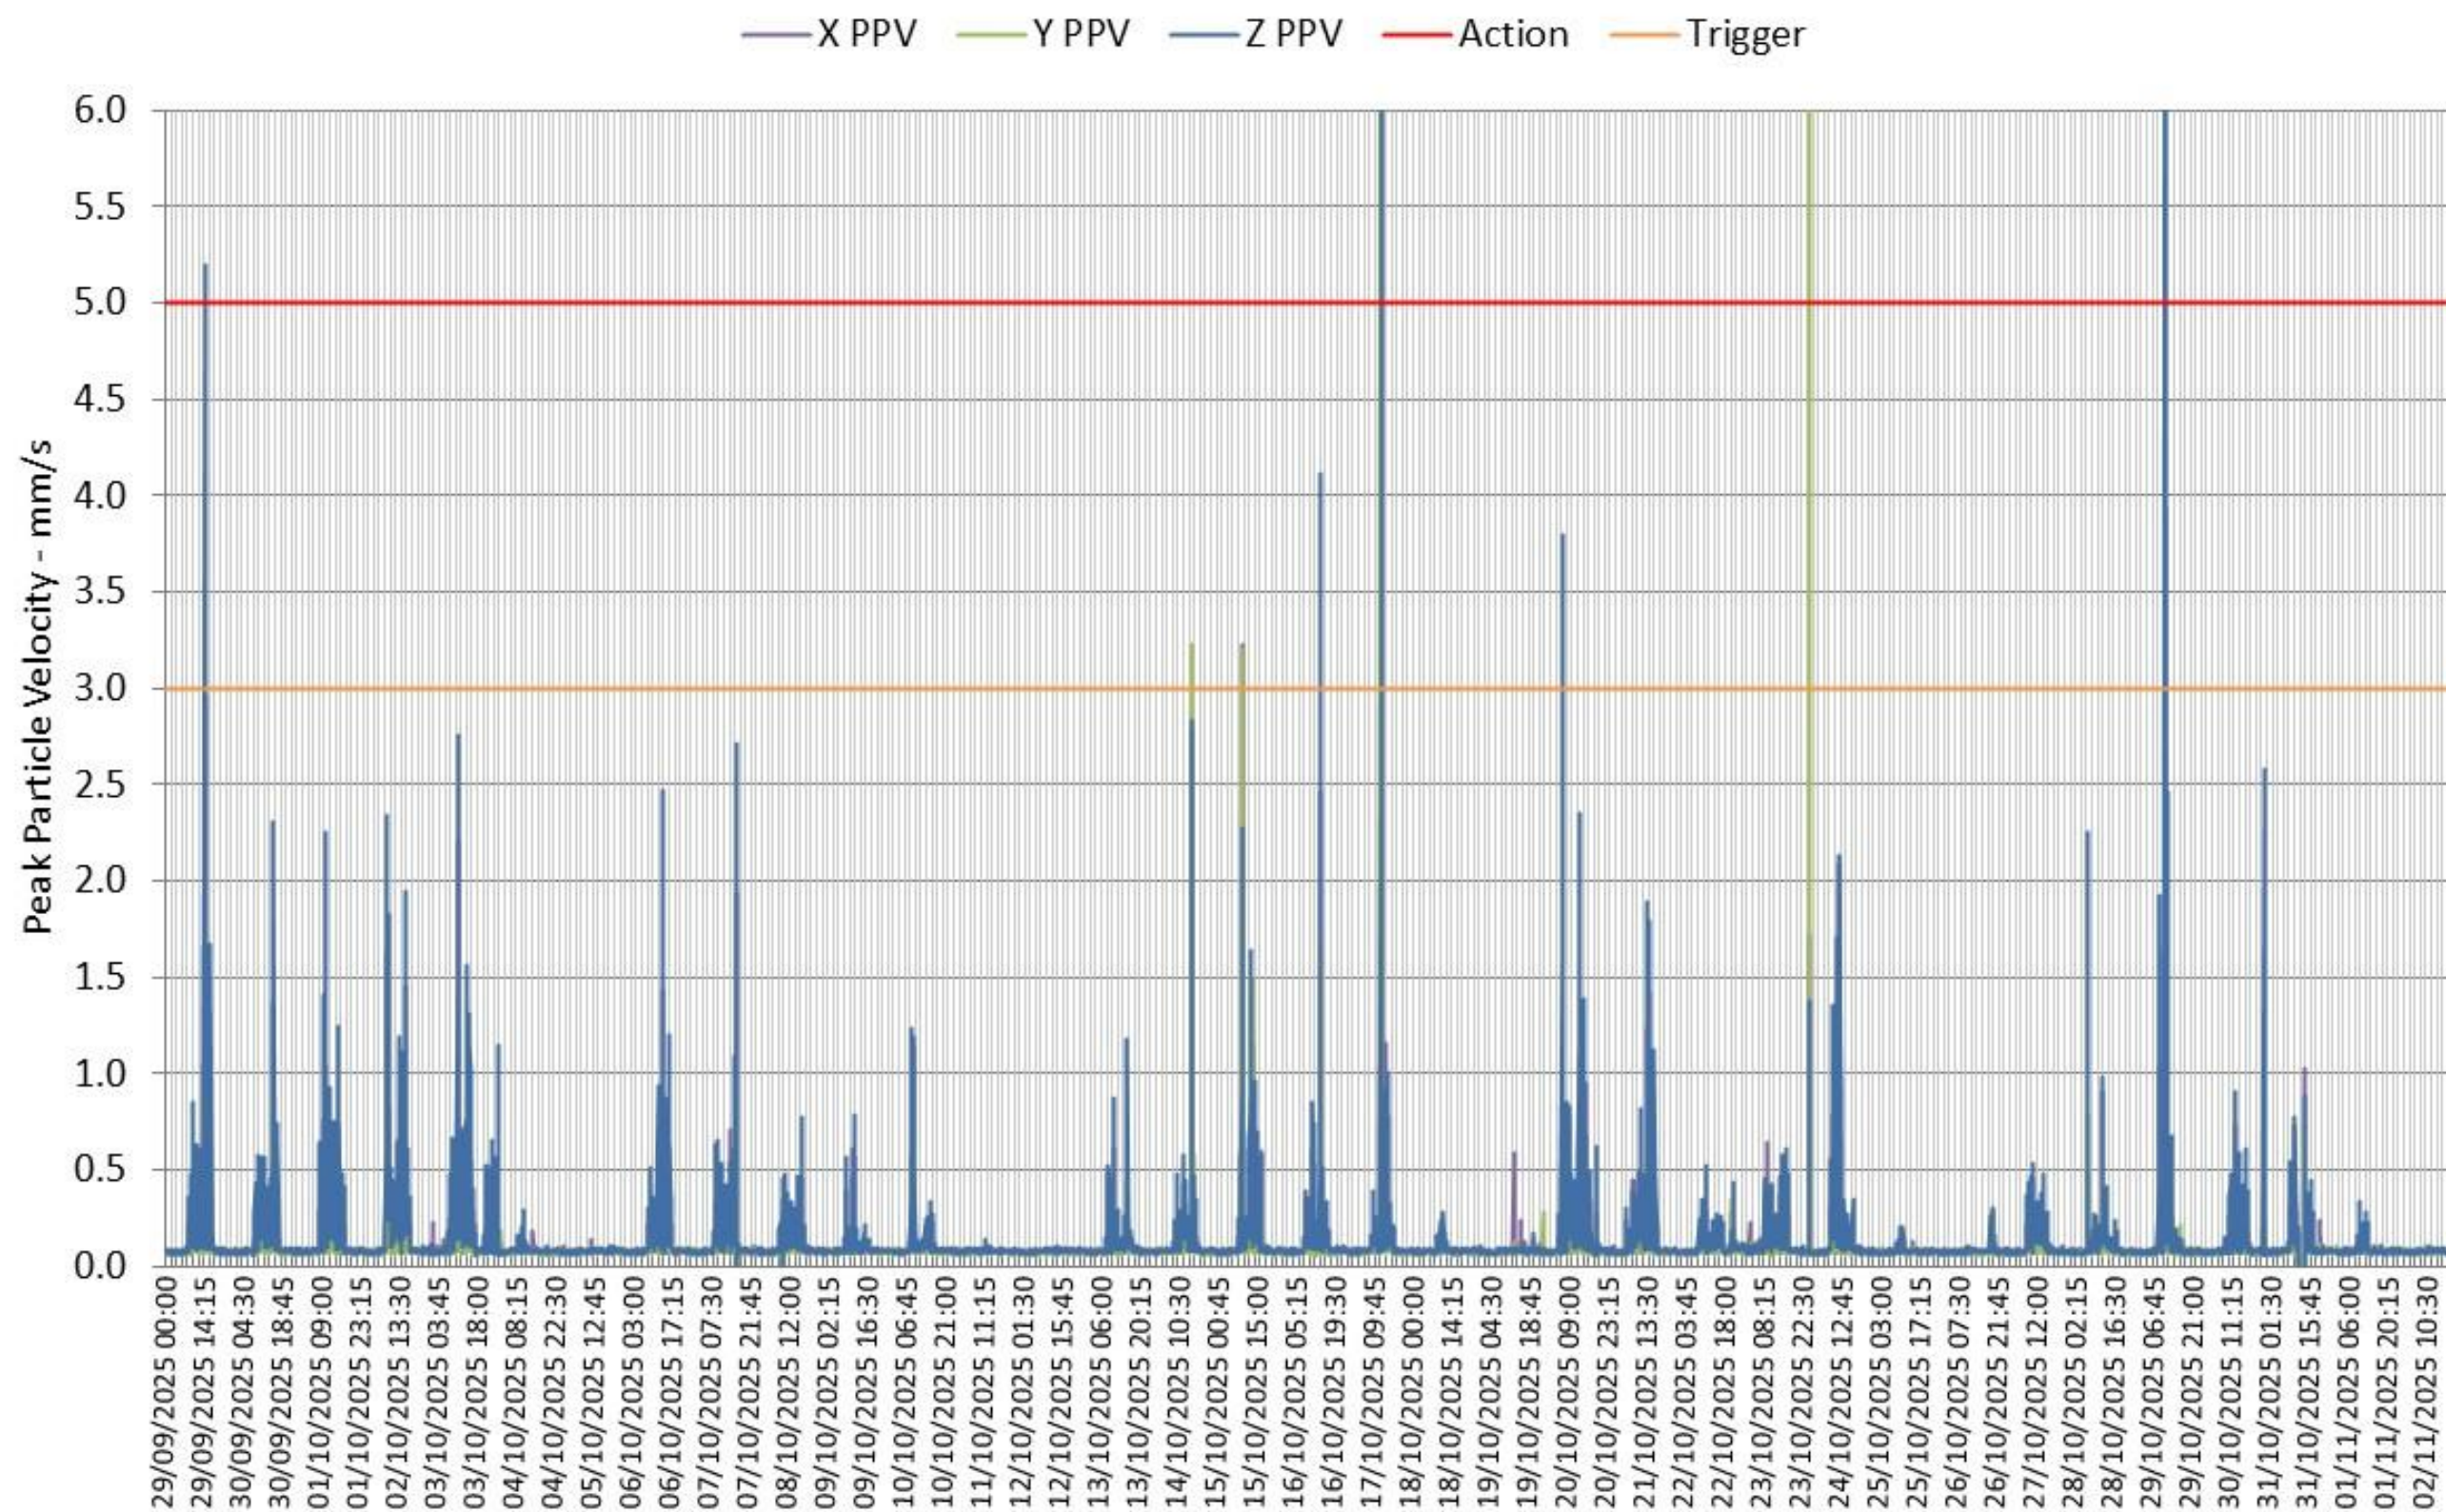
### Grenfell Tower VMP2: 29/09/25 - 02/11/25 Vibration Data

- There were **five (5) exceedances** of the **Red Action level 5.0mm/s**, one of which occurred outside working hours and **five (5) further exceedances** of the **Amber Trigger Level** in this reporting period.

| Monitoring Location | Date and Time of Exceedance | Measured Level of Exceedance (mm/s) | Red Action Alert Level (mm/s) | Cause of Exceedance | Mitigation |
|---|---|---|---|---|---|
| VMP2 | 29/09/2025 14:15 | 5.20 | 5.0mm/s | Due to isolated nature and magnitude these exceedances were due to an accidental disturbance of the MEMS sensor. | |
| | 17/10/2025 12:05 | 17.98 | | Routine maintenance of the | Due to isolated nature and magnitude, these exceedances were due to an accidental disturbance of the MEMS |
| | 17/10/2025 12:10 | 96.68 | | | |

| | | | | vibration monitor. | sensor during routine maintenance of the vibration monitor. |
| | 24/10/2025 00:40 | 6.41 | | Exceedance occurred outside of typical site working hours. | |
| | 29/10/2025 10:40 | 10.99 | | Cable repair works. | Exceedance is due to an accidental disturbance of the MEMS sensor during cable repair works near the monitor. |
