Rail Accident Report

Fatal accident at Stratford London Underground station 26 December 2023

Report 01/2025
January 2025

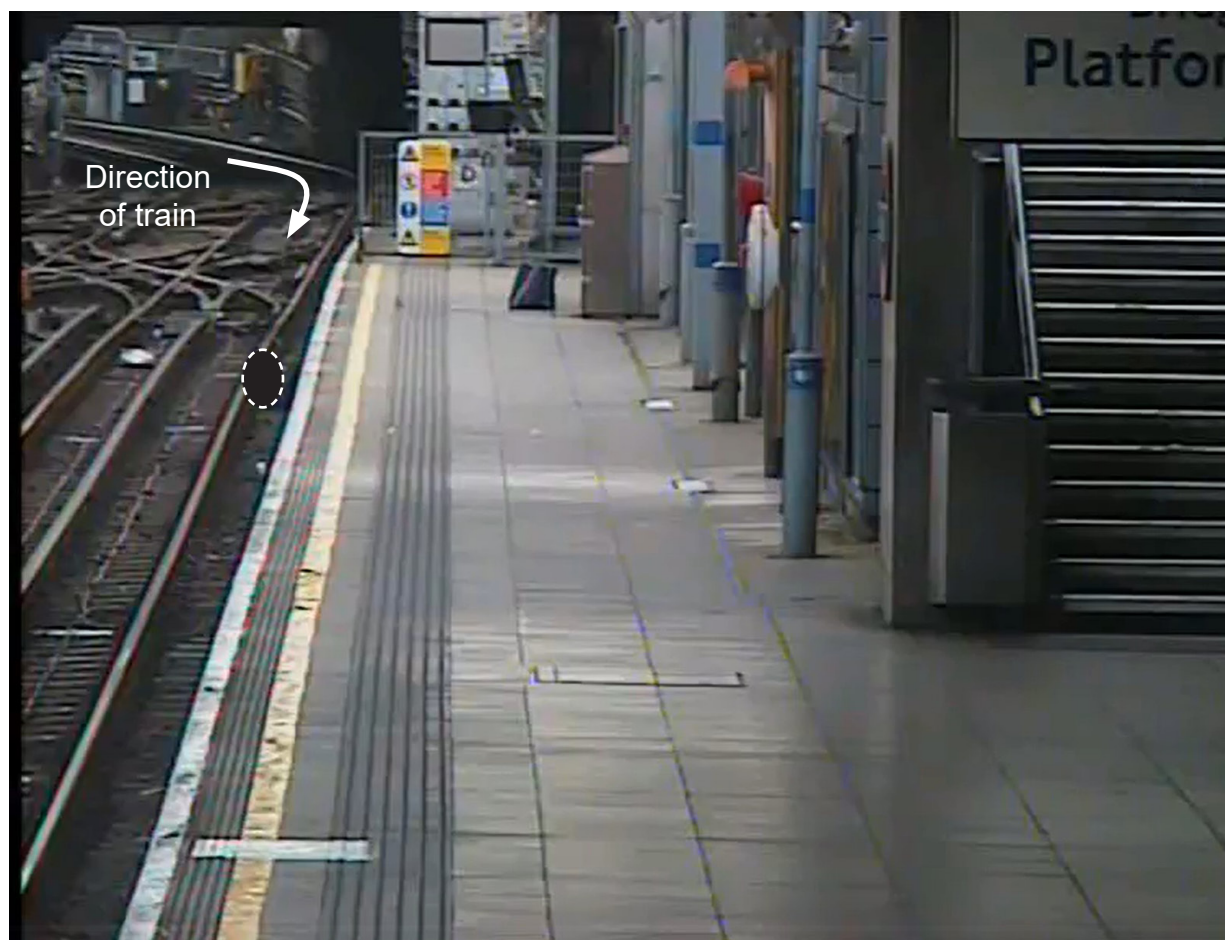
4: 2023/12/26 14:49:57.569

- 35 At 14:44:54, station CCTV shows that the passenger stood up from sitting on the bench and immediately stumbled forward, falling a distance of around 0.7 metres from the platform surface and onto the track. The bag remained on the platform in front of the bench.
- 36 Between approximately 14:45 and 14:46, station CCTV images show the passenger sitting up and making attempts to get back onto the platform. They then lie down on the track, parallel to the rails, on the part of the track between the platform and the nearest running rail (figure 5).

Figure 5: CCTV image of the passenger's position on the track, with an oval outlined in white depicting location of the passenger (courtesy of LUL, with RAIB annotations).

- 70 Station CCTV images show that the passenger was lying alongside the rail closest to the platform edge once they had fallen onto the track. They were wearing dark outer clothing with their lighter shirt also being partly visible (paragraphs 33 and 36).

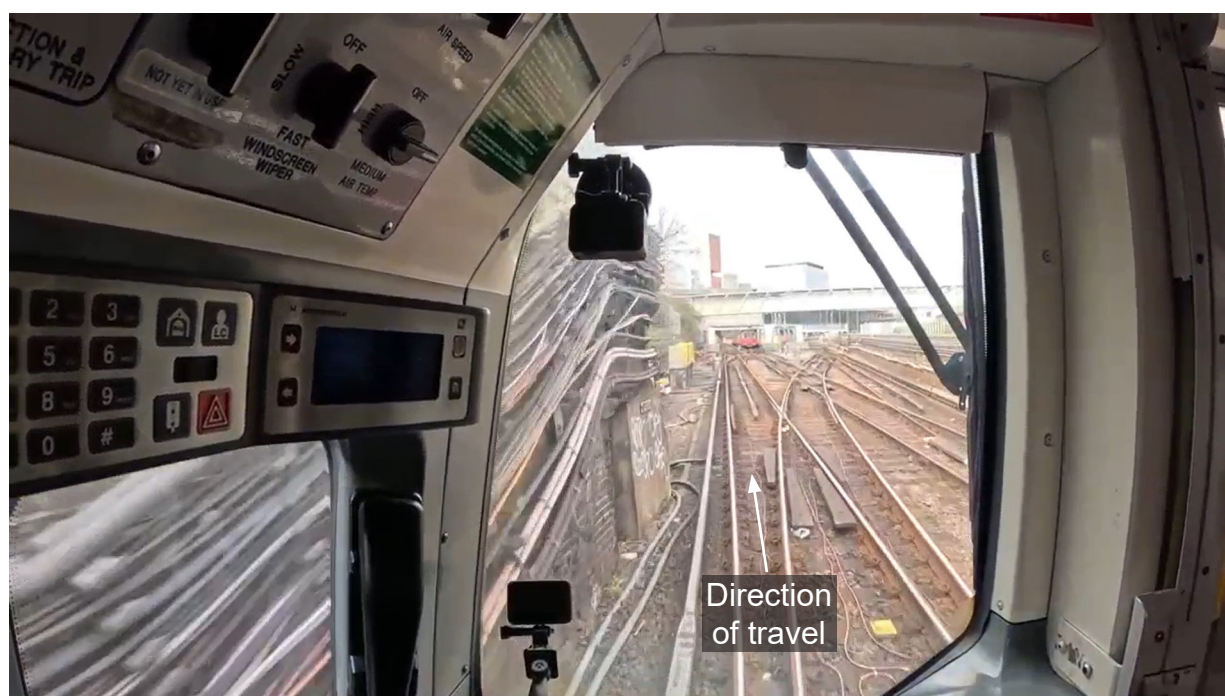
- 72 As the train approached the station during the reconstruction, the TO reported first seeing the test object from approximately 112 metres away (figure 8). For the reconstruction, LUL sprayed a yellow line across the track at a distance of 40 metres on approach to the passenger's location. This yellow line was positioned at what LUL had calculated to have been the latest point at which the emergency brake could have been applied to stop the train before reaching the passenger, taking into account the deceleration rate of the train and the decision time of the TO. When the TO could see this yellow line, they were able to discern the nature of the obstruction on the track, and to judge that there was a clear safety risk. Therefore, RAIB has concluded that the train could have been stopped before reaching the passenger, had the passenger been seen and the brakes applied before or at this point (figure 9).

Figure 8: The moment that the reconstruction TO was able to recognise the reference object on the track, approximately 112 metres from the object.
