# Collision of train load with a footbridge on Dean Forest Railway, 14 August 2025

## Summary of the accident

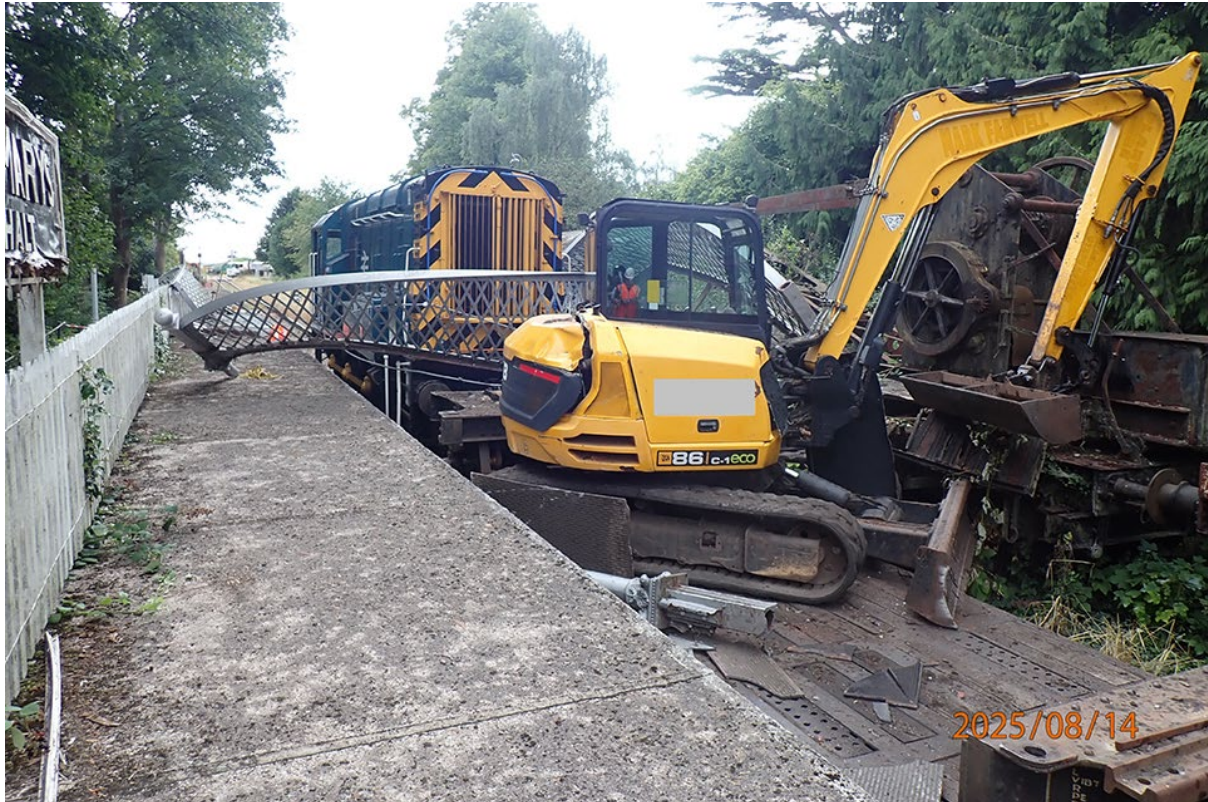
At around 10:55 on Thursday 14 August 2025, part of a 360-degree excavator being transported on a train struck the footbridge which carries a public footpath over the Dean Forest Railway at St Mary's Halt station, Lydney, Gloucestershire. The train was travelling at around 10 mph (16 km/h) when the accident occurred. The footbridge collapsed as a result of the collision, with parts of it falling onto the station platform and the moving train.

Accident scene looking towards rear of train.

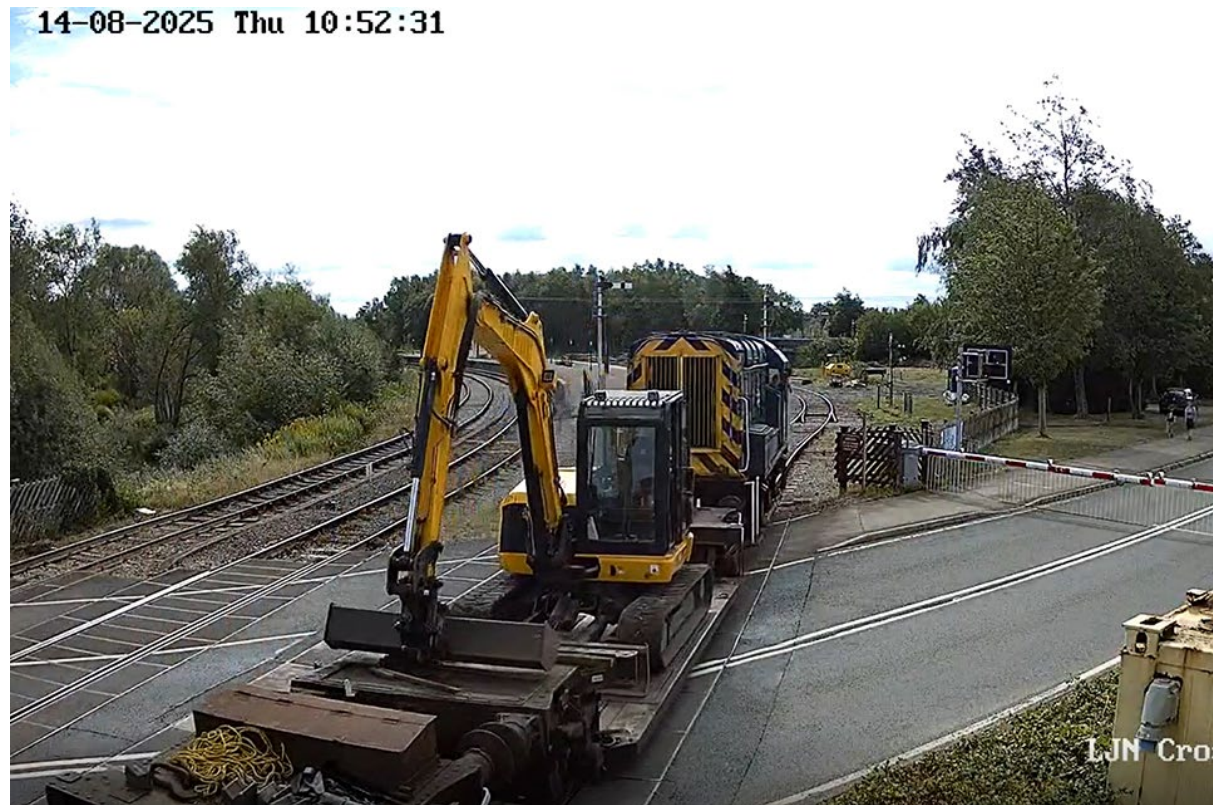
Excavator operator 2 loaded the 8-tonne excavator onto the wagon and stowed it with its bucket resting on the raised upper deck at the front, as they had previously done with the 6-tonne excavator. During the loading, the train driver and shunter went to inspect a different wagon in another part of the station yard and did not witness the loading activity. There was no requirement for the driver or shunter to check the load before the train departed and there is no equipment to allow out-of-gauge loads to be detected at Lydney Junction.

**CCTV image showing incident train travelling towards the camera near Lydney Junction station, shortly before the accident (courtesy of Dean Forest Railway).**

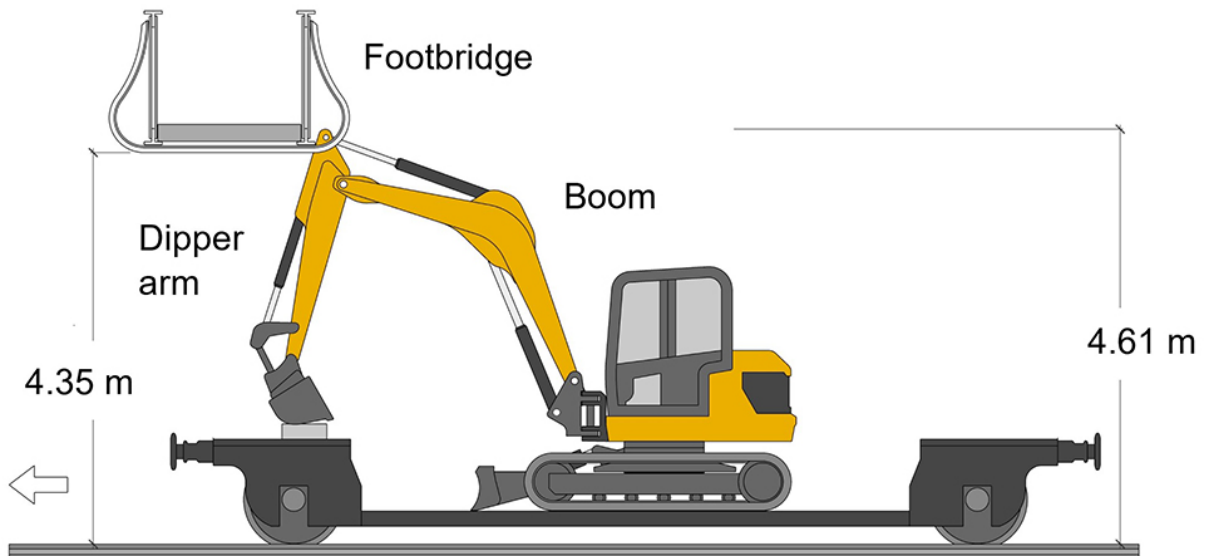
The accident occurred because the 360-degree excavator was stowed on the wagon with its bucket resting on the wagon's raised front deck. This increased the excavator's overall height and meant that the upper part of its dipper arm, attached to the boom, was too high to pass under the footbridge.

Following the accident, a reconstruction showed that the top of the 8-tonne excavator's dipper arm was 4.61 metres above rail level when the accident occurred. This meant it was 0.26 metres higher than the underside of the footbridge, making a collision inevitable.

**Diagram showing actual height of 8-tonne excavator compared with footbridge.**

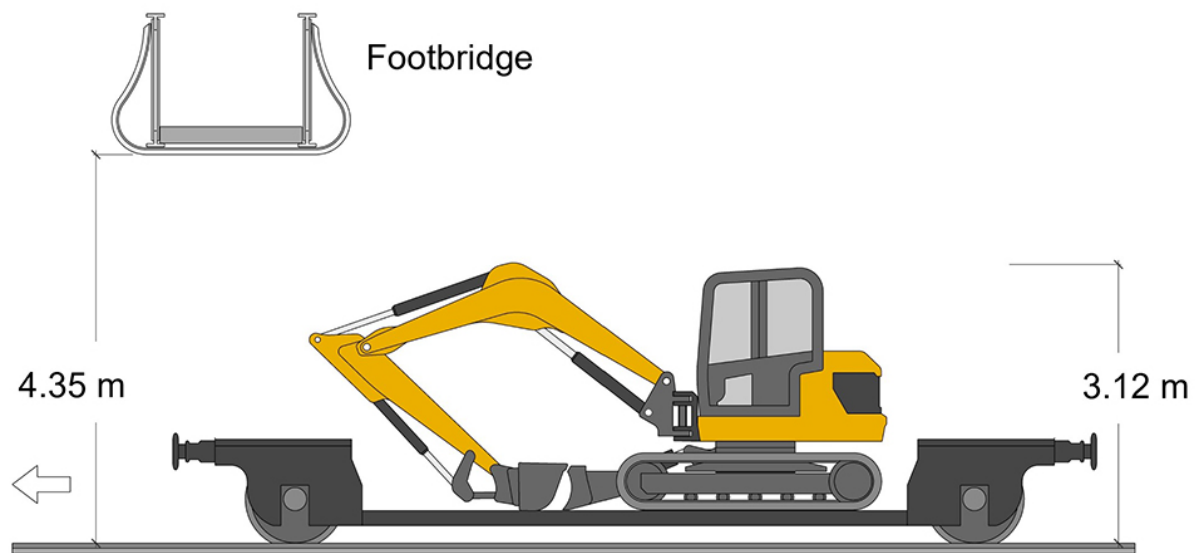
Post-accident testing also showed that the 8-tonne excavator could be positioned on the wagon, so the highest part of the boom was 3.12 metres above rail level.

**Diagram showing 8-tonne excavator correctly loaded.**
