Accident

Aircraft Type and Registration:	Spitfire Mk 26B, G-ENAA	
No & Type of Engines:	1 Isuzu V6 piston engine	
Year of Manufacture:	2013 (Serial no: LAA 324-15097)	
Date & Time (UTC):	28 July 2024 at 1258 hrs	
Location:	Enstone Airfield, West Oxfordshire	
Type of Flight:	Private	
Persons on Board:	Crew - 1	Passengers - None
Injuries:	Crew - 1 (Fatal)	Passengers - N/A
Nature of Damage:	Aircraft destroyed	
Commander's Licence:	Airline Transport Pilot's Licence	
Commander's Age:	71 years	
Commander's Flying Experience:	21,740 hours (of which 19 were on type) Last 90 days - 2 hours Last 28 days - 1 hours	
Information Source:	AAIB Field Investigation

Synopsis

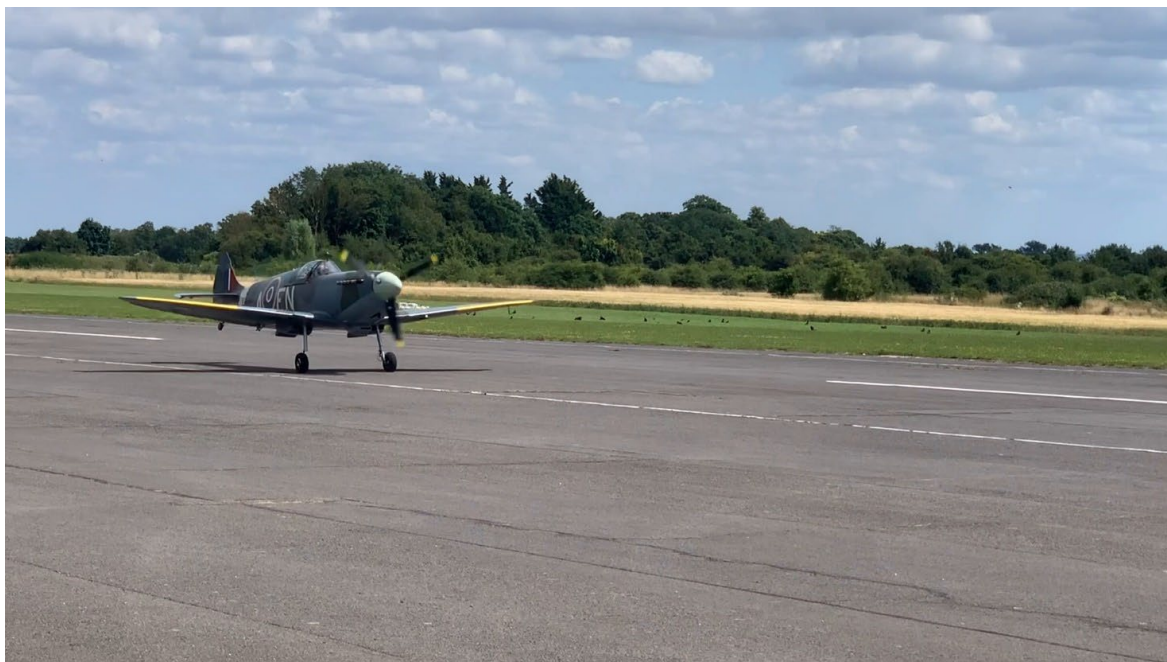
Figure 4

When the aircraft's airspeed reached approximately 45 kt, the tail of the aircraft lifted to an almost horizontal attitude (Figure 4), which coincided with a brief left rudder input, and the aircraft yawed to the left. The elevator could then be observed to move to a pitch up (control surface up) position, which was near to its full travel position, and the tail of the aircraft quickly lowered back towards the runway (Figure 5). The elevator remained in a pitch-up position, whilst the tailwheel tyre bounced on and off the runway surface several times. The aircraft's weight then settled on the tail wheel, which was almost coincident with the main landing gear tyres leaving the runway surface (Figure 6).

Tail initially lifts towards horizontal position

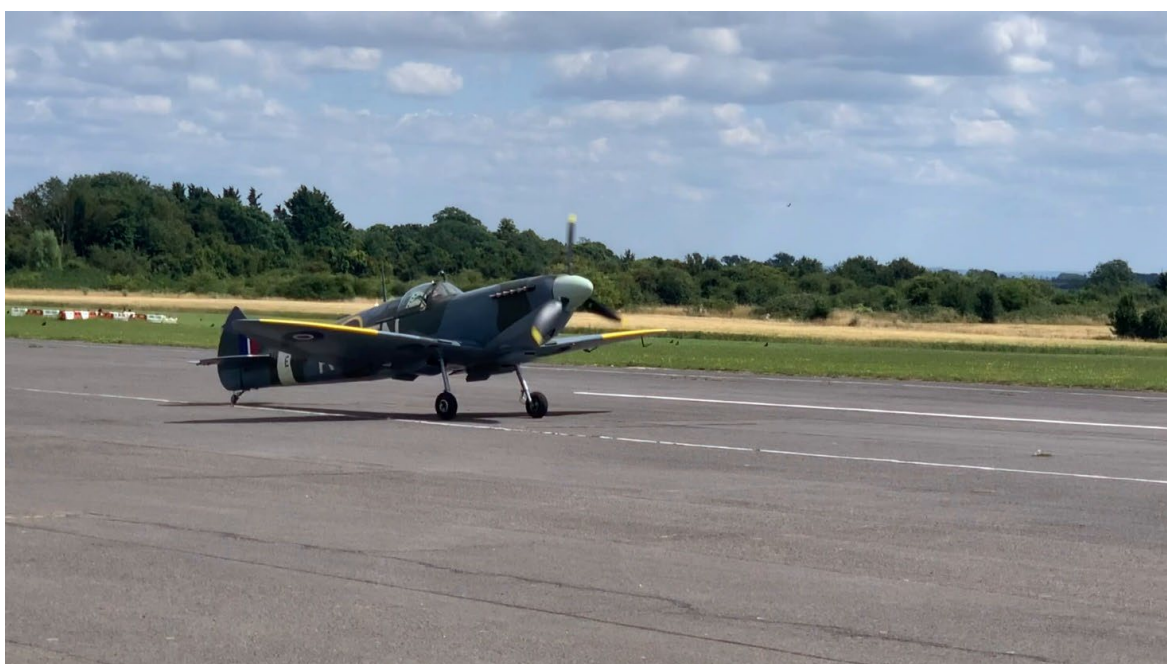
Figure 5

Tail wheel touches back down

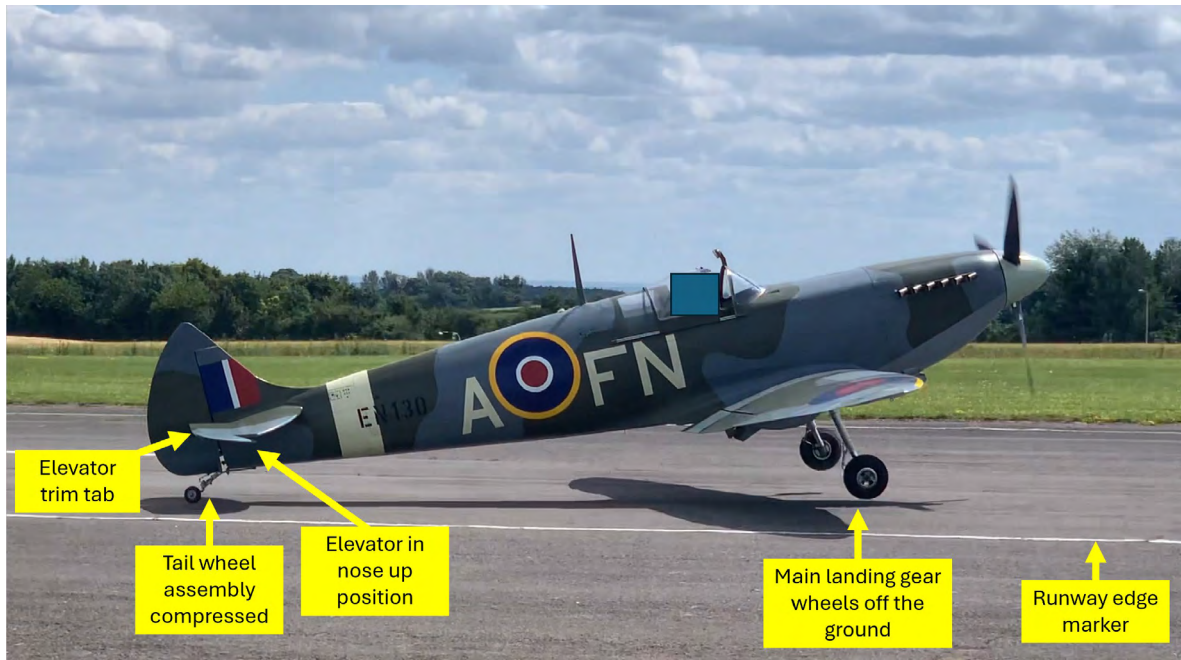
Figure 6

As the aircraft passed the witness's position, the pilot's head could be seen to be in an upright position and facing forward. At this point in the recording it was also possible to see that the flaps had been extended to about 10° and the elevator trim tab was set to approximately its mid-travel nose-up (surface down) position¹.

Aircraft attitude as it passed the witness position

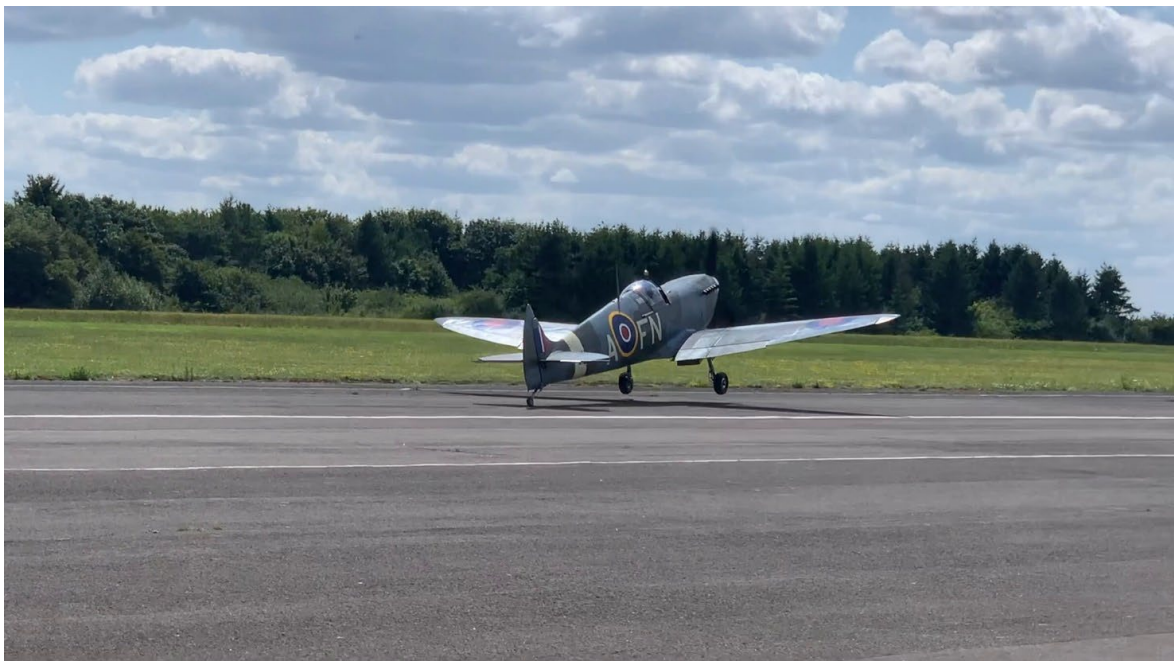
Figure 7

The aircraft continued to head towards the left side of the runway with the main wheels just clear of the runway surface whilst the tailwheel remained in contact (Figure 7). The aircraft's pitch attitude was about 12° nose-up. As the aircraft reached the side of the runway its airspeed was approximately 63 kt and it pitched up quickly at a rate of about 12°/s and started to climb (Figure 8). The elevators could then be seen to move quickly to a more neutral position. The pitch attitude reached just over 20° and the data indicated that the aircraft's airspeed reduced to approximately 58 kt. The aircraft then started rolling left, with a slight reduction in its pitch attitude to about 18° nose-up (Figure 9).

Aircraft approaching the left side of the runway

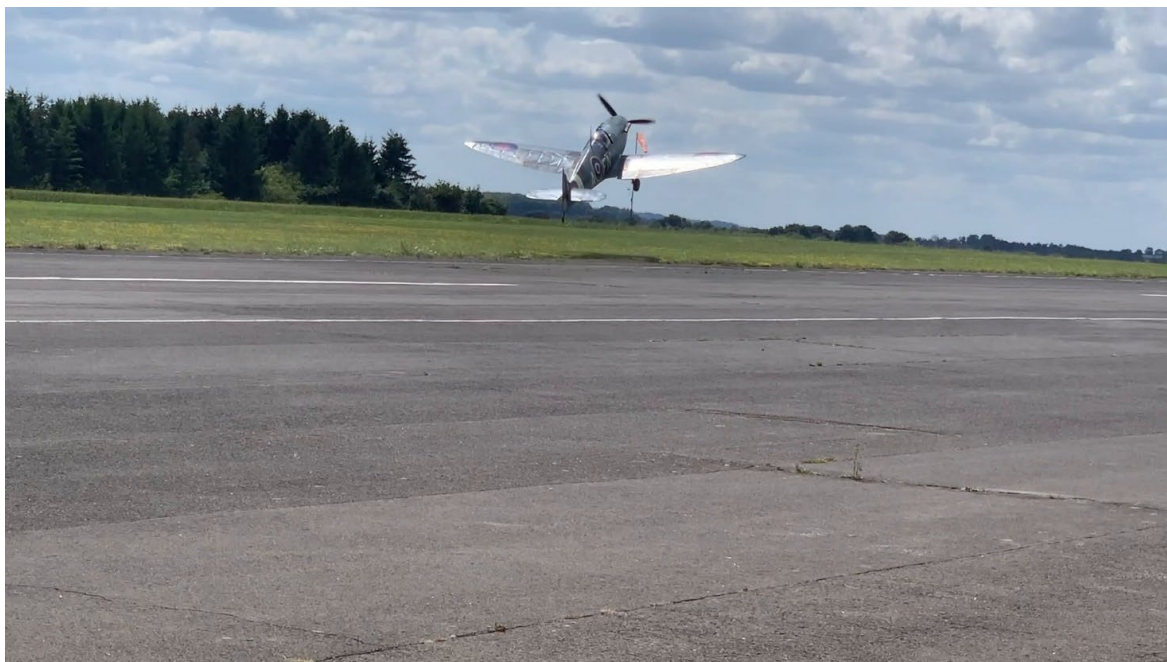
Figure 8
Aircraft pitches up at 12°/s

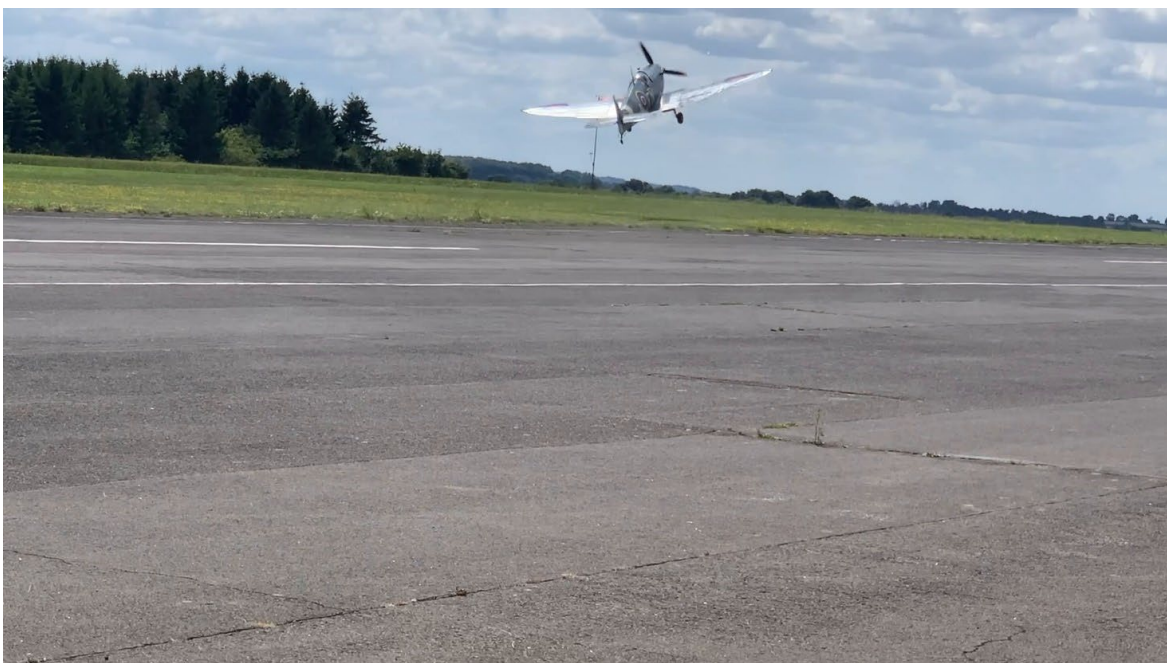
Figure 9
Aircraft rolls left

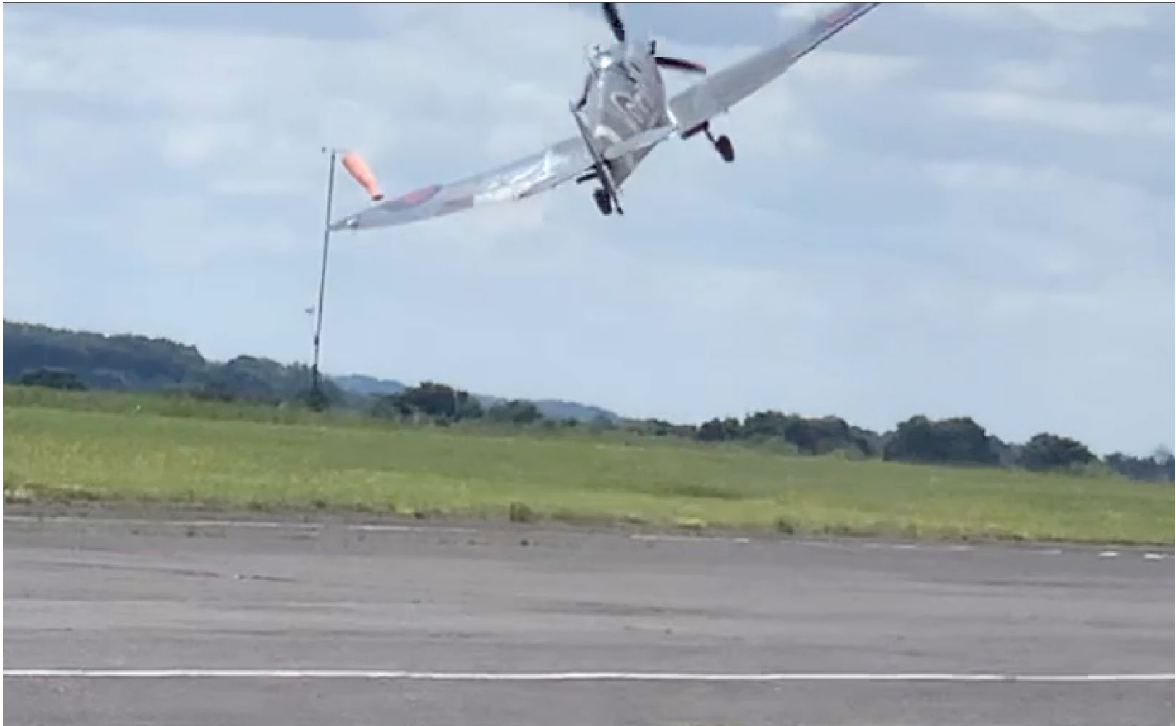
Figure 10

The aircraft's ailerons were then observed to move to a right roll position (left aileron surface down / right aileron surface up) (Figure 10) but the aircraft continued rolling left. The footage of the aircraft captured by the witness ended shortly after this point but the continuing flight path of the aircraft was recorded by one of the CCTV cameras (Figure 11). When the aircraft's bank angle reached about 30°, its pitch attitude briefly stabilised at about 15° nose-up but as the bank angle reached about 40° the roll rate increased quickly to about 70°/s. The aircraft's nose started to drop and the aircraft descended, with the bank angle reaching about 120° before the aircraft struck the ground, left wingtip first, at 1257:40 hrs.

Aircraft continues to roll left with counter (right roll) ailerons applied

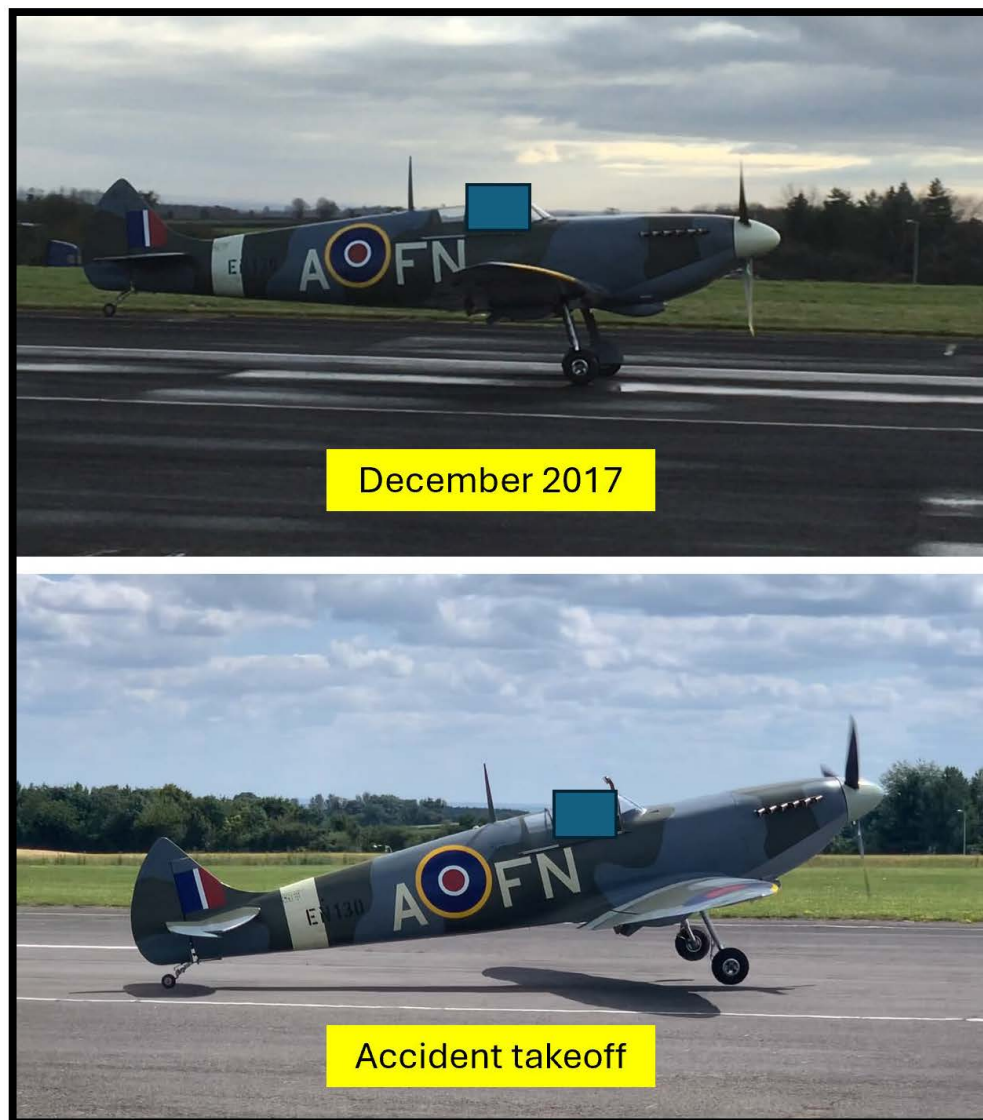
Figure 12 shows the difference between G-ENAA's pitch attitude during the accident takeoff and that in December 2017, and Figure 13 shows the difference in the initial climb attitudes adopted.

Figure 12
Difference in pitch attitude prior to takeoff

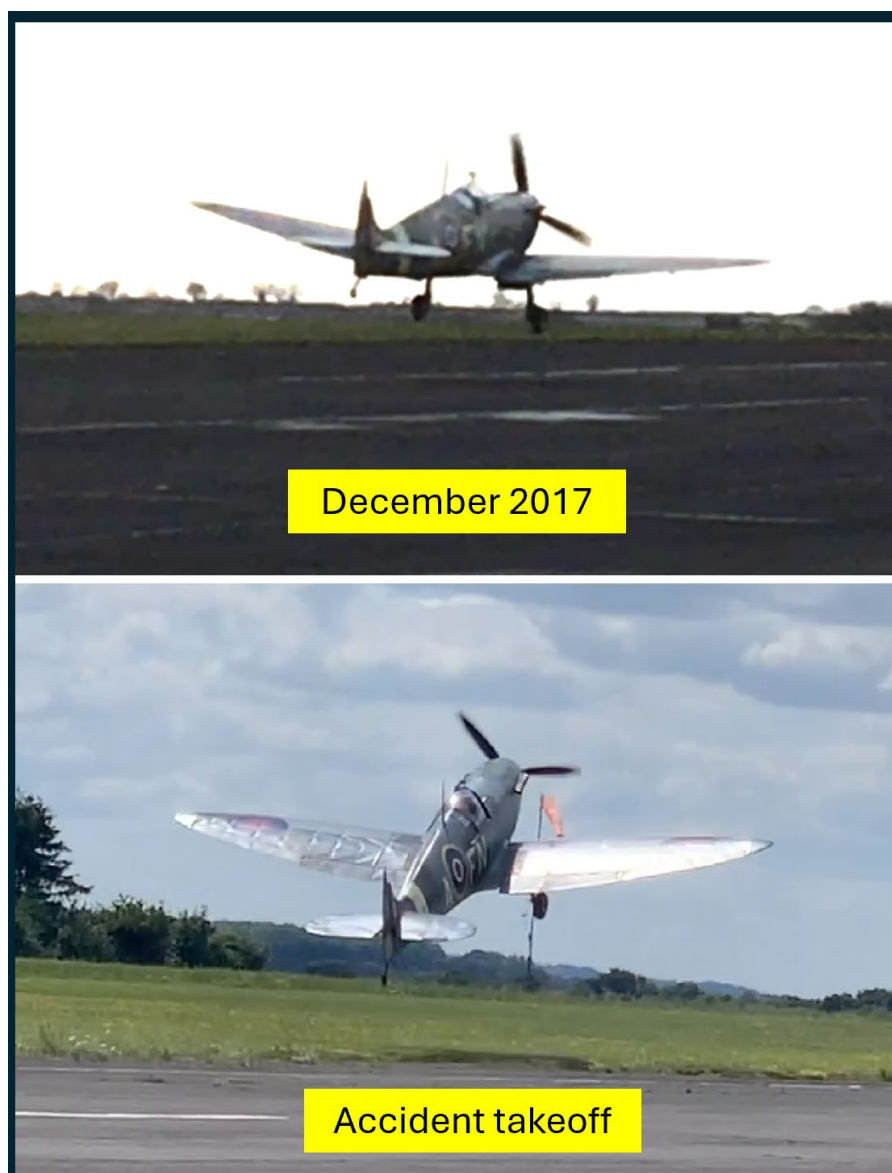
**Figure 13**

Difference in pitch attitude during initial climb
