Accident

Aircraft Type and Registration:	Boeing 737-8AS, 9H-QAA	
No & Type of Engines:	2 CFM-56 turbofan engines	
Year of Manufacture:	2017 (Serial no: 44782)	
Date & Time (UTC):	21 August 2024 at 0808 hrs	
Location:	London Stansted Airport	
Type of Flight:	Commercial Air Transport (Passenger)	
Persons on Board:	Crew - 6	Passengers - 181
Injuries:	Crew - None	Passengers - None
Nature of Damage:	Damage to tail cone, tail fuselage and APU	
Commander's Licence:	Airline Transport Pilot's Licence	
Commander's Age:	35 years	
Commander's Flying Experience:	6,407 hours (of which 6,150 were on type) Last 90 days - 225 hours Last 28 days - 78 hours	
Information Source:	Aircraft Accident Report Form submitted by the pilot and further enquiries by the AAIB

Synopsis

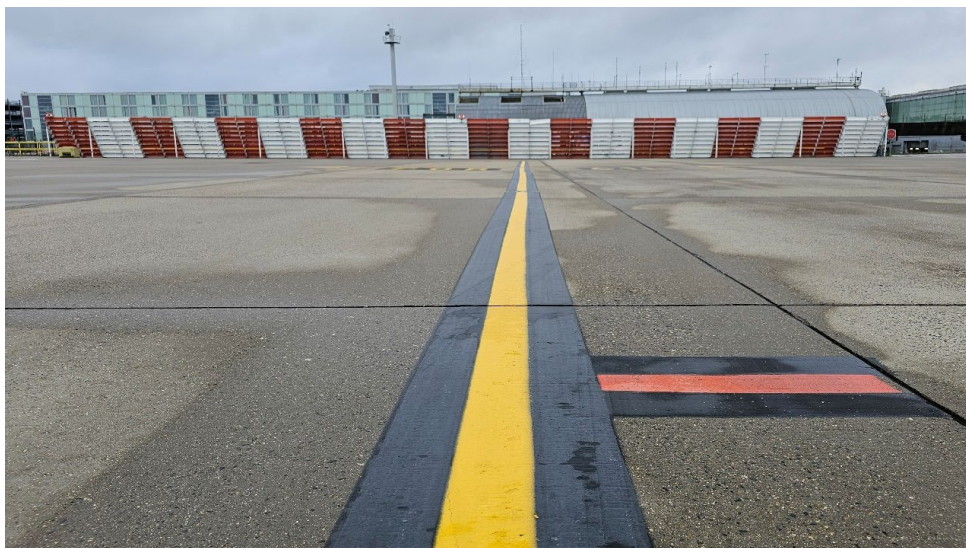
Figure 4

TRPs were introduced at Stansted in 2020. A TRP consisted of a 0.5 m red line, painted on one side of the taxiway line (Figure 4). They are used for Code C³ aircraft or smaller⁴. The TRP on Taxiway Delta is between Stands 61L and 61R. There is a 14.97 m clearance behind a B737-800 and the blast fence when its nosewheel is on the TRP.

Image of the TRP and blast fence around the time of the accident

The tug instructor was also a qualified headset operator and wingman. He reported that he had driven past the TRP while he was focussing on speaking to the trainee. He added that the TRP was not very prominent and obscured underneath the aircraft's fuselage. He said that because the aircraft's engines had not been started, there was no thrust opposing the tug's idle engine power during the later part of the pushback. While aircraft engines are more commonly started during pushback, it is not unusual (as in this case) for crew to delay starting them until after the tug has disconnected.

The driving instructor and wingman suggested the TRP was not very prominent. The airport operator has increased the size of TRPs at the airport.

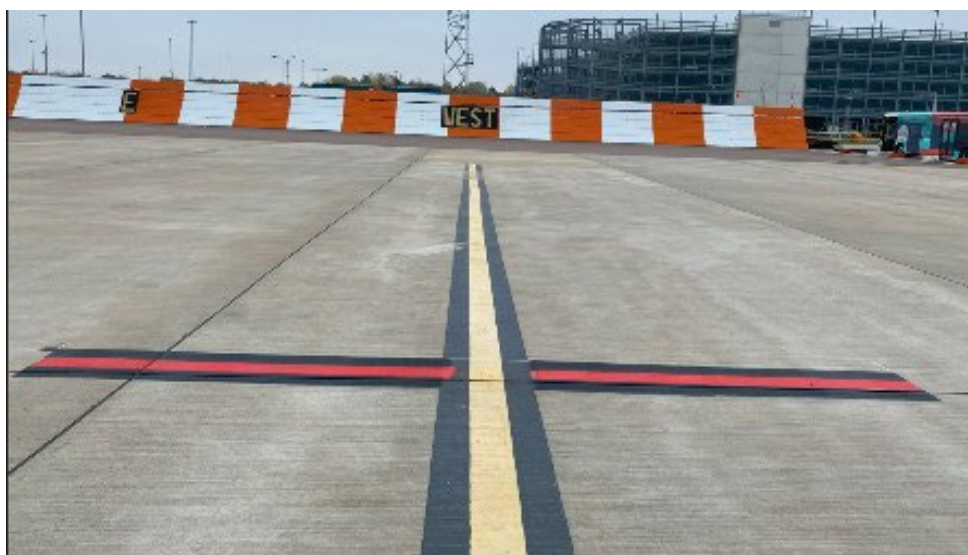
Figure 5

Upgraded TRP since the accident

Since this accident the airport operator has increased the length of TRPs from 0.5 m to 1 m and painted it on both sides of the taxiway centre line (Figure 5).

The maximum nosewheel tug release points have all been increased in size from 0.5 m to 1 m and painted it either side of the taxiway centre line.
