AAIB Bulletin

12/2025

Aircraft Type and Registration:	Cessna T210M, N761JU	
No & Type of Engines:	1 Continental TSIO-520-R piston engine	
Year of Manufacture:	1977 (Serial no: 21062300)	
Date & Time (UTC):	11 April 2024 at 1609 hrs	
Location:	Leeds East Airport	
Type of Flight:	Private	
Persons on Board:	Crew - 1	Passengers - 1
Injuries:	Crew - 1 (Minor)	Passengers - 1 (Fatal)
Nature of Damage:	Propeller and nose landing gear damaged. Structural damage from becoming inverted. Aircraft damaged beyond repair	
Commander's Licence:	UK Private Pilot's Licence (Aeroplanes) and FAA Private's Pilot's Licence (Foreign Based)	
Commander's Age:	79 years	
Commander's Flying Experience:	1,378 hours (of which 62 were on type) Last 90 days - 10 hours Last 28 days - 5 hours	
Information Source:	AAIB Field Investigation

An undetected pitch trim setting resulted in the pilot attempting to takeoff with close to full NOSE DOWN elevator trim. The pilot rejected the takeoff, whereupon the aircraft briefly became airborne, but the pilot was unable to effectively control the aircraft in pitch. The aircraft bounced several times causing the aircraft's nosewheel to fail and the aircraft to slew off the r

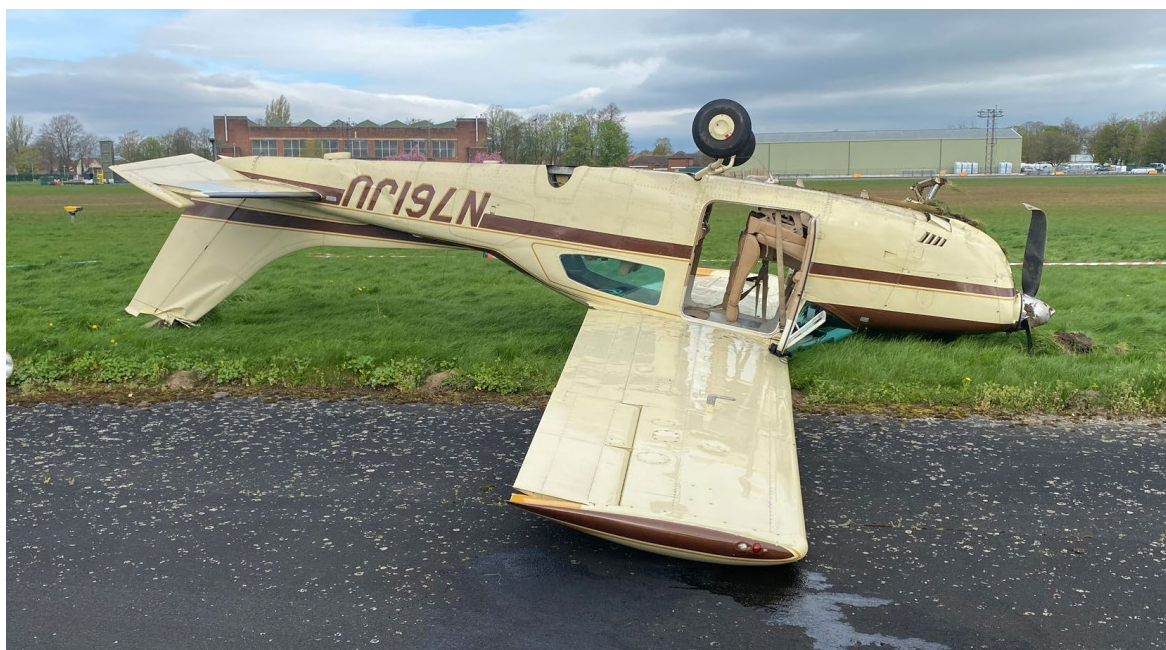
Figure 2

After lining up, the pilot set the power and began the takeoff roll. He reported that the initial stages of the takeoff proceeded normally. At approximately 70 kt he tried to rotate the aircraft for lift off but found the “stick would not move” and the aircraft continued to accelerate. The pilot later described that it felt like “the autopilot was on” and was restricting his pitch authority. With sufficient runway ahead, he decided to reject, rather than continue, the takeoff. At this stage he estimated the airspeed would have been in the region of 100 kt. He reported that when he closed the throttle to initiate the stop, the aircraft “jumped off the ground” and climbed to approximately 20 ft. Once N761JU was off the ground the pilot was unable to hold its nose-up and the aircraft descended rapidly, landing heavily on the nosewheel. Eyewitnesses reported seeing the aircraft touchdown and bounce two or three times before, on the last bounce, the nosewheel detached and N761JU settled onto its nosewheel strut. The pilot only recalled one bounce before the aircraft adopted a nose-down attitude with its propeller striking the runway. Despite the pilot’s application of brake and rudder to try and keep the aircraft on the centreline, he was unable to stop it drifting to the right as it decelerated. At approximately 40 kt groundspeed, N761JU left the paved surface, the remains of the nose landing gear dug into soft ground and the aircraft inverted (Figure 2).

N761JU inverted at the edge of Runway 24

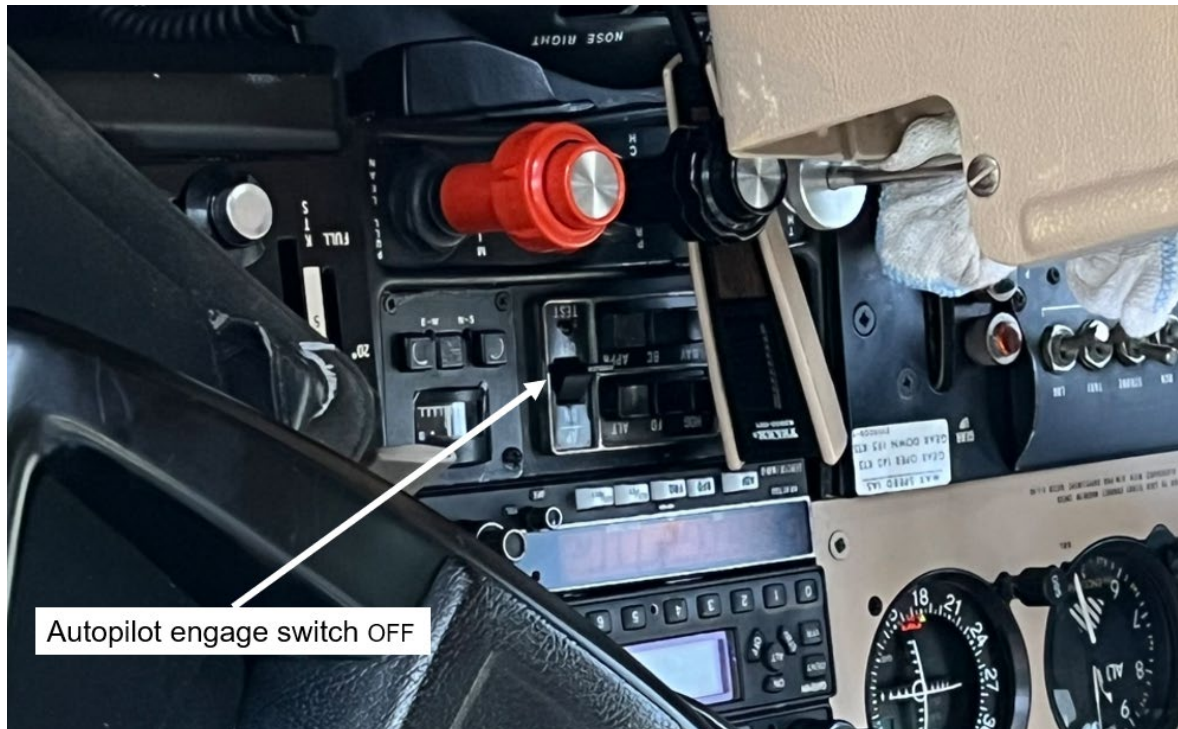
Figure 3

The pilot described that, when the aircraft came to rest, both he and the passenger were “hanging in [their] seat straps.” When the pilot asked him if he was okay, the passenger did not respond and appeared to be unconscious. The pilot turned the aircraft master switch off before releasing his lap belt and vacating the cockpit. He immediately went round to the passenger’s side of the aircraft, by which time the airfield rescue services had arrived and taken control of the situation. The pilot was asked to move clear of the aircraft while the fire crew extricated the unresponsive passenger. Once the passenger was moved clear of the immediate vicinity of the aircraft, one of the fire crew began performing CPR. Fuel was leaking from the wings, so the other member of the fire crew returned to the aircraft and confirmed its battery switch was turned off to minimise the risk of subsequent fire. The fireman reported seeing the autopilot engage switch in the ON position when he checked the battery switches were OFF. The photograph he took around that time showed the switch to be in the OFF position (Figure 3).

Photograph taken by fire crew showing autopilot engage switch off
(Note: Aircraft is inverted)

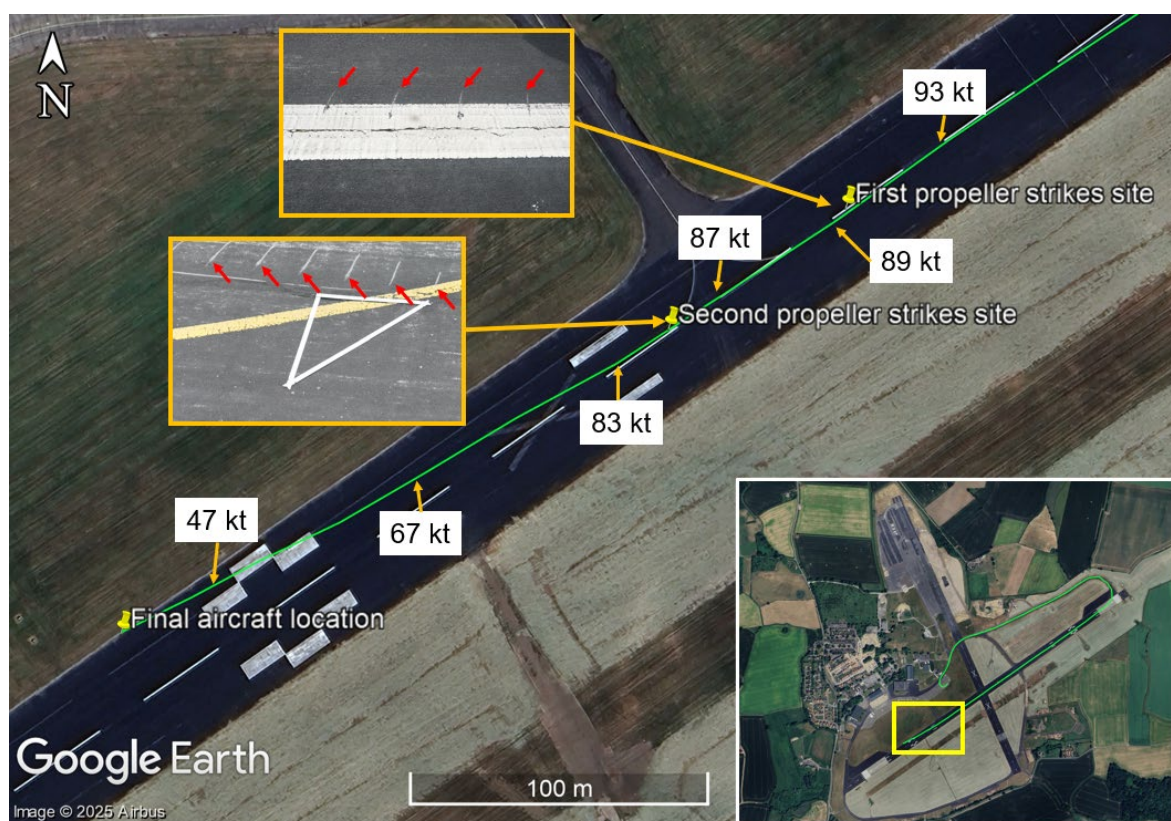
Figure 4

The aircraft came to rest inverted off the right side of Runway 24 between the touchdown markers and Precision Approach Path Indicator lights for Runway 06 (Figure 4). There was a furrow created by the remains of the nose landing gear leg leading up to the aircraft. The left wing was over the runway surface with fuel leaking from the filler cap. The aircraft was structurally intact with damage to the propeller and vertical fin, and the nose landing gear wheel was missing.

All the missing nose landing gear components were recovered from the runway and surrounding run off areas. A continuous scrape along the runway surface had been created by the nose leg from the point at which the nosewheel had failed, which led to the edge of the runway and the furrow in the soft ground.

There was also evidence of propeller ground strikes at two locations along N761JU's path. The first set of strikes appeared to have occurred before the nosewheel hub separated from the nose strut.

Accident site near Runway 06 threshold & location of propeller strike marks.

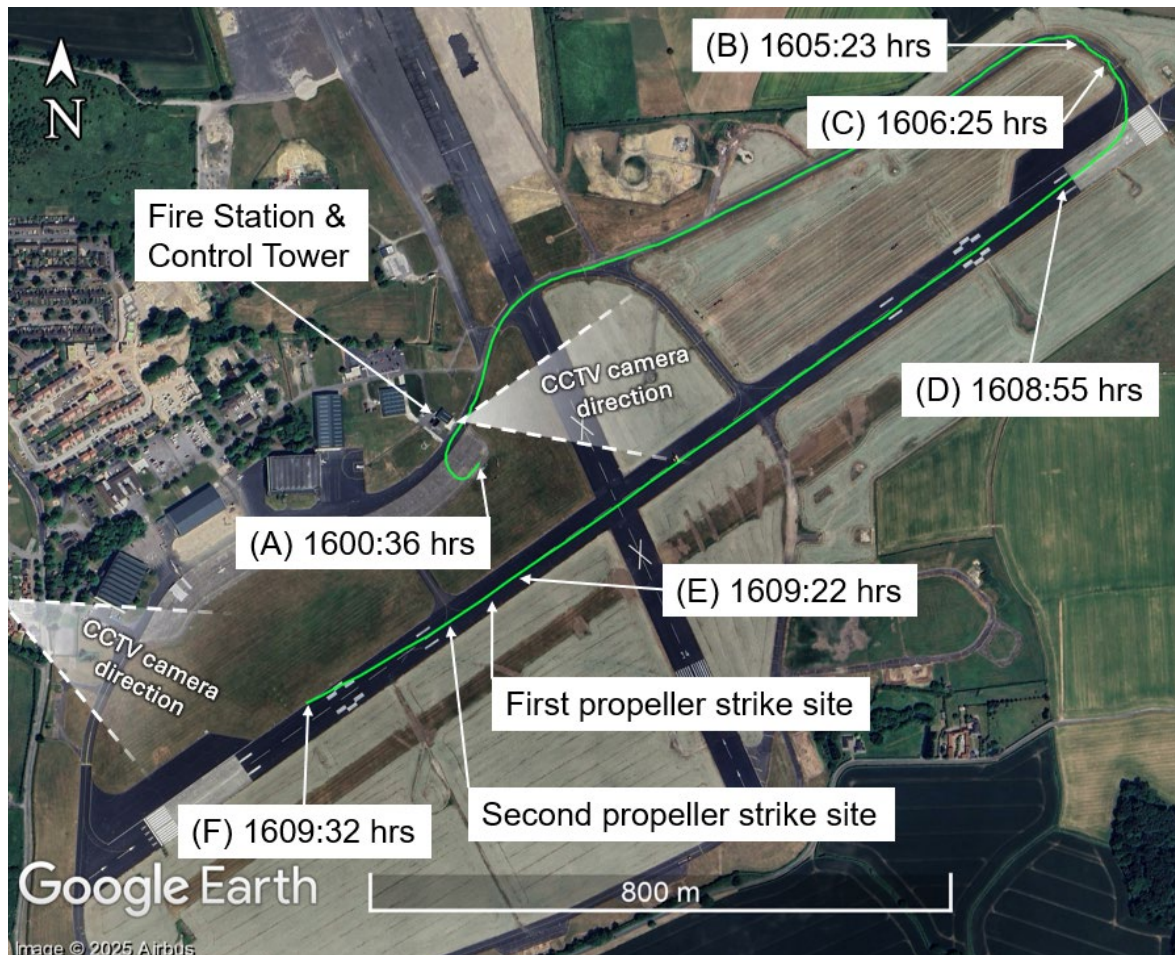
Figure 5 shows the ground track recorded by the tablet navigation application. Point A shows the location at the start of the recording, which was next to the refuelling bowser. The recordings indicate that N761JU made a 45° turn on the taxiway before stopping at

point B. N761JU remained stationary for approximately 30 seconds, before taxiing to point C, corresponding to the runway holding point. N761JU then waited at the holding point for two minutes. N761JU then entered the runway and commenced the takeoff roll, aligning with the centreline at point D. The recorded groundspeed peaked at 93 kt at point E, before coming to rest at point F.

N761JU ground track and notable locations

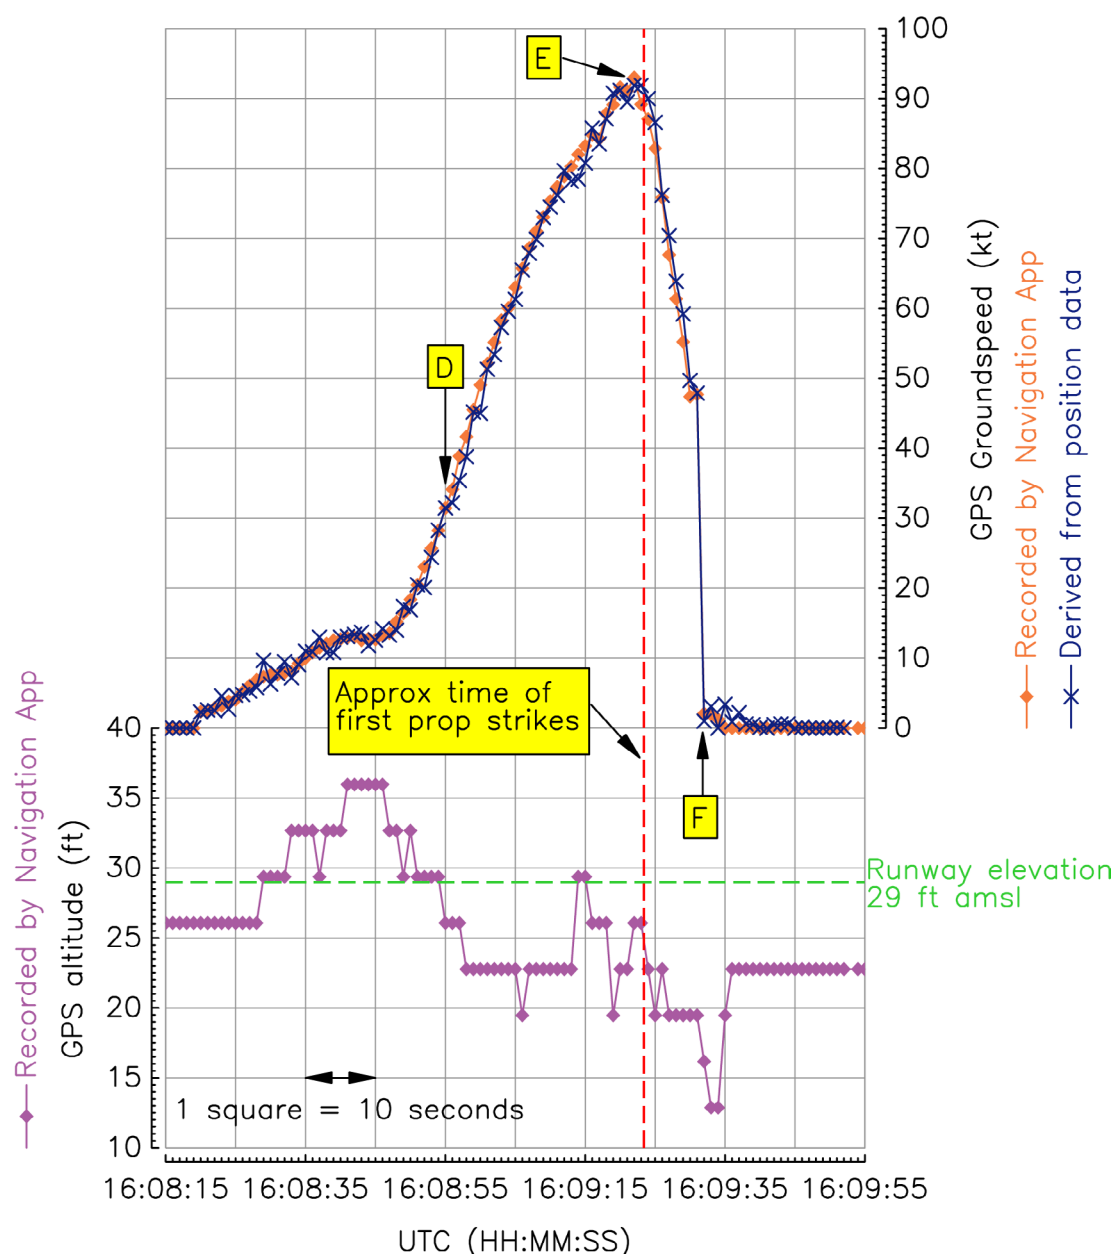
Figure 6 shows the recorded GPS groundspeed and altitude during the takeoff roll, with points D, E and F from Figure 5 overlaid. Derived groundspeed from recorded position data is also shown.

GPS altitude and groundspeed recorded during the takeoff roll

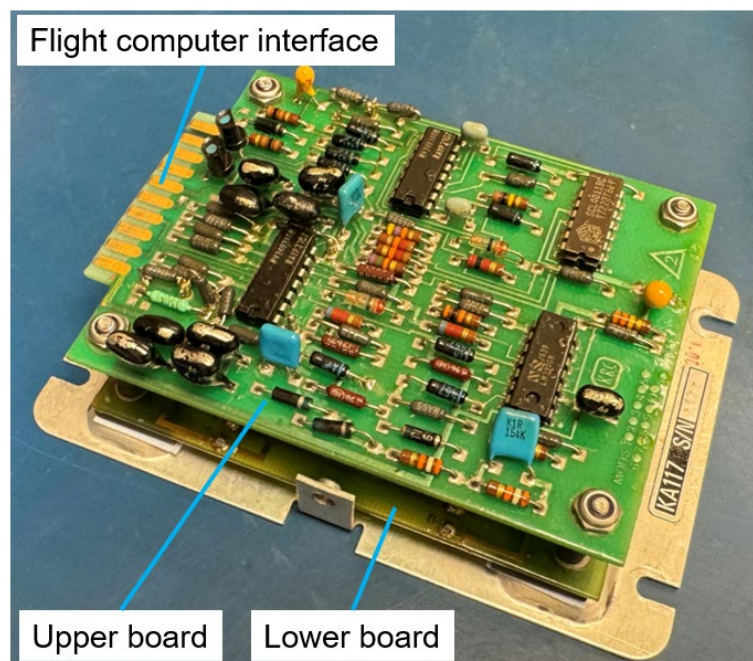
Figure 12

PCBs inside the KA 117 pitch trim adapter

The pitch trim adaptor was removed from the aircraft, by disconnecting the two multi-pin plugs, and taken to a company specialising in King autopilot systems. The KA 117 was plugged into a King test set in accordance with the KA 117 maintenance manual and a series of test points performed. The unit failed the first test point because the TRIM UP CMD [command] LED was permanently lit, indicating that the KA 117 was sending a continuous trim UP command to the flight computer.

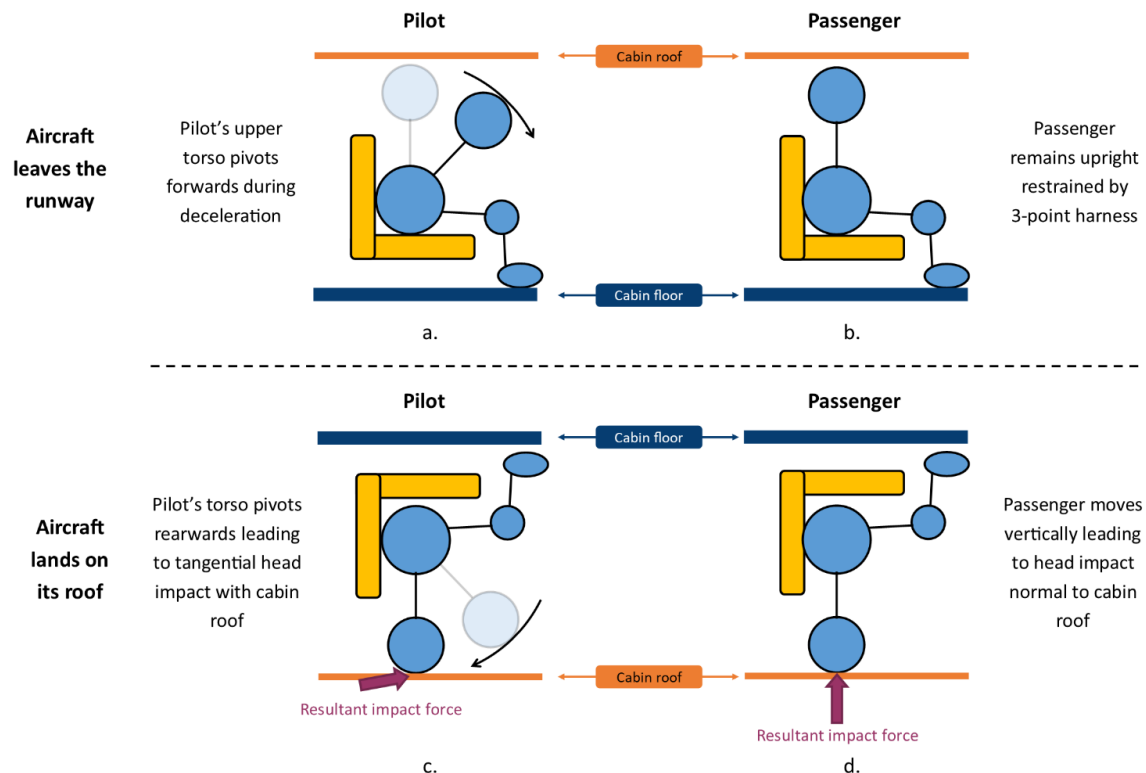
Figure 16

- Because the pilot's upper torso was unrestrained, it would have pivoted forward as the aircraft rapidly decelerated and inverted after leaving the runway (Figure 16a).
- The passenger's upper torso would likely have remained more erect, restrained by the shoulder strap (Figure 16b).
- As the aircraft landed on its roof, the pilot's head and torso would have moved rearwards and down in an arc, leading to a more tangential head impact (Figure 16c).
- Any movement of the passenger in his straps would have been primarily vertical in nature leading to an impact with the roof along the axis of his spine (Figure 16d).

Analysis of potential body movement during later stage of accident sequence

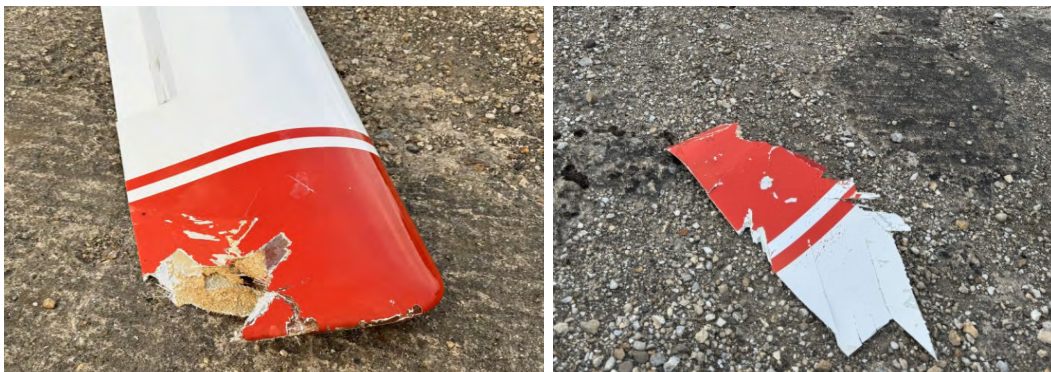
Figure 6

The right wingtip had impact damage; a section of the underside wingtip skin had become detached and was found approximately 40 m further back in the debris field (Figure 6).

G-DCTB right wingtip damage, and underside wingtip skin section

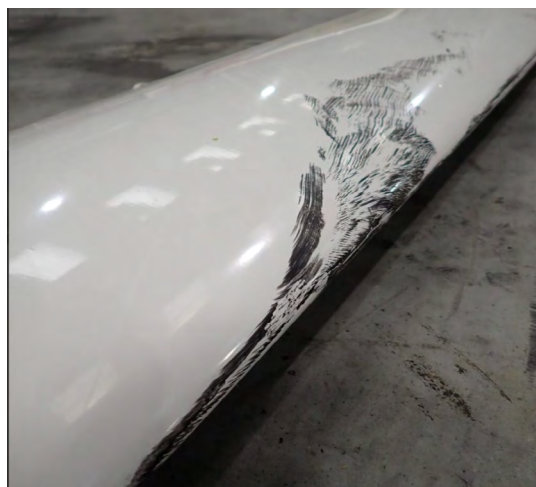
Figure 7

The right wing's leading edge was covered with heavy black marking, that extended to both upper and lower surfaces (Figure 7).

G-DCTB leading edge marks

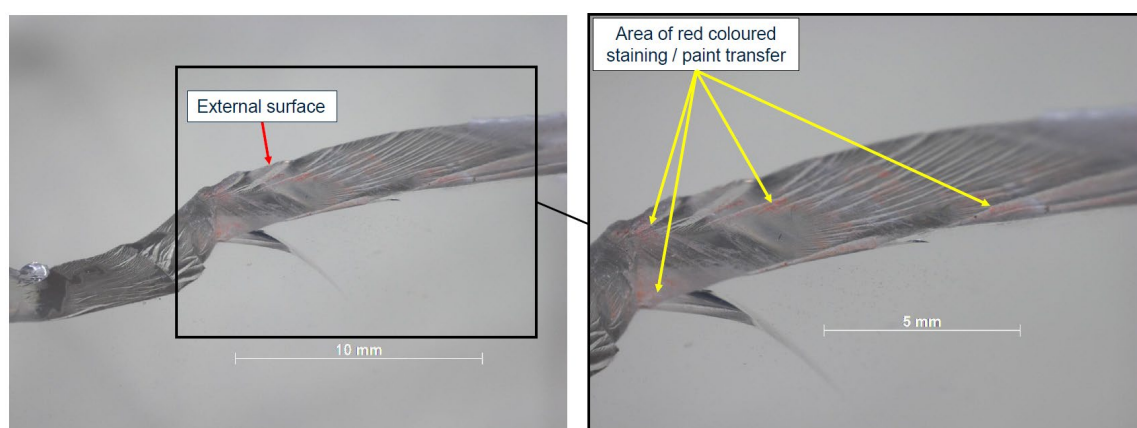
Figure 9

The analysis showed visible 'scarp' features (feather patterns) typical of brittle fracture on the edges of the fragments. This indicates the canopy failed from being distorted, rather than from an impact load. There was evidence of red paint transfer on fracture surfaces of two of the fragments (Figure 9) which were retrieved from the farthest part of the debris field.

Red paint transfer on canopy fragment fracture face

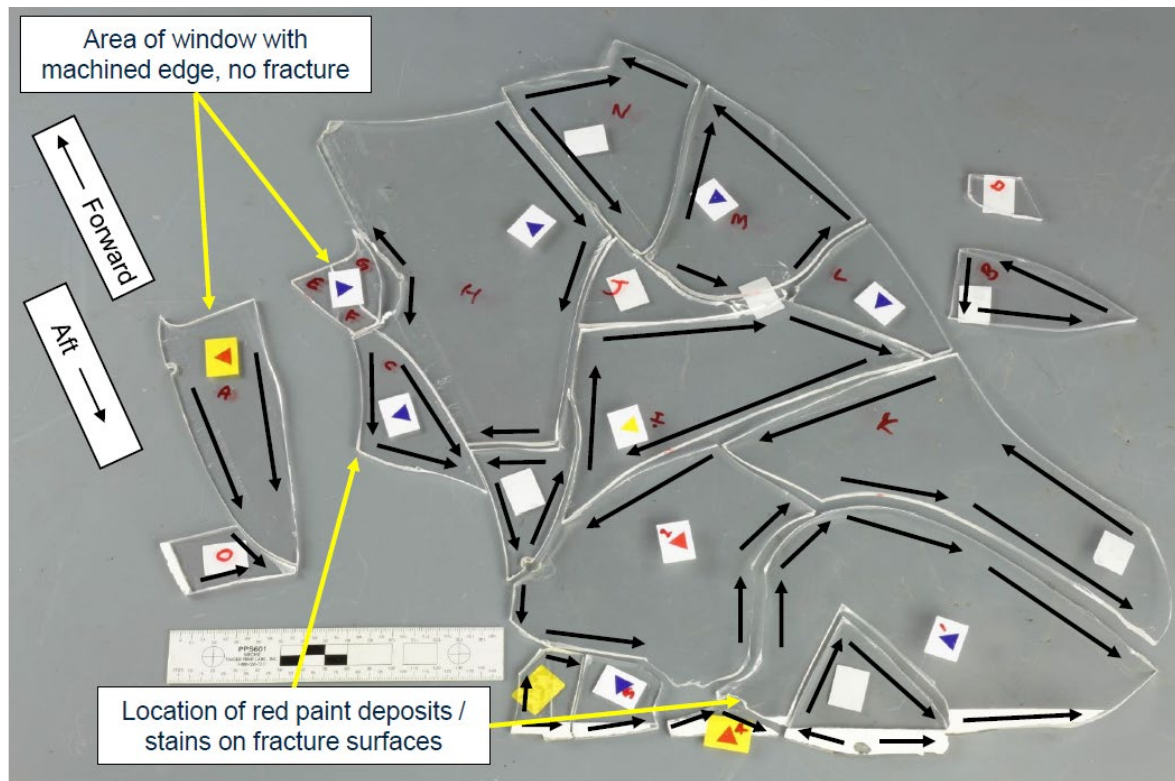
Figure 10

Crack initiation was likely to have been from at or near the window aperture, running through an area of red paint deposit. The fracture direction ran aft and upwards, before returning to the front of the canopy (Figure 10). The two areas of red paint transfer indicate pressure being broadly applied to the canopy between these points before the canopy flexed and broke, and the paint was then able to transfer onto the fracture surfaces.

Canopy fragment reconstruction and fracture directions

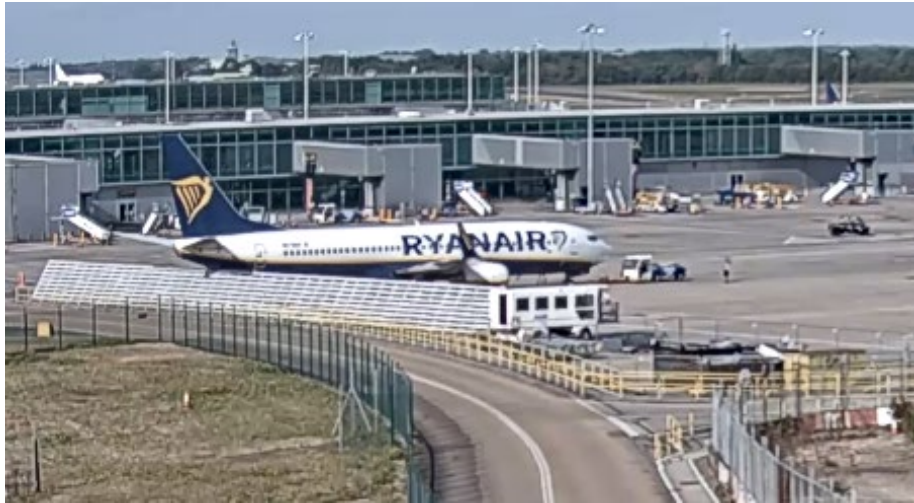
Figure 2

Images of the collision with the blast fence from CCTV

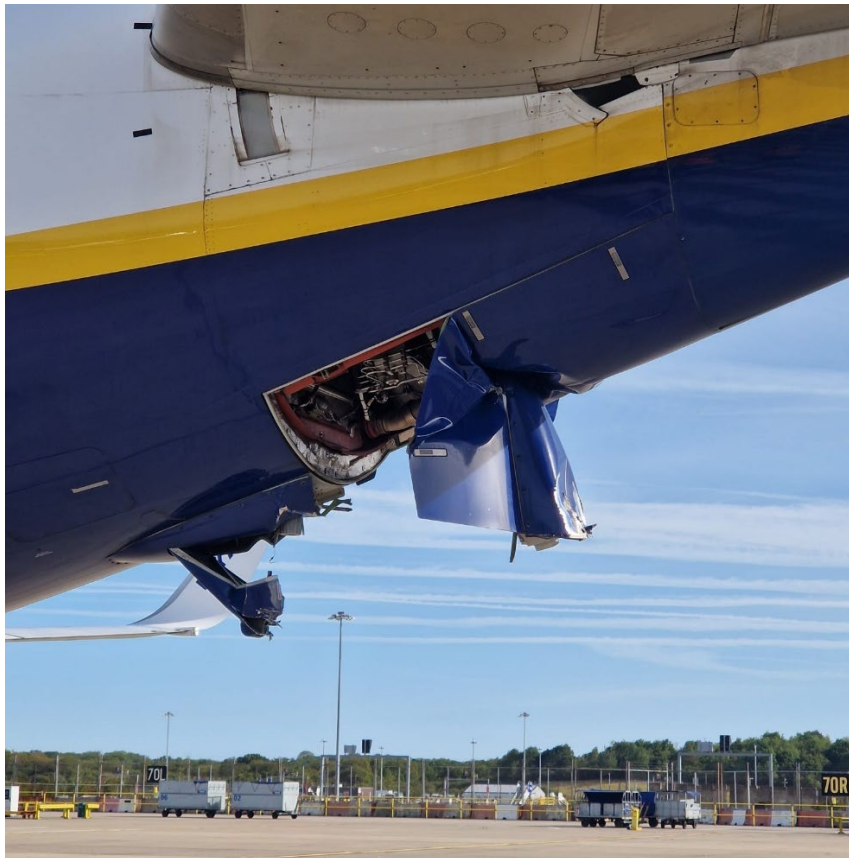
Figure 3

Rear of the aircraft showing the damage sustained

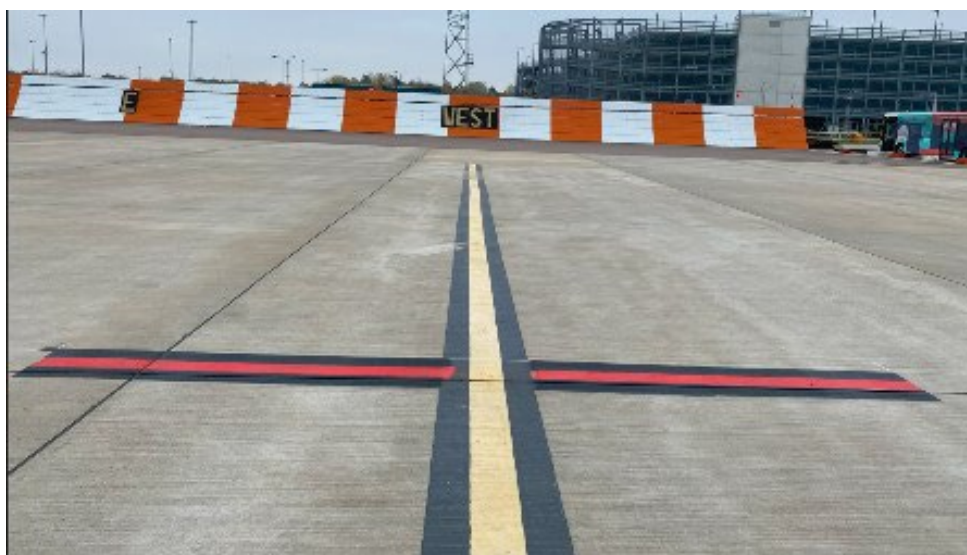
Figure 5

Upgraded TRP since the accident

Since this accident the airport operator has increased the length of TRPs from 0.5 m to 1 m and painted it on both sides of the taxiway centre line (Figure 5).
