Report on the investigation of
the capsized and foundering of the prawn trawler

Odyssey (FR 70)

REPORT NO 17/2025

DECEMBER 2025

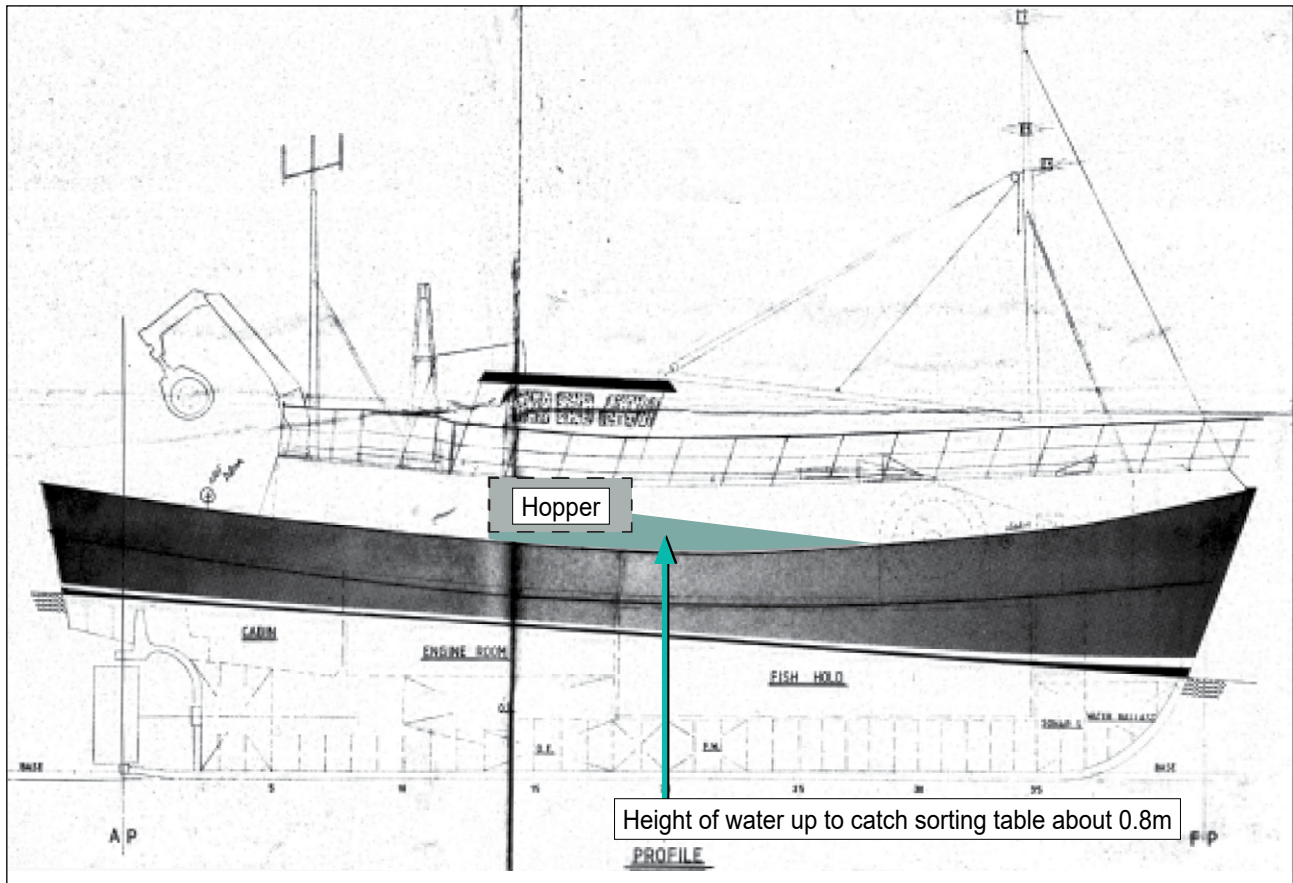
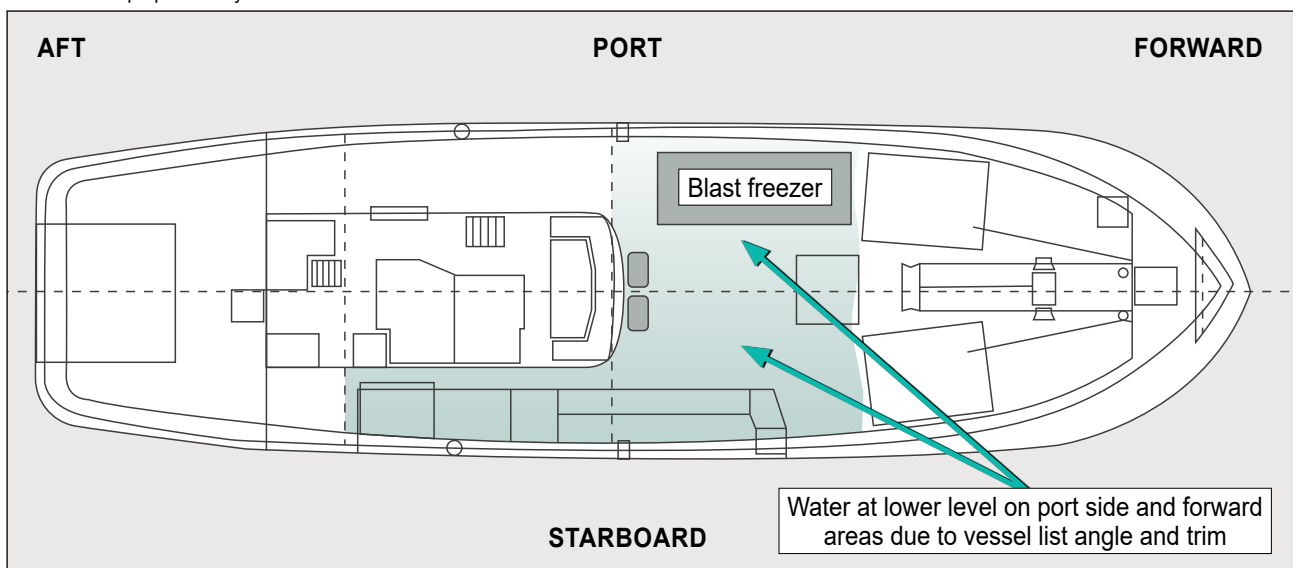
Figure 2: General arrangement, showing the area of flooding

Before *Odyssey* capsized, floodwater was observed to have accumulated to the top of the catch sorting table within the shelter deck (see **Figure 2**). There had been no indication of flooding elsewhere on the vessel as the engine room was checked and no bilge alarms had sounded. The hopper contained catch from the starboard side net and the port side net was hanging from the A-frame ready to be emptied. The crane was fully extended to the port side to counter the developing list to starboard.

Odyssey capsized and foundered after a significant amount of water accumulated on the shelter deck, creating an overwhelming heeling moment and catastrophically reducing the vessel's stability.

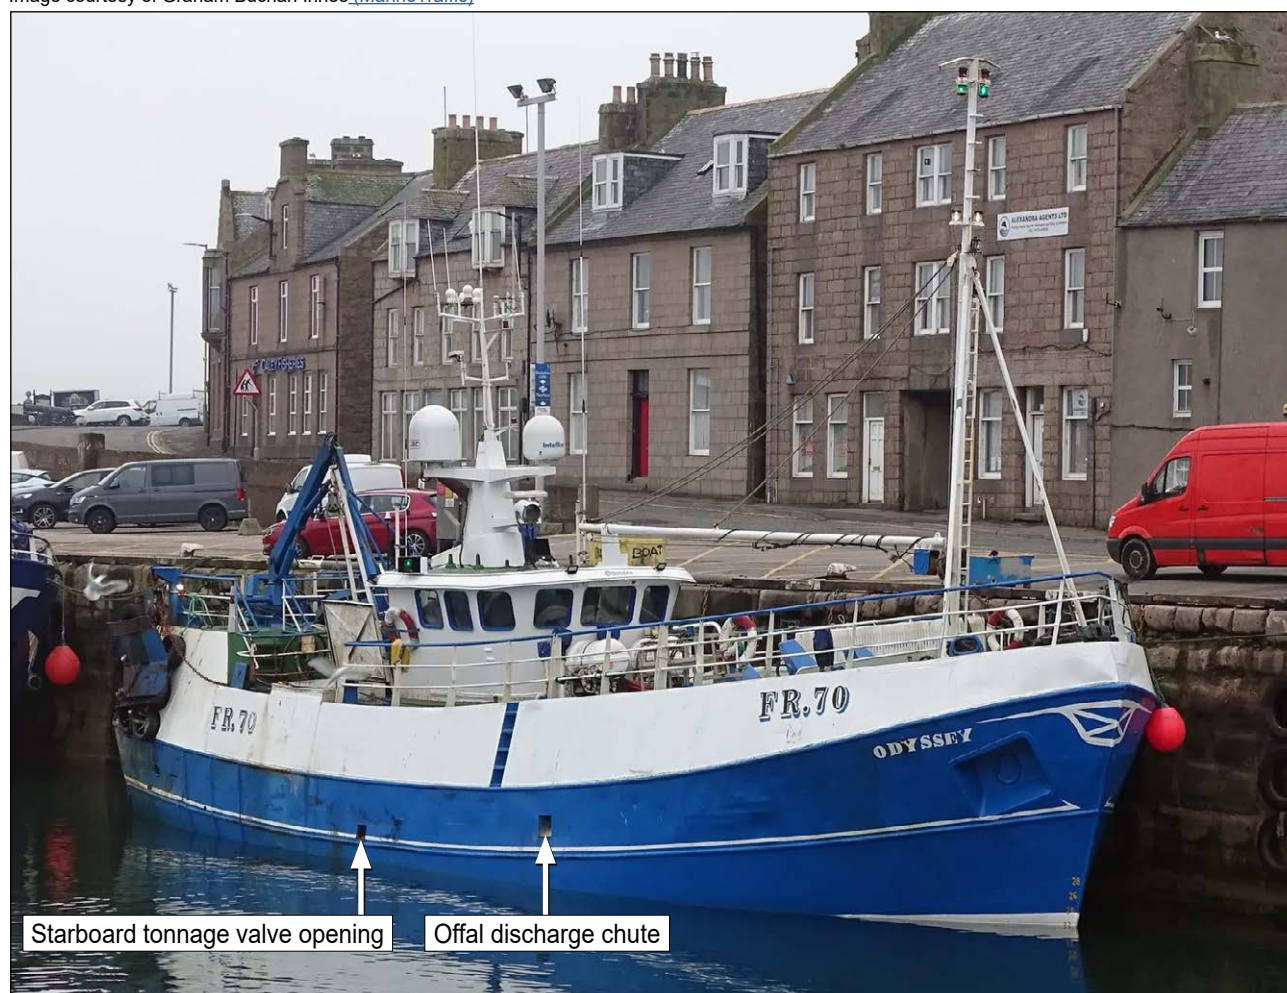
Figure 4: Starboard side openings

These calculations indicate that, as the shelter flooding increases, the vessel's starboard list increases and so does its vulnerability to additional heeling moments. With 12m³ flood water in the shelter, both the starboard tonnage valve and the fish gut chute would become immersed and the vessel's predicted equilibrium heel angle would exceed 20 deg. Such large heel angles would potentially result in loose onboard weights such as catch, gear etc. shifting to the low side, thus exerting an additional heeling moment. With 32m³ flood water in the shelter, a heeling moment of ~40 tm⁶ (ie equivalent to 12.5 tonnes shifting by 3.2 metres, or half the beam) would overwhelm the vessel.

4m³ of flood water would cause the immersion of the tonnage valve⁷, whilst the fish gut chute would maintain a positive freeboard. With 12m³ shelter flooding, the tonnage valve would be approximately 800mm underwater and the fish gut chute would be at the equilibrium waterline.

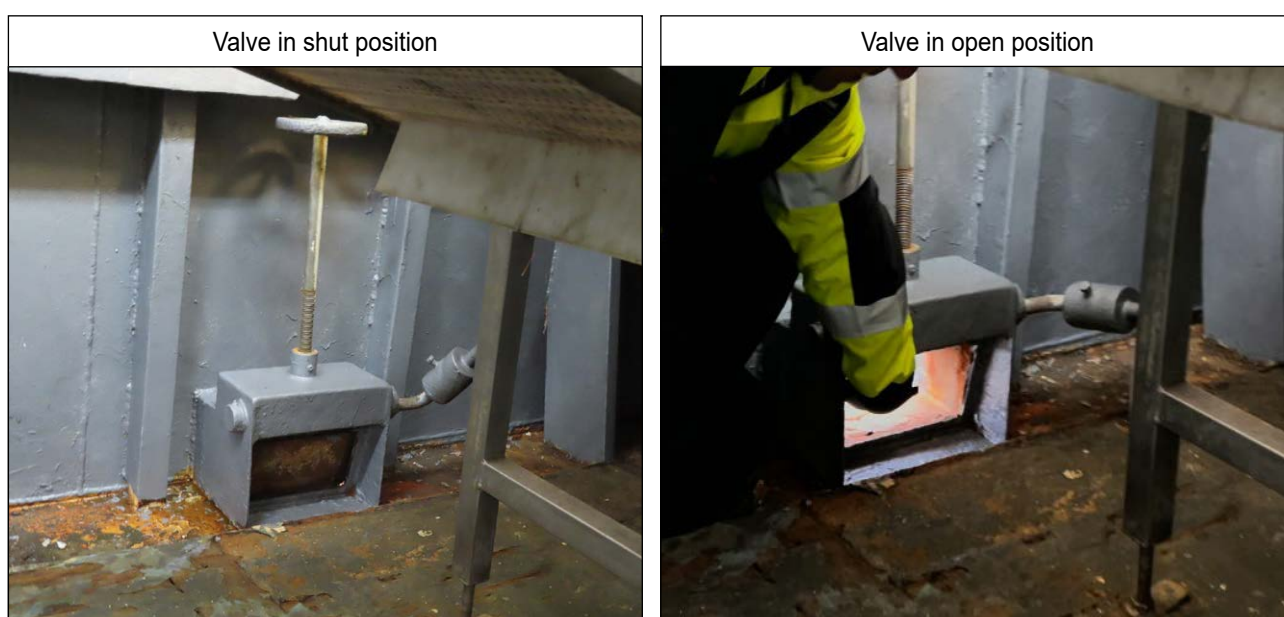
Figure 5: Example tonnage valve

A tonnage valve (**Figure 5**) was a non-return flap valve installed in permitted openings in the side of weathertight shelter decks. Designed to drain water from the deck while preventing water ingress from outside, tonnage valves were fitted with a counterweight to ensure the valve functioned up to heeling angles of 15°, and a hand-operated, screw down spindle that enabled them to be shut completely. Tonnage valves were required to be shut when not in use as a vessel's intact stability was only valid when the weathertight shelter's structure remained secure.

Odyssey's crew regularly monitored the status of the tonnage valves to ensure they moved freely. The vessel's tonnage valves were always left free to open, even when not in use for water freeing. The MCA had found six deficiencies in *Odyssey's* tonnage valves during routine surveys and inspections conducted before 2019, ranging from the valves being *stiff* to being totally seized and requiring replacement.

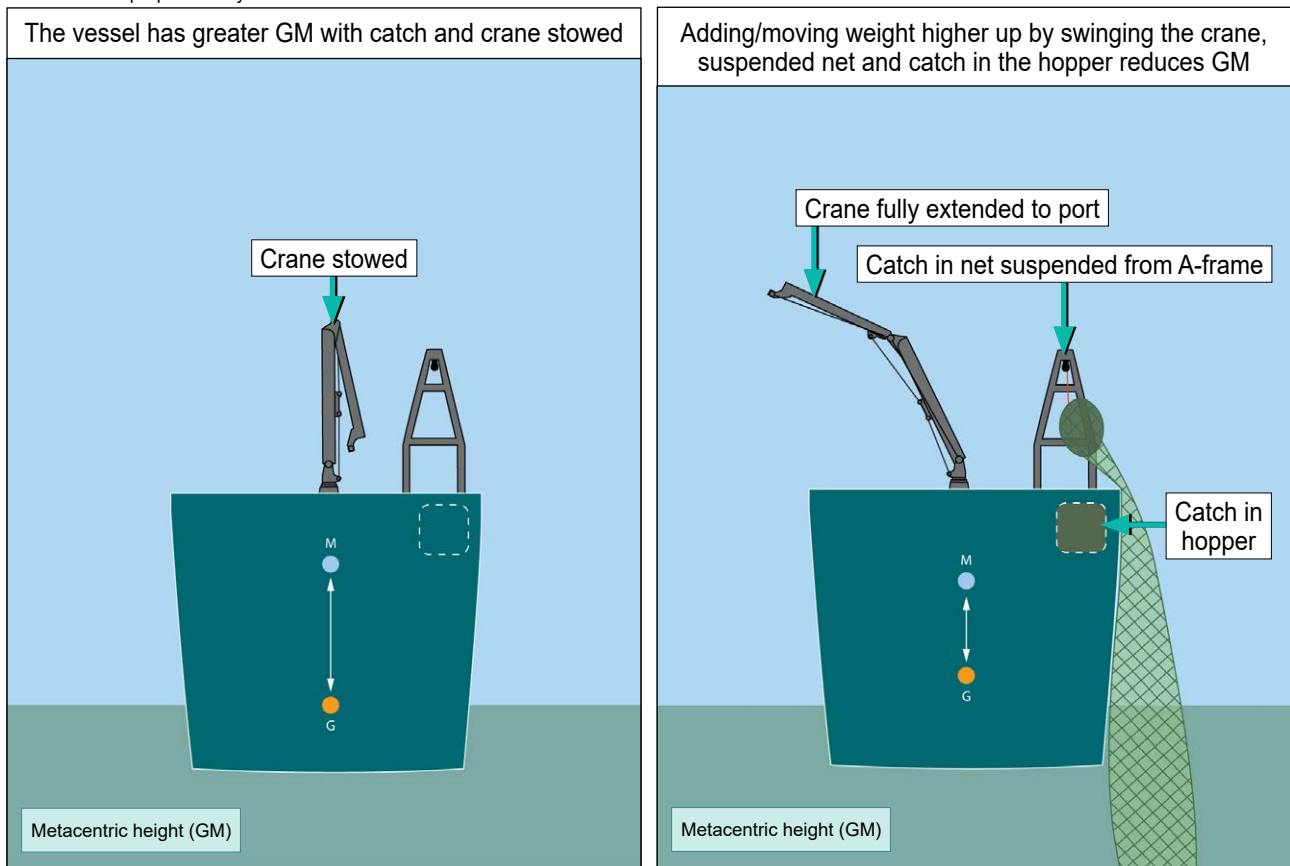
Figure 6: Reduction in GM due to operational condition

Stability modelling indicated that as little as 4m³ of water on the shelter deck created a loss of stability, reducing the vessel's ability to recover and increasing the vulnerability to capsize. As the vessel listed unsecured items likely shifted to starboard, further increasing the heeling moment. Additional water could also have entered through the offal discharge chute as it became submerged. It was calculated that 32m³ of floodwater would produce an overwhelming heeling moment, enough to capsize the vessel. *Odyssey*'s operational condition at the time raised its centre of gravity, reducing the metacentric height and the area under the righting arm curve (**Figure 6**). This in turn shortened the time and volume of water required to capsize the vessel. *Odyssey* complied with the intact stability requirements in MSN 1872 (F) Amendment 1 as demonstrated by the recent stability assessment conducted after the structural modifications were carried out. This was confirmed by the stability assessment carried out by the Wolfson Unit during the investigation. While the SIB highlighted the risks associated with a full hopper and the importance of stowing catch promptly, there was probably little scope to increase the speed of that part of the operation.

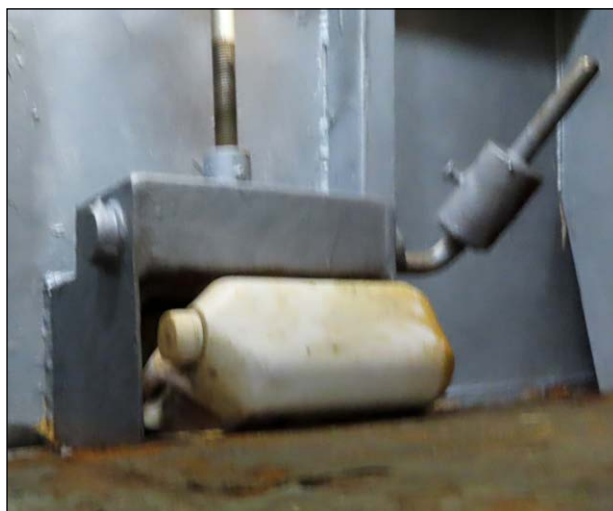
Figure 7: Example of a tonnage valve blocked by a loose object

When the flood was discovered *Odyssey's* skipper estimated that the vessel was heeled over approximately 15° to 20°, which corresponded to about 12m³ of floodwater. This indicated that *Odyssey* had less than 10 minutes before capsizing from the deck wash pump capacity alone, which aligns with the accident's timings. There was no evidence to suggest that the tonnage valves were defective or shut as the crew had not previously observed any water accumulation on the shelter deck. The crew had always operated with the valves open and they had been regularly maintained. Although previous MCA surveys and inspections had found several instances of compromised tonnage valves on board *Odyssey*, these had not occurred in the last 5 years or been observed at the most recent survey. It is therefore likely that a loose item on the shelter deck blocked or partially obstructed the opening enough to allow the deck wash water to accumulate (**Figure 7**), similar to the accident on board *Angela*.

The starboard tonnage valve likely became fully or partially blocked by a loose item on the shelter deck. This meant that water was unable to drain freely, causing it to build up and compromise the vessel's stability.

3. The starboard tonnage valve likely became fully or partially blocked by a loose item on the shelter deck. This meant that water was unable to drain freely, causing it to accumulate and compromise the vessel's stability. [2.3.3]

- 2025/150** Provide guidance on the additional measures that can be implemented to adequately address the risk of water accumulation on weathertight shelter decks caused by blocked, seized, or shut tonnage valves or other water freeing arrangements.

2. The investigation found it likely that the shelter deck drainage had become blocked. It is critical that shelter decks are kept free of any loose items that might interfere with drainage through tonnage valves or other water freeing arrangements. Even a partial blockage could be enough to allow water to build-up rapidly.
