Rail Accident Report

Buffer stop collision at London Bridge station 13 December 2024

Report 09/2025
December 2025

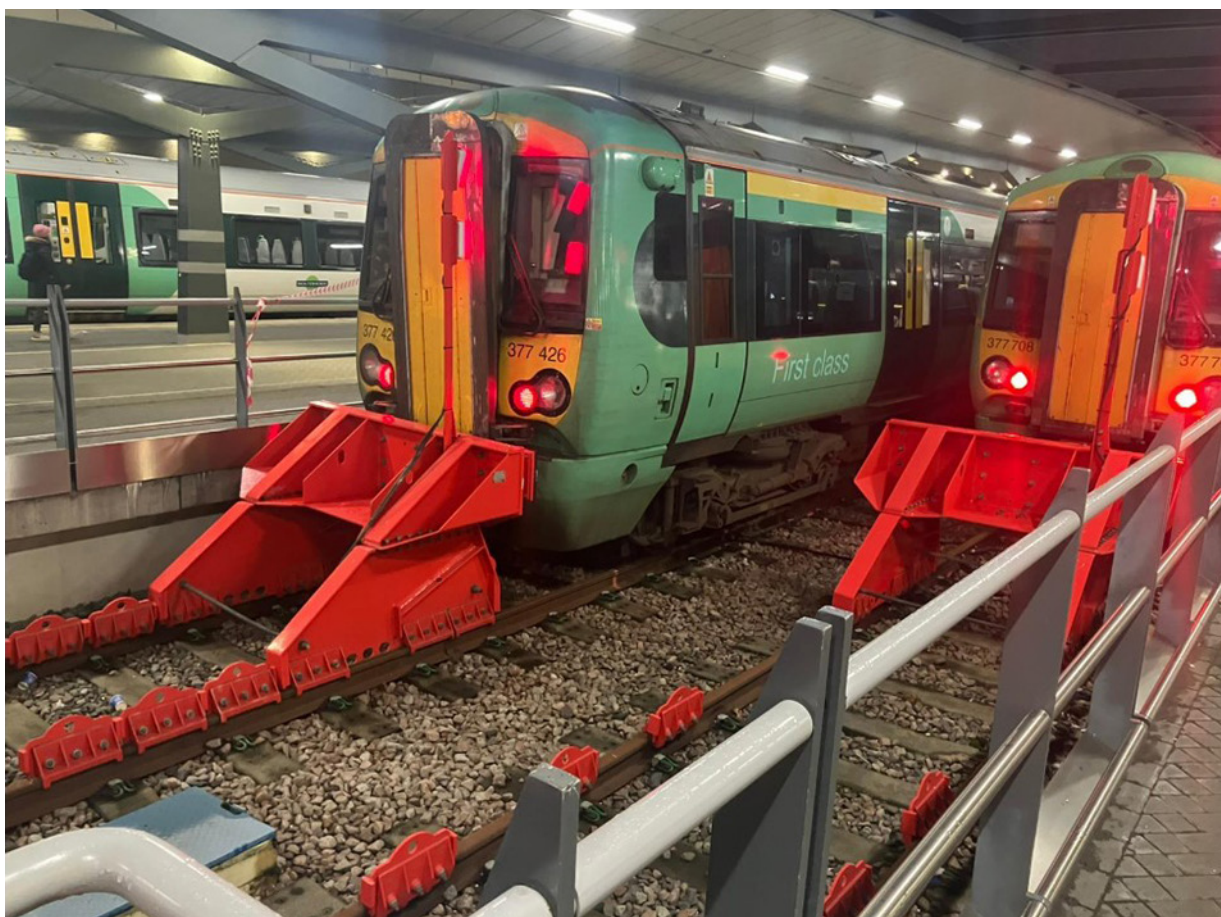
- 4 There were no reported injuries to the driver or to the passengers on the train.
- 5 There was minor damage to the buffer stop and to the signalling equipment. Repairs were made and the platform reopened later the same day.

Figure 2: View of train 2F40 after it collided with the buffer stop at platform 12.

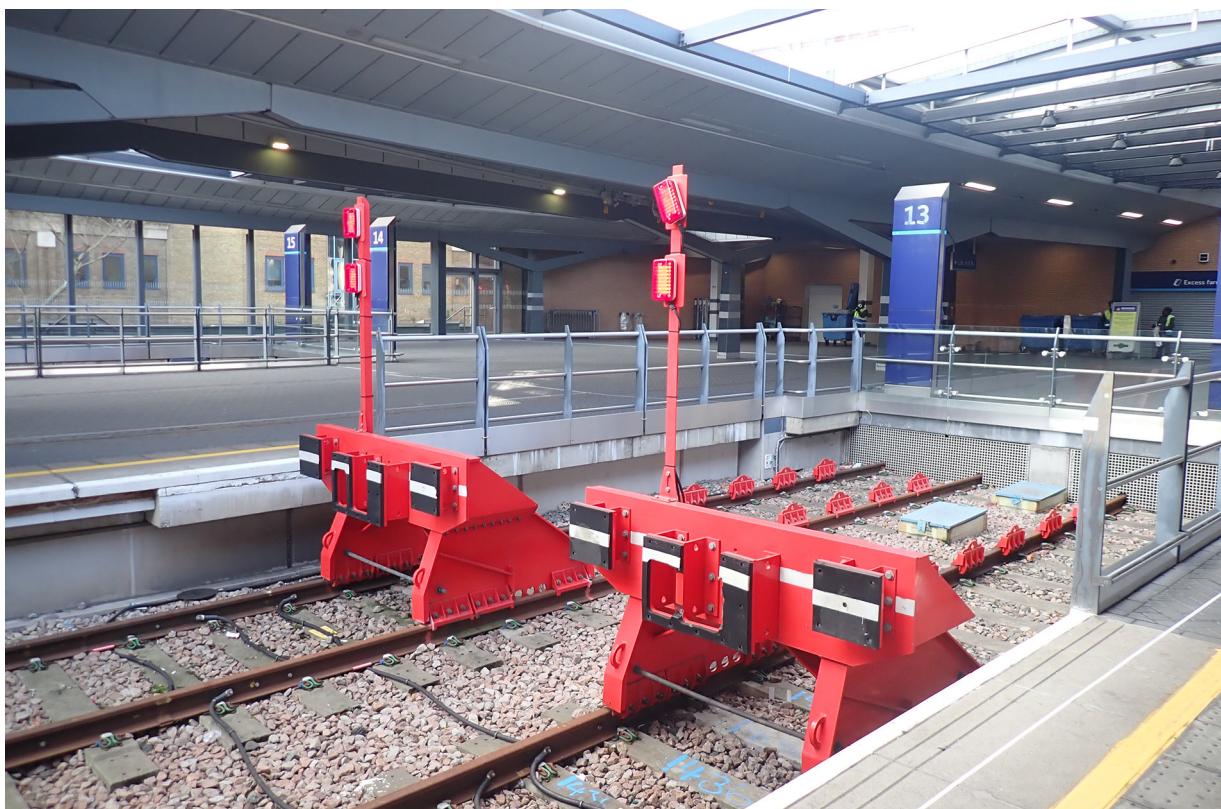
- 19 Platform 12 at London Bridge station is fitted with buffer stops of a sliding design, which absorb energy by moving along the rails when struck, slowed by friction blocks (figure 4).

Figure 4: On the right, in their normal position the buffer stops of platform 12 at London Bridge station (courtesy of Network Rail).

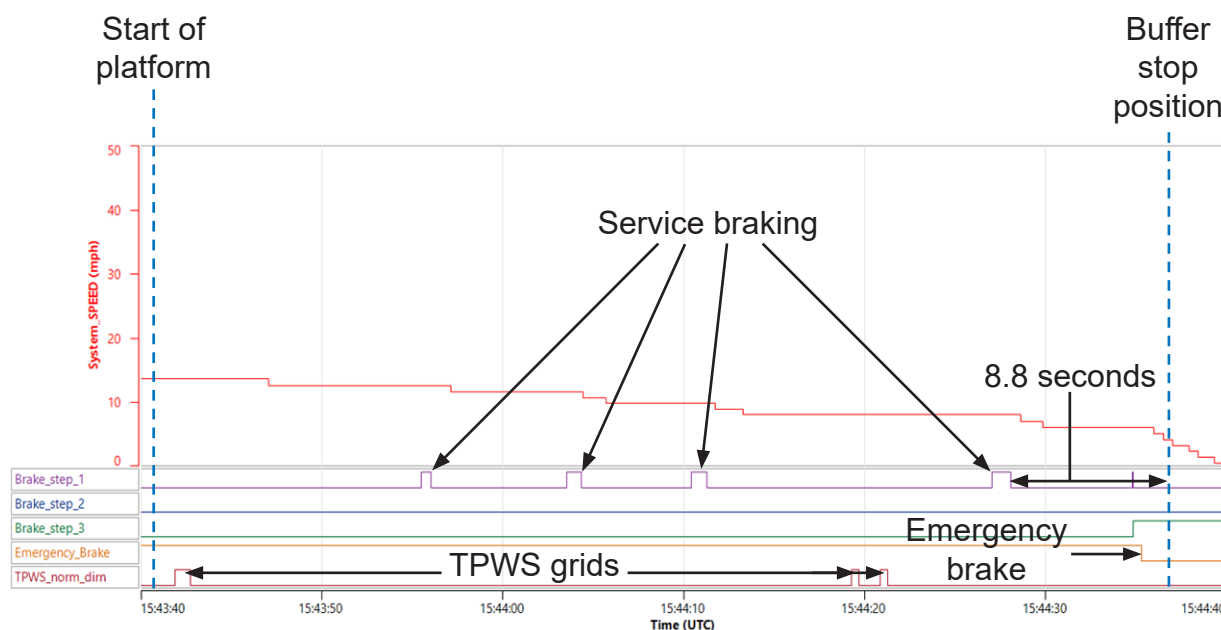
- 29 After focusing on controlling the train's speed for the buffer stop TPWS sensor, the driver did not remember anything further until they became aware that the train had hit the buffer stop. However, OTDR data shows that, after passing the TPWS sensor, the driver made several brake applications. At 15:44:24 they made a brake step 1 application for just over a second. At 15:44:32, about 1 second before the collision, there was a 0.1 second application of brake step 1, a 0.5 second application of full-service braking, followed by an emergency brake application. This remained applied until the train was stationary, after the collision (figure 5).

Figure 5: Train data showing driver control actions before the collision.

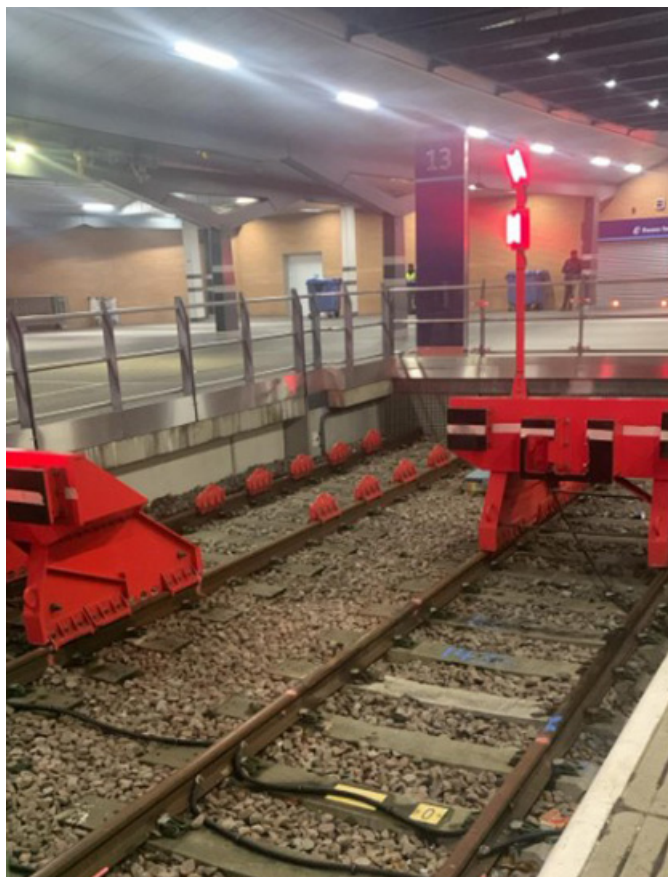
- 30 The train came to a stand having pushed the buffer stops around 3 metres from their installed position. The buffer stops operated as intended and reached three of the five available friction blocks that are designed to help slow a train to a stop (figure 6).
- 31 The driver contacted the signaller to report the accident. Passengers were able to leave the train normally and there were no reported injuries. British Transport Police officers, who were already on duty on the station, attended the scene immediately.
- 32 The train departed from the station at 20:45 and was taken to Selhurst depot for testing and examination. The platform was returned to service at 23:51.

Figure 6: Buffer stops at London bridge platform 12 after the collision.

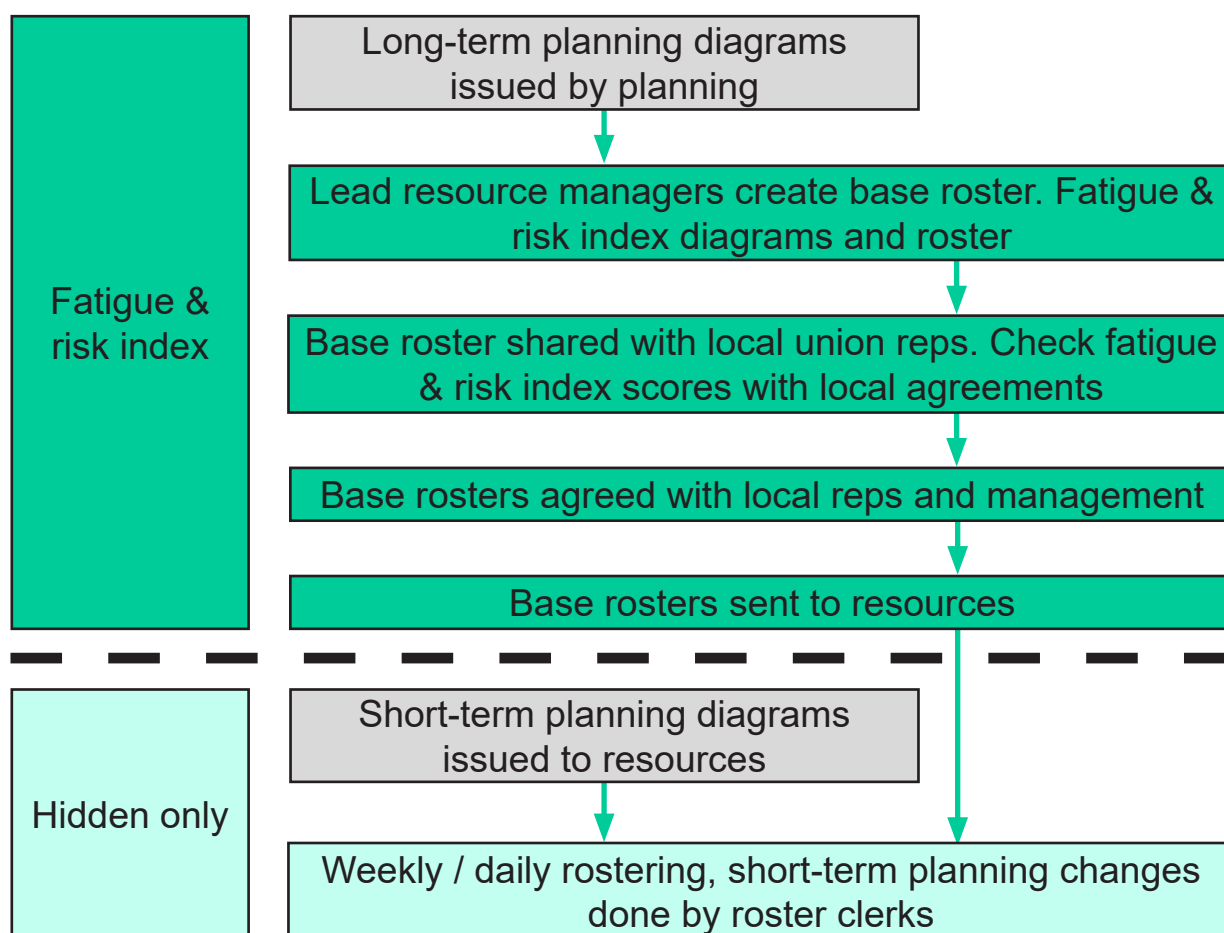
- 60 Appearance sheets are used to communicate to drivers the shifts they have been allocated and to show the amendments to the base roster (including changed diagrams and any overtime). These sheets are then sent to the resource managers who then deal with STP diagrams that have no allocated driver because of, for example, sickness, annual leave or training commitments. If any diagrams remain uncovered the work will be offered for rest day working. The only check made by resource managers for fatigue risk at this point is against the Hidden limits (figure 7).

Figure 7: Diagram showing the rostering process in place at GTR at the time of the accident.

- 64 Although checks are made to identify working patterns that may possibly cause fatigue when designing the base roster, subsequent changes that are then incorporated into the roster are subject to fewer checks of this nature, as they are only checked to see if they are compliant with Hidden limits. This increases the likelihood that the final roster produced will not adequately manage the risk of fatigue for a driver.
