Near miss with track workers near London Bridge station, 30 July 2025

Summary of the incident

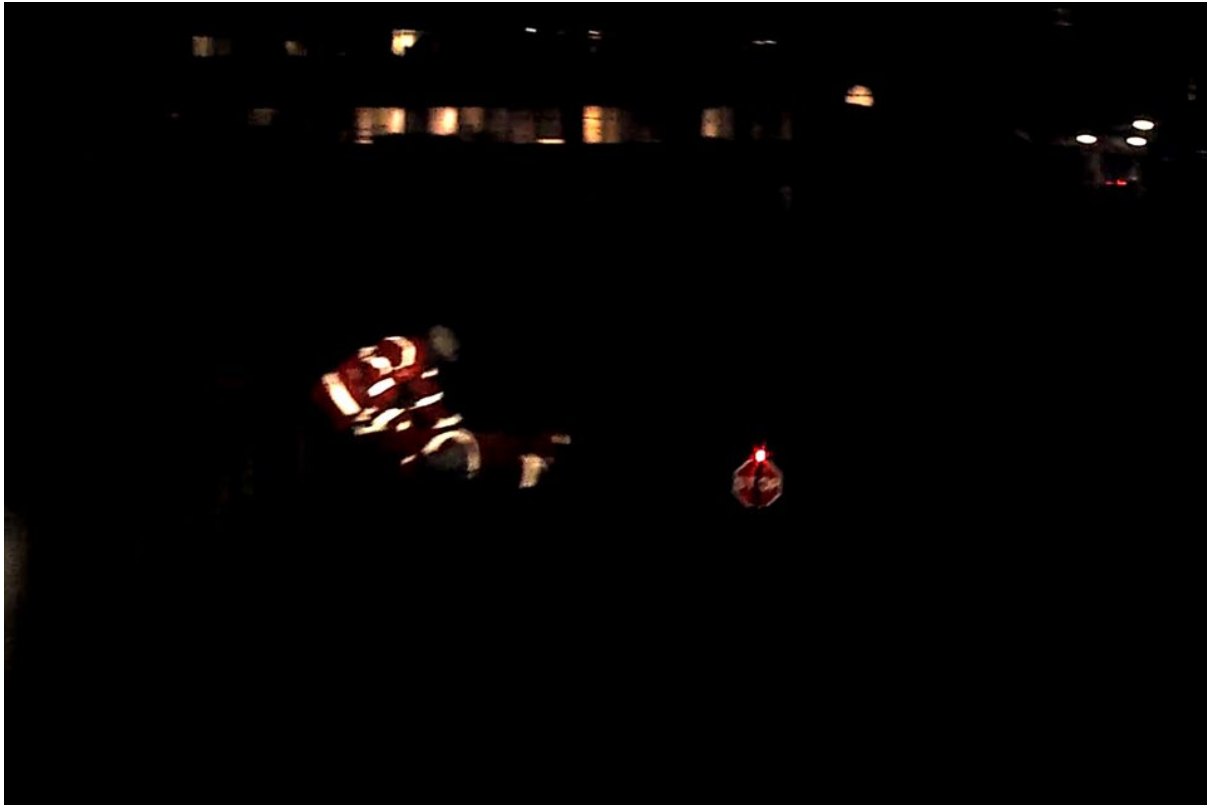
The train was travelling at 19 mph (31 km/h) as it approached. On seeing people on the line ahead, the driver made an emergency brake application and the train stopped before it reached the track workers' position. Forward-facing CCTV from this train shows that the track workers climbed onto a lineside walkway once they became aware of the train, with one assisting the other to get clear of the track. No one was injured in the incident, and no damage was caused.

Forward-facing CCTV image from incident train showing track workers climbing onto a lineside walkway. The red possession limit board is on the track ahead (courtesy of Govia Thameslink Railway (GTR)).

The incident occurred because the PS COSS placed a possession limit board (PLB) on a section of the Down Charing Cross line that was still open to trains.

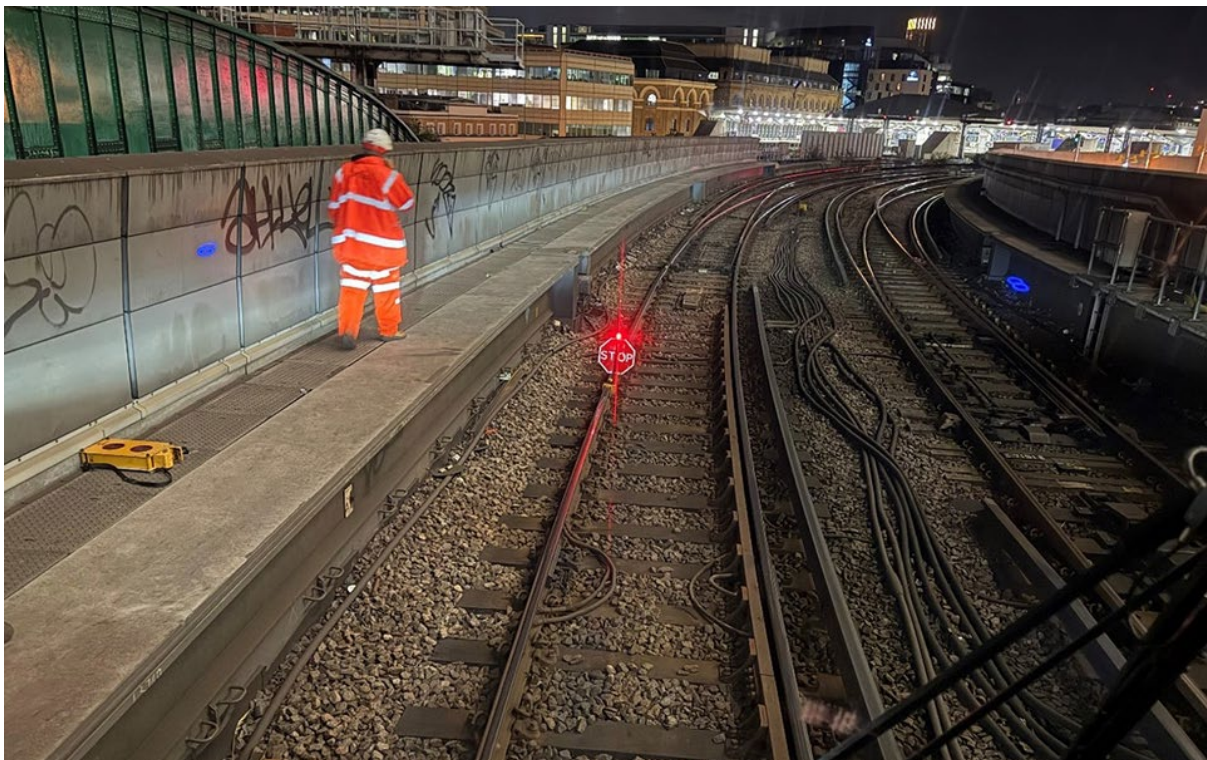
Image from cab of incident train after stopping, showing the possession limit board with London Bridge station ahead (courtesy of GTR).

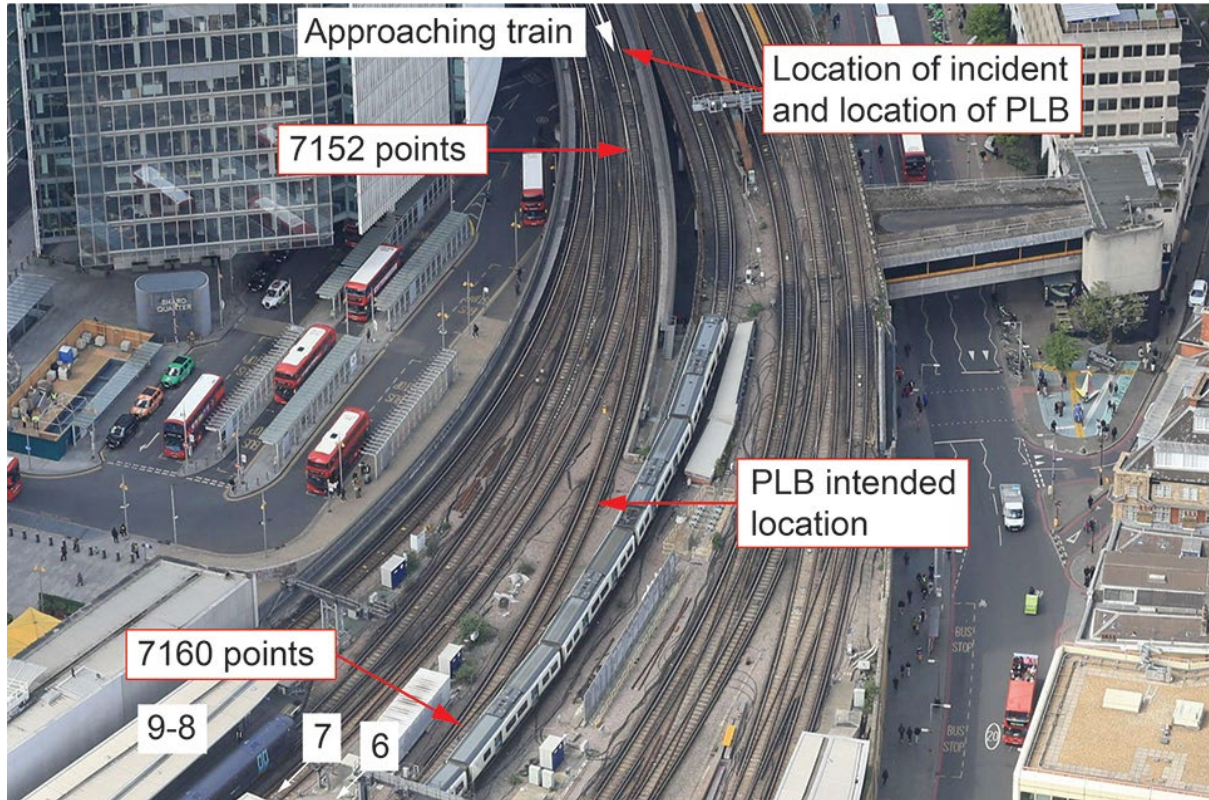
The Down Charing Cross line is used by southbound trains travelling from Blackfriars or Waterloo East towards London Bridge. The line divides at 7152 points to give access either to platform 6 or to platform 7 at London Bridge station. Platform 6 was included in the possession, whereas platform 7 remained open to traffic. The train involved was signalled towards platform 7. The PLB should have been placed beyond 7160 points to block the line towards platform 6, and on approach to 7160 points, close to the platform end.

Aerial view of northern approach to London Bridge station (courtesy of Network Rail Routeview).

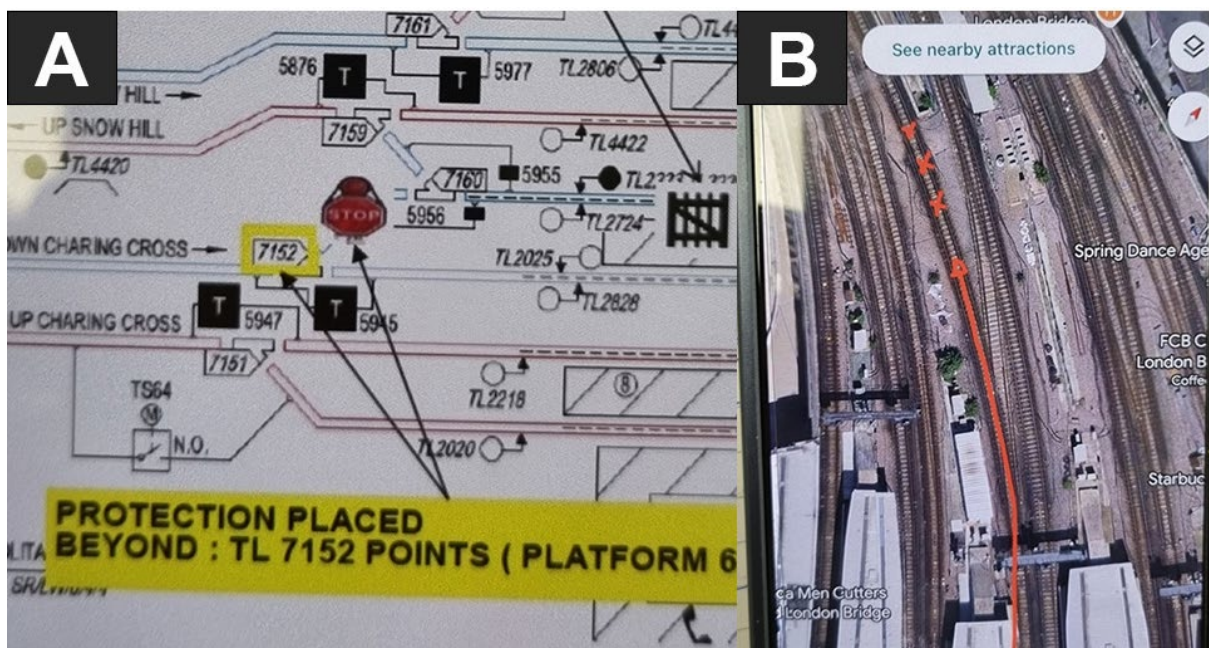
The shift for both trackworkers started at 22:00 on the evening of 29 July. However, the PS COSS arrived at London Bridge after 23:00, due to issues with their travel into London. Consequently, they did not attend a planned in-person briefing with the ES and had to be briefed by phone instead. As the PS COSS was undertaking this role for the first time at this location, Vital stated it had expected the PS COSS to arrive at the planned start time to allow sufficient time for site familiarisation, manage the signing-in process, and complete pre-task co-ordination.

Images from PS COSS's mobile phone showing annotated diagrams to indicate where PLB should be placed.
