Rail Accident Report

Derailment of a freight train at Audenshaw, Greater Manchester 6 September 2024

Report 10/2025
December 2025

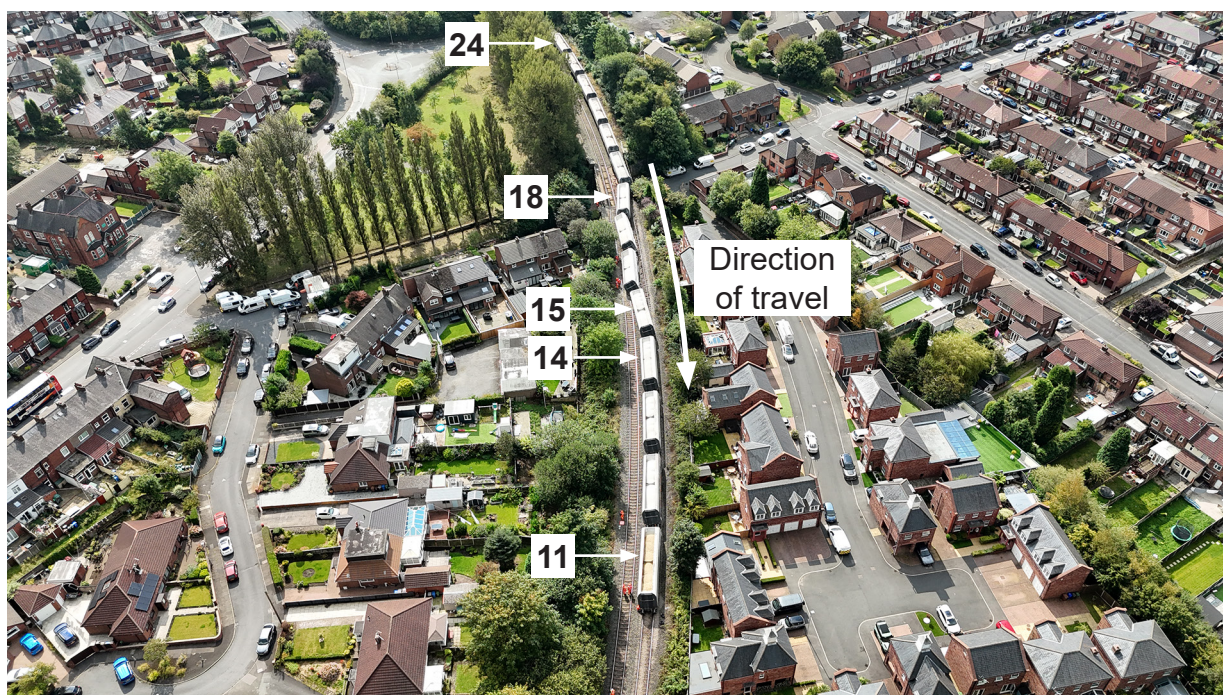
- 5 The bridge is approximately 14 metres long. The derailment happened between 2.4 and 4.8 metres from the start of the bridge and was caused by widening of the gauge (the distance between the rails), which allowed the right-hand wheels of the leading bogie of wagon 11 to drop between the rails. This caused the left-hand wheels of the wagon's leading bogie to flange climb over the left rail as the derailed wheels on the right-hand side became constrained. The right-hand wheels of the trailing bogie also dropped between the rails, with its left-hand wheels causing the rail to roll over. Wagons 12 to 14 all derailed to the left in a similar manner. As wagon 15 crossed the bridge, the right-hand rail broke underneath it at a welded joint. The rear wheels of wagons 15 and those of wagons 16 to 18 derailed to the right, initially running on the bridge deck before digging into the ballast, once they had passed over the bridge (figure 2).

Figure 2: The derailed wagons.

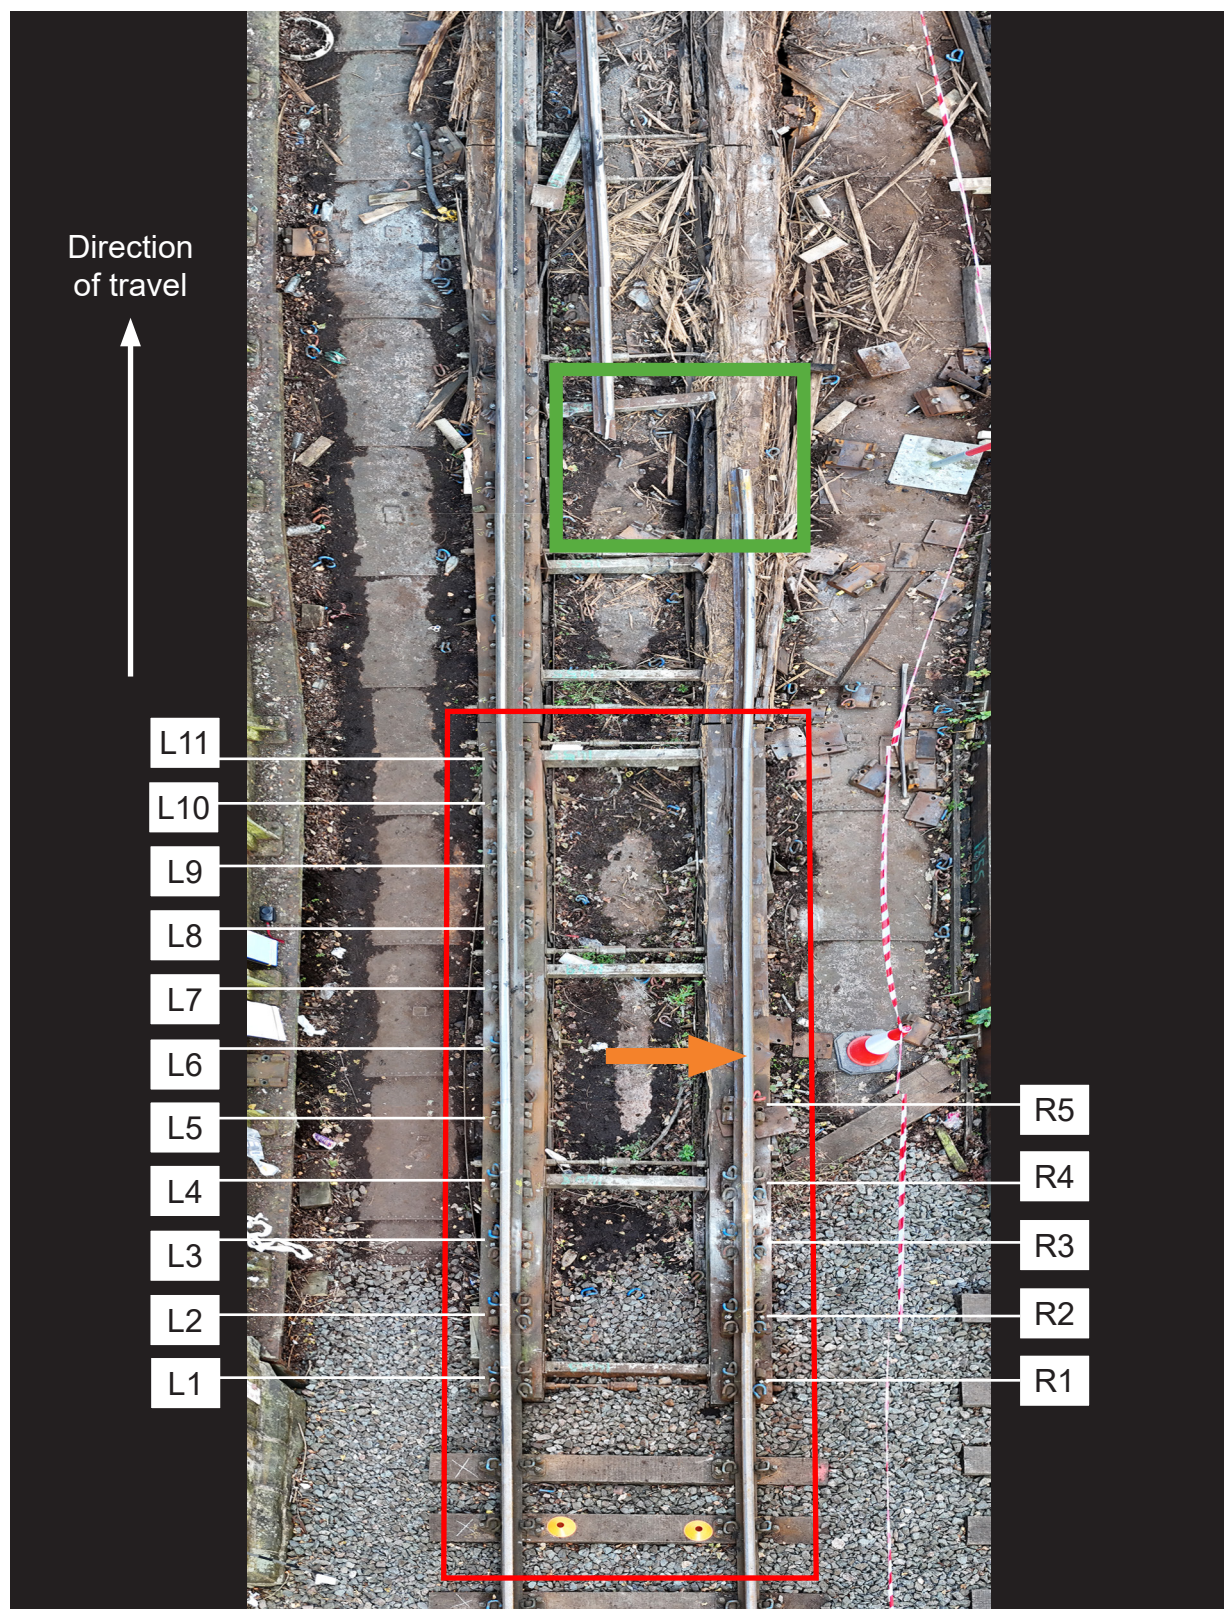
- 42 The wheels of the leading bogie of wagon 15 followed the same path until the right-hand rail broke under the wagon at a welded rail joint (green box in figure 7). Consequently, the unrestrained wheels of the rear bogie of wagon 15 derailed to the right. These wheels ran off the longitudinal bearers and onto the bridge deck, puncturing holes in it and causing debris to fall onto the footpath below. Continuing forward, these derailed wheels ran off the bridge and onto the ballast on its far side, continuing to run to the right of the original track's position.

Figure 7: Area of the LBS showing the point of derailment (arrow) and the location of the broken rail welded joint (green box). The red box indicates the track section that was removed from site for the detailed examinations. (Note: all baseplates beyond R5 were displaced during the derailment).

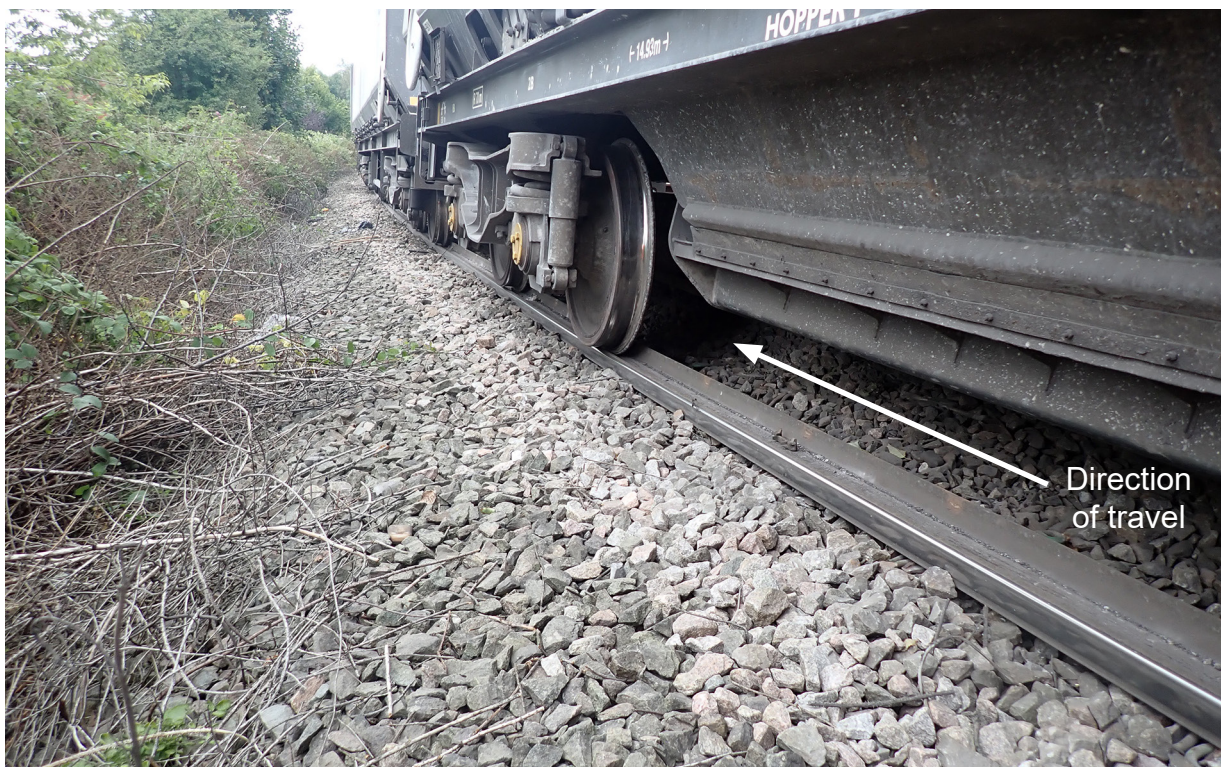
- 41 The wheels of the trailing bogie of wagon 11 followed the same path, but instead of climbing over the left-hand rail, these wheels caused the rail to overturn, rolling it free from its rail clips. The left-hand wheels then ran along the web of the overturned rail (figure 8). The following wagons 12 to 14 all derailed in the same way, with their left-hand wheels also running along the web of the overturned rail.

Figure 8: The overturned left-hand rail.

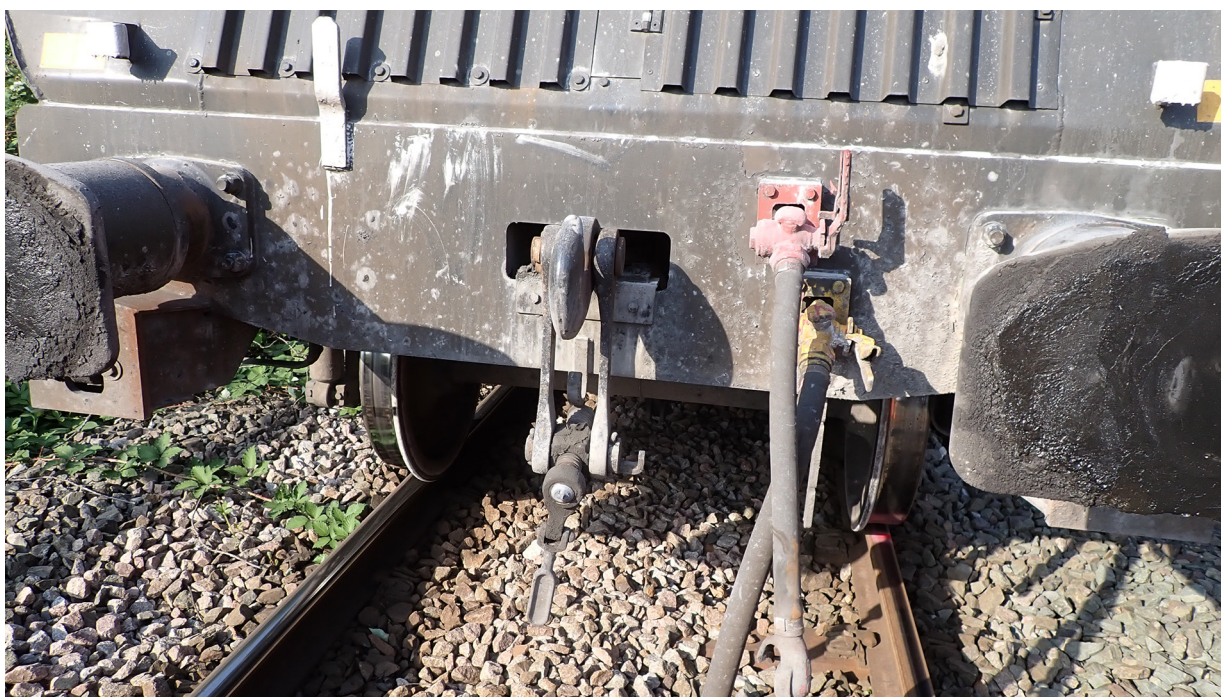
- 6 The train continued until the coupling separated between wagon 10 and the derailed wagon 11, causing the train's brakes to automatically apply. The two sections of the train stopped about 70 metres apart.
- 7 No one was injured during the derailment, although there was a group of track workers underneath the bridge at the time. When they heard the noise from the derailed wagons, they quickly moved clear of the bridge. None were struck by falling debris from the bridge.
- 8 The accident caused significant damage to the bridge and track infrastructure. Five of the derailed wagons sustained significant amounts of damage. Both tracks of the railway line over the bridge were closed for more than 8 weeks to recover the wagons and repair the infrastructure.

Figure 9: The broken coupling between wagons 10 and 11.

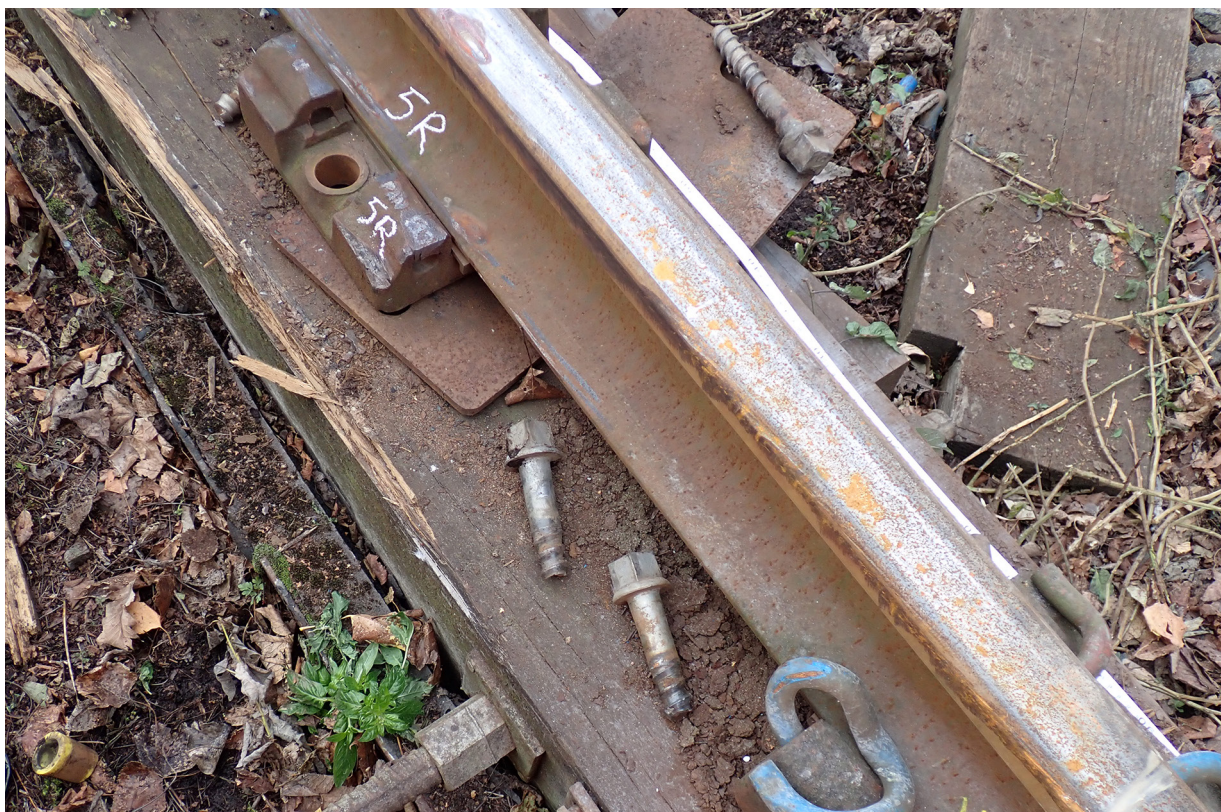
- 62 Each baseplate position was examined, with a record made of the components still in place and their condition. RAIB found that in some of the locations where the baseplate was still present, the screws had broken, but their upper portions remained in place within their ferrules and the associated baseplates' bossed holes. Some of these broken screws were so tightly wedged in the baseplate that they required a spanner to remove them. These upper portions of screws, together with those recovered from the debris scattered on the bridge deck close to the section on which the derailment initiated (a total of 22 components), were sent to an external organisation to be metallurgically examined to identify the mode of failure (figure 10).

Figure 10: Broken screws recovered from the debris on the bridge.

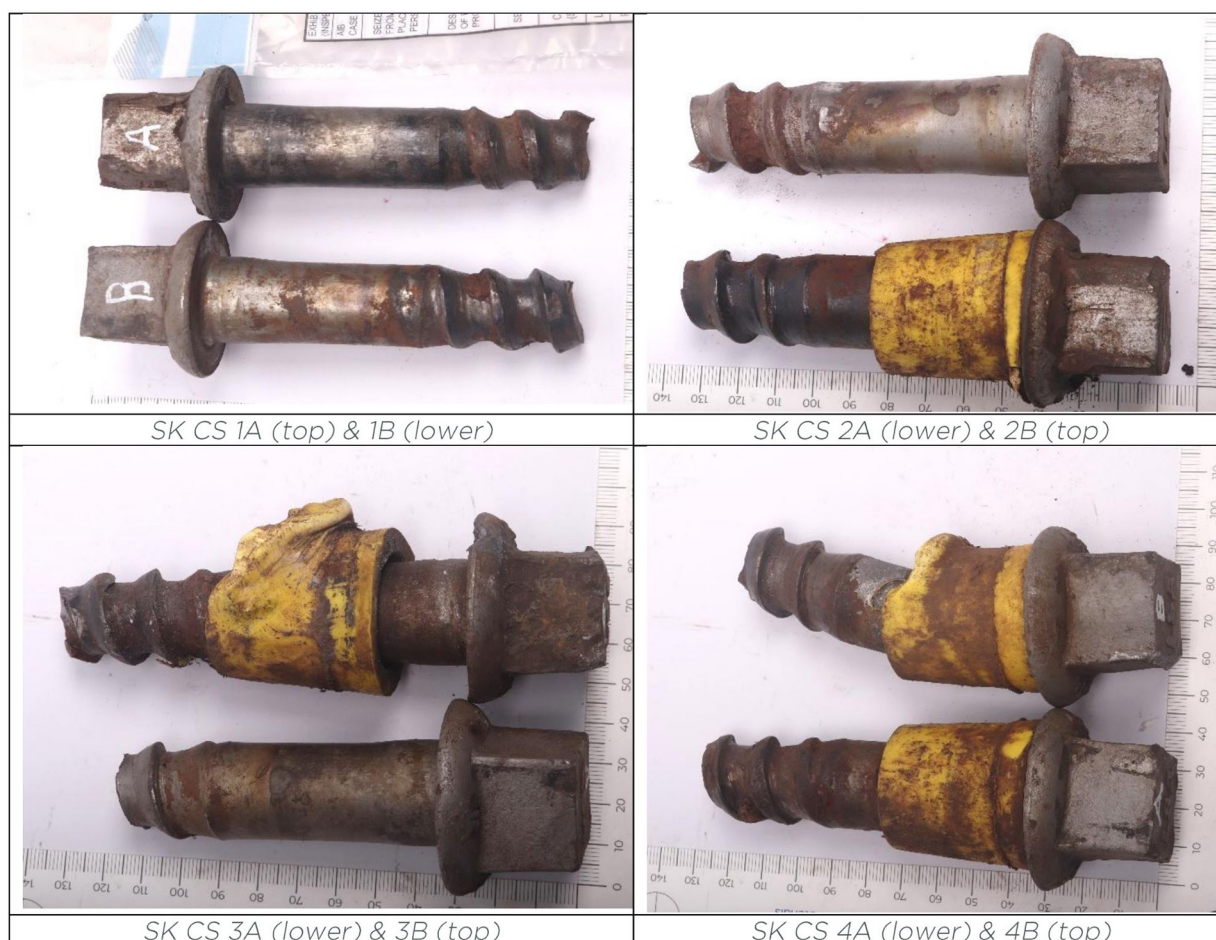
- 63 All the upper portions examined had failed within the first three threads close to where the plain shank ends and the threaded section begins (paragraph 24 and figure 11). The planes of all the fractures were below the upper surface of the bearer. There was also evidence of bending deformation on some of the screws.

Figure 11: Examples of broken upper portions of screws before metallurgical examination.

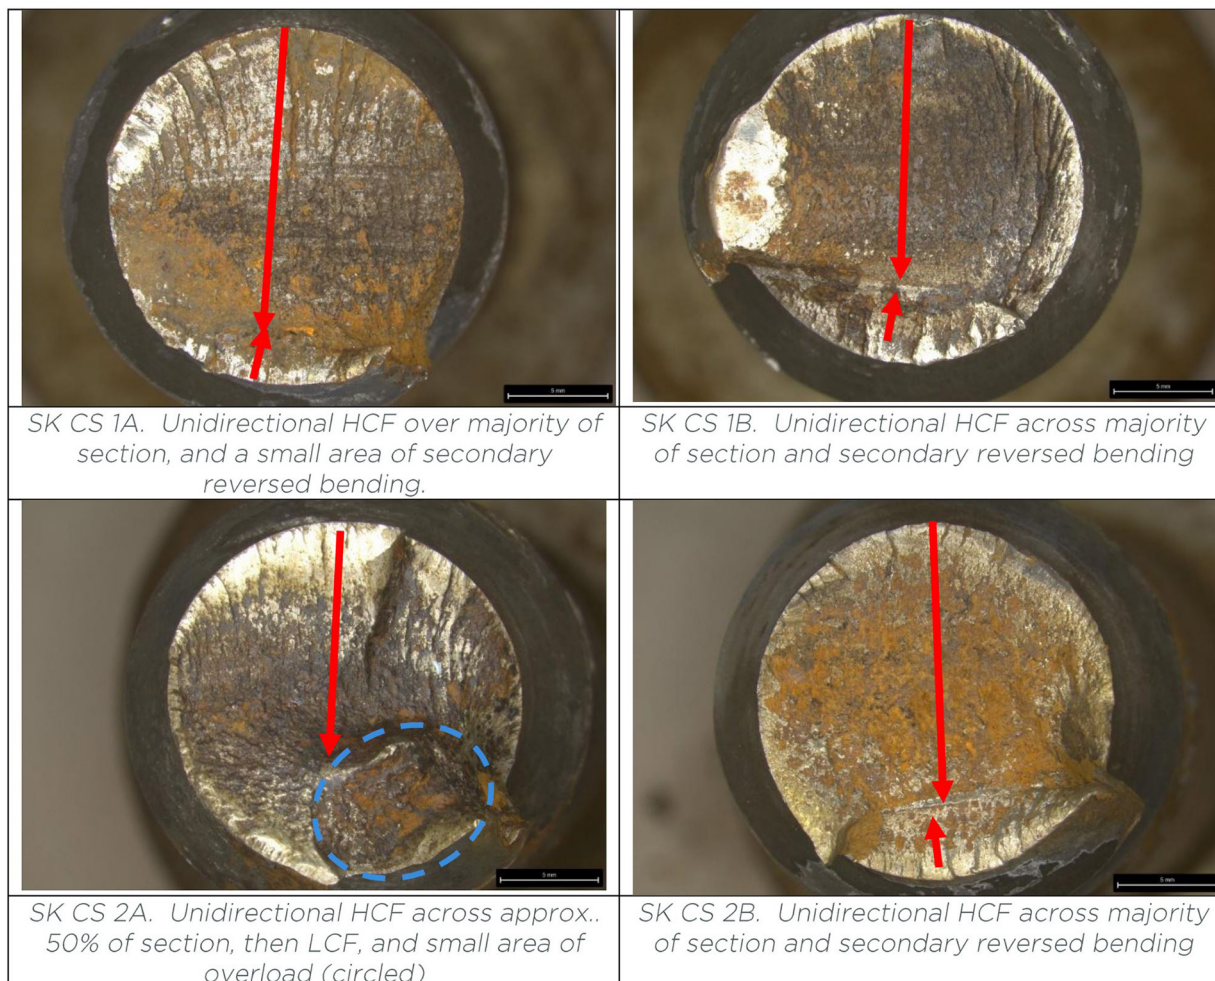
- 65 Although it was not possible from this examination to determine the ages or the sequence of the screw failures, the presence of HCF, LCF and overload failure shown on figure 12 indicates that there had been concurrent fatigue crack growth activity in all the samples examined. There was also evidence of reversed bending in most of the samples.

Figure 12: Fracture face examination showing reversed bending fatigue in three of the four samples shown, and one with signs of fatigue followed by final overload failure.

- 66 The presence of LCF followed by final overload failure in some of the screws (figure 12, lower left) indicates that the load and hence the stresses in these screws had increased once those exhibiting HCF were either partially or fully fractured. This then led to more rapid fatigue crack growth (that is, higher load and fewer loading cycles) in those showing LCF which subsequently broke by overload failure. This shows that some screws were in a deteriorated condition before the arrival of train 6J46.

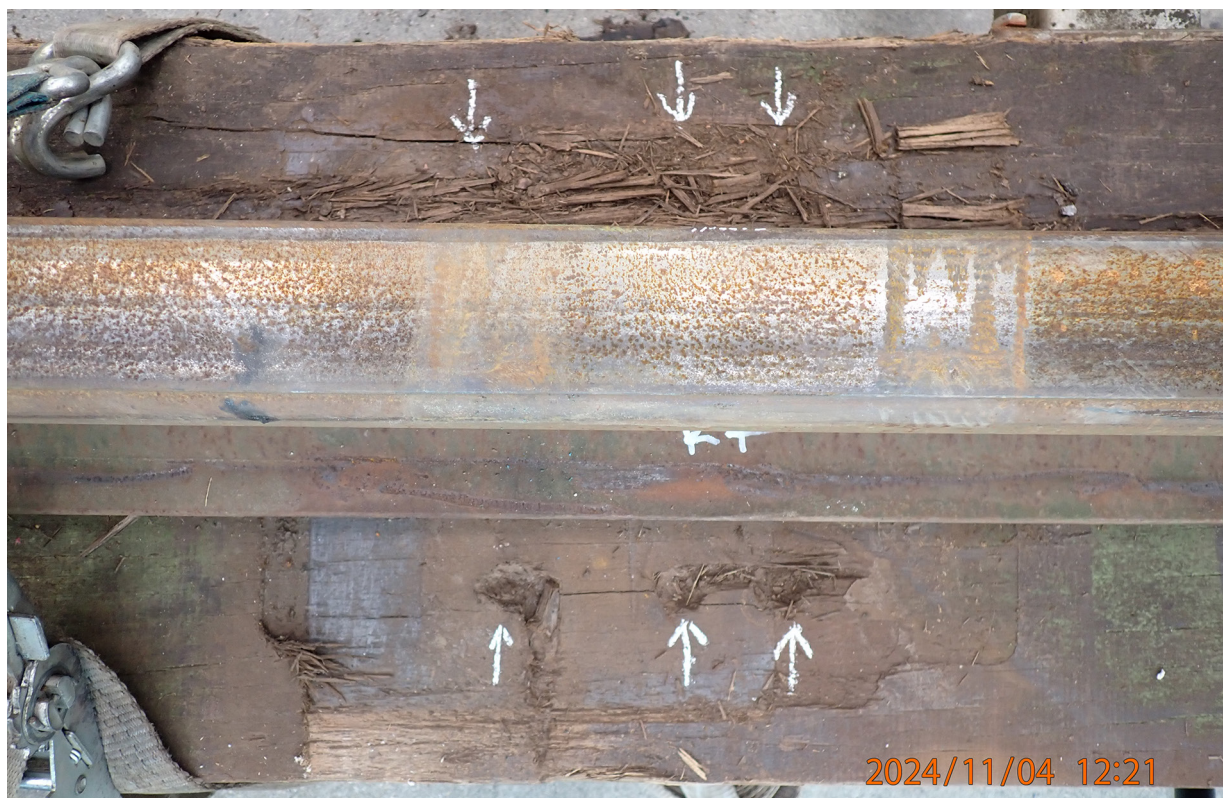
- 67 The examinations found that at baseplate positions R5 to R9 on the right-hand rail and at baseplate position L6 on the left-hand rail there were indications of multiple holes in the bearers (figure 13). Both the use of a metal detector and X-ray images confirmed the presence of lower screw portions at the majority of these locations, with some holes where no screw was present (figure 14). This showed that there had been previous screw failures and replacements before the fitting of the screws which were in place at the time of the derailment.

Figure 13: The R7 baseplate position showing evidence of previous screw holes.

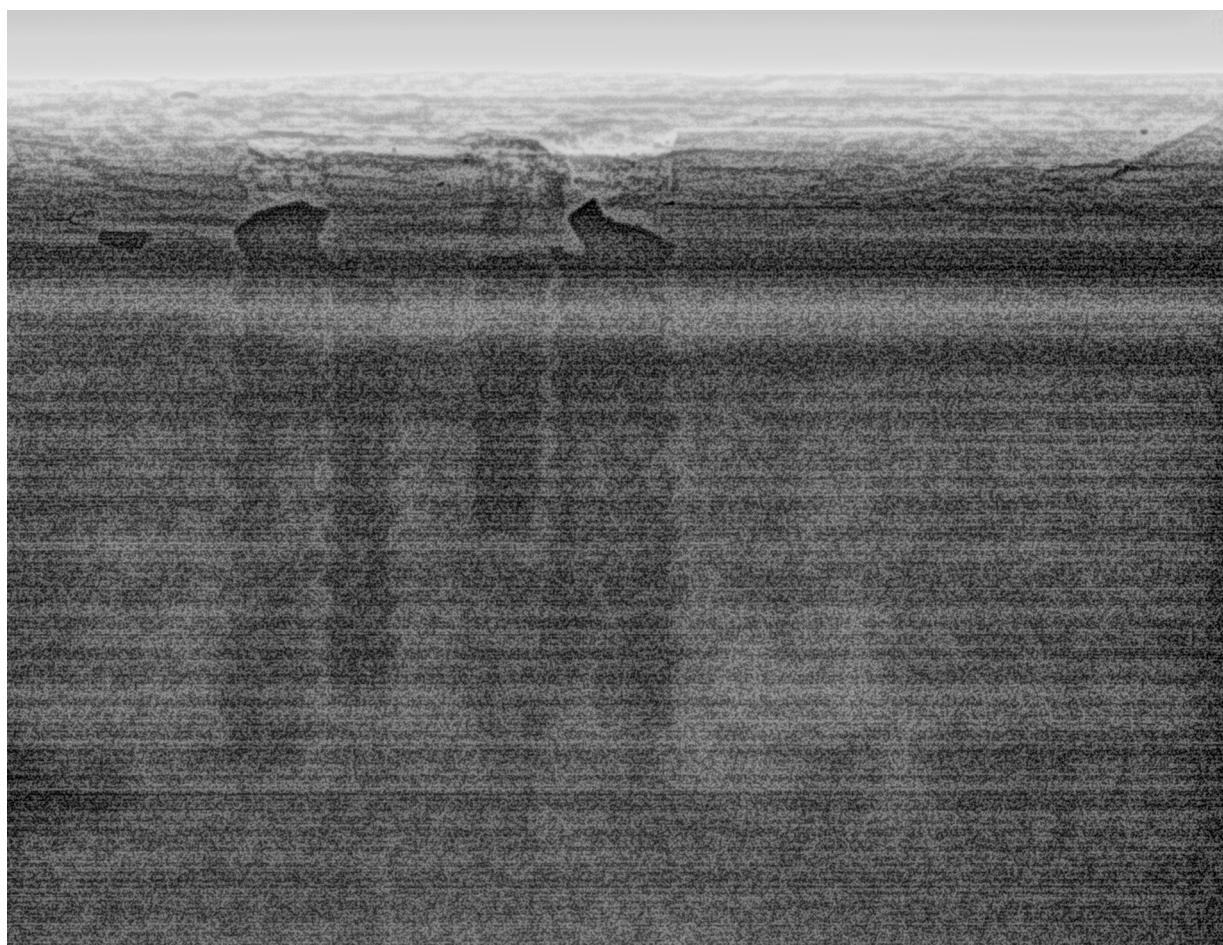
Figure 14: X-Ray image showing the presence of lower portions of broken screws within the bearer (courtesy of British Transport Police).

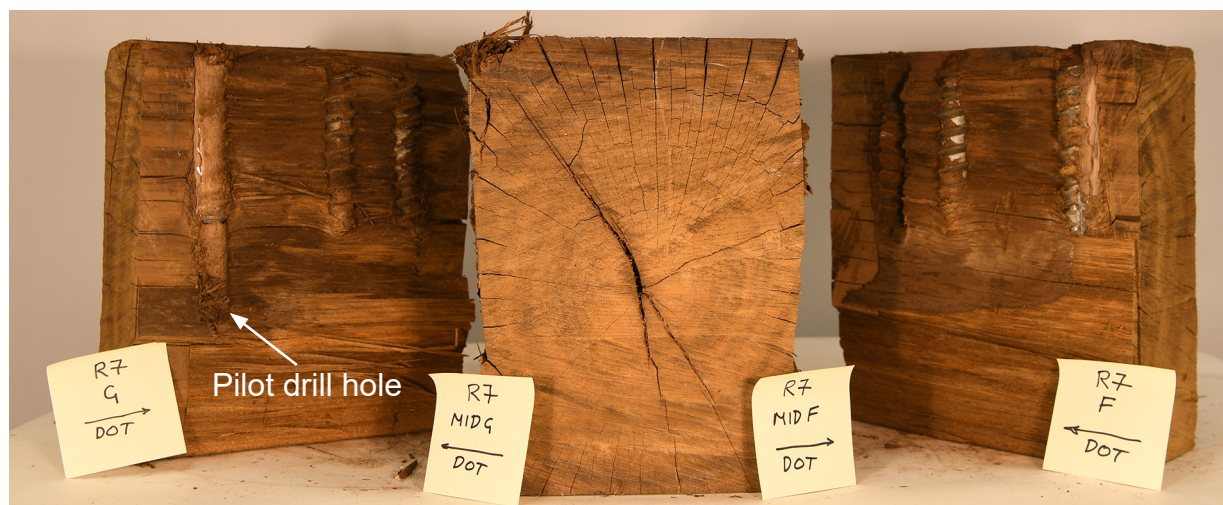
- 68 Cross sections were cut from the right-hand bearer and sawn open to remove the lower portions of the broken screws so they could be metallurgically examined. This examination found that all the older portions of screws had failed in fatigue, in the same manner as those in place at the time of the derailment.

Figure 15: Cross sections of the bearer at the R7 baseplate location revealing the lower portions of broken screws.

- 69 The timber cross section at the R7 baseplate location is shown in figure 15. This is representative of the other cross sections examined. On each side of the bearer, where the baseplate had been located (the baseplate was not present due to derailment damage during the accident), there were three distinct drilled holes. A deeper pilot hole can be seen in one location. There is also wood grain deformation at the tip of one of the screws (central hole in figure 16), indicating that that hole had not been drilled to a sufficient depth. There was also evidence that both LSA and the shorter AS screws had been used at some time.

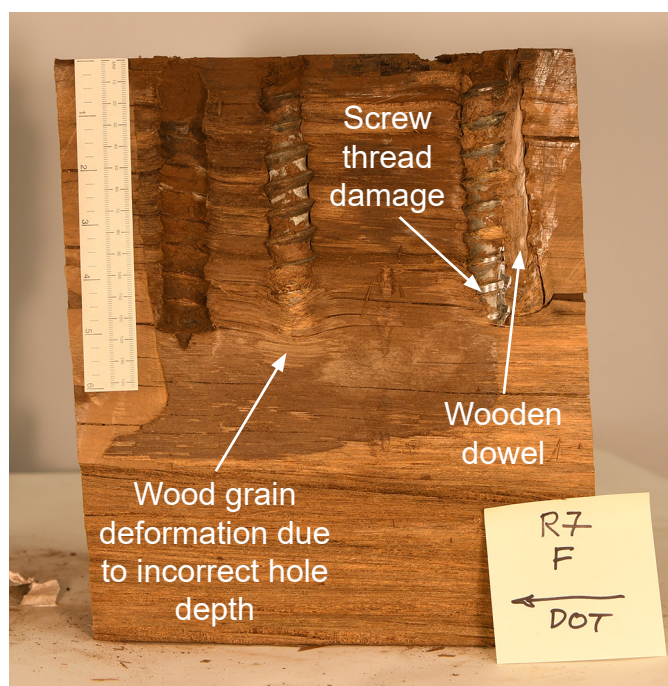
Figure 16: The screws and holes found within the sectioned R7 baseplate location.

- 72 It was noted that the drilled holes were very close to one another, sometimes breaking into each other. There is a requirement within standards to have a minimum distance between adjacent holes (see paragraph 206).

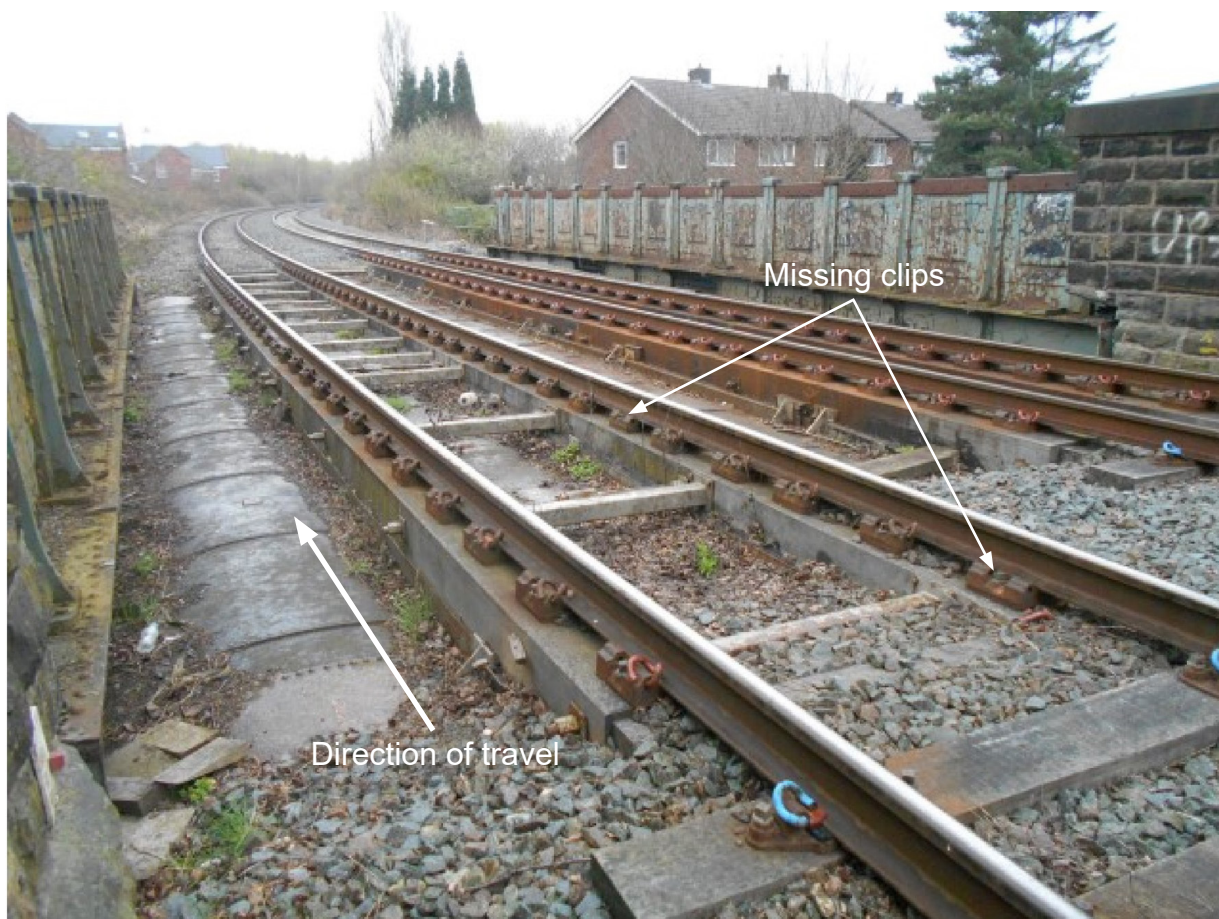
- 75 Figure 17 shows an image of the bridge deck and LBS within a structure examination report dated April 2016. It shows that, on the down line, there was some ballast migration at the leading end of the LBS and that the baseplates were originally clipped with only two clips per plate (and a few of the rail clips had been highlighted as missing).

Figure 17: The LBS on bridge 3 during a structure examination in April 2016 (courtesy of Network Rail with RAIB annotations).

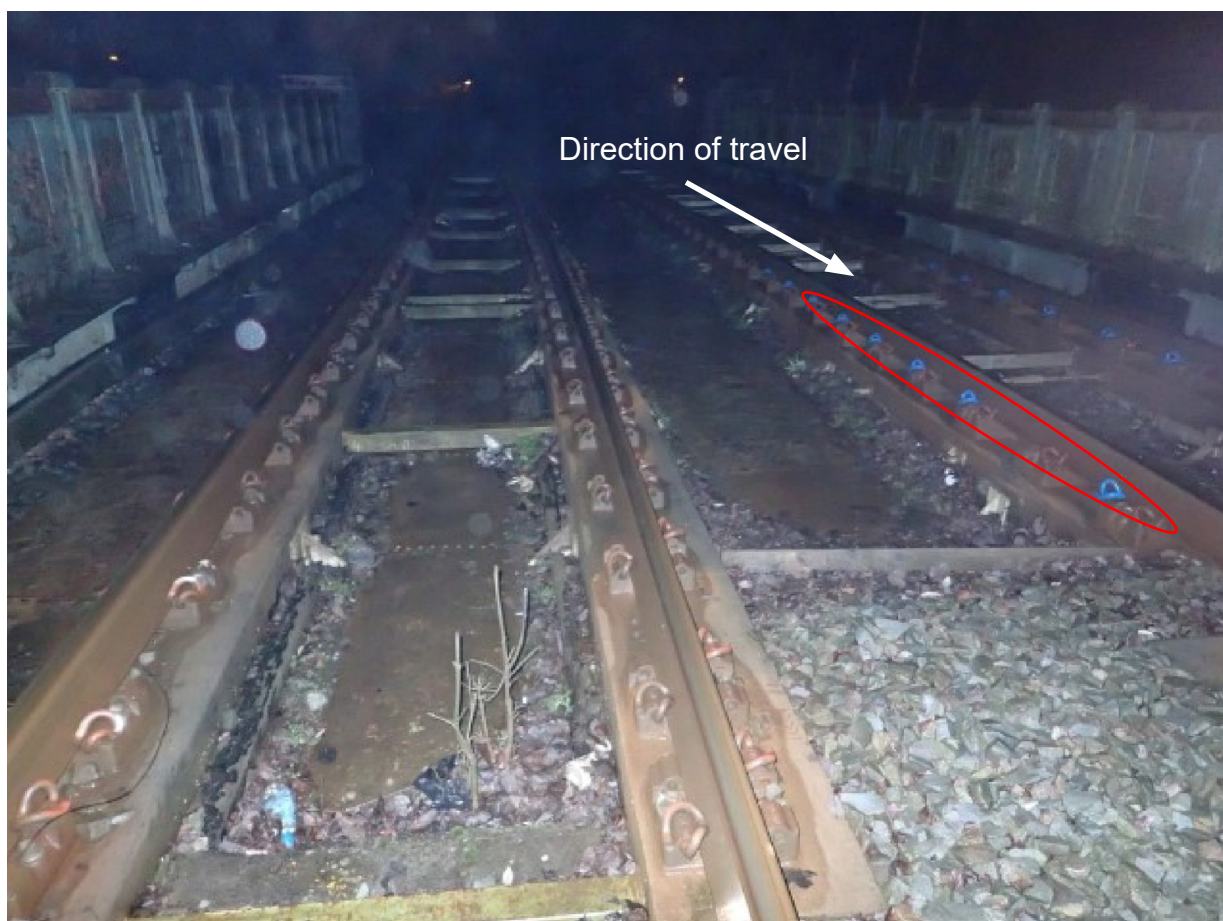
Figure 18: The LBS on bridge 3 during a structure examination in January 2018 showing additional rail clips on baseplates at the north end of the down line (courtesy of Network Rail with RAIB annotations).

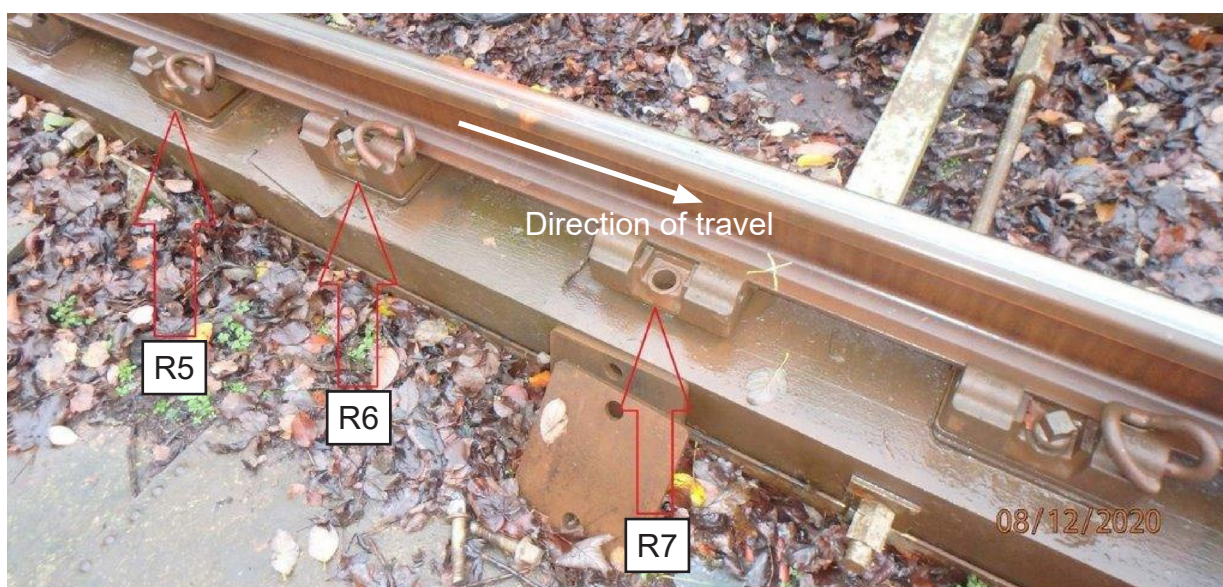
- 77 In December 2020, a structures examination identified broken screws, missing clips and displaced steel packing pieces on the right-hand rail of the down line (figure 19). This was at the south end of the bridge where the derailment took place in September 2024. Figure 19 has been annotated by RAIB to indicate baseplate positions R5, R6 and R7. This is the same location at which the derailment of train 6J46 was initiated by gauge spread.

Figure 19: The leading section of the right-hand bearer on bridge 3 observed during a structures examination of the bridge in December 2020 showing baseplates with missing rail clips, evidence of broken screws and displaced steel packing pieces (courtesy of Network Rail with RAIB annotations).

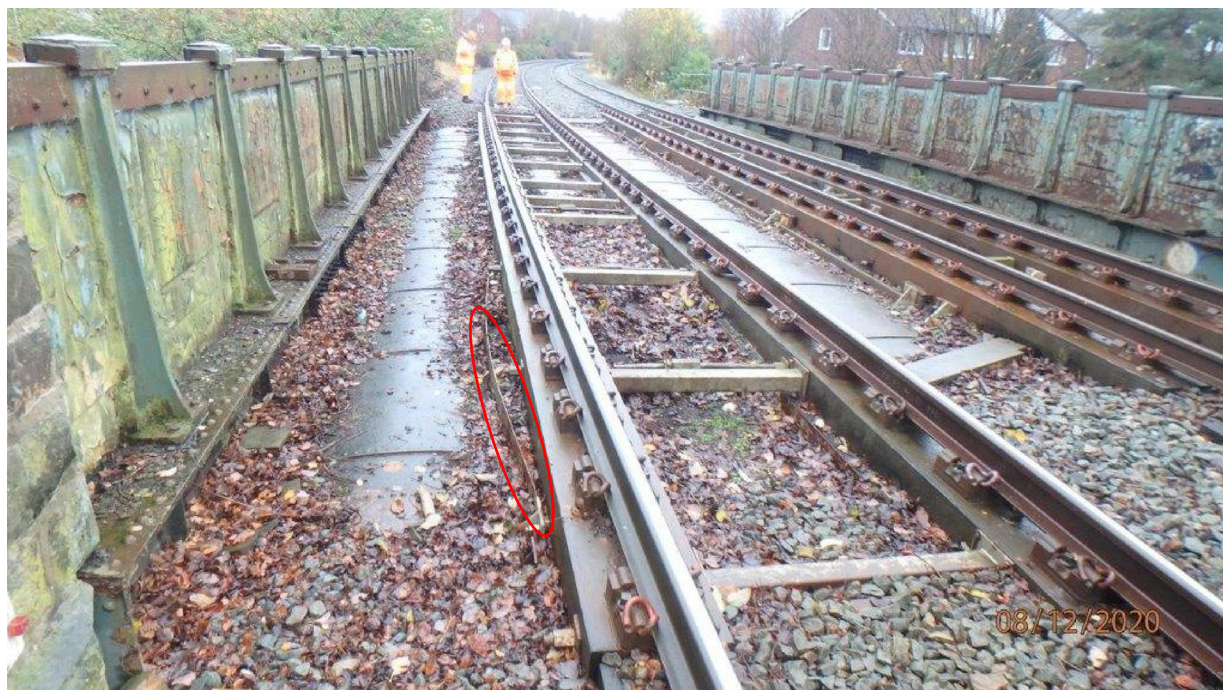
- 80 Another observation made during the structures examination in December 2020 related to the deflection in the steel strip on the cess (left-hand) bearer (figure 20). Following the derailment, RAIB found that there was no cleat fixed to the bridge deck at the mid-span of the bowed strip (nor were there any signs that there had ever been one). When the leading section of the LBS was removed from the bridge, it was found that the plywood packing pieces under the bearer had shifted towards the left causing the bow in the steel strip (figure 21). The inserts in figure 21 also show the stack of 13 plywood packing pieces recovered from a single vertical section between the bridge deck and the bearer, together with a broken vertical restraint rod from the far end of the right-hand bearer of the first LBS section recovered from site.

Figure 20: The leading section of the down line on bridge 3 observed during a structure examination in December 2020 showing the bowed steel strip and the location of the missing cleat (courtesy of Network Rail with RAIB annotations).

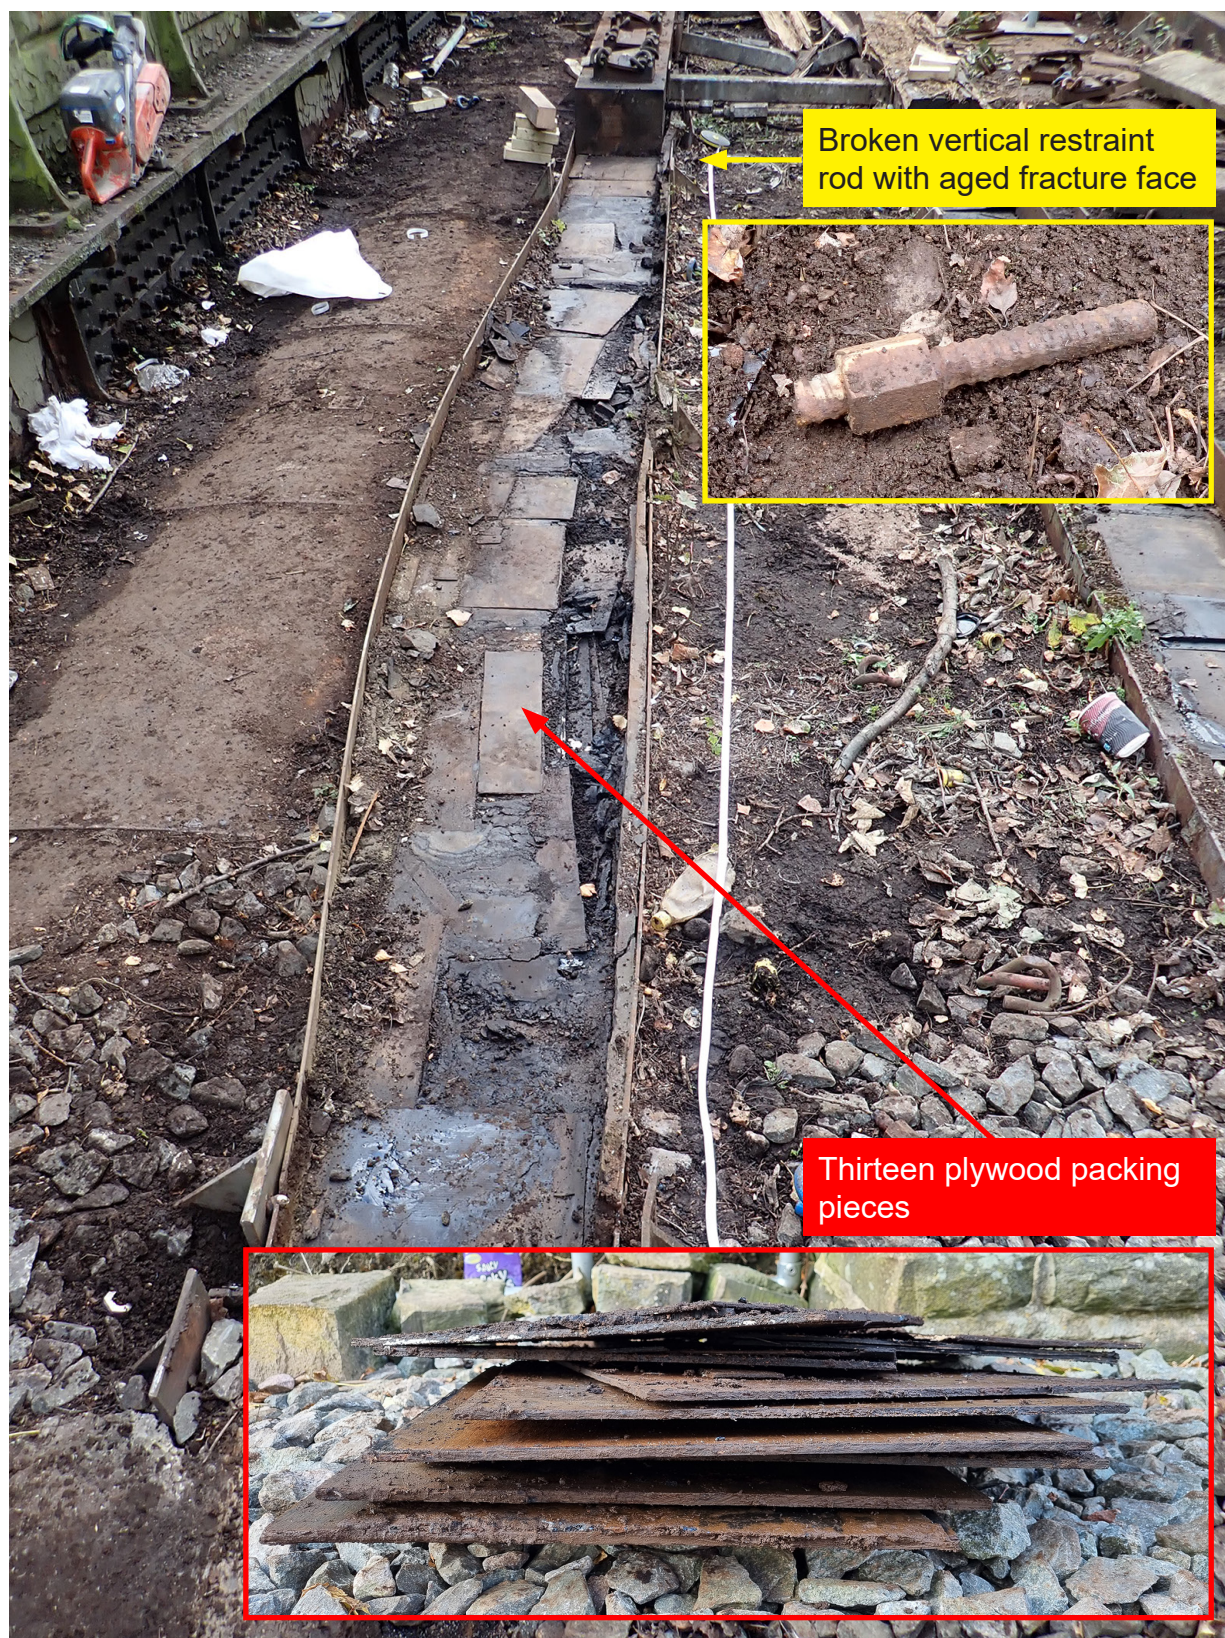
Figure 21: The leading section of the down line cess-side bearer on bridge 3 following removal of the bearer and rail.

- 81 The movement of the plywood packing pieces together with the aged fracture of the vertical restraint rod at the end of the bearer suggest that there had been differential vertical deflection between the LBS and the bridge deck. This, and the lack of cleat on the cess side of the steel strip allowed the many plywood packing pieces (which were found to be damp and slippery following the accident) to slide to the left. There are no records from Guide Bridge depot regarding the bowed strip or the broken rod at around that time. The bowed strip and broken rod are not mentioned in the inspection records during the months before the derailment.
- 82 Many of the structures inspection reports over this time noted missing or rotten wooden wedges (figure 22). RAIB also observed this at some of the cleat locations during its time on site.

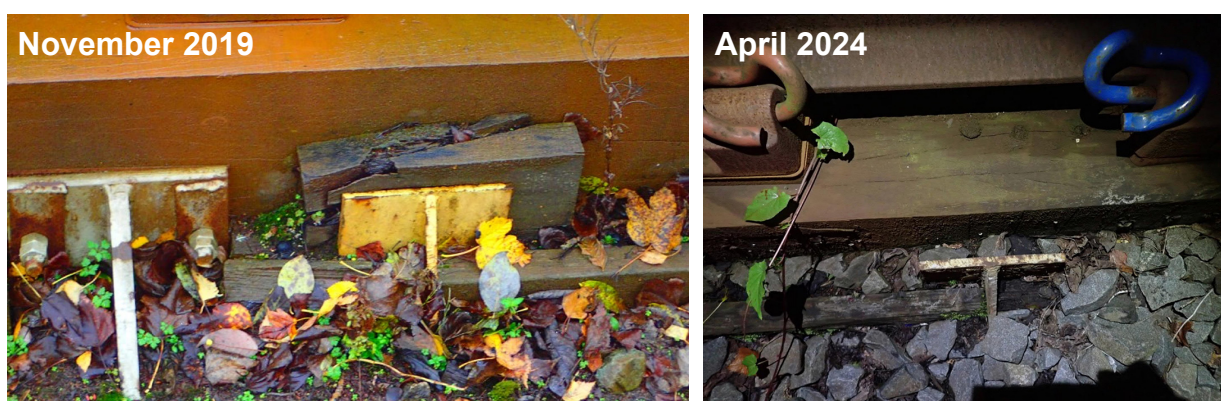
Figure 22: Photographs from structure examination reports on two dates showing the typical states of the wooden wedges between the cleats and the bearer sides (courtesy of Network Rail with RAIB annotations).

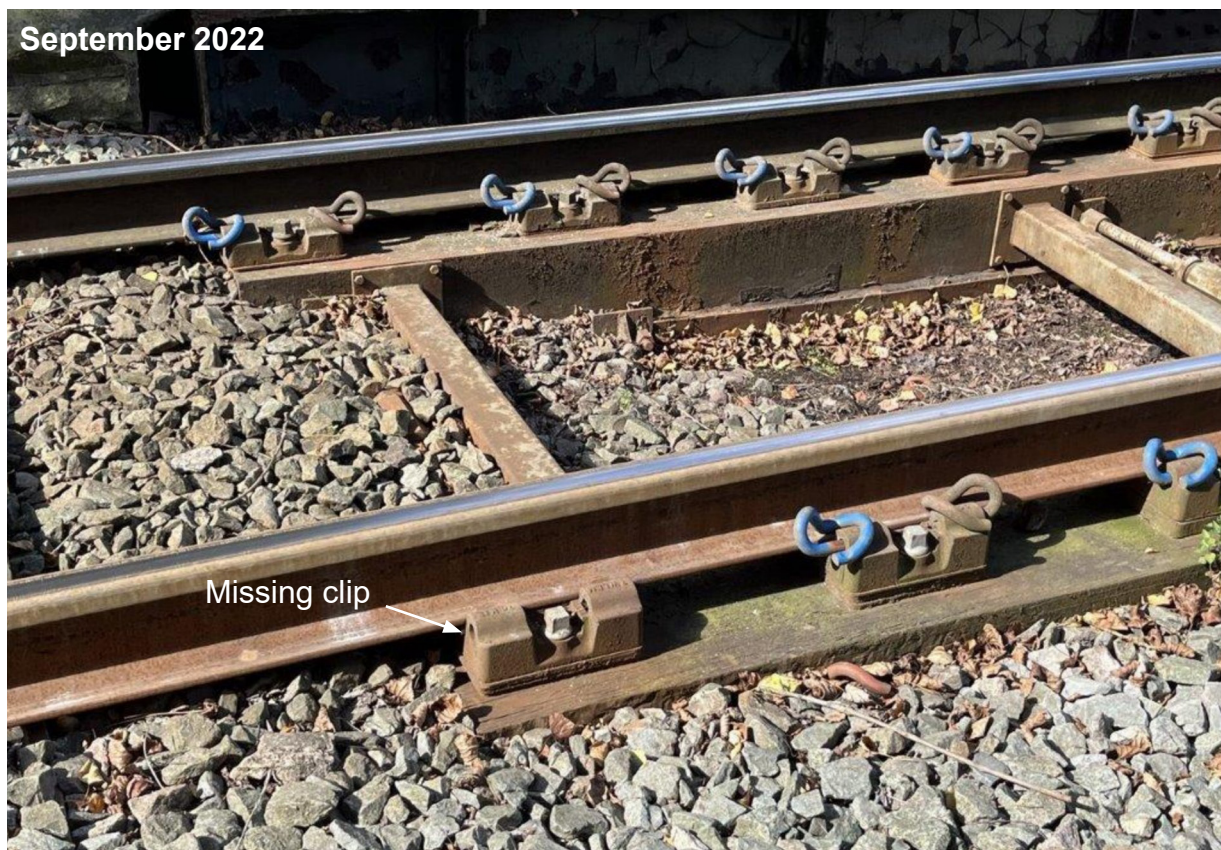
Figure 23: The presence of additional clips on the baseplates and missing clips from the baseplate at position R1 observed during a structure examination report in September 2022 (courtesy of Network Rail with RAIB annotations).

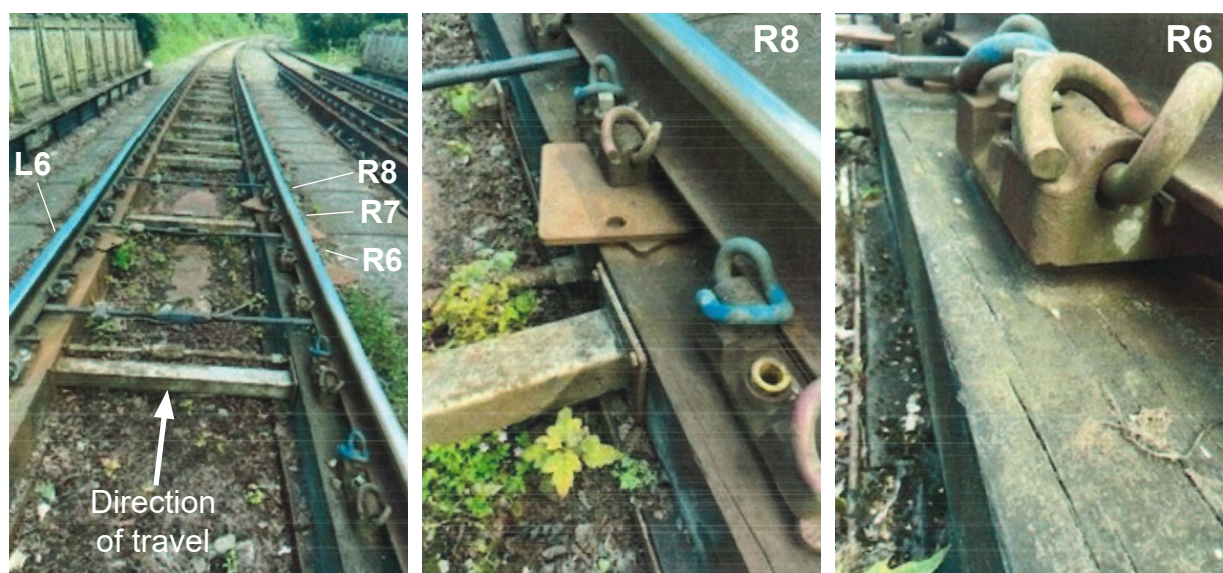
- 87 Attached to this SVI report were some photographs (figure 25). Witness evidence states that these were taken at the time of this inspection. The left image shows the south end of the down line, and three gauge tie bars can clearly be seen. The centre and right images show locations with evidence of broken screws. These are at adjacent baseplate locations to those that had failed in 2020 (paragraph 77) and were in the same area as the screw failures which led to this later derailment.

Figure 25: The down line as observed on the 9 August 2023 SVI report showing gauge tie bars fitted and displaced steel packing plates (courtesy of Network Rail with RAIB annotations).
