Rail Accident Report

Derailment of a freight train at Audenshaw, Greater Manchester 6 September 2024

Report 10/2025
December 2025

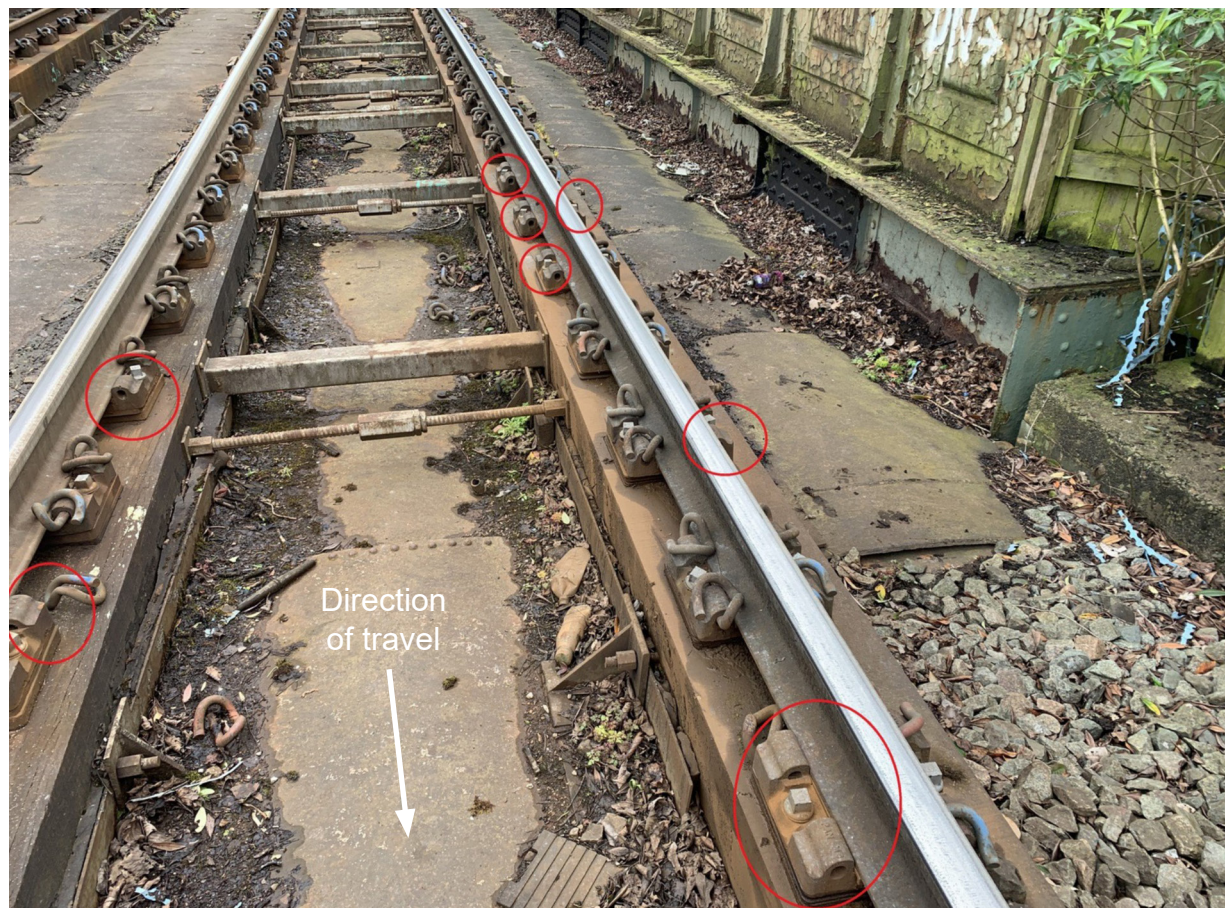
- 90 Between August 2023 and the derailment in September 2024, there were repeated instances of rail clips coming loose, even though additional clips had been fitted throughout the LBS. A structures examination in April 2024 recorded that clips were again missing at the north end of the LBS (figure 26). The ringed annotations on the image were added by the structure's inspector.

Figure 26: The LBS as observed during a bridge examination report in April 2024 showing the missing rail clips at the north end of the down line (courtesy of Network Rail with RAIB annotations).

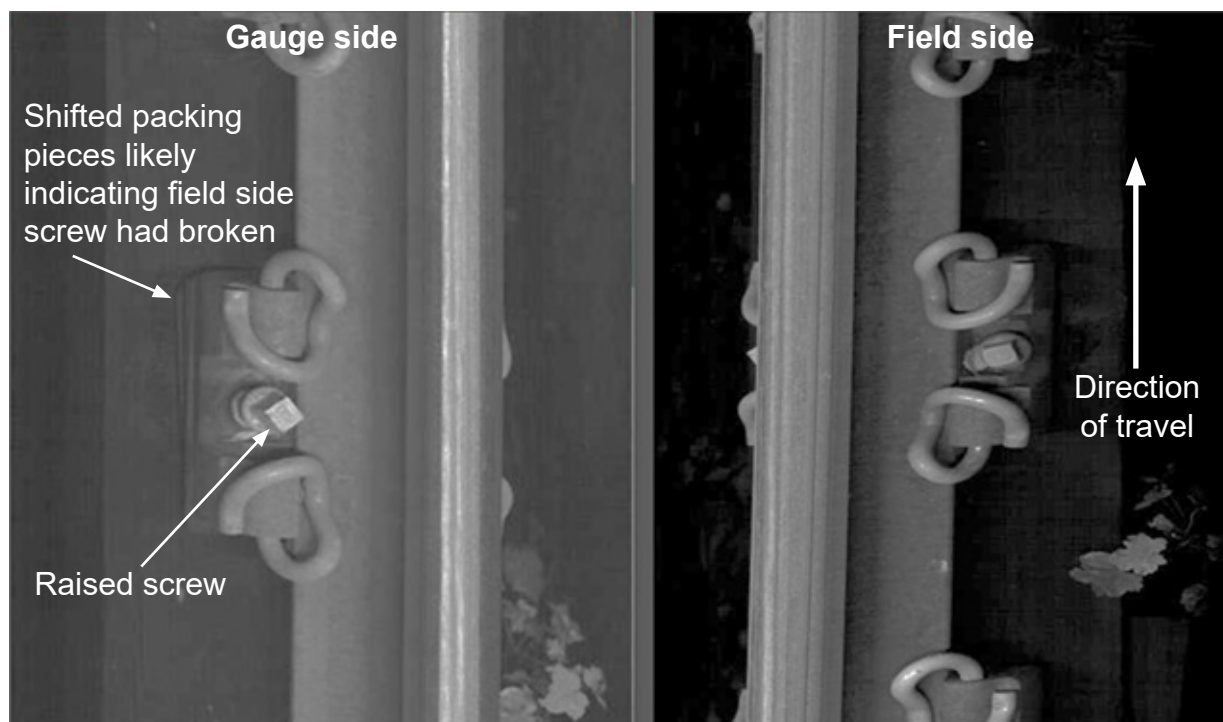
- 91 Images captured by the plain line pattern recognition (PLPR) track inspection train during the last track geometry recording run on 28 August 2024 also recorded the presence of missing rail clips and the automatic pattern recognition system alerted the delivery unit to this (see paragraph 155).
- 92 RAIB's detailed examination of the PLPR images showed the packing pieces under baseplate R6 had possibly shifted and the screw appeared to be raised (figure 27). This image likely indicates that the screw on the field side may have been broken. However, the PLPR system is not capable of automatically detecting these failures (see paragraph 149).

Figure 27: Baseplate R6 image from a PLPR train in August 2024 (courtesy of Network Rail with RAIB annotations).

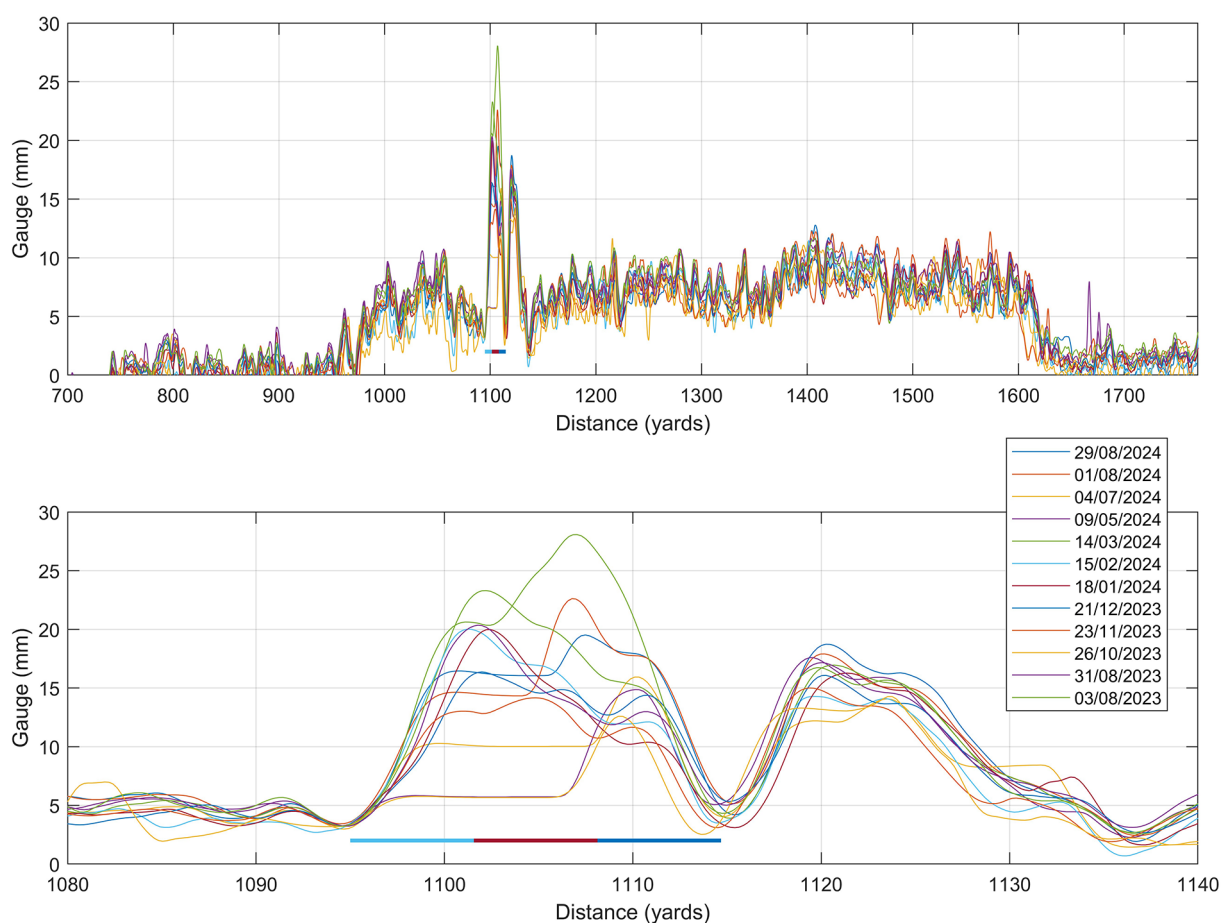
- 96 The gauge was found to have been historically wide across the bridge since 2018. Network Rail standard NR/L2/TRK/001 Module 11, 'Track geometry - Inspections and minimum actions', issue 11 dated 5 March 2022, requires that a recorded 35 mm variation in gauge width needs a correction within 36 hours, and that a 25 mm variation needs a correction within 28 days. It also defined a limit of 8 mm in gauge variation over a 3-metre length. In the year before the derailment, there had been more extensive variation in the gauge, but it was not sufficient to trigger the 36-hour correction limit (figure 28). The gauge variations within the 3-metre distance were also within limits. Periodic dip angle recordings were also evident on the entry to and exit from the bridge, suggesting that it was likely that the bridge had been moving relative to the embankments on either side.

Figure 28: Gauge width variation 2023 to 2024.

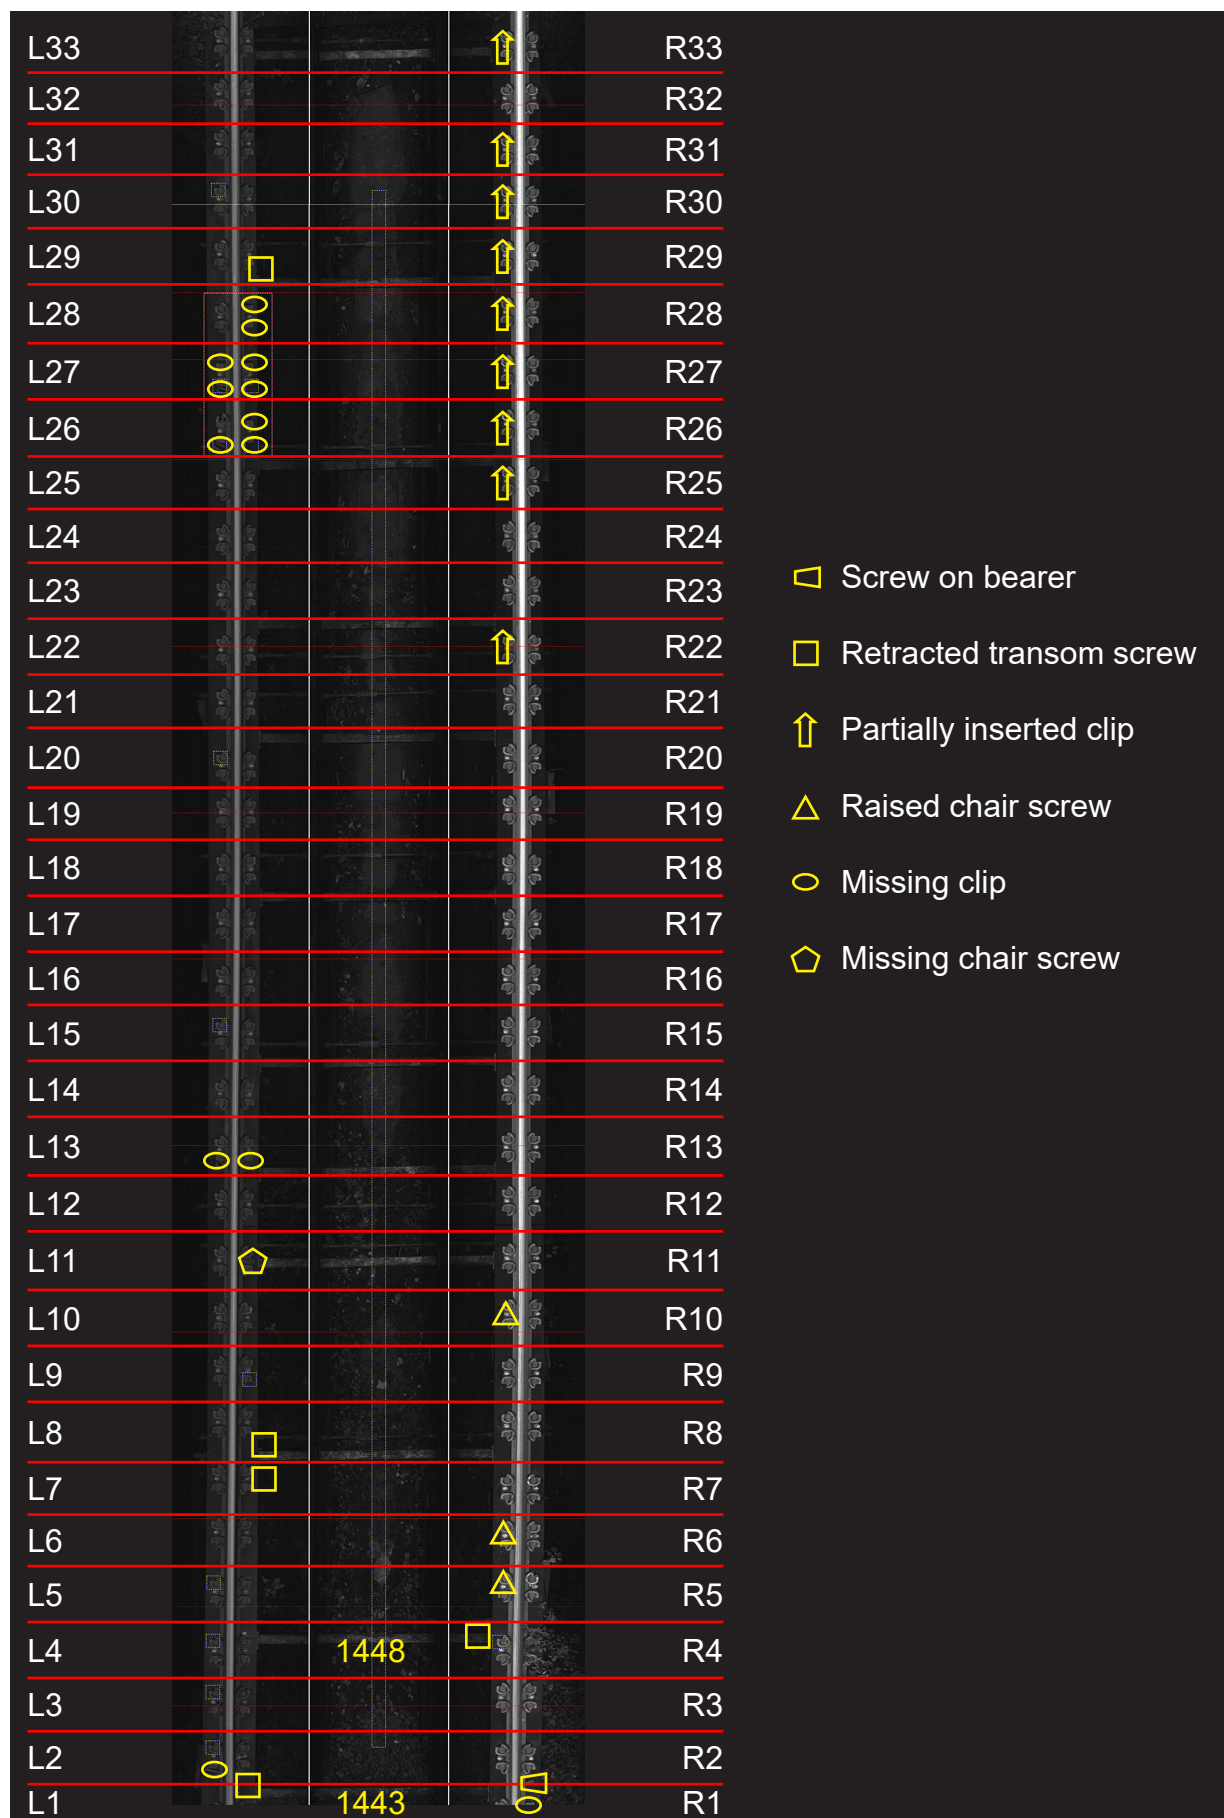
- 157 RAIB examination of the detailed images captured by the cameras of the PLPR system 9 days before the accident revealed missing and raised screws (figure 27), along with the missing rail clips which had been reported by the system (figure 33). From this, and considering the aged condition of the screw fracture faces, it is very likely that some of the screws were already broken 9 days before the derailment.

Figure 33: Composite of the full LBS using images from PLPR (courtesy of Network Rail with RAIB annotations).

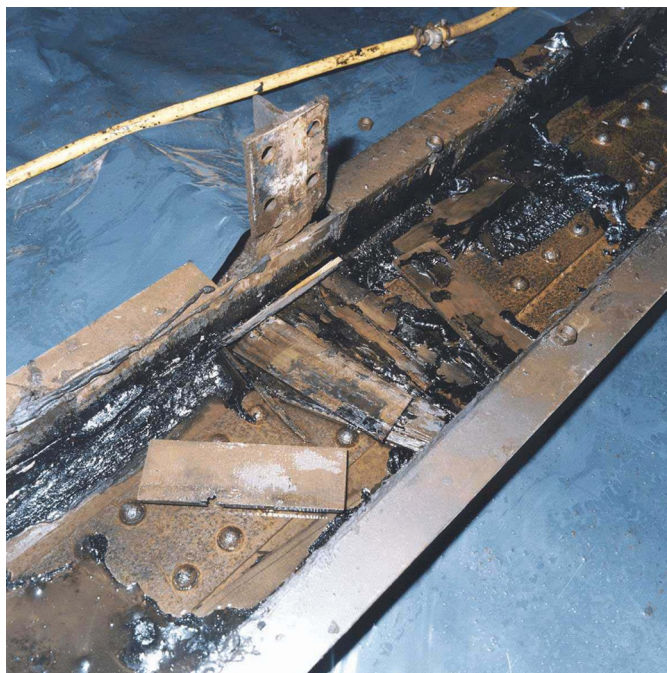
Figure 36: Failed 1997 LBS installation at Althorpe (from business process document NR/SP/TRK/9003 courtesy of Network Rail).

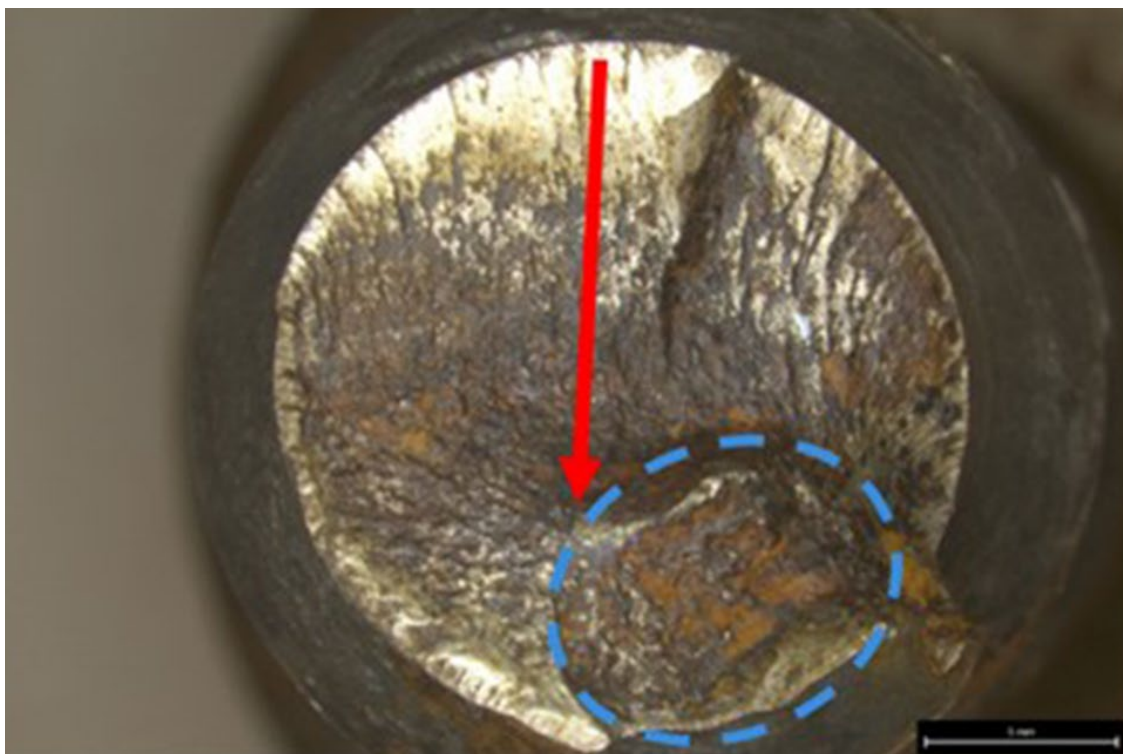
Figure 1: Fracture face of the upper portion of a recovered screw with indications of unidirectional high-cycle and low-cycle bending fatigue and a small area of overload (circled).

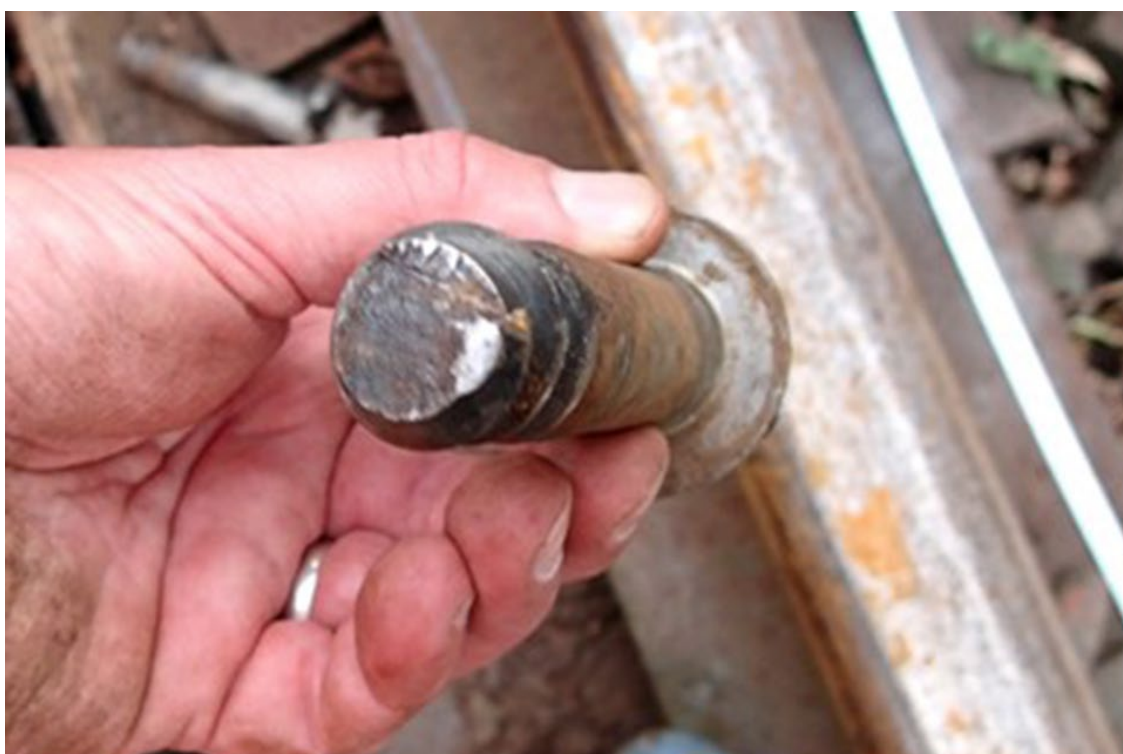
Figure 2: One of the recovered top portions of a screw with signs of historical fracture and subsequent failure by overload (bright area).
