Serious Incident

Aircraft Type and Registration:	Airbus A320-251N, G-UZEF	
No & Type of Engines:	2 CFM International Sa LEAP-1A26 turbofan engines	
Year of Manufacture:	2025 (Serial no: 12383)	
Date & Time (UTC):	20 April 2025 at 0547 hrs	
Location:	South-western UK Airspace	
Type of Flight:	Commercial Air Transport (Passenger)	
Persons on Board:	Crew - 6	Passengers - 177
Injuries:	Crew - None	Passengers - None
Nature of Damage:	None	
Commander's Licence:	Airline Transport Pilot's Licence	
Commander's Age:	53 years	
Commander's Flying Experience:	15,100 hours (of which 9,100 were on type) Last 90 days - 115 hours Last 28 days - 45 hours	
Information Source:	Aircraft Accident Report Form submitted by the pilot and enquiries by the AAIB

Synopsis

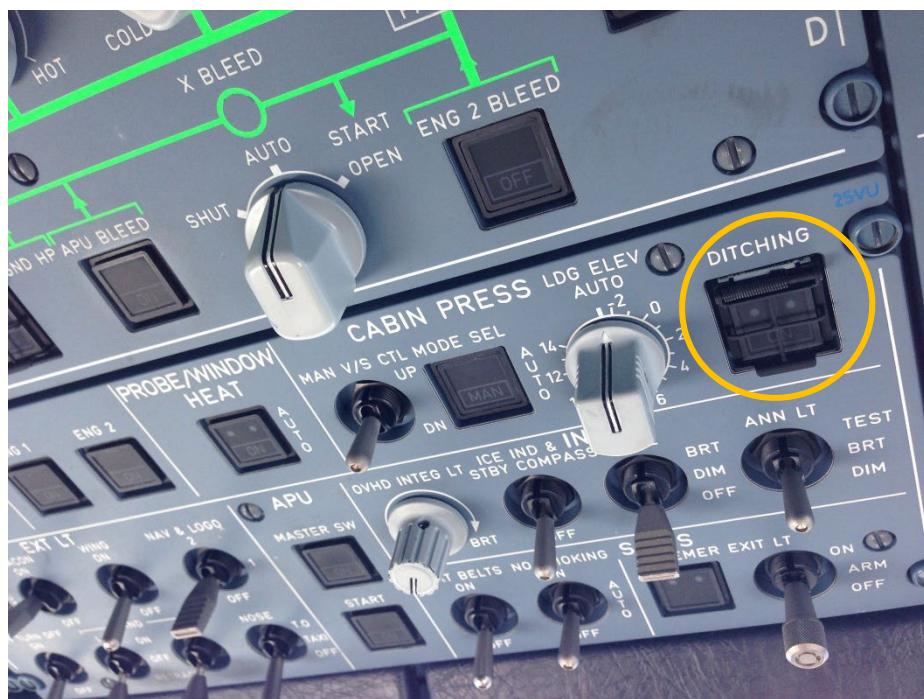
Figure 1

The commander used the relevant checklist in the Quick Reference Handbook (QRH), which was available to both crew members on their electronic tablet devices, to configure the aircraft. The de-icing crew arrived and performed a tactile check, reporting to the commander there was no longer any requirement to de-ice. Therefore, the flight crew began to reinstate the configuration of the aircraft referencing the checklist but, in doing so, omitted to return the ditching pushbutton to OFF (Figure 1).

Ditching pushbutton, situated on the right side of the overhead panel ©A320 Guide

A number of these reports included comments about it being difficult to see the ditching pushbutton, and associated internal lighting, from the left seat because it is obscured by the landing elevation dial (Figure 1) which protrudes from the panel.

- The operator included this event in their pilot safety magazine in December 2025.
- The manufacturer updated the de-icing checklist to add a comment and a note below the action lines “DITCHING pb ... ON” and “DITCHING pbOFF” to draw the attention that if the ditching pushbutton is left ON after completion of the fluid spraying, it will lead to a lack of pressurisation in flight and ultimately to the triggering of the excess cabin altitude alert.
