Accident

Aircraft Type and Registration:	Airbus A380-841, G-XLEI	
No & Type of Engines:	4 Rolls-Royce RB211 Trent 970-84 turbofan engines	
Year of Manufacture:	2014 (Serial no: 173)	
Date & Time (UTC):	6 December 2024 at 1203 hrs	
Location:	Over the Atlantic Ocean, South of Greenland	
Type of Flight:	Commercial Air Transport (Passenger)	
Persons on Board:	Crew - 24	Passengers - 277
Injuries:	Crew - 1 (Serious) 23 (None)	Passengers - 1 (Serious) 276 (None)
Nature of Damage:	None	
Commander's Licence:	Airline Transport Pilot's Licence	
Commander's Age:	57 years	
Commander's Flying Experience:	21,557 hours (of which 5,178 were on type) Last 90 days - 172 hours Last 28 days - 44 hours	
Information Source:	Aircraft Accident Report Form submitted by the pilot and subsequent enquiries by the AAIB

Synopsis

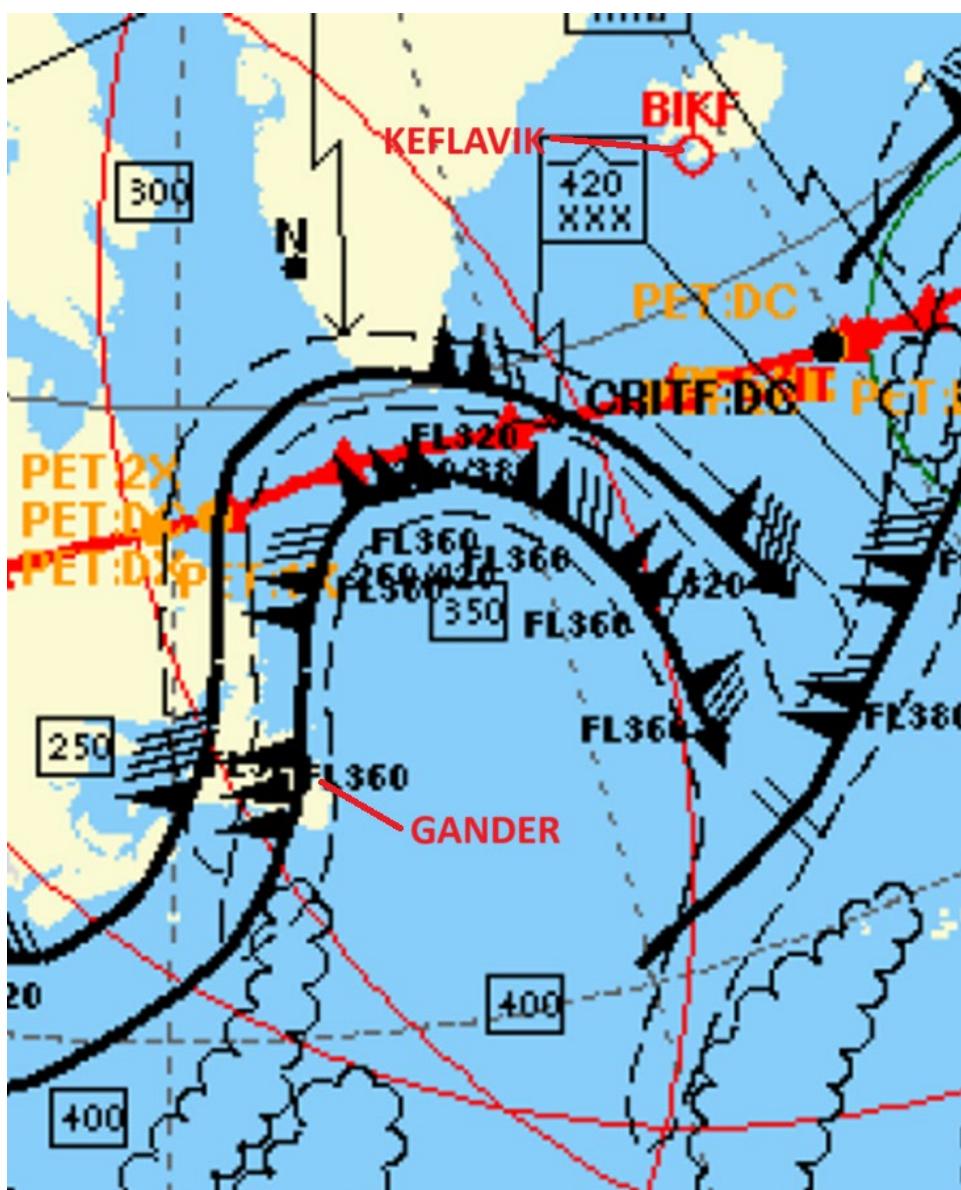
Figure 1

The briefing documentation provided to the crew before departure contained no 'significant weather warnings' (SIGMETs)¹ for the route. The North Atlantic significant weather chart valid at 1200 hrs (Figure 1) forecasted that the aircraft would transit an area of moderate turbulence south of Greenland.

Excerpt of weather chart showing jet stream at FL360, and related forecast turbulence

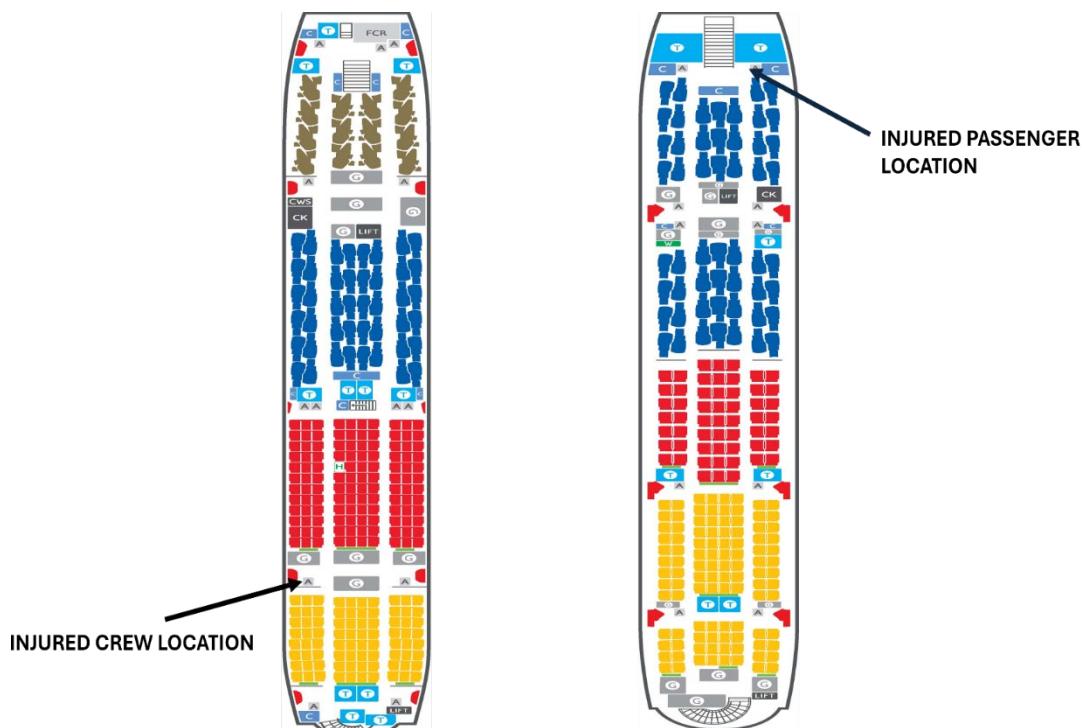
Figure 2

Location of injured persons on the lower deck (left) and upper deck (right)

Soon after, the IFL was informed that a passenger in the upper deck was also injured. That passenger reported that he left his seat to use the lavatory. He described the aircraft as "undergoing light chop" but, having been asleep prior to that, had not noticed the seat belt signs being on, and had not heard any announcements. While returning to his seat he described the aircraft making a sudden movement upward and sideways, and believed that the movement of the floor with respect to his foot broke his ankle.

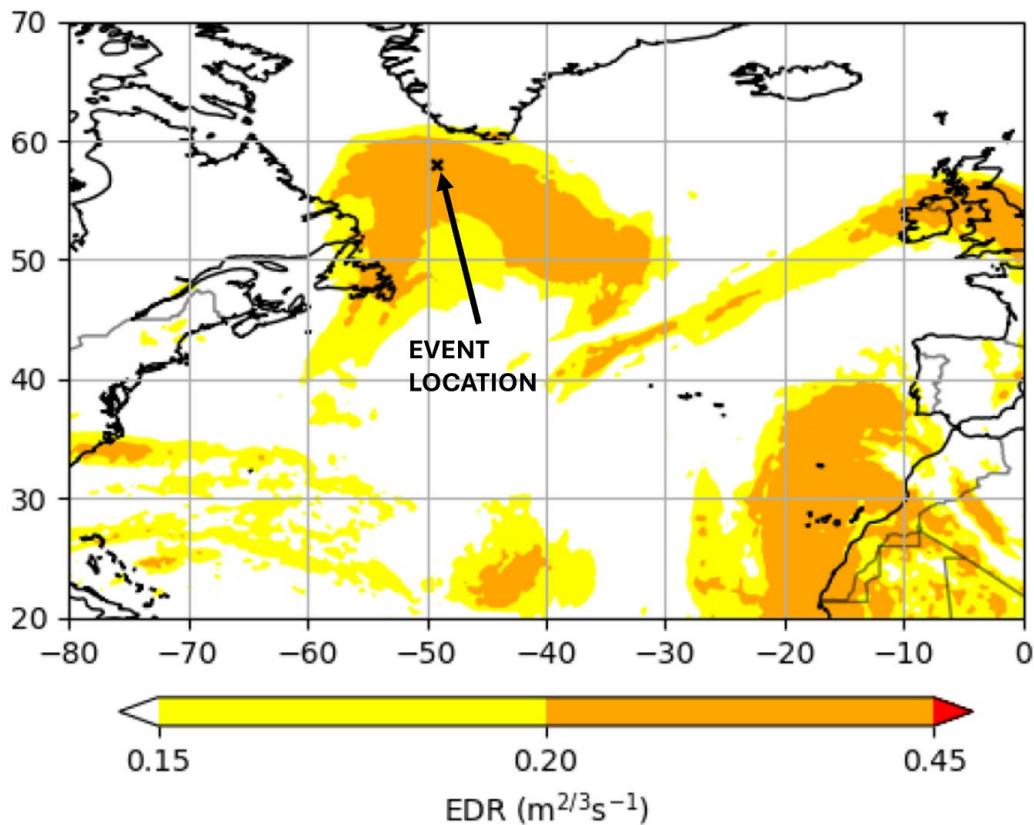
Figure 4
EDR Forecast Chart

The Met Office produced a report on the weather situation for the time of the event. It contained an analysis of the Eddy Dissipation Rate (EDR) for the region (Figure 5). EDR represents the rate at which turbulent kinetic energy is converted into thermal energy. It is used in flight planning and real-time weather monitoring. Higher EDR values correspond to more intense turbulence, while lower values suggest smoother airflow. The report explained that the position of the aircraft when the accident occurred is annotated as a black 'x' on Figure 4, which was '*located within a large area of moderate turbulence*'.
