Accident

Aircraft Type and Registration:	Cameron Z-275, G-VBFT	
No & Type of Engines:	No engines	
Year of Manufacture:	2009 (Serial no: 11215)	
Date & Time (UTC):	10 April 2025 at 1755 hrs	
Location:	Earls Colne, Essex	
Type of Flight:	Commercial Air Transport (Passenger)	
Persons on Board:	Crew - 1	Passengers - 10
Injuries:	Crew - None	Passengers - 1 (Serious 1 (Minor) 8 (None))
Nature of Damage:	Significant fire damage to balloon envelope and basket	
Commander's Licence:	Commercial Pilot's Licence	
Commander's Age:	56 years	
Commander's Flying Experience:	332 hours (of which 19 were on type) Last 90 days - 28 hours Last 28 days - 10 hours	
Information Source:	Aircraft Accident Report Form submitted by the pilot

Synopsis

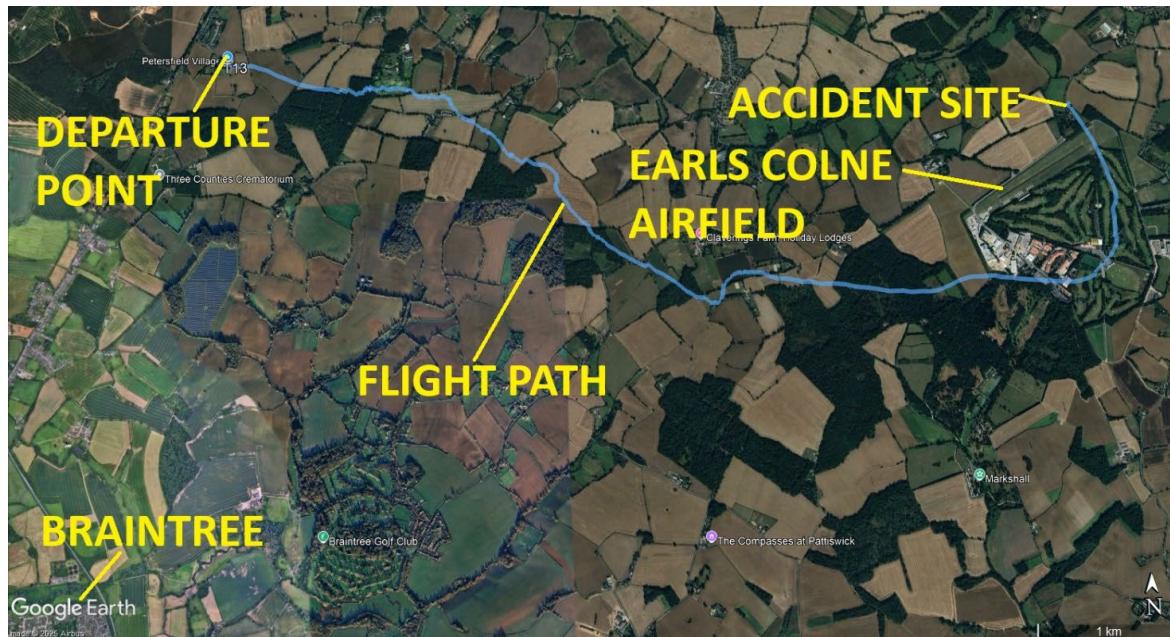
The balloon took off from Petersfield village, Gosfield at 1653 hrs with ten passengers for a pleasure flight. The balloon climbed to an operating altitude of between 1,000 and 2,000 ft. The wind was 280° at approximately 8 kt so the balloon flew to the east. The flight path, recorded by GPS, is shown at Figure 1.

Figure 1
GPS flight path of G-VBFT

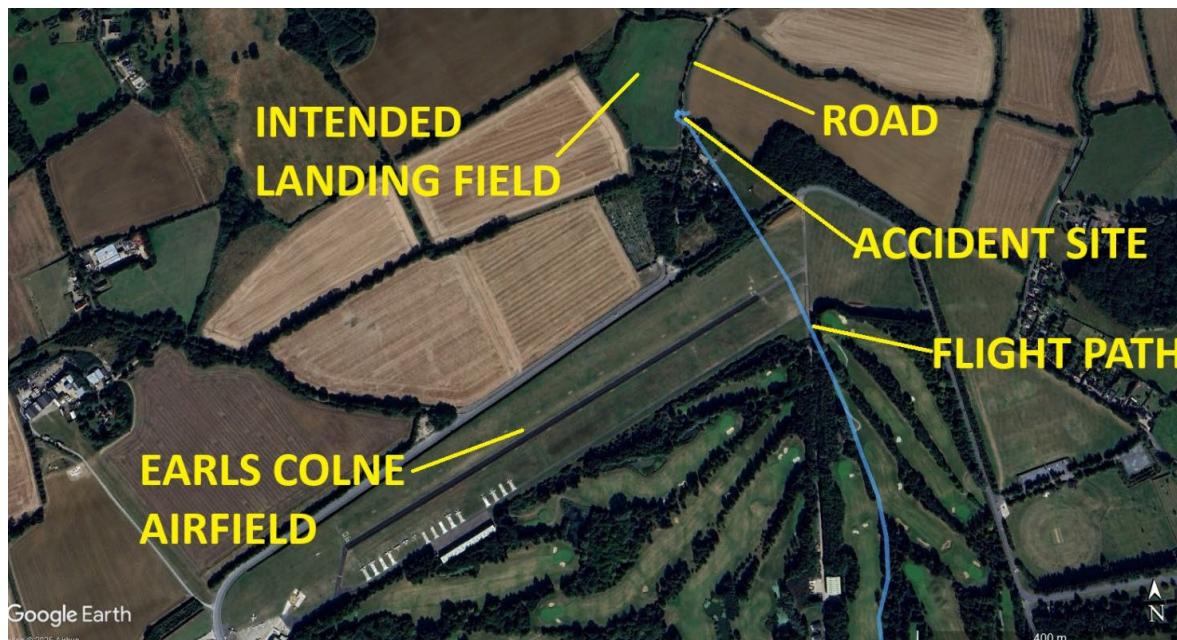
After flying for approximately 40 minutes the pilot commenced a descent and began to look for somewhere to land. The balloon was in the vicinity of Earls Colne airfield and although the airfield was closed, the pilot of G-VBFT was in radio contact with other aircraft in the vicinity. As the balloon descended the wind direction backed by approximately 90° , and the balloon flew North over Earls Colne. The pilot identified a suitable field for landing just to the north of Earls Colne and made an approach. The landing area is shown in Figure 2.

Figure 2
Landing area

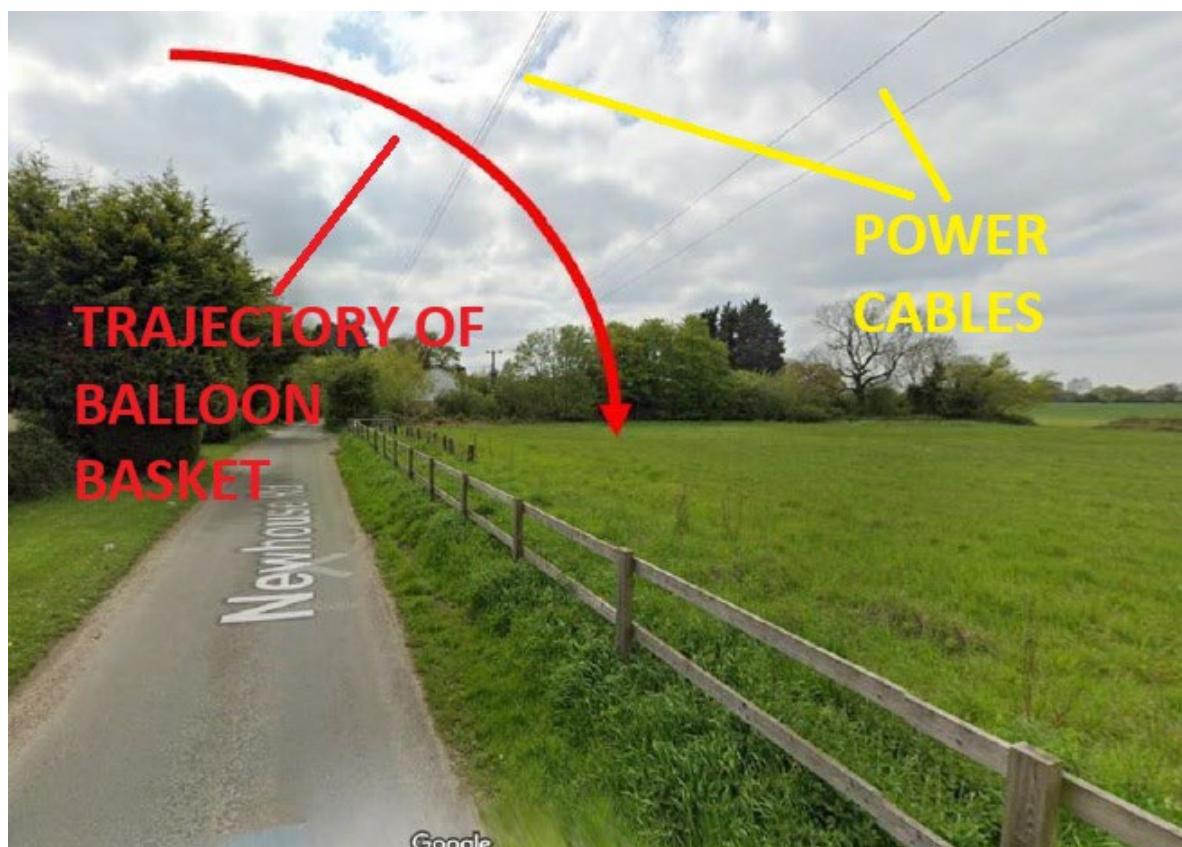
The pilot observed a set of wires running along the road on the eastern edge of the intended landing field. He directed the passengers to take up their landing positions in the basket. The pilot described the approach as “normal”. The balloon crossed the road and the wires, landing with the basket upright, just inside the chosen field, at 1757 hrs. The pilot intended to touch down as soon as possible after the field’s perimeter, and the wires he had observed, to give maximum room for the envelope¹ to collapse downwind of the basket. Having the basket as close as possible to the perimeter would ease its subsequent recovery. The pilot’s intent was to land keeping the basket and envelope upright for the passengers to disembark. After touchdown the pilot realised there was another set of wires approximately 30 ft into the field (Figure 3).

Figure 3
Landing site looking south along road

The pilot made an approach to what he believed to be an appropriate landing area, recognising that a set of power cables ran along the road bordering his chosen field. He successfully landed just beyond those wires. Only when the balloon basket had touched down, did the pilot recognise there was a second set of wires in the field. As the balloon basket dragged along the ground, the envelope broke the wires. The wires contacted parts of the basket structure and fell to the ground.

Just after touchdown the balloon struck a set of low level power cables which the pilot did not see during the approach, and which were not depicted on the maps he was using.

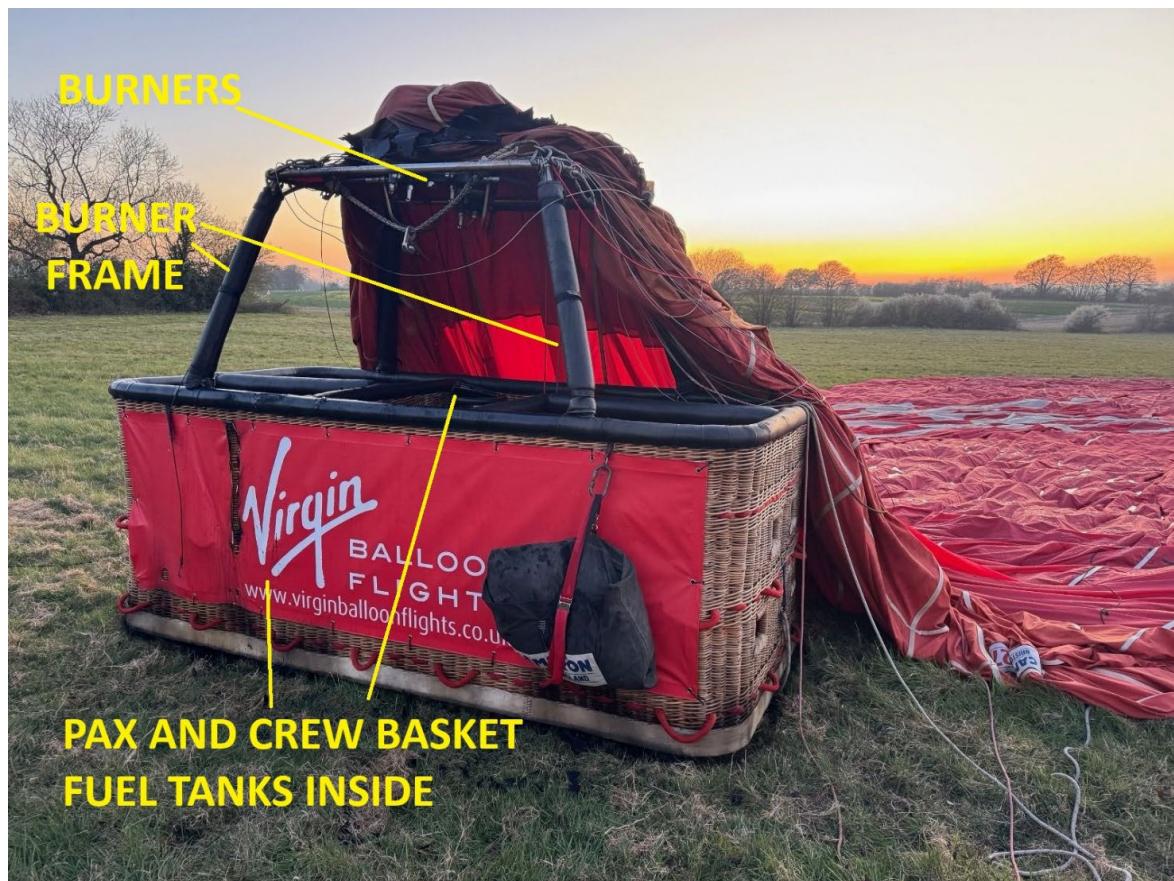
The balloon basket touched down and dragged a few feet. As the envelope began to deflate, the balloon hit the second set of wires, which were heard to break. The pilot turned off the fuel cylinders and the mouth of the balloon envelope descended over the burners (Figure 4). The pilot was uncertain where the wires had fallen and, being concerned about any threat of electrocution from the metal frame holding the burners, he elected not to extinguish the pilot flames.

Figure 4
General arrangement of basket
