AAIB Bulletin

1/2026

Published: 8 January 2026.

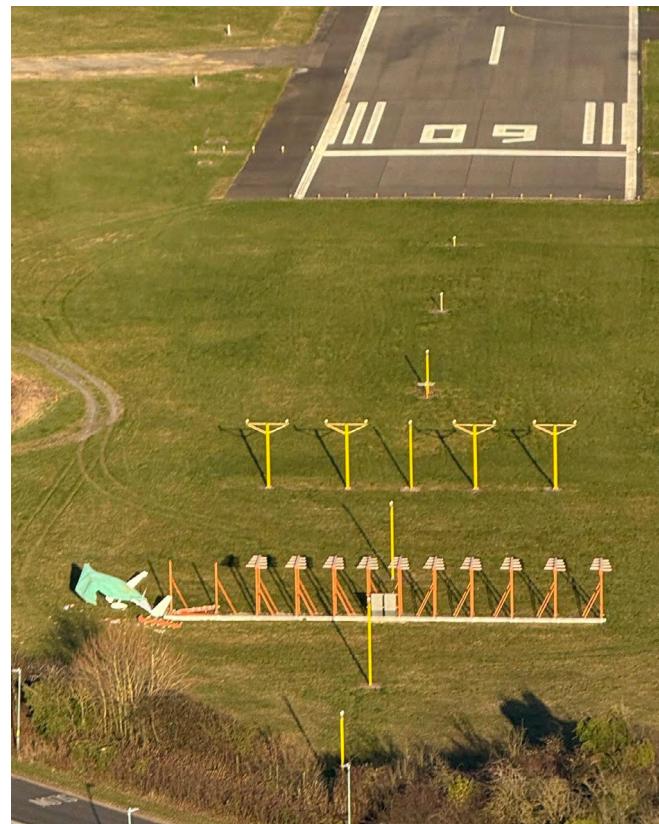
The aircraft returned to Gloucestershire Airport after an uneventful local flight operating up to FL80. The pilot flew a Required Navigation Performance (RNP) approach to Runway 09, intending to go around on final approach. He extended the belly airbrake during the approach. On short final, at about 500 ft agl, he advanced the throttle and realised that the engine had suffered a complete loss of power. He managed to fly over a road and a line of bushes on the airfield boundary, but landed short and struck the ILS localiser before coming to rest at the side of the structure (Figure 1).

Figure 1
G-BYLZ accident location at Gloucestershire Airport

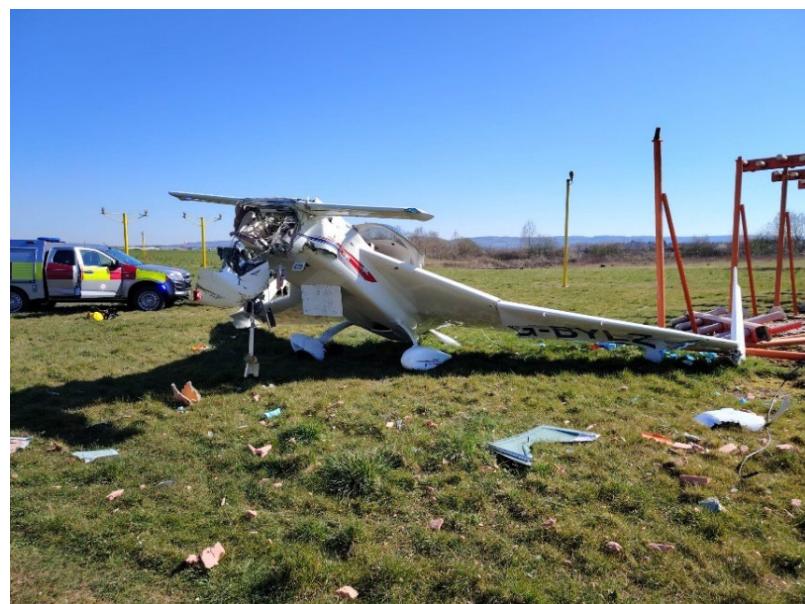
The pilot suffered minor injuries and the aircraft was destroyed (Figure 2), along with damage to the ILS localiser installation.

Figure 2
G-BYLZ following the accident

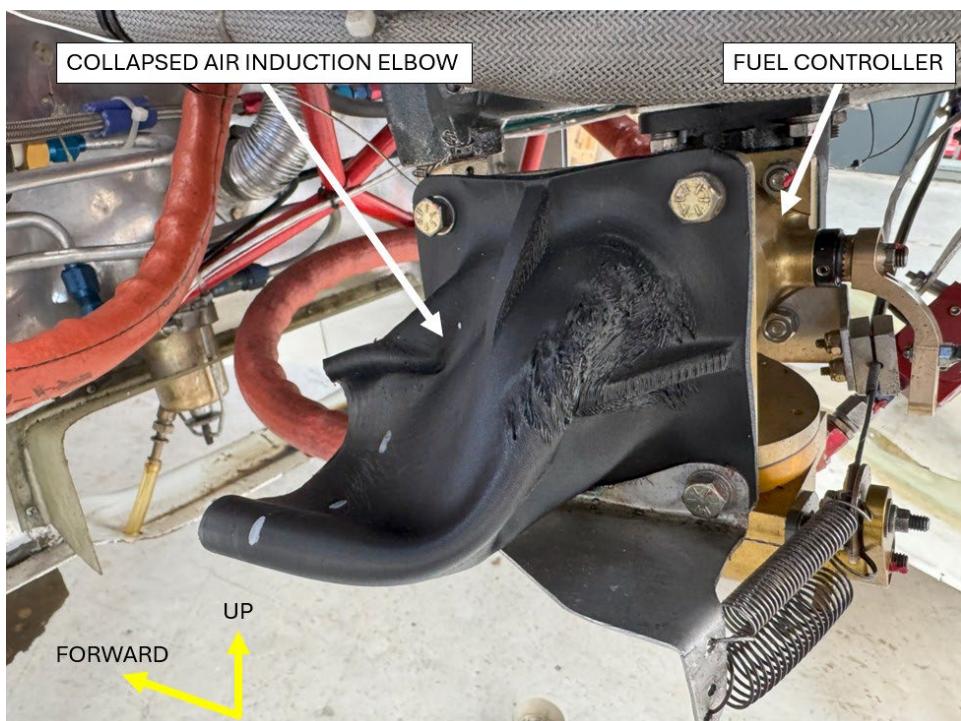
Examination of the aircraft revealed that a plastic air induction elbow attached to the fuel controller had collapsed (Figure 3), severely restricting the induction airflow to the engine, causing the loss of power.

Figure 3
Collapsed air induction elbow

The air induction elbow was a 3D-printed plastic component that had been installed during the modification to the fuel system. A forward-facing air filter had been clamped to the forward end of the elbow, but this had detached and was found loose in the lower engine cowling.

The aircraft's engine failed to produce power on final approach due to the collapse of the air induction elbow, which severely restricted the induction airflow into the fuel controller. When the pilot realised that the engine was no longer producing power, the options for a safe landing were limited by the low altitude and obstacles ahead of the aircraft.

Installation of the 3D-printed induction elbow as part of the fuel system modification was not identified as a hazard by the aircraft owner, as he believed that the temperature capability of the filament material used in the induction elbow was at least equivalent to the laminated epoxy material version specified in the aircraft's build manual. Testing of the elbow's material after the accident showed that it had a significantly lower glass transition temperature than epoxy resin, although the exact material composition of the 3D-printed elbow was not determined. The 3D-printed induction elbow also did not include the section of aluminium tube at its forward end, which would have provided additional structural support to the elbow despite the elevated temperature present within the lower engine cowling.

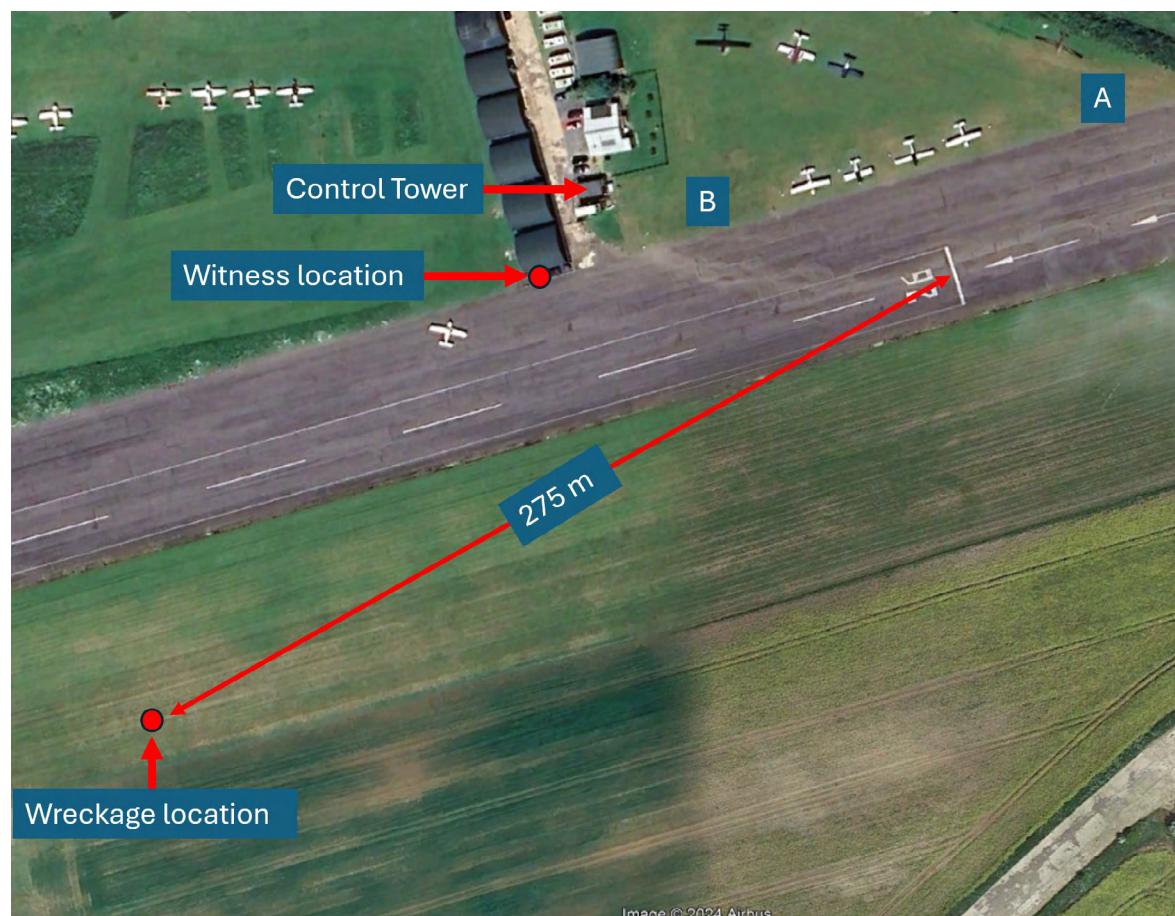
Figure 2

The aircraft came to rest at the southern edge of the south side grass Runway 26, approximately 45 m from the edge of tarmac Runway 26. The ground marks showed that the left wingtip struck the ground first, followed by the propeller and engine. Distinct propeller strikes on the ground indicated propeller rotation at the time of impact. The impact sequence was dynamic, with the right wing then striking the ground before the aircraft came to rest inverted. An intense post-crash fire, centred on the cockpit, caused extensive damage to the central part of the aircraft and engine bay.

Relative position of control tower, taxi points A and B, witness and wreckage

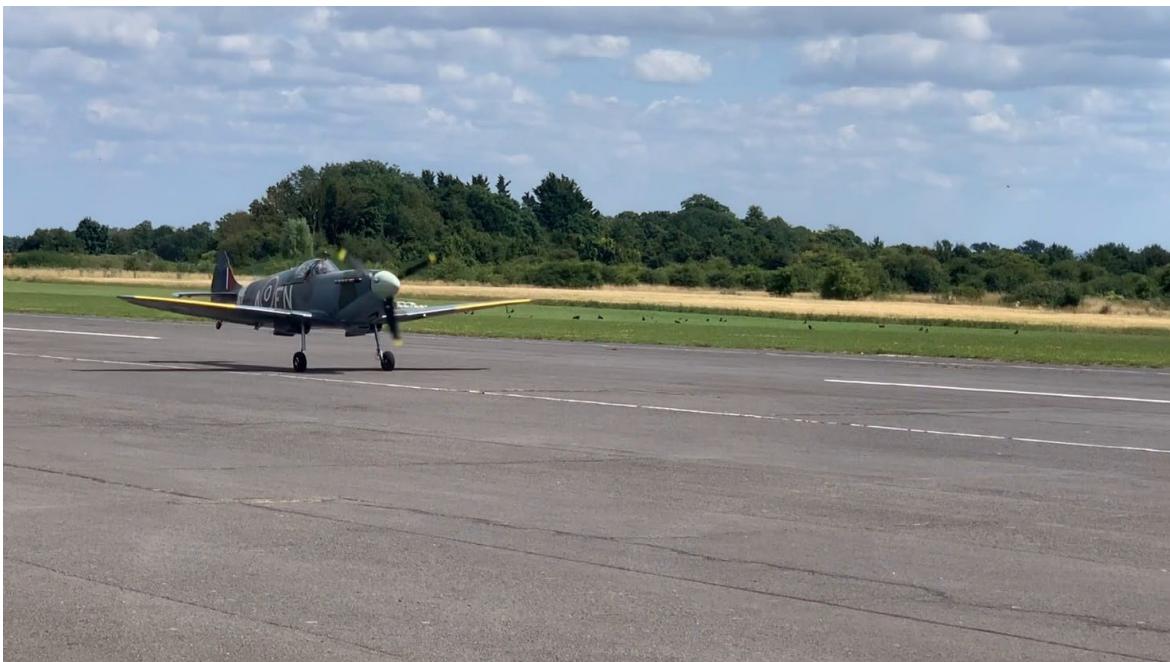
When the aircraft's airspeed reached approximately 45 kt, the tail of the aircraft lifted to an almost horizontal attitude (Figure 4), which coincided with a brief left rudder input, and the aircraft yawed to the left. The elevator could then be observed to move to a pitch up (control surface up) position, which was near to its full travel position, and the tail of the aircraft quickly lowered back towards the runway (Figure 5). The elevator remained in a pitch-up position, whilst the tailwheel tyre bounced on and off the runway surface several times. The aircraft's weight then settled on the tail wheel, which was almost coincident with the main landing gear tyres leaving the runway surface (Figure 6).

Figure 4
Tail initially lifts towards horizontal position

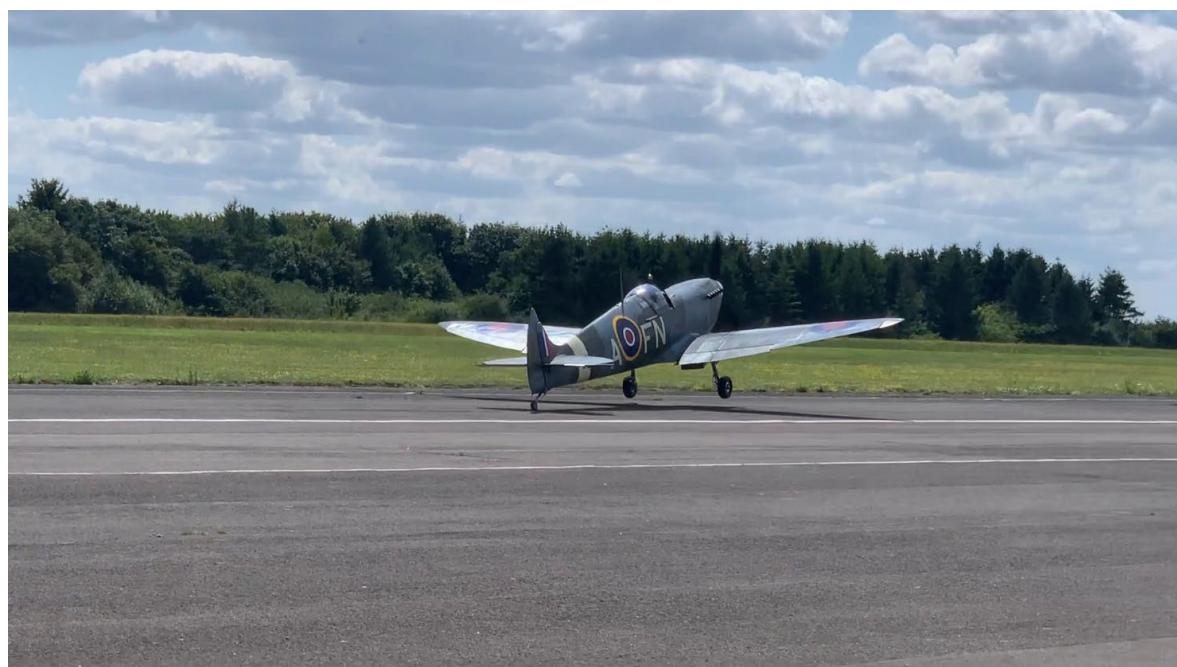
Figure 7
Aircraft approaching the left side of the runway

The accident sequence began when the natural tendency of the aircraft to yaw left during takeoff was not contained, leaving the aircraft heading towards the left side of the runway. One explanation of subsequent events was that, given the marked pitch up control input, the pilot was trying to lift off as he approached the edge of the paved surface. The pilot may have suffered a startle response that caused his actions in the rapid pitch-up to be instinctive and – given the outcome – inappropriate. The nose-up trim setting would have reduced the control forces required to initiate the rapid pitch-up and so the pilot may have over-estimated the control input required to lift off. Once the aircraft began to roll left, the right-roll deflection of the ailerons observed in the video might have been an instinctive response from the pilot to attempt a correction of the roll attitude.

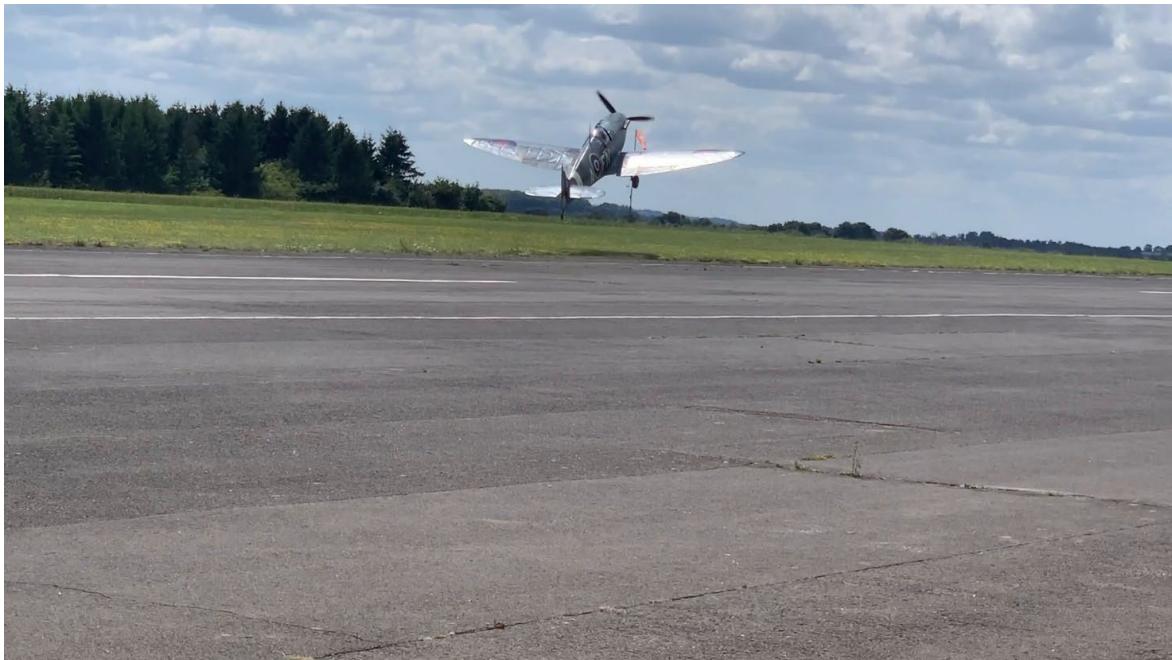
Figure 8

Aircraft pitches up at $12^\circ/\text{s}$

As the aircraft pitched up, the applied g and hence the stalling speed would have increased. It is probable that the aircraft speed was below the increased stalling speed in the manoeuvre and so the wing stalled. As there was power applied, once the wing stalled the torque reaction from the propellor would cause the aircraft to roll left, which was the motion observed. This was followed by a right-roll aileron input, but as this action deflected the left aileron downwards it would have increased the angle of attack on the left wing. Post stall, this increase in angle of attack would have further reduced lift on the left wing, exacerbating the roll to the left, and would have increased drag causing the aircraft to yaw left.

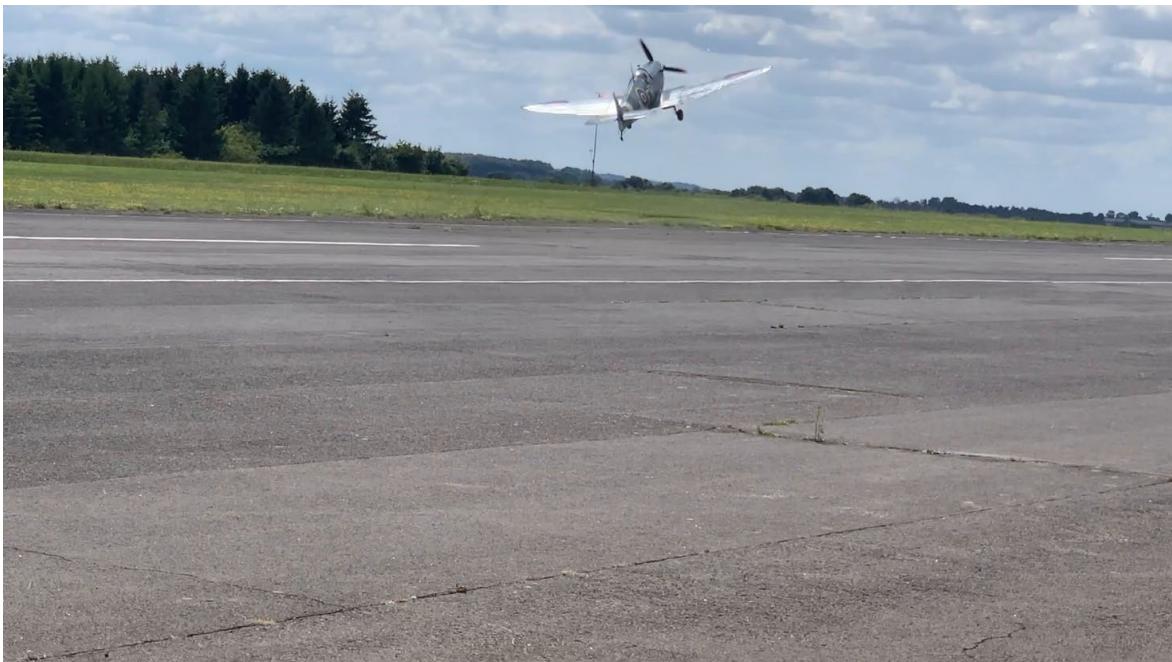
Figure 9

Aircraft rolls left

The roll to the left would have induced a sideslip which would also have caused the aircraft to yaw left. As the outside, right wing's speed would have been increased by the yaw, the lift on the right wing would also have increased further exacerbating the left roll. The aircraft rolled rapidly, and the left wingtip touched the ground causing the aircraft to continue to roll and yaw left before it came to rest. A large fire ensued around the forward fuselage area and the pilot sustained fatal injuries.

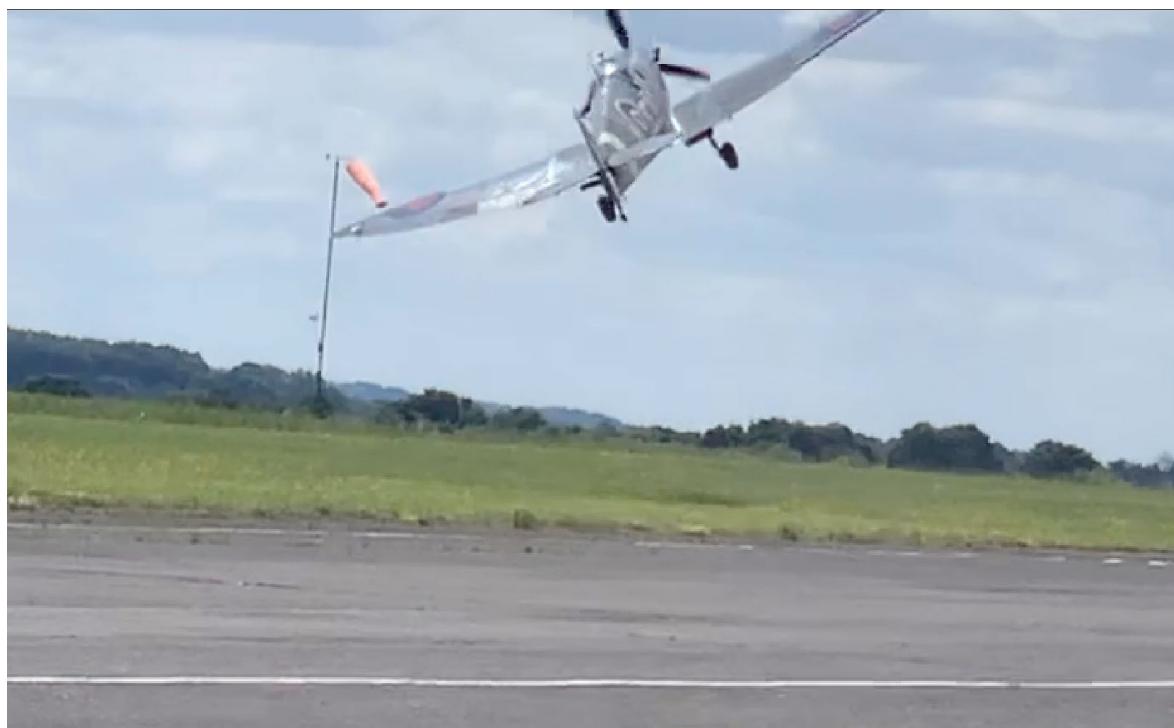
Figure 10

The aircraft's ailerons were then observed to move to a right roll position (left aileron surface down / right aileron surface up) (Figure 10) but the aircraft continued rolling left. The footage of the aircraft captured by the witness ended shortly after this point but the continuing flight path of the aircraft was recorded by one of the CCTV cameras (Figure 11). When the aircraft's bank angle reached about 30° , its pitch attitude briefly stabilised at about 15° nose-up but as the bank angle reached about 40° the roll rate increased quickly to about $70^\circ/\text{s}$. The aircraft's nose started to drop and the aircraft descended, with the bank angle reaching about 120° before the aircraft struck the ground, left wingtip first, at 1257:40 hrs.

Aircraft continues to roll left with counter (right roll) ailerons applied

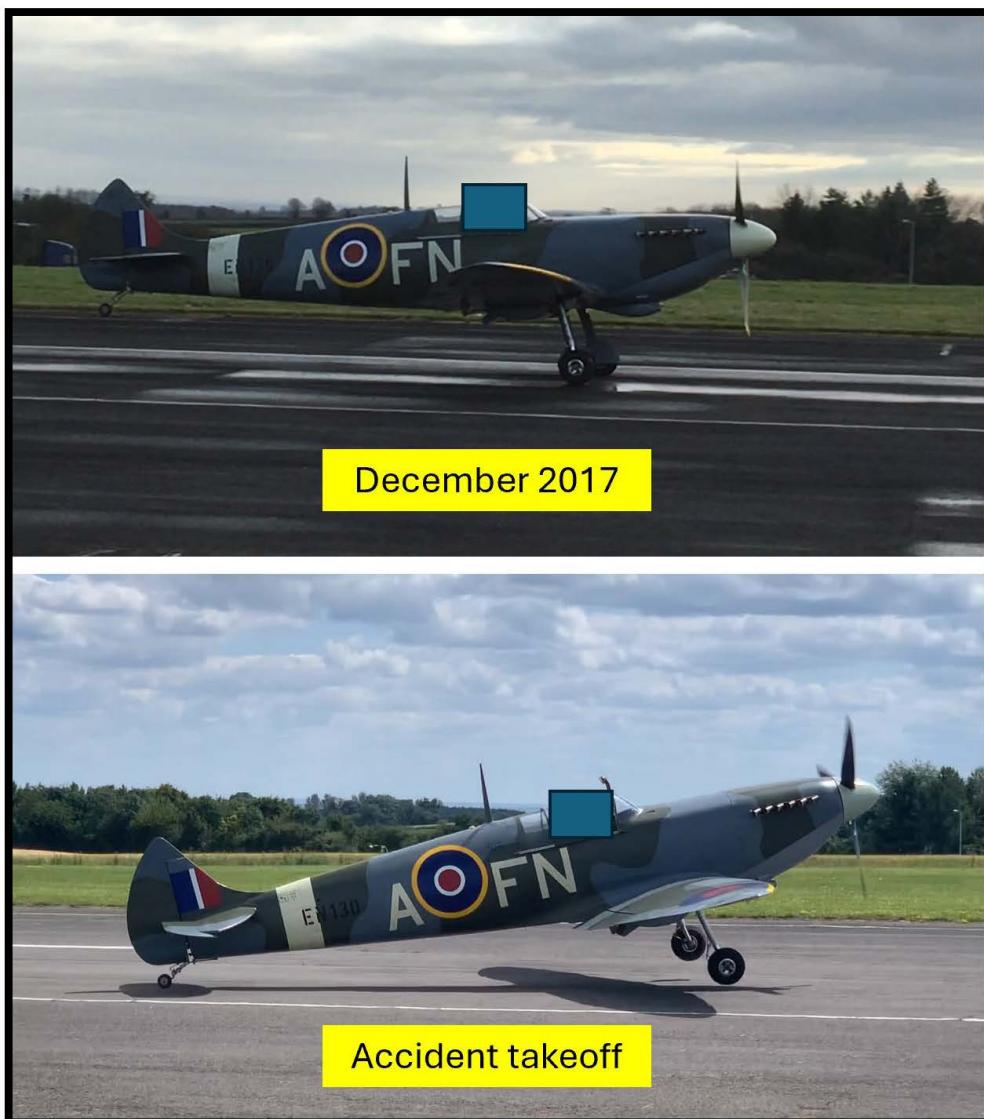
Figure 12 shows the difference between G-ENAA's pitch attitude during the accident takeoff and that in December 2017, and Figure 13 shows the difference in the initial climb attitudes adopted.

Figure 12
Difference in pitch attitude prior to takeoff

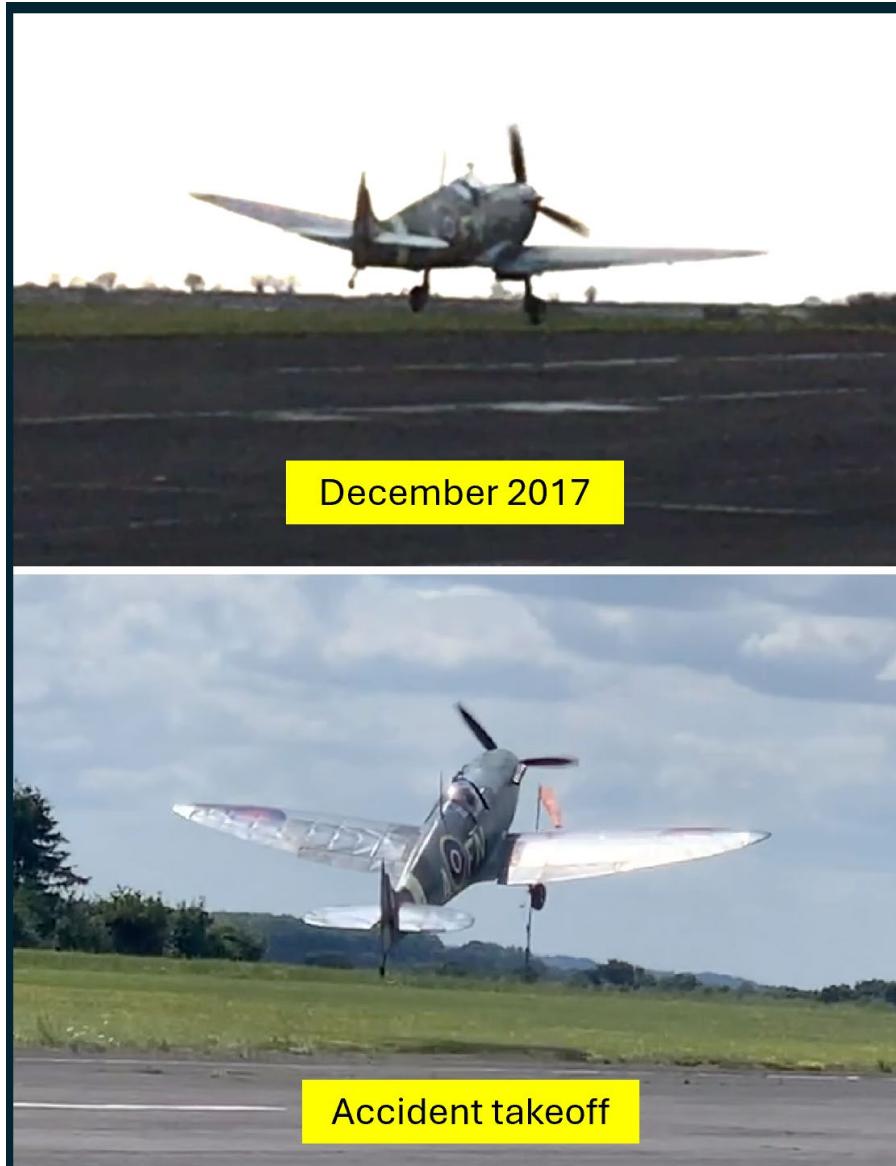
Figure 13
Difference in pitch attitude during initial climb

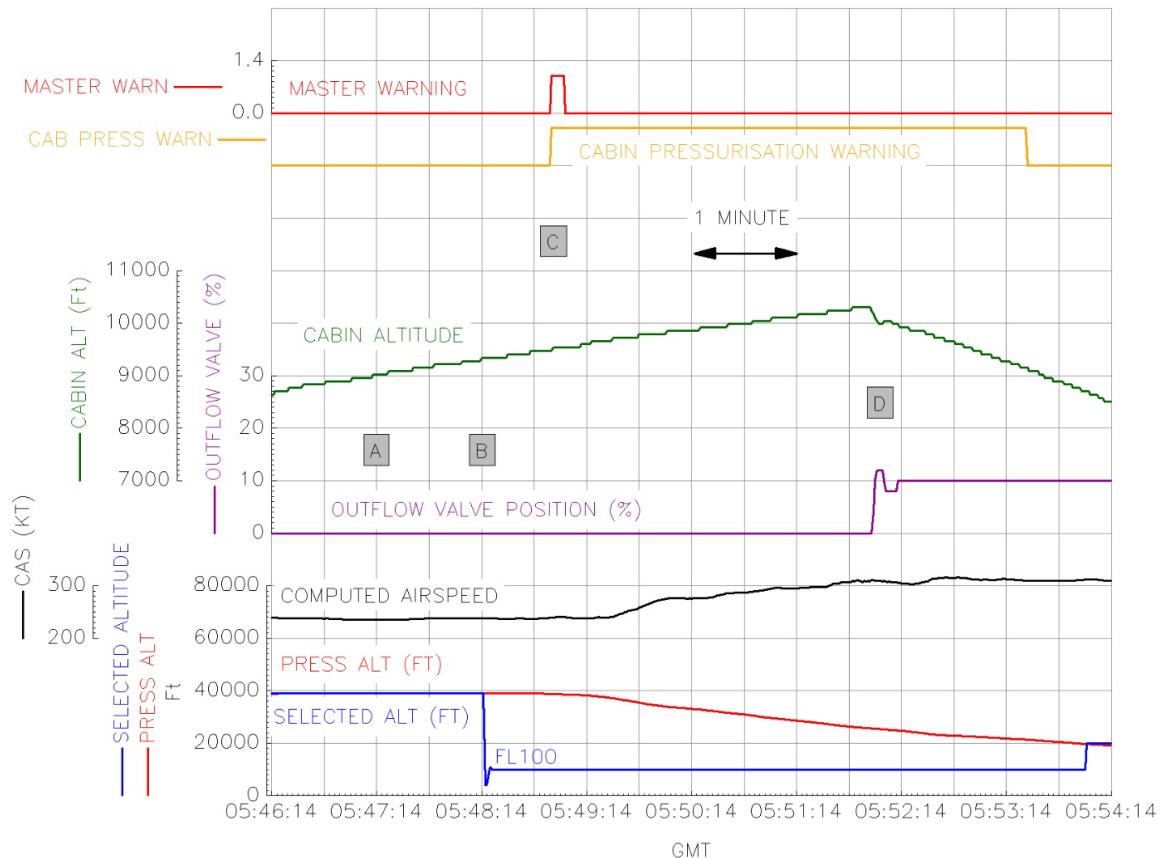
Figure 2
G-UZEF FDR data

At 0547:14 hrs, the aircraft was at FL390 and the recorded cabin altitude was climbing past 9,000 ft. The CVR recorded the commander questioning why both packs were shown as OFF (Figure 2, Point A). The crew donned oxygen masks and a minute later, the autopilot selected altitude reduced from FL390 to FL100 and the aircraft descended (Figure 2, Point B). A MAYDAY was declared and the cabin altitude continued to climb. At 0548:54 hrs, the recorded cabin pressurisation warning was recorded, accompanied by a Master Warning audible on the CVR (Figure 2, Point C).

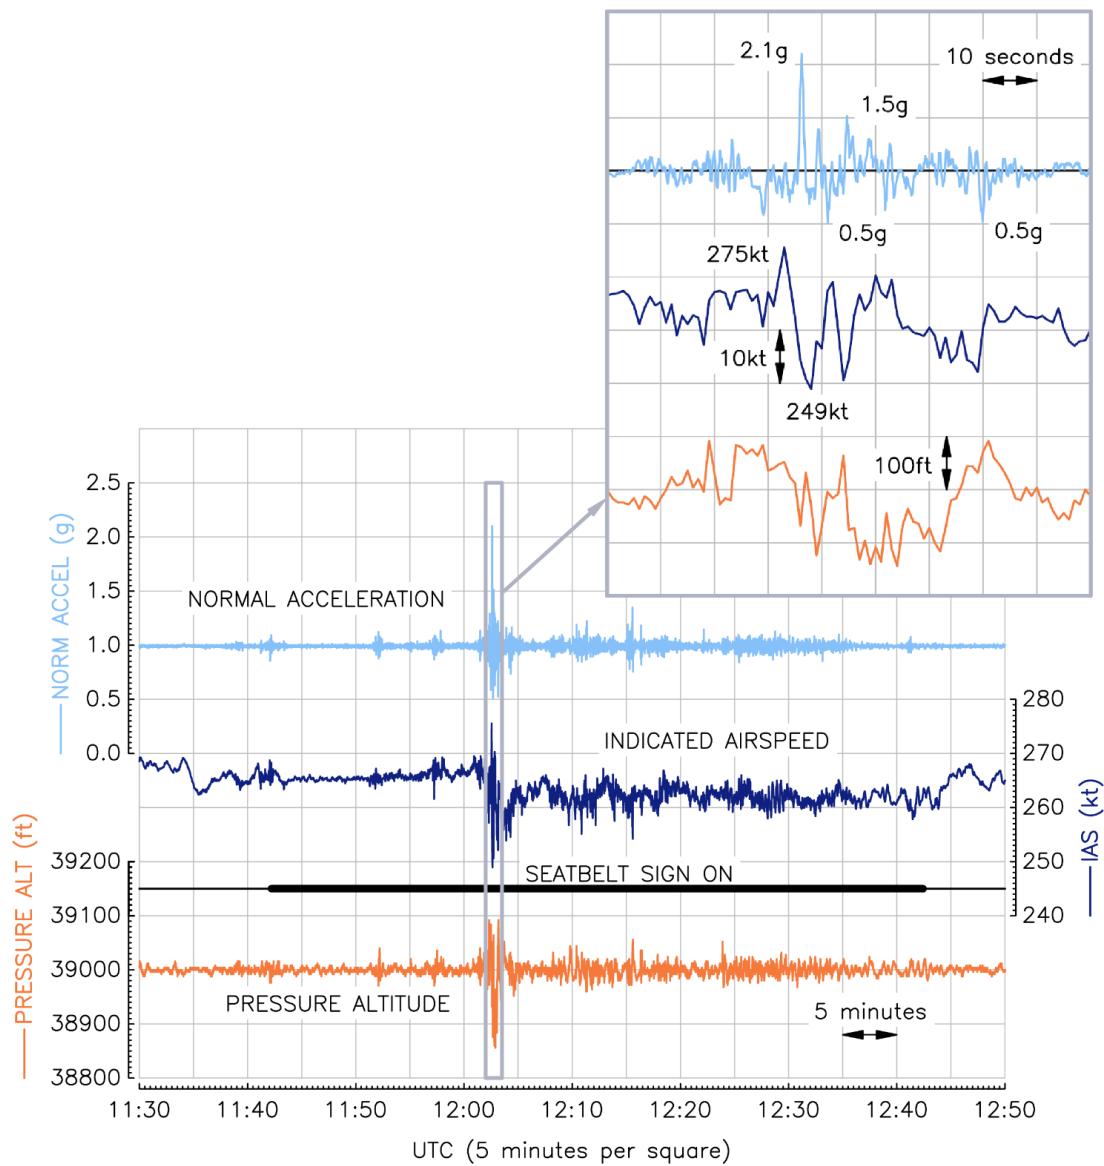
Figure 3
G-XLEI flight data for the turbulence event

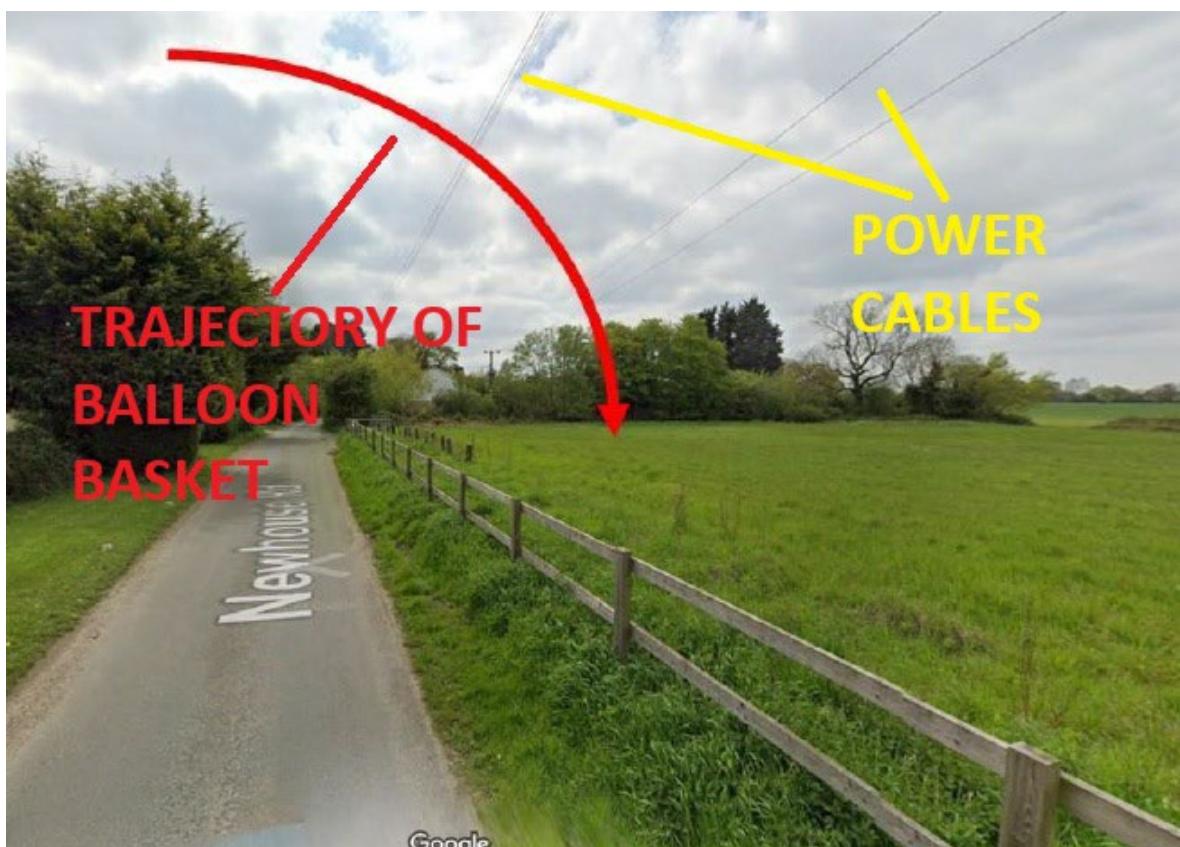
The pilot observed a set of wires running along the road on the eastern edge of the intended landing field. He directed the passengers to take up their landing positions in the basket. The pilot described the approach as “normal”. The balloon crossed the road and the wires, landing with the basket upright, just inside the chosen field, at 1757 hrs. The pilot intended to touch down as soon as possible after the field’s perimeter, and the wires he had observed, to give maximum room for the envelope¹ to collapse downwind of the basket. Having the basket as close as possible to the perimeter would ease its subsequent recovery. The pilot’s intent was to land keeping the basket and envelope upright for the passengers to disembark. After touchdown the pilot realised there was another set of wires approximately 30 ft into the field (Figure 3).

Figure 3
Landing site looking south along road

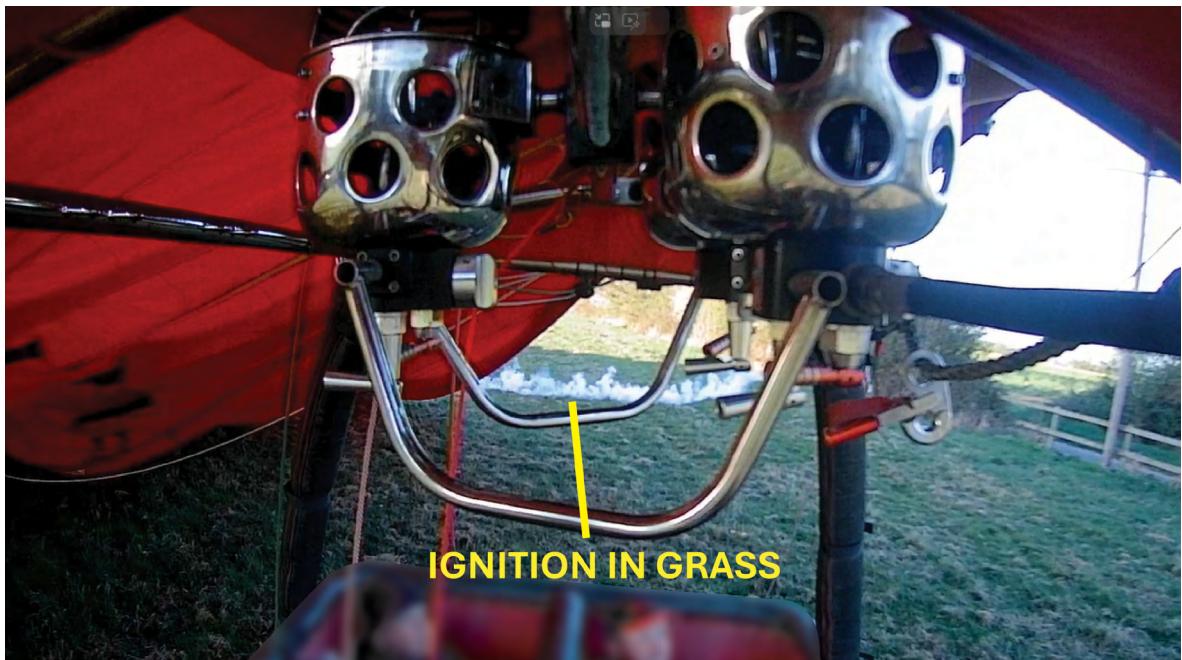
The falling wires ignited the grass near the balloon (Figure 5) at around 1757 hrs and, shortly after, smoke began emanating from under the basket (Figure 6). The pilot told the passengers to get out and move clear of the basket.

Figure 5
Ignition in grass

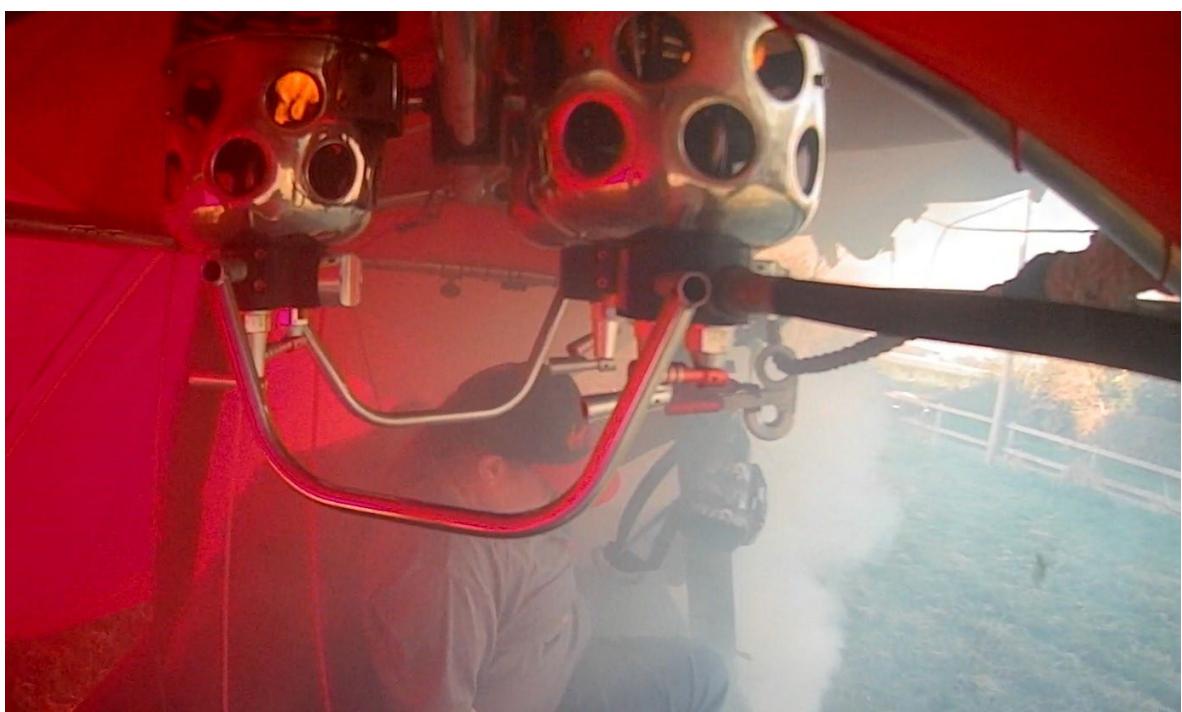
Figure 6
Evacuation
