Report on the investigation of
the fatal injury to a deckhand following a chain failure
on the scallop dredger

Honeybourne III (PD905)

16 nautical miles south of Newhaven, England
on 6 October 2023

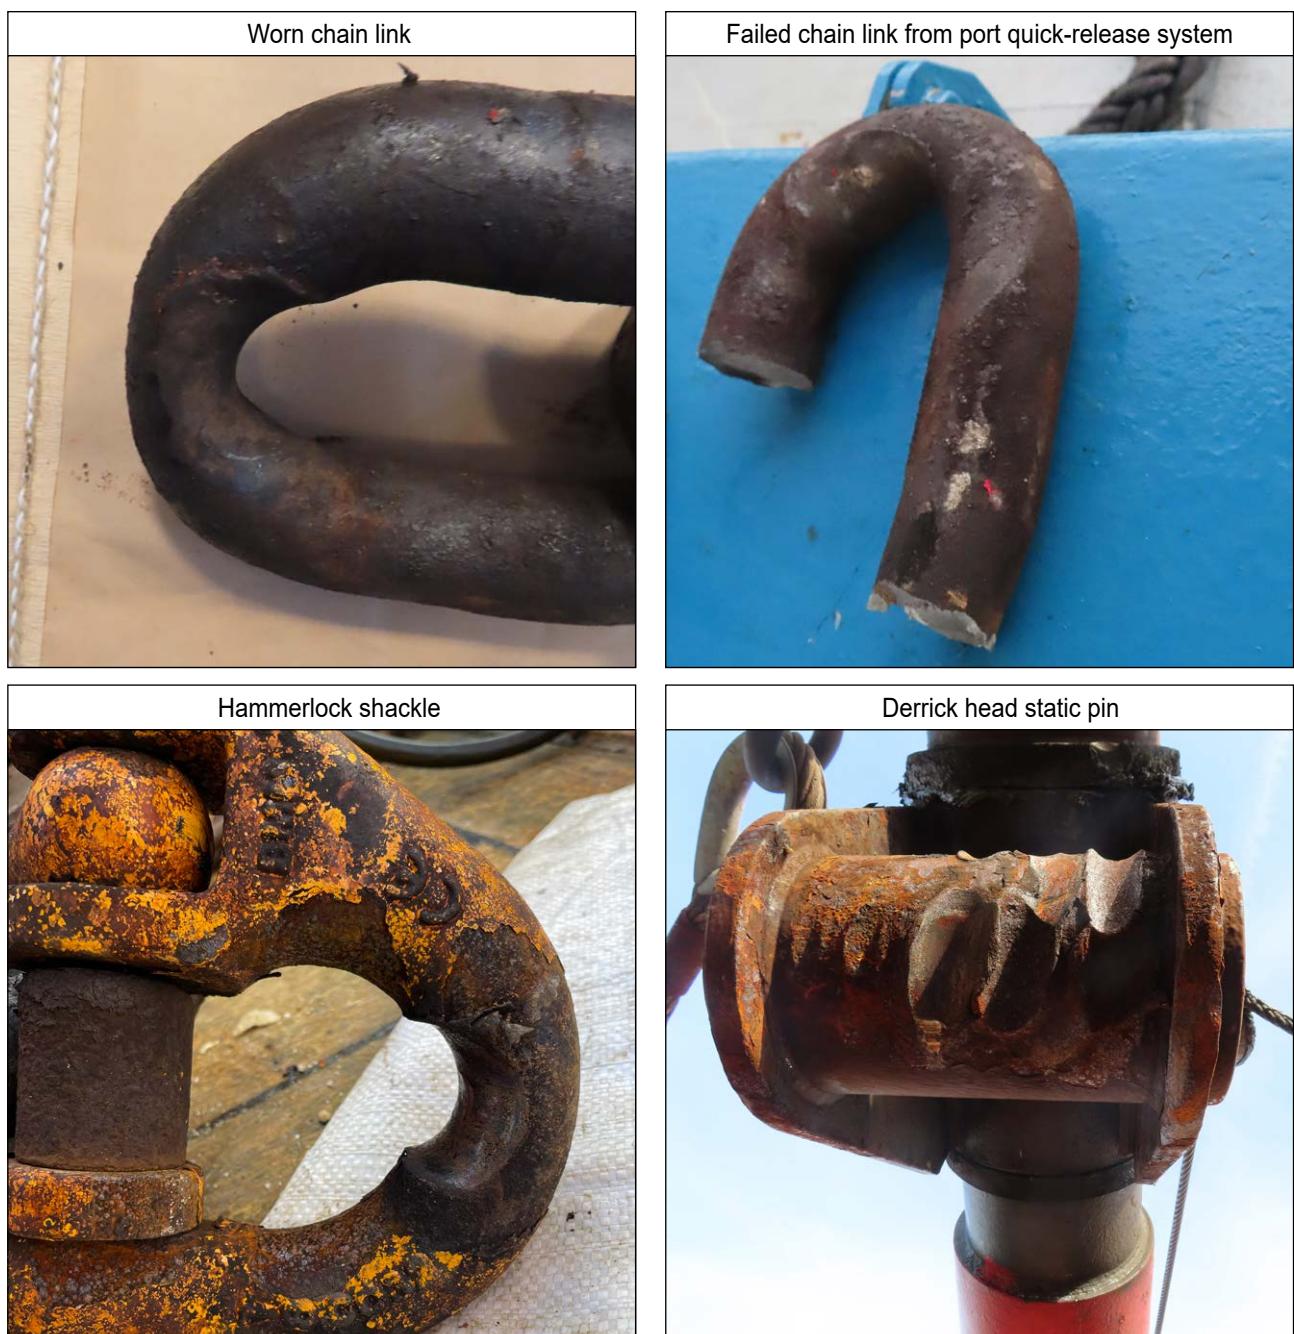
Figure 6: Wear and damage to load-bearing components on port derrick

There was significant wear to the load-bearing components supporting the dredging gear (**Figure 6**), specifically:

- the static pins and edges of the cheek plates in the derrick heads;
- the chain links of the quick-release assemblies; and
- the crown of the port hammerlock shackle connecting the port quick-release chain to the towing block.

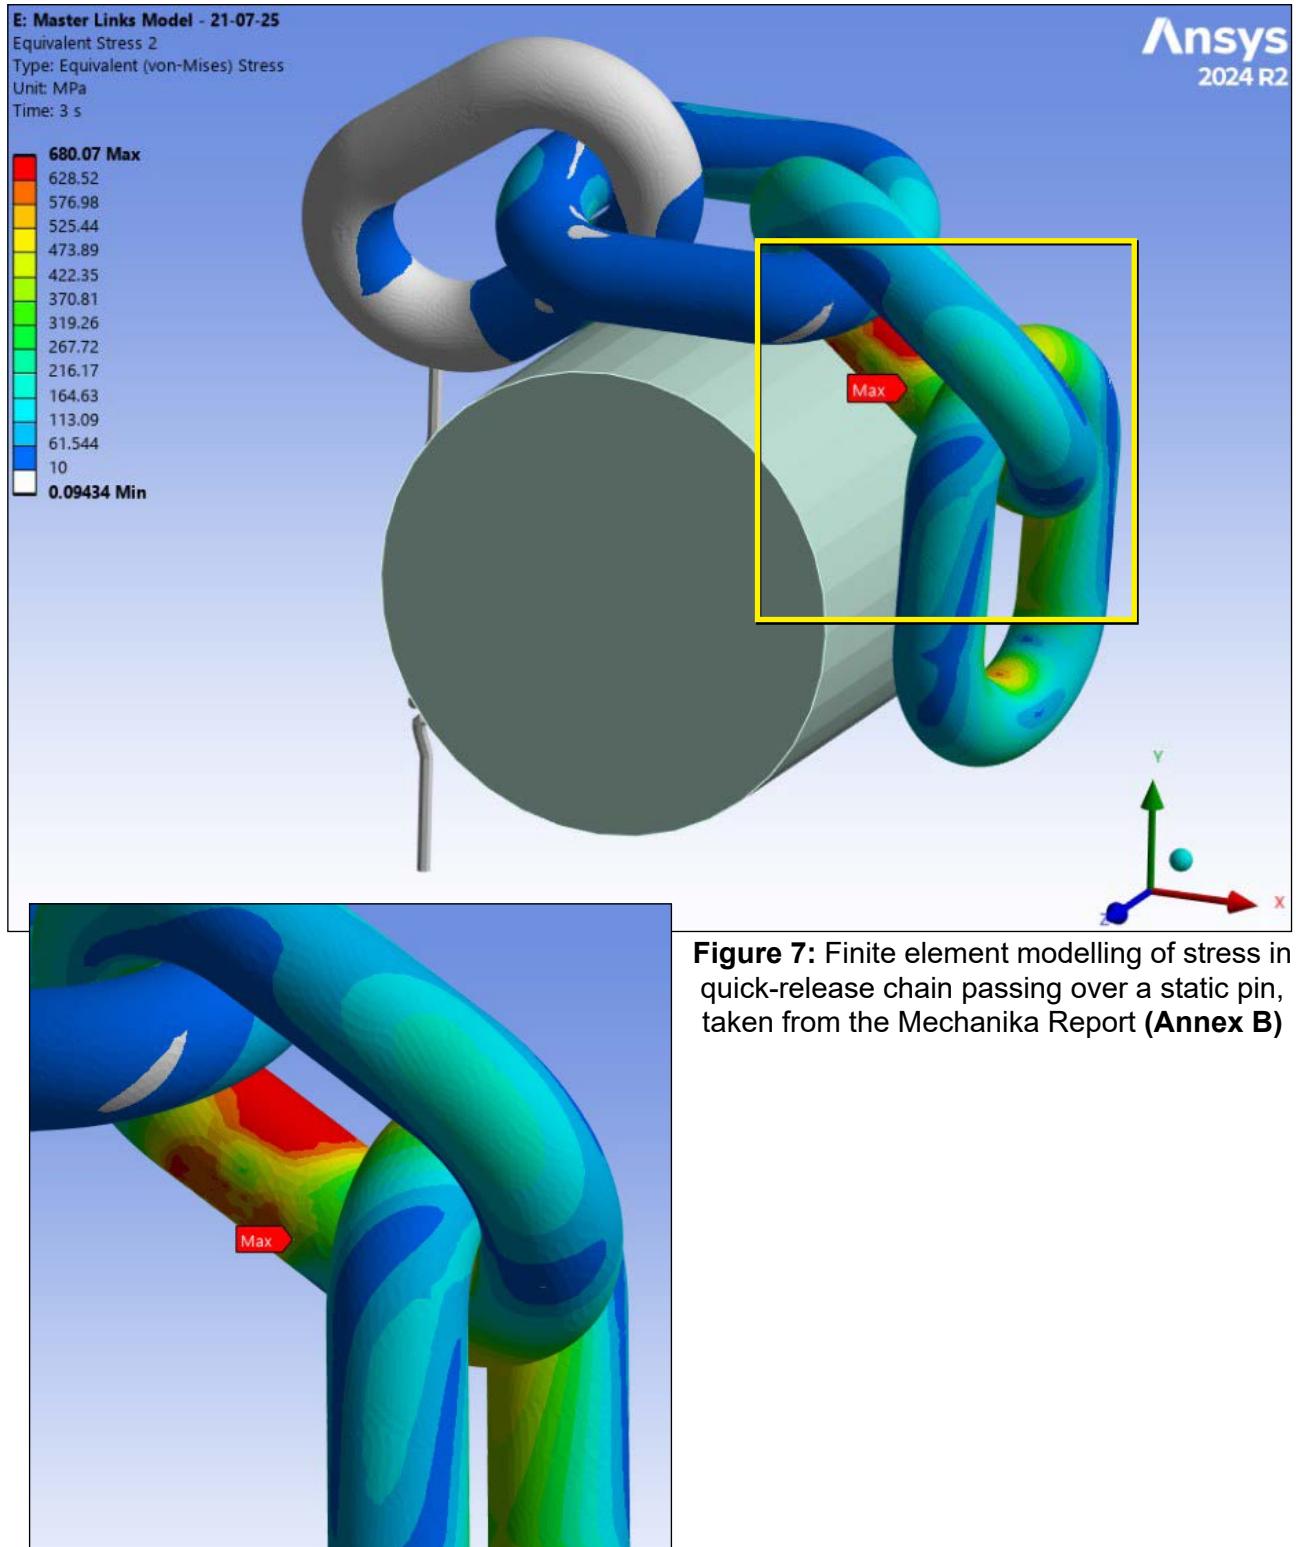
Figure 7: Finite element modelling of stress in quick-release chain passing over a static pin, taken from the Mechanika Report (**Annex B**)

The static pin design is unsafe and promotes secondary bending in the links...

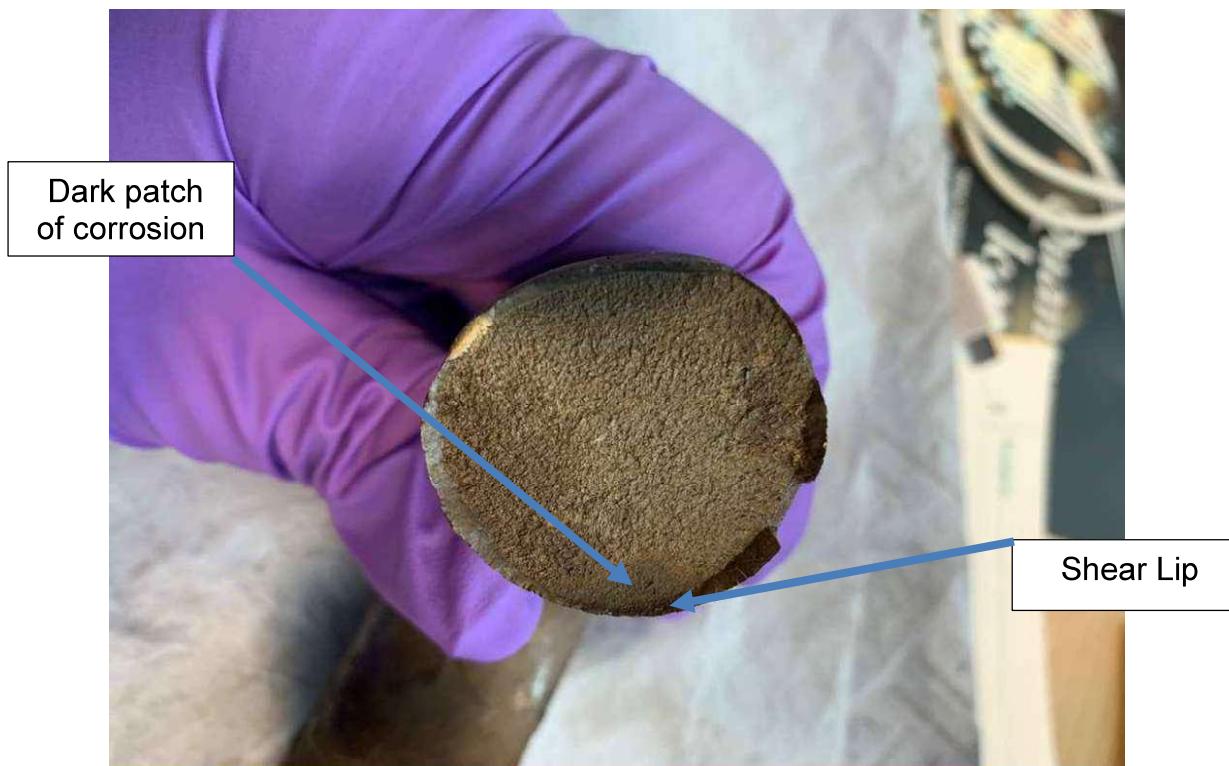
Figure 4: Partial Chain Link Fracture Face 1, sample 23307 (image 20240605_152035447_iOS rotated)

- Fracture mechanism – the partial chain link had two different fracture types on each face of the link. One face showed a faceted cleavage fracture consistent with a brittle fracture; the other fracture surface showed evidence typical of a ductile failure.

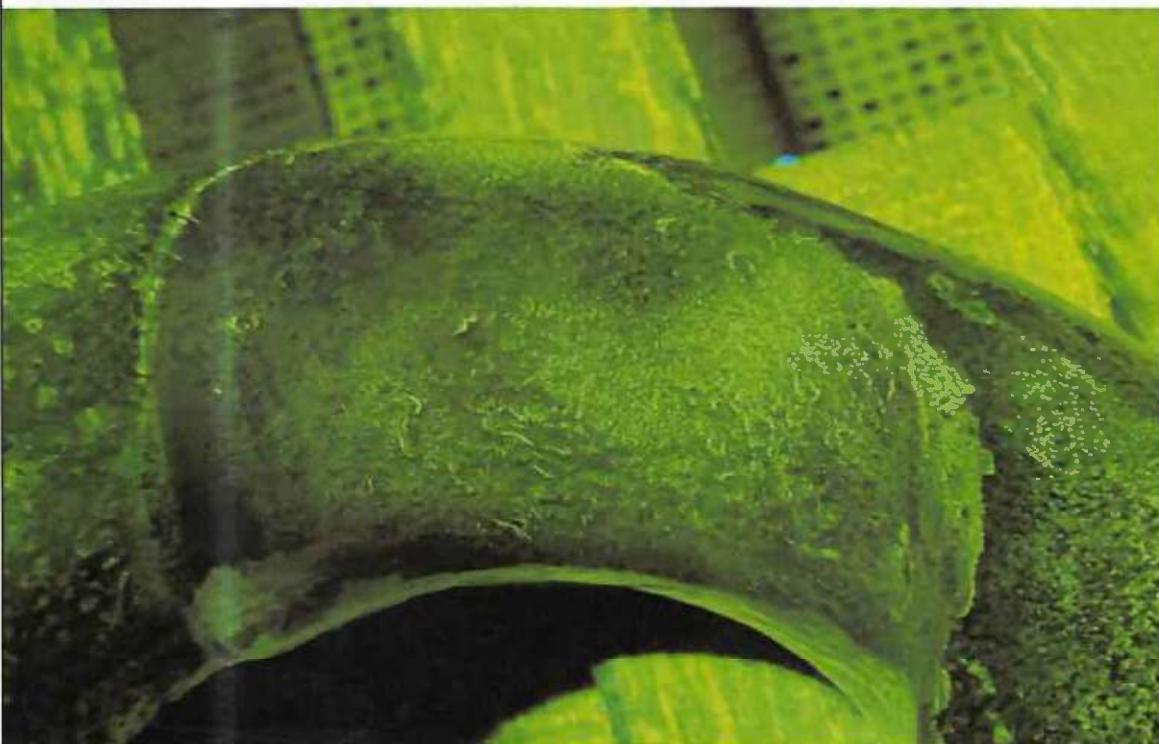
Chain Link, crack indication noted, severe wear noted on the internal radius, several stress cracks noted.

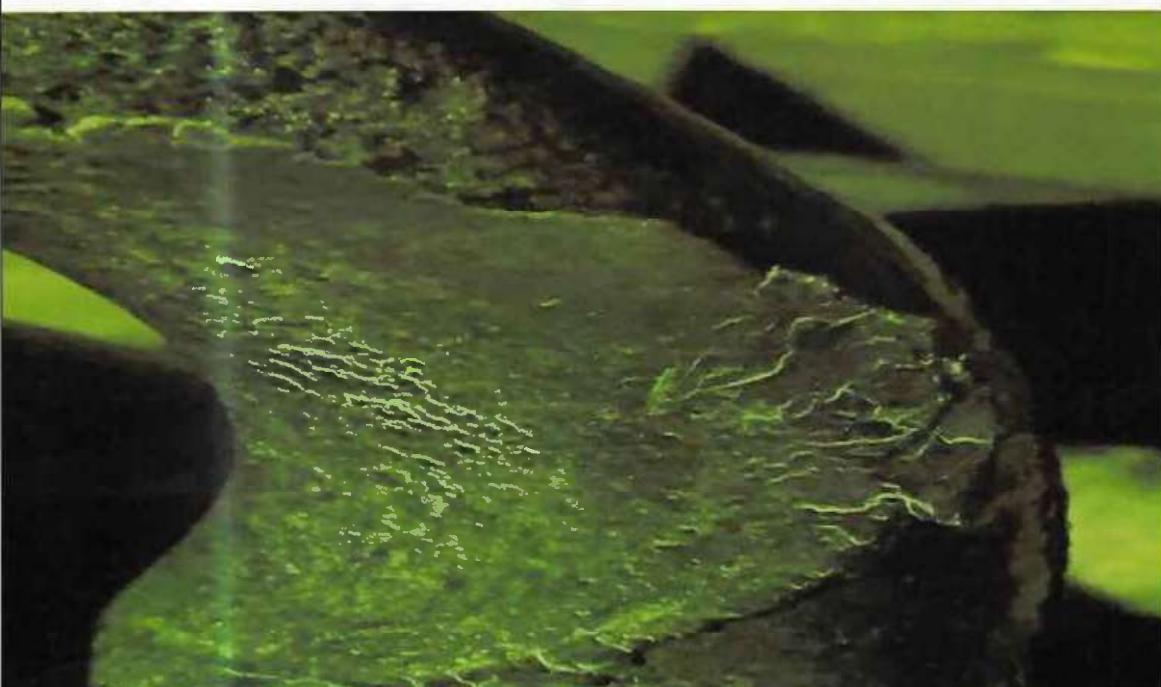
Chain Link, crack indication noted, sever wear noted on the internal radius, several stress cracks noted.
Cracking noted towards the outer radius edge.

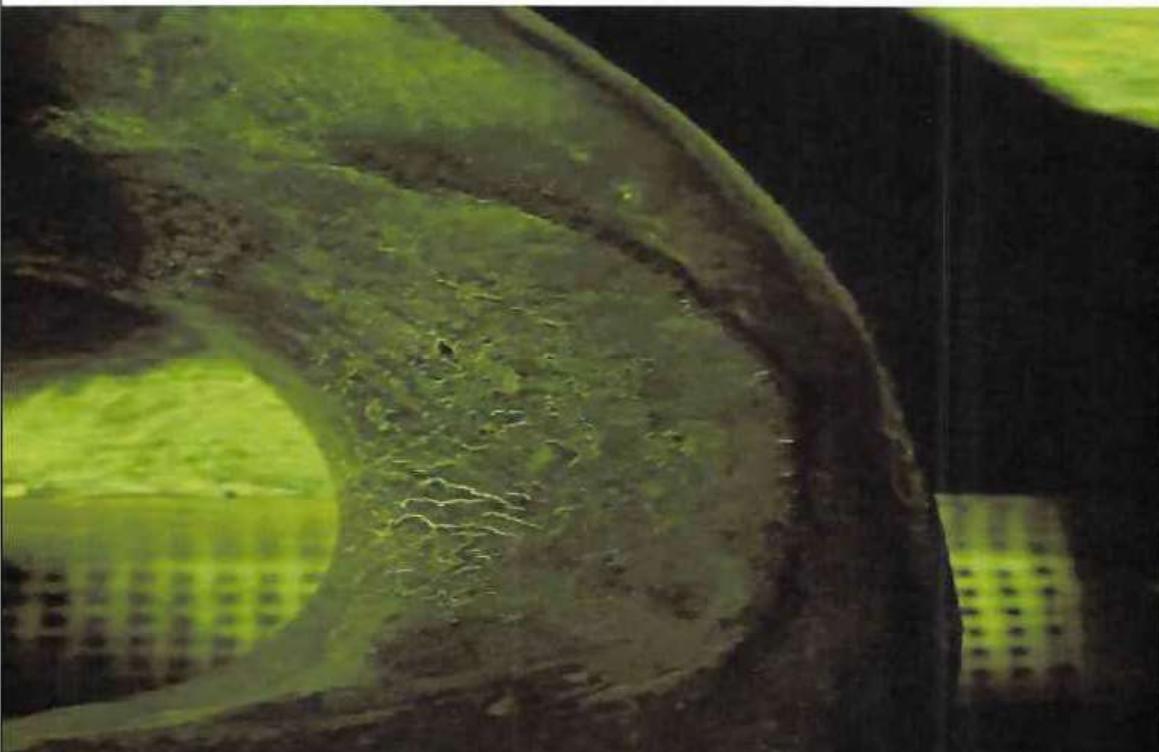
Chain Link, crack indication noted, sever wear noted on the internal radius, several stress cracks noted.

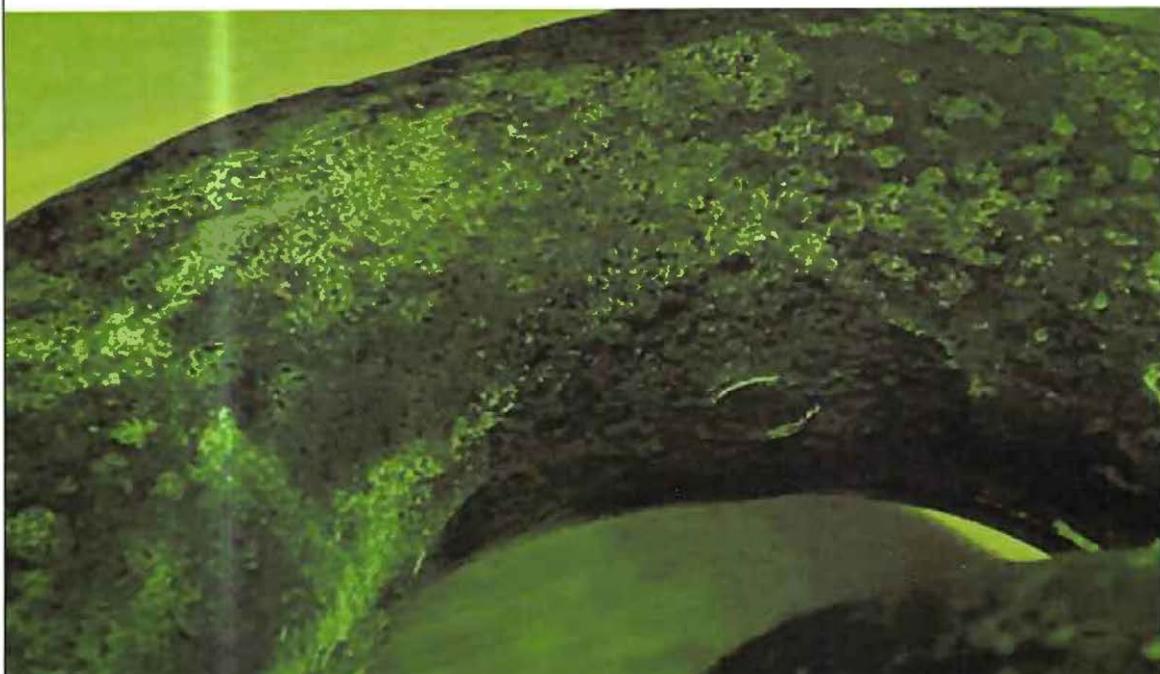
Chain Link, crack indication noted, sever wear noted on the internal radius, several stress cracks noted.

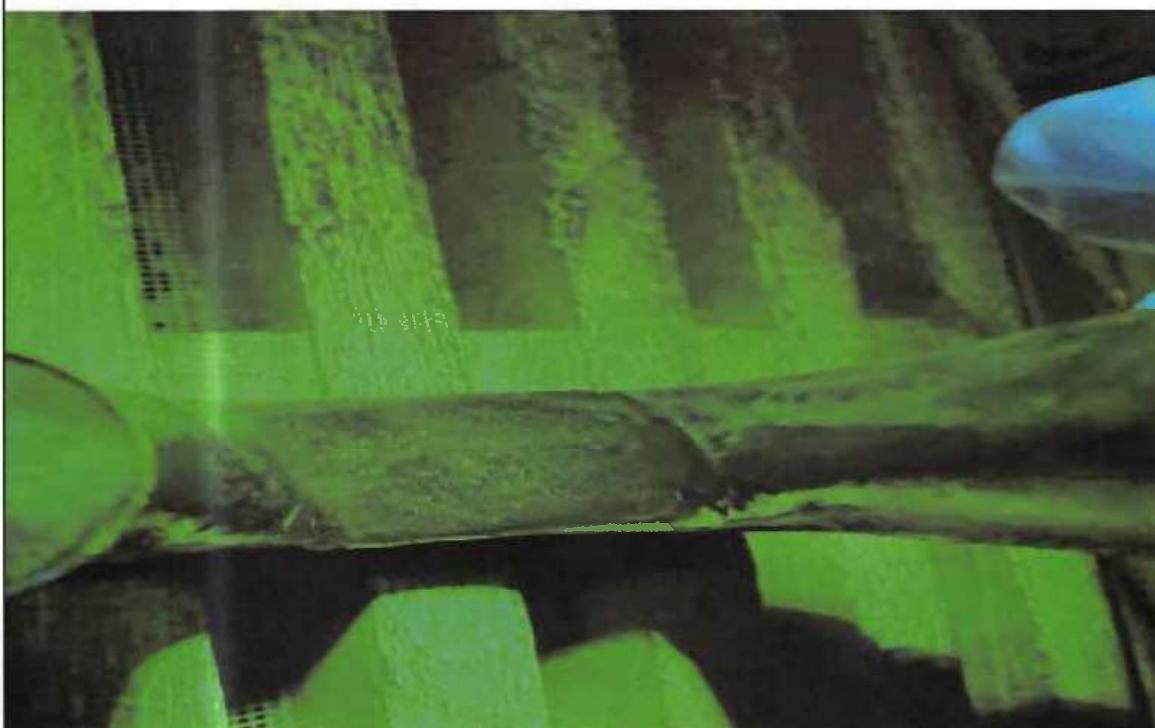
Rounded indication noted, with presence of cracking around the edge.

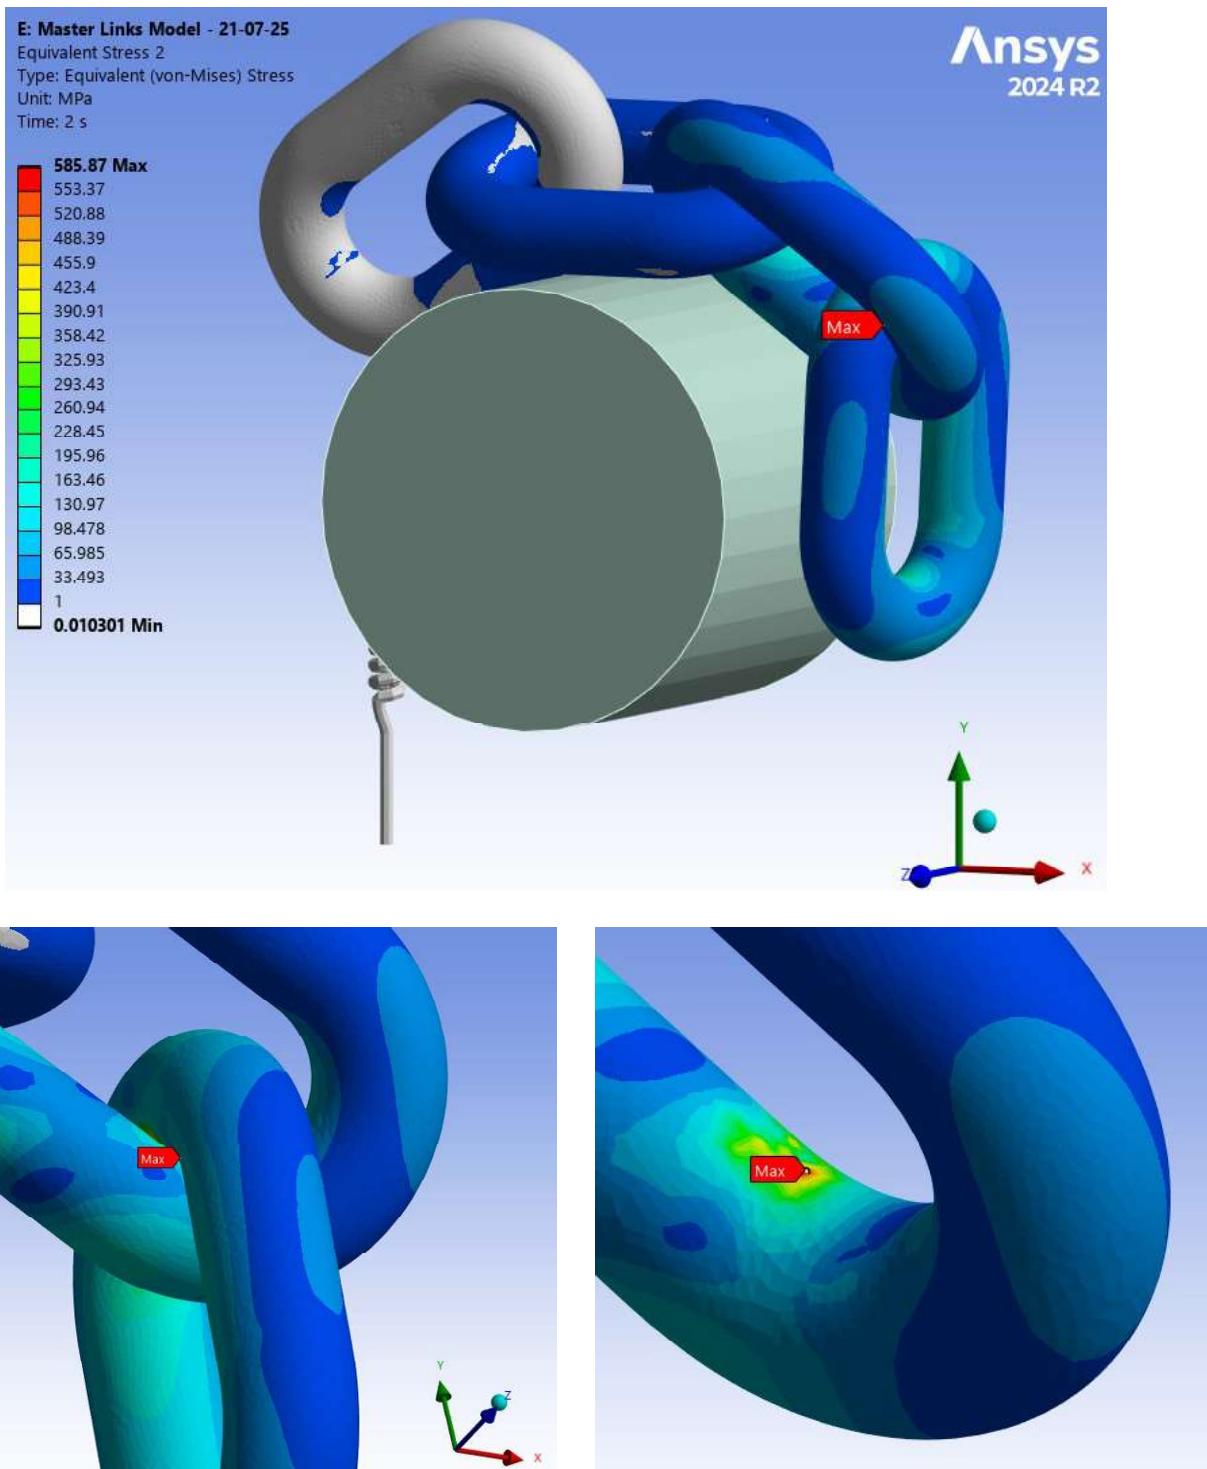
Figure 11 - Equivalent von-Mises Stress - LC1

The maximum equivalent stress is shown in Figure 11 and is 586 MPa on Link 2. Although the von-Mises stress does not exceed the material yield strength of the link, there is high compressive stress and therefore some plastic strain is also present (Figure 12). In Hertzian contact models in ANSYS, localized plastic strain can appear even if the reported equivalent von Mises stress is below the defined yield stress. ANSYS often averages stress values across nodes or elements when displaying results. As a result, a stress peak slightly above yield may be averaged down to below yield in the output, while still causing plastic strain in localized regions. This is common near contact zones where the mesh is fine and stress gradients are steep, as found in this study.

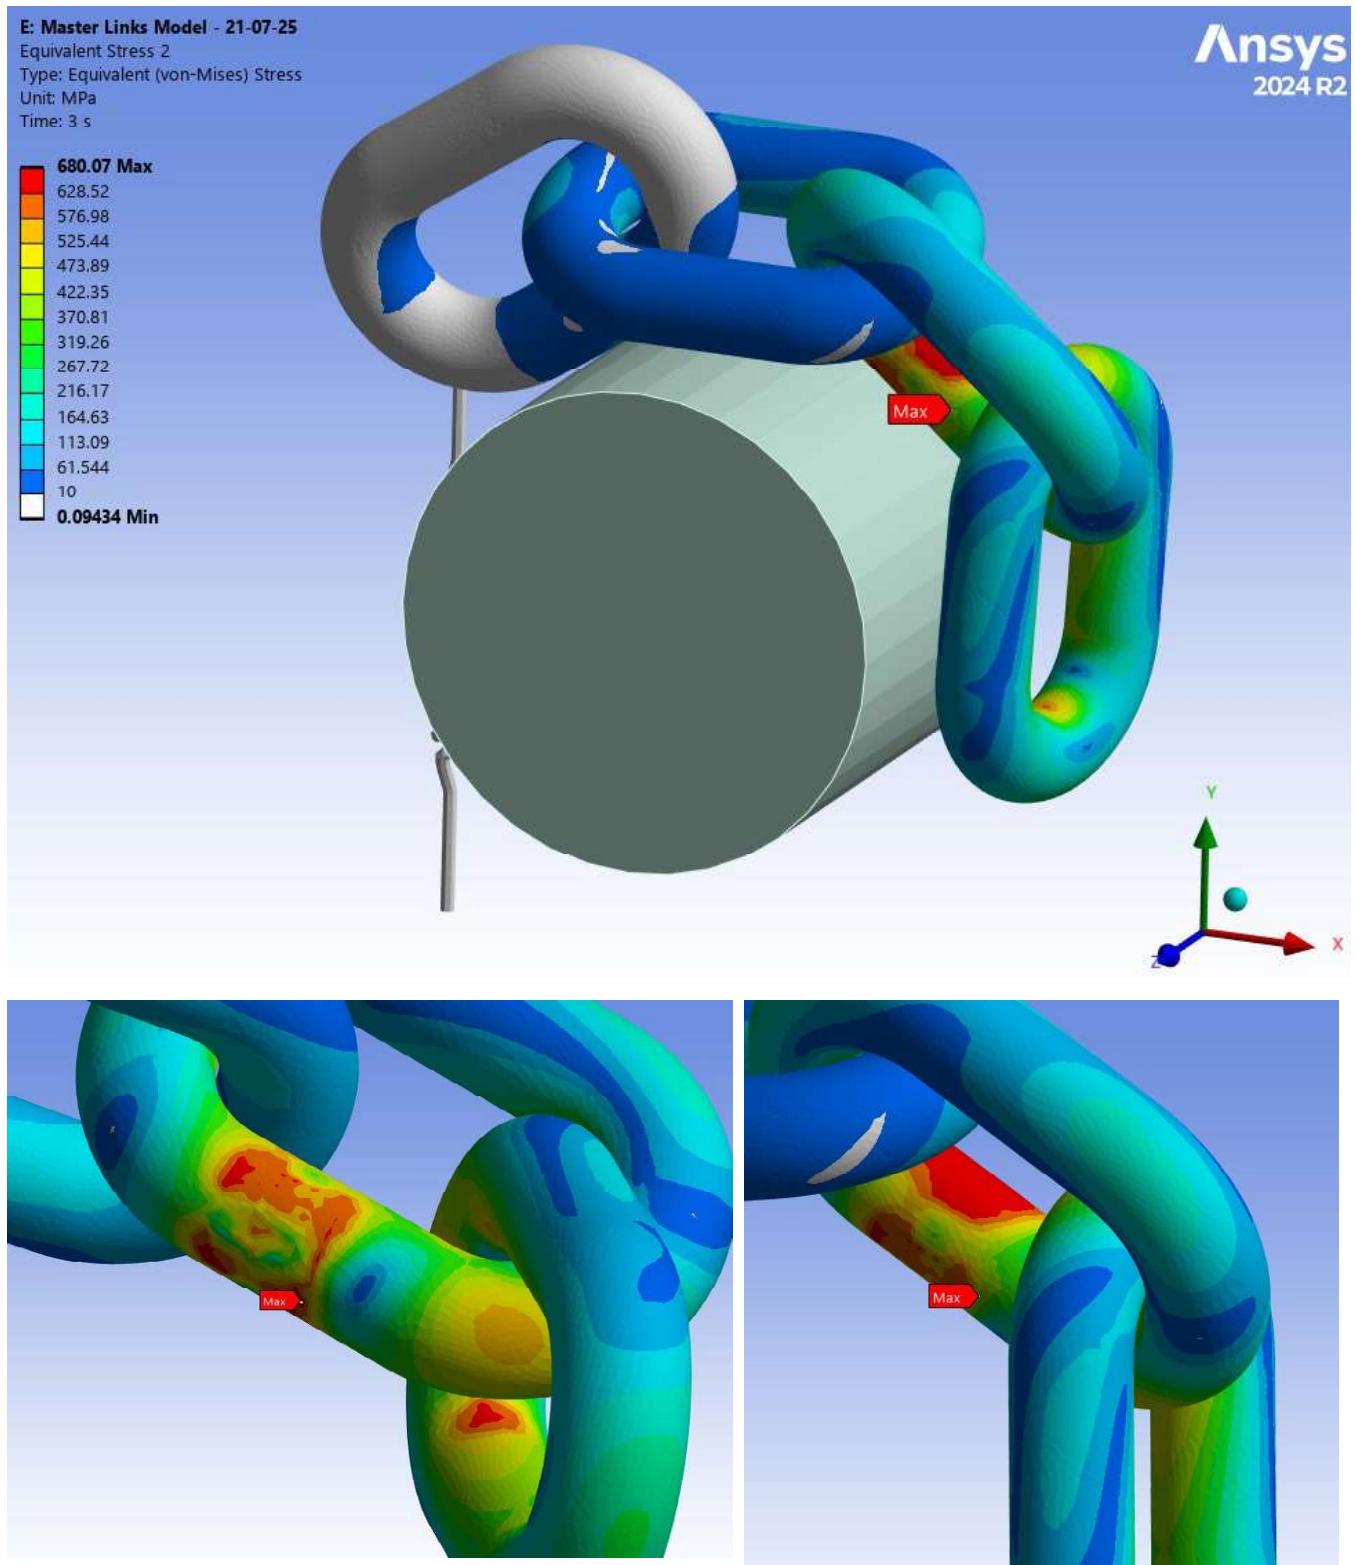
Figure 15 - Equivalent von-Mises Stress - LC2

The maximum equivalent stress is shown in Figure 15 and is 680 MPa on Link 2. This exceeds the material yield strength of the link and therefore the plastic strain is also considered in Figure 16.
