# Abbreviated Dust Monitoring Report

Monitoring Period: 01 December 2025 to 04 January 2026

<b>Project:</b>	Grenfell Tower
<b>Document Ref:</b>	EEMC-DMR-201/104 – Grenfell Tower Rev 00
<b>Period:</b>	01 December 2025 to 04 January 2026

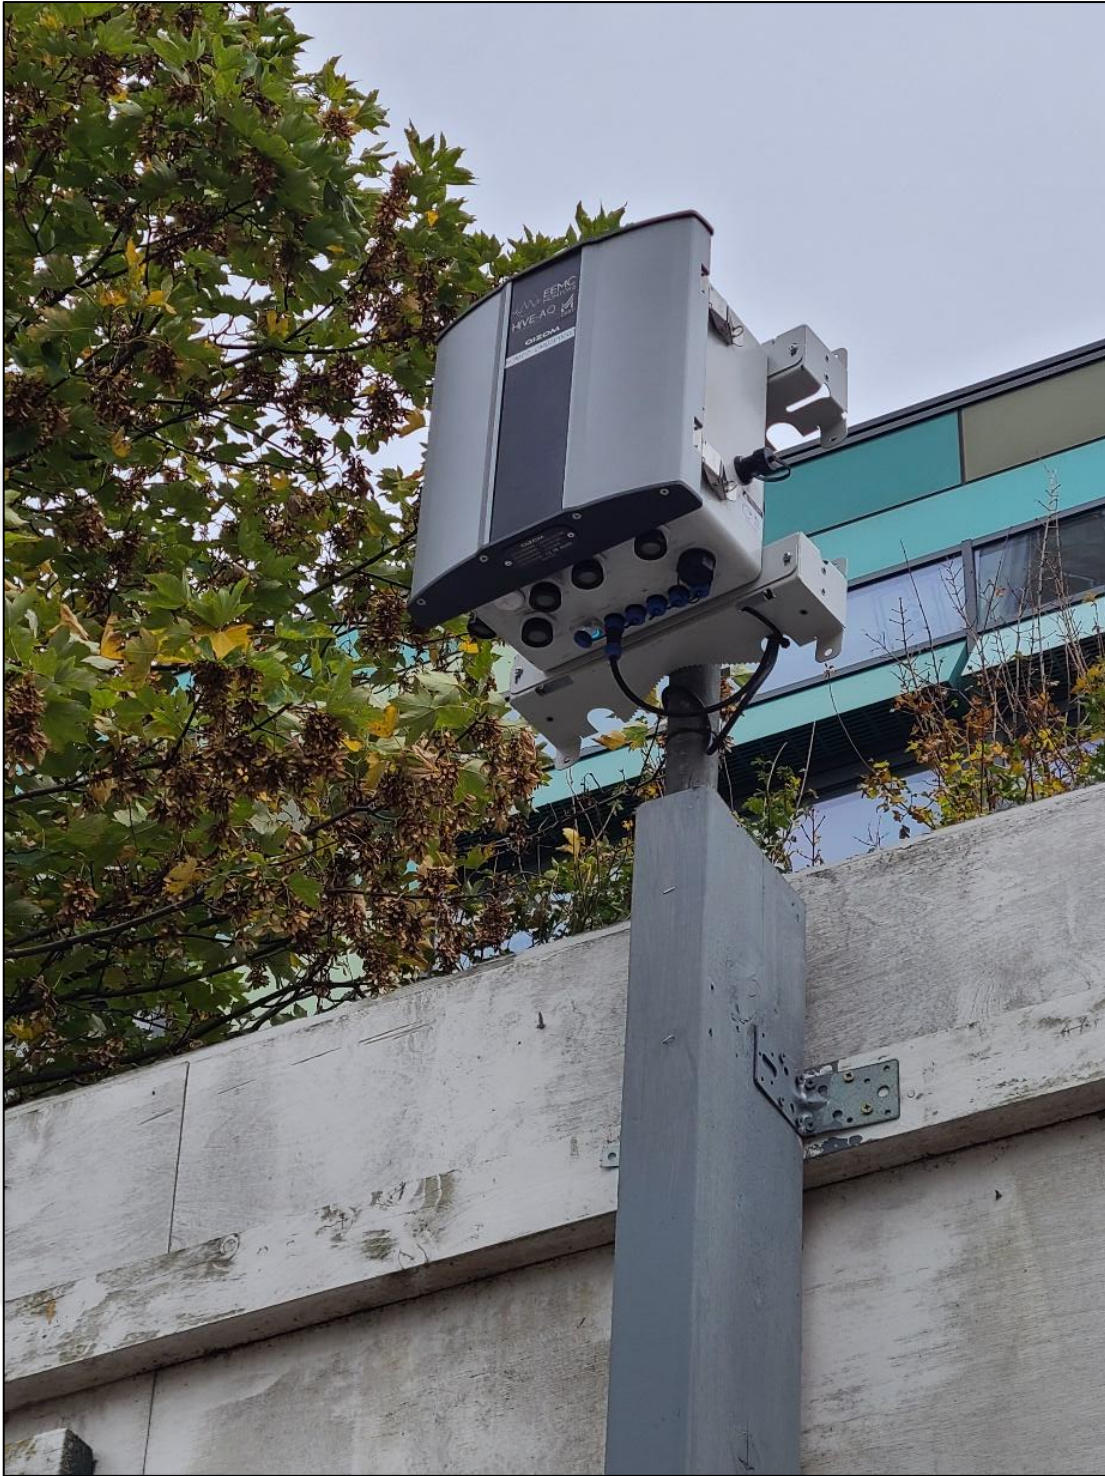
**Images 3 – DMP2 Monitoring Location** (photo taken on site on 19/5/2025).

There were **fifteen (15) exceedances** of the 15-minute PM<sub>2.5</sub> 54 (µg/m<sup>3</sup>) and **fourteen (14) exceedances** of the 15-minute PM<sub>10</sub> 150 (µg/m<sup>3</sup>) Amber Trigger levels at **DMP2**.

Time and Date of Exceedance	Measured Level of Exceedance (µg/m <sup>3</sup> )	Particle Size	Alert Level	Monitoring Location	Cause of Exceedance
17/12/2025 04:15	64.5	2.5 µg/m <sup>3</sup>	54 µg/m <sup>3</sup> Trigger Level (15min)	DMP2	Due to the early hours these occurred, the exceedances all being consecutive on 17 <sup>th</sup> December and the high humidity readings. It is very likely that these exceedances were <u>caused by fine rain/misty weather</u> and are not representative of any site works.
17/12/2025 04:30	87.0				
17/12/2025 04:45	105.2				
17/12/2025 05:00	121.2				
17/12/2025 05:15	134.6				
17/12/2025 05:30	155.7				
17/12/2025 05:45	96.3				
17/12/2025 06:00	130.1				
17/12/2025 06:15	87.7				
17/12/2025 06:30	89.8				
17/12/2025 06:45	101.4				
17/12/2025 07:00	105.2				
17/12/2025 07:15	86.9				
17/12/2025 07:30	83.5				
17/12/2025 07:45	81.5

17/12/2025 04:30	265.3	10 µg/m <sup>3</sup>	150 µg/m <sup>3</sup> Trigger Level (15min)	DMP2	Due to the early hours these occurred, the exceedances all being consecutive on 17 <sup>th</sup> December and the high humidity readings. It is very likely that these exceedances were <u>caused by fine rain/misty weather</u> and are not representative of any site works.
17/12/2025 04:45	348.5				
17/12/2025 05:00	446.8				
17/12/2025 05:15	511.3				
17/12/2025 05:30	449.0				
17/12/2025 05:45	275.6				
17/12/2025 06:00	403.9				
17/12/2025 06:15	249.8				
17/12/2025 06:30	271.1				
17/12/2025 06:45	338.3				
17/12/2025 07:00	353.0				
17/12/2025 07:15	320.3				
17/12/2025 07:30	225.5				
17/12/2025 07:45	253.8

There were **four (4) exceedances** of the 1-hour PM<sub>10</sub> 190 (µg/m<sup>3</sup>) and **four (4) exceedances** of the 1-hour PM<sub>2.5</sub> 70 (µg/m<sup>3</sup>) Red Action Alert levels at **DMP2**.

Time and Date of Exceedance	Measured Level of Exceedance (µg/m <sup>3</sup> )	Particle Size	Alert Level	Monitoring Location	Cause of Exceedance	Mitigation	
17/12/2025 05:00	94.5	2.5 µg/m <sup>3</sup>	70 µg/m <sup>3</sup> Red Action Level (1hour)	DMP2	Due to the early hours these occurred, the exceedances all being consecutive on 17 <sup>th</sup> December and the high humidity readings. It is very likely that these exceedances were <u>caused by fine rain/misty weather</u> and are not representative of any site works.	Occurred outside of Working hours.	
17/12/2025 06:00	129.2						
17/12/2025 07:00	96.0						
17/12/2025 08:00	75.9						
17/12/2025 05:00	302.1	10 µg/m <sup>3</sup>	190 µg/m <sup>3</sup> Red Action Level (1hour)	DMP2		Due to the early hours these occurred, the exceedances all being consecutive on 17 <sup>th</sup> December and the high humidity readings. It is very likely that these exceedances were <u>caused by fine rain/misty weather</u> and are not representative of any site works.	Occurred outside of working hours.

*\*Foggy weather can affect PM<sub>2.5</sub> due to a combination of; stagnant air, low wind and an increase in humidity. It can also be explained due to a phenomena known as- pollutant fog. This is due to an increased humidity, causing a false reading of water droplet molecules on the light scattering sensor. Increased humidity can cause aerosols to absorb water and therefore grow in size. This is known as 'hygroscopic growth'.*
