Report on the investigation of
a fall from a pilot ladder, resulting in the death of a pilot
while boarding the cargo vessel
Finnhawk from pilot vessel ***Humber Saturn***
in the approaches to the Humber Estuary, England
on 8 January 2023

Finnhawk/Humber Saturn

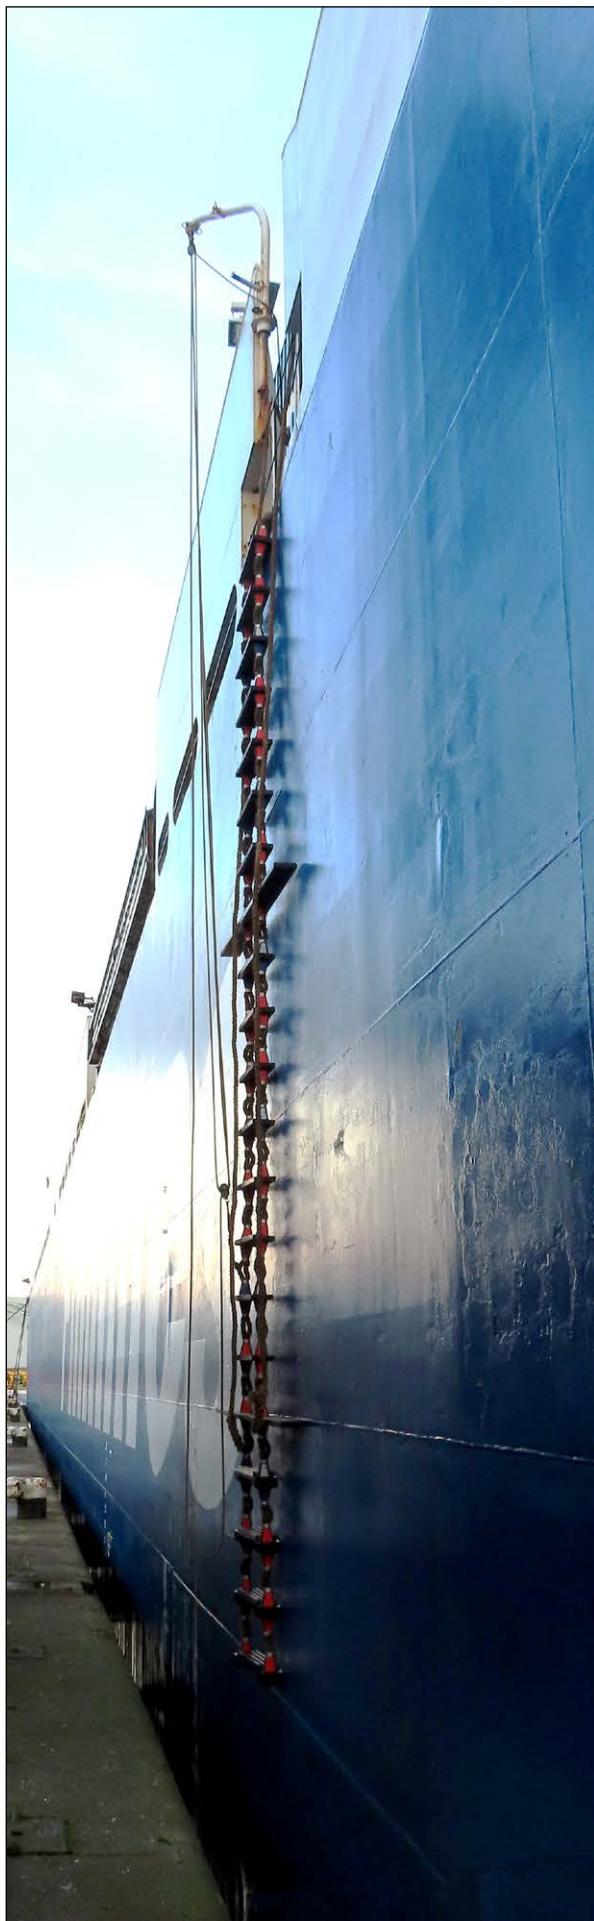
Figure 3: *Finnhawk's* pilot ladder

At about 1300, the pilot unclipped his harness from *Humber Saturn*'s safety rail, stepped onto the pilot boarding ladder and began his climb. The pilot's upper body was further away from the ladder than his lower limbs and his progress was very slow. When the pilot was 2m to 2.5m above the pilot vessel's deck he stopped and looked up at *Finnhawk*'s two crew members on the deck above, before suddenly leaning further back and letting go of the ladder, releasing both hands simultaneously. The pilot then fell backwards without making a sound and landed on his back on the port side of *Humber Saturn*'s deck house and safety rail, just in front of the wheelhouse windows (**Figure 4a**). The shell of the pilot's safety helmet broke and came off when he struck the pilot vessel. *Humber Saturn*'s deckhand saw the pilot land on the pilot vessel and attempted unsuccessfully to grab him. The pilot then slipped from the pilot vessel's deck and fell into the gap between the two vessels.

Finnhawk was a Finland registered ro-ro cargo vessel that operated between Helsinki, Finland and Hull, England. The vessel's pilot ladder was inspected post-accident and found to be of an approved design, in good condition and correctly secured to the vessel. The pilot ladder's retrieval line had been rigged leading aft and attached just below the last spreader.

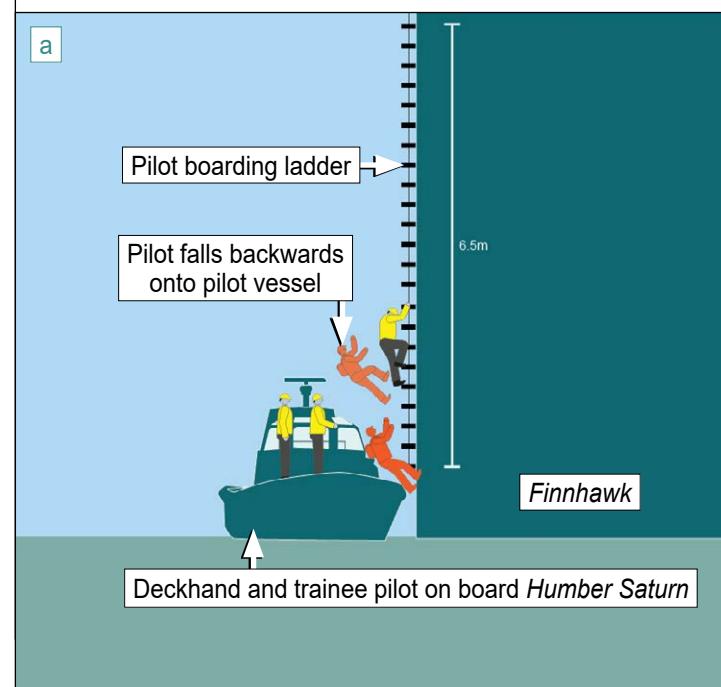
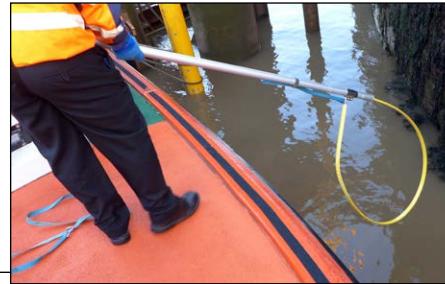
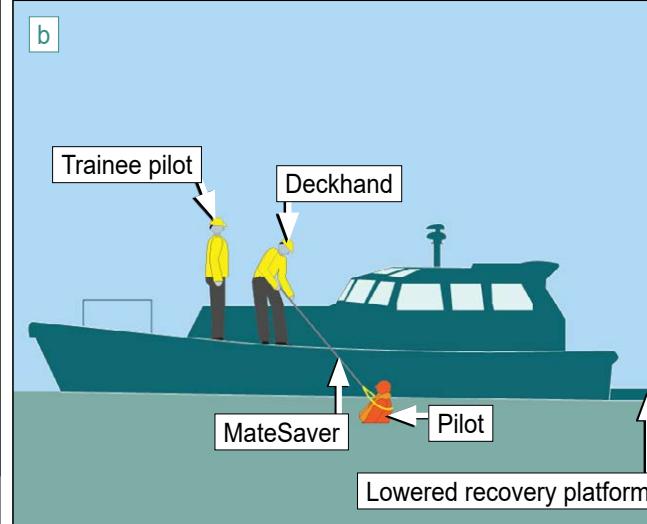
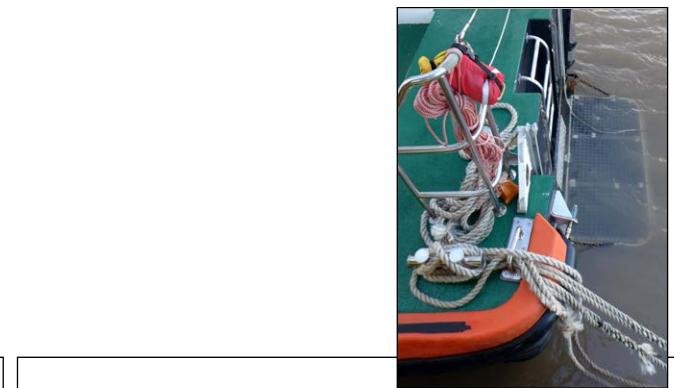
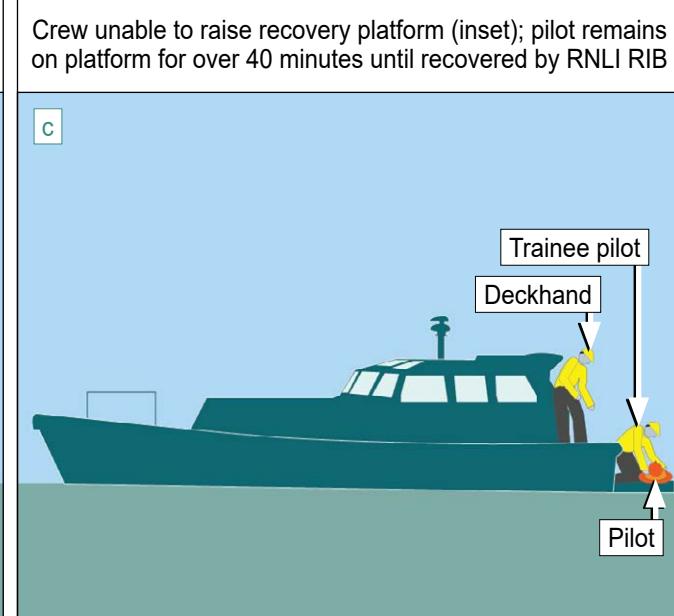
Figure 4: The pilot's fall and recovery to the pilot vessel

The pilot climbing *Finnhawk*'s pilot ladder before falling onto pilot vessel deck; his safety helmet breaks and comes off on impact

Coxswain stops pilot vessel near the pilot and deckhand manoeuvres him towards the stern recovery platform using the MateSaver MOB rescue pole (inset)

Humber Saturn's coxswain had to keep the pilot vessel moving ahead at slow speed as sea conditions were causing water to wash over the pilot on the lowered recovery platform. Seeing this, the trainee pilot jumped down onto the partially submerged recovery platform, lifted the pilot's head clear of the cold water and talked to him. The trainee pilot was occasionally chest-deep in water while supporting the pilot and was unable to determine whether the pilot was still breathing.

Humber Saturn's crew quickly manoeuvred the pilot vessel alongside the injured pilot and moved him onto the vessel's lowered recovery platform; however, a defect prevented them from being able to recover him to the main deck. The injured pilot consequently remained partially immersed in cold seawater for over 40 minutes on the lowered recovery platform, during which the crew were unable to assess his condition, carry out first aid, begin CPR or employ the pilot vessel's defibrillator. It is almost certain that the pilot's immersion in cold water and the delay in his recovery and first aid treatment significantly reduced his chance of survival.
