# Rail Accident Report

**Buffer stop collision at London Bridge station  
13 December 2024**

Report 09/2025  
v2 January 2026

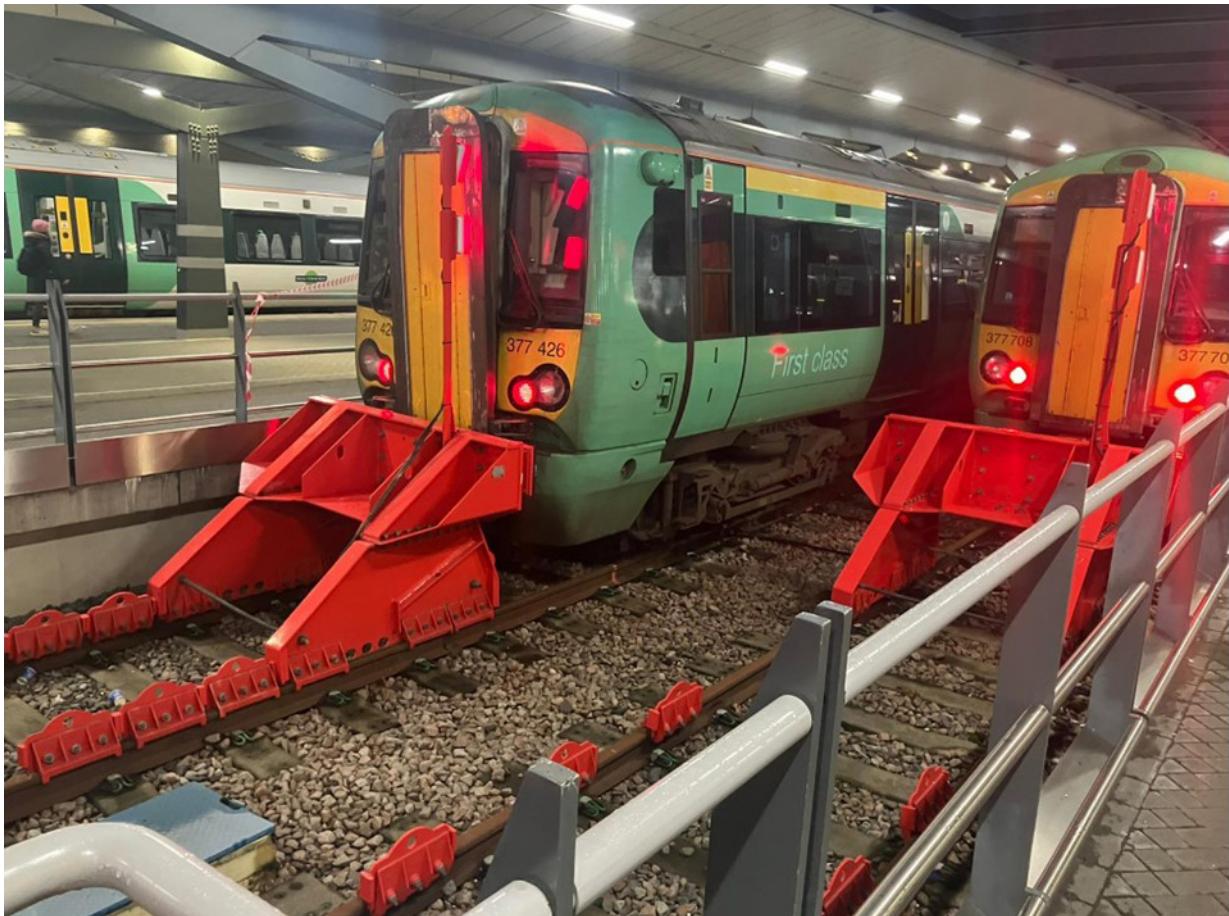
At around 15:45 on Friday 13 December 2024, a passenger train operated by Southern Railway struck the buffer stop on arrival in platform 12 at London Bridge station at a speed of around 5 mph (8 km/h). There were no reported injuries to the driver or to the passengers on the train and there was very minor damage caused to the train and railway infrastructure.

5 There was minor damage to the buffer stop and to the signalling equipment. Repairs were made and the platform reopened later the same day.

Figure 2: View of train 2F40 after it collided with the buffer stop at platform 12.

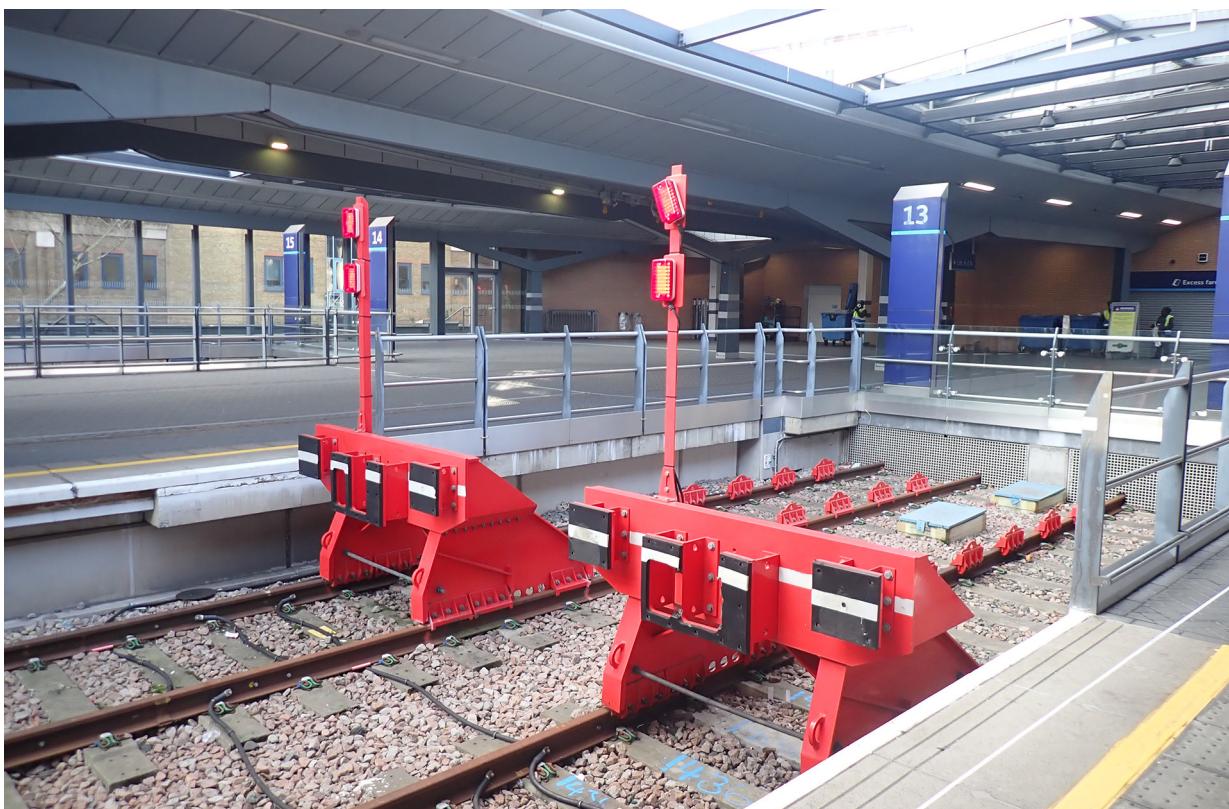
- 19 Platform 12 at London Bridge station is fitted with buffer stops of a sliding design, which absorb energy by moving along the rails when struck, slowed by friction blocks (figure 4).

Figure 4: On the right, in their normal position the buffer stops of platform 12 at London Bridge station (courtesy of Network Rail).

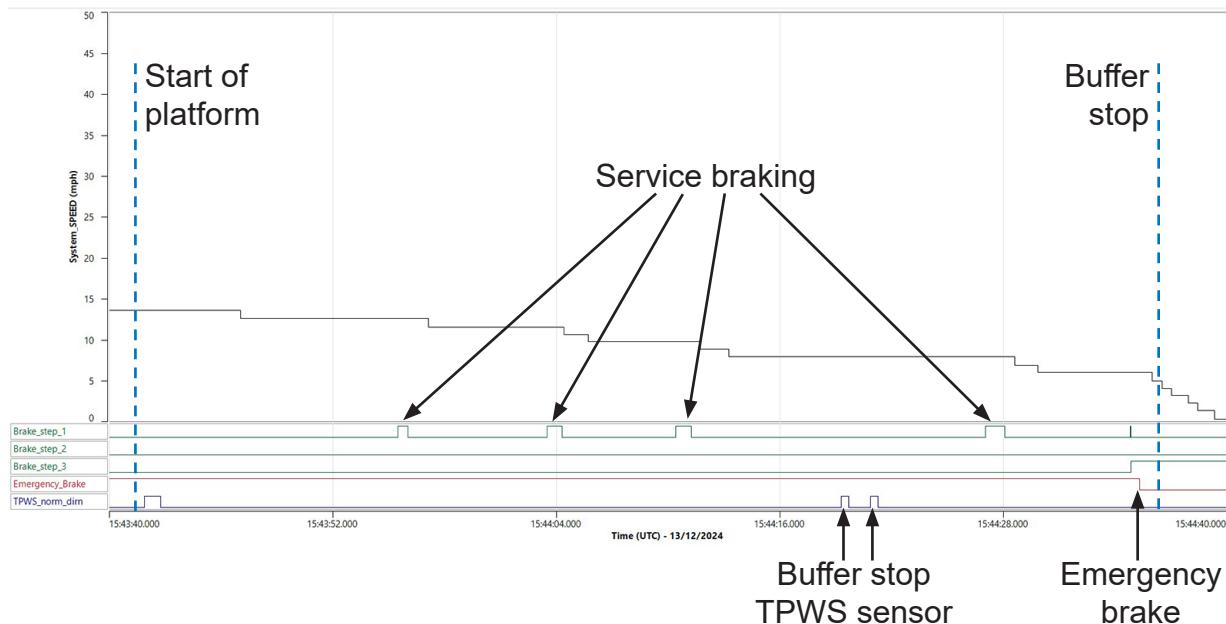
29 After focusing on controlling the train's speed for the buffer stop TPWS sensor, the driver did not remember anything further until they became aware that the train had hit the buffer stop. However, OTDR data shows that, after passing the TPWS sensor, the driver made several brake applications. At 15:44:24 they made a brake step 1 application for just over a second. At 15:44:32, about 1 second before the collision, there was a 0.1 second application of brake step 1, a 0.5 second application of full-service braking, followed by an emergency brake application. This remained applied until the train was stationary, after the collision (figure 5).

Figure 5: Train data showing driver control actions before the collision.

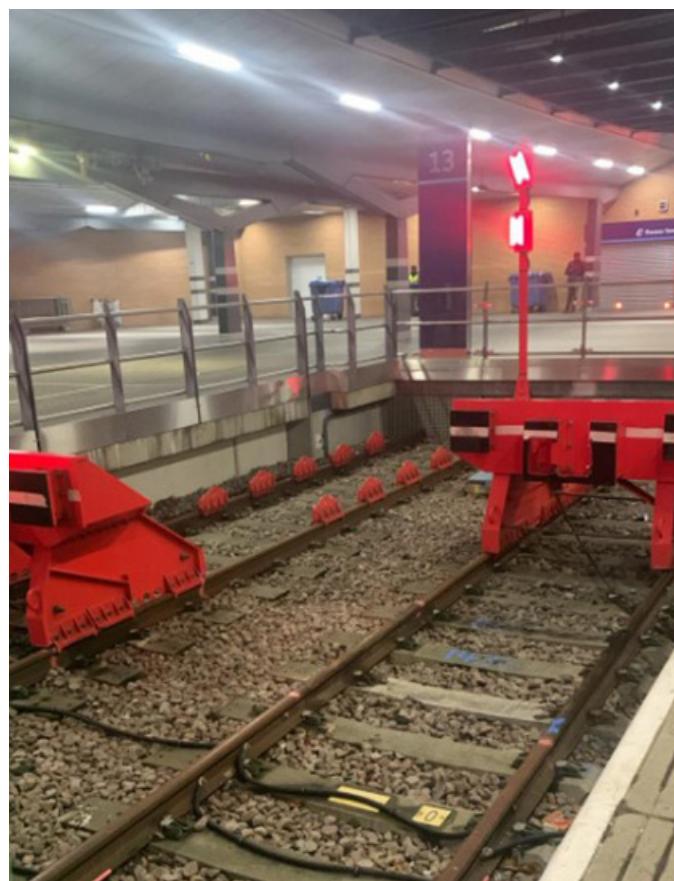
*Figure 6: Buffer stops at London bridge platform 12 after the collision.*

32 The train departed from the station at 20:45 and was taken to Selhurst depot for testing and examination. The platform was returned to service at 23:51.
