Report on the investigation of
the collision between the crude oil tanker ***Apache*** and
the stern trawler ***Serinah (GH 116)***
in the Firth of Clyde, Scotland
on 25 April 2024

Apache and Serinah

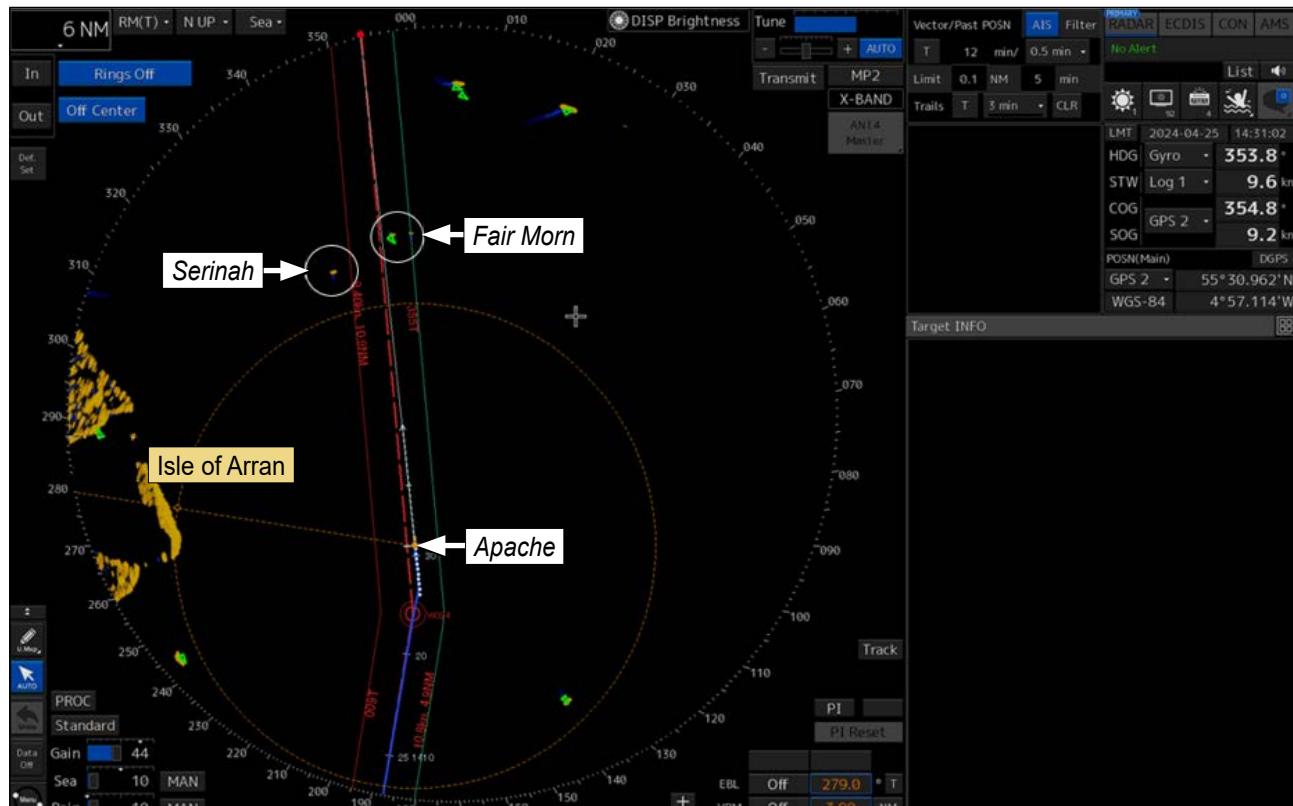
Figure 2: Apache's radar at 1431

Apache's X-band¹ radar was set to a range of 6 nautical miles (nm) with true trails selected. The vessel's S-band² radar was set to a 12nm range. The scale on Apache's Electronic Chart Display and Information System (ECDIS) corresponded to a range of 6nm. *Serinah* was visible on the radar at a distance of 4.4nm, fine on the port bow proceeding north on a parallel track to *Apache* (Figure 2). *Serinah* was visible to the bridge team on *Apache*. The fishing vessel *Fair Morn* was tracking to the south-east.

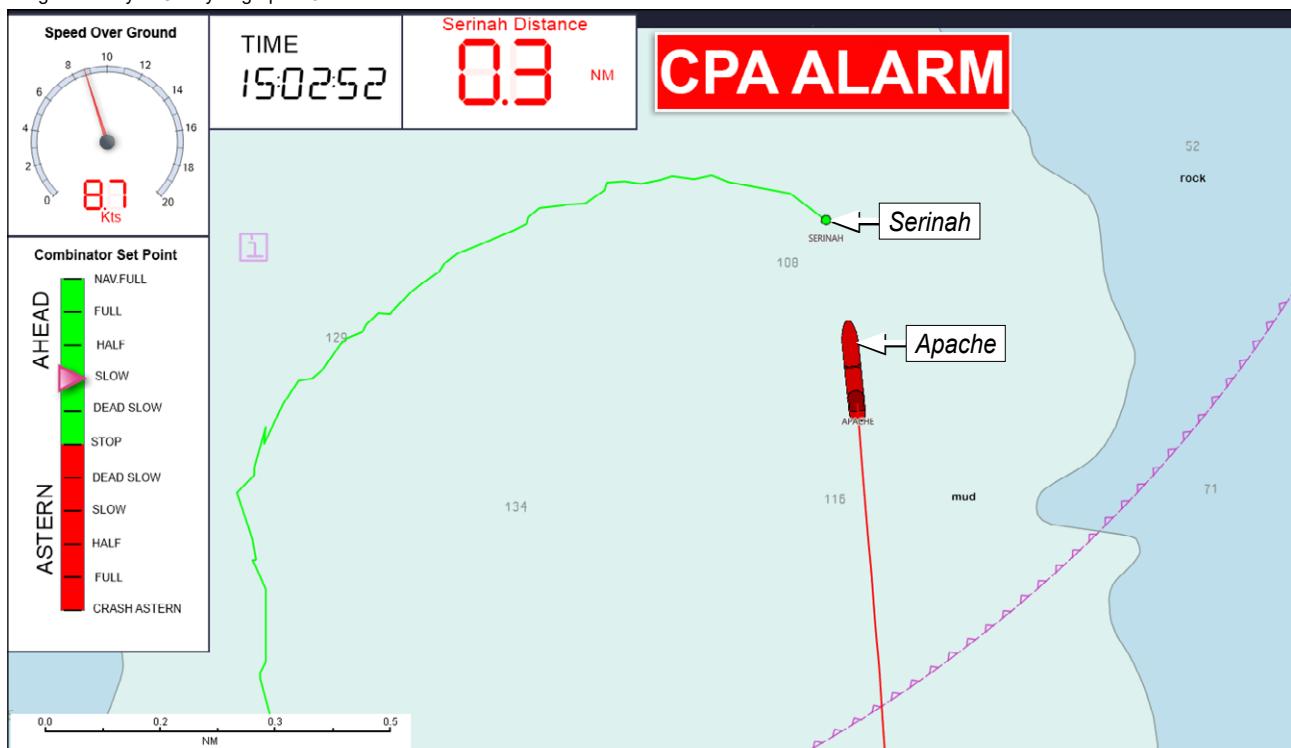
Figure 3: Positions of *Apache* and *Serinah* at 1502:52

By 1501, the two vessels were 0.6nm apart on a steady bearing with a risk of collision. At 1502:52 *Apache*'s 2/O acquired *Serinah* as a target on the radar (**Figure 3**). The closest point of approach (CPA) alarm immediately sounded, showing a CPA of 0.3nm with a time to closest point of approach (TCPA) of 1.49 minutes. After consulting with the master the 2/O sounded one long blast on *Apache*'s forward whistle. *Serinah* then disappeared from view under the bow of *Apache*, as the two vessels were about 100m apart.

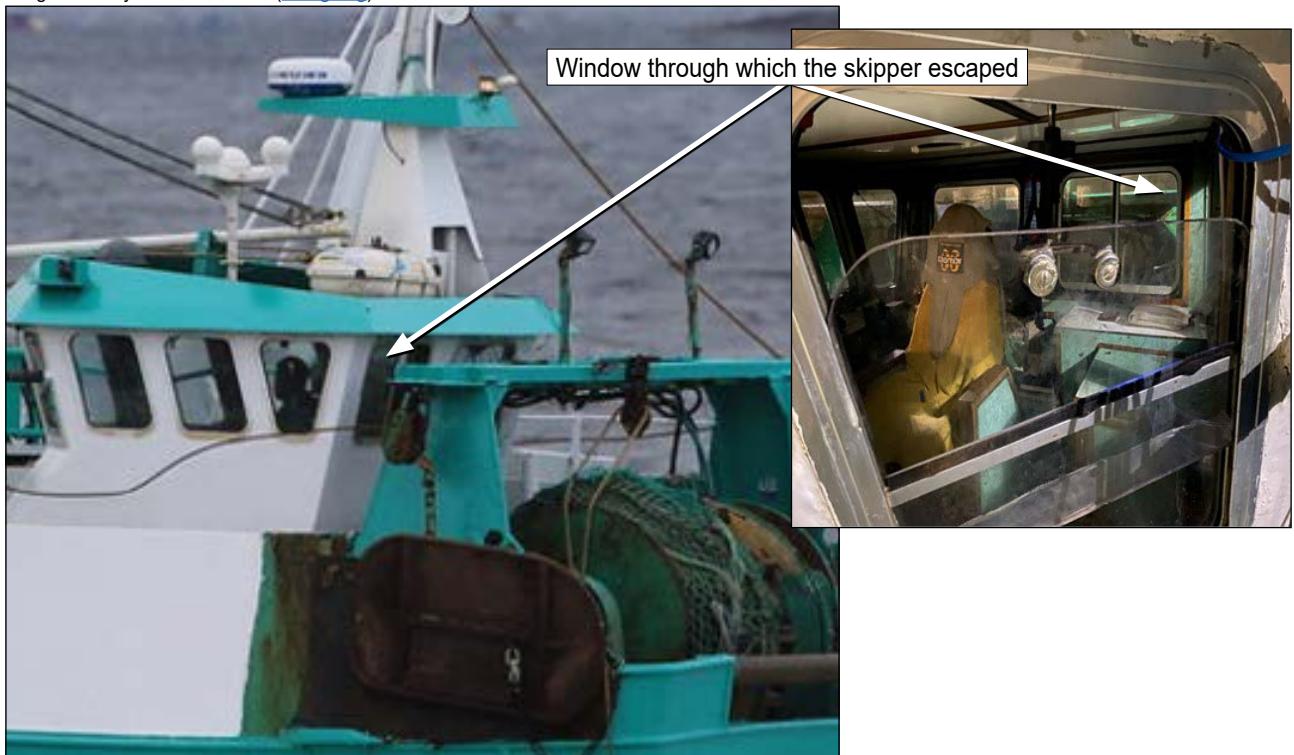
Figure 4: Aft windows in *Serinah*'s wheelhouse

Serinah's hull penetration was pushed underwater and the vessel started to flood. *Serinah*'s skipper was still in the wheelhouse and, seeing that the egress route through the accommodation was flooded, grabbed a personal flotation device (PFD) and climbed out of the wheelhouse through an aft window (**Figure 4**).

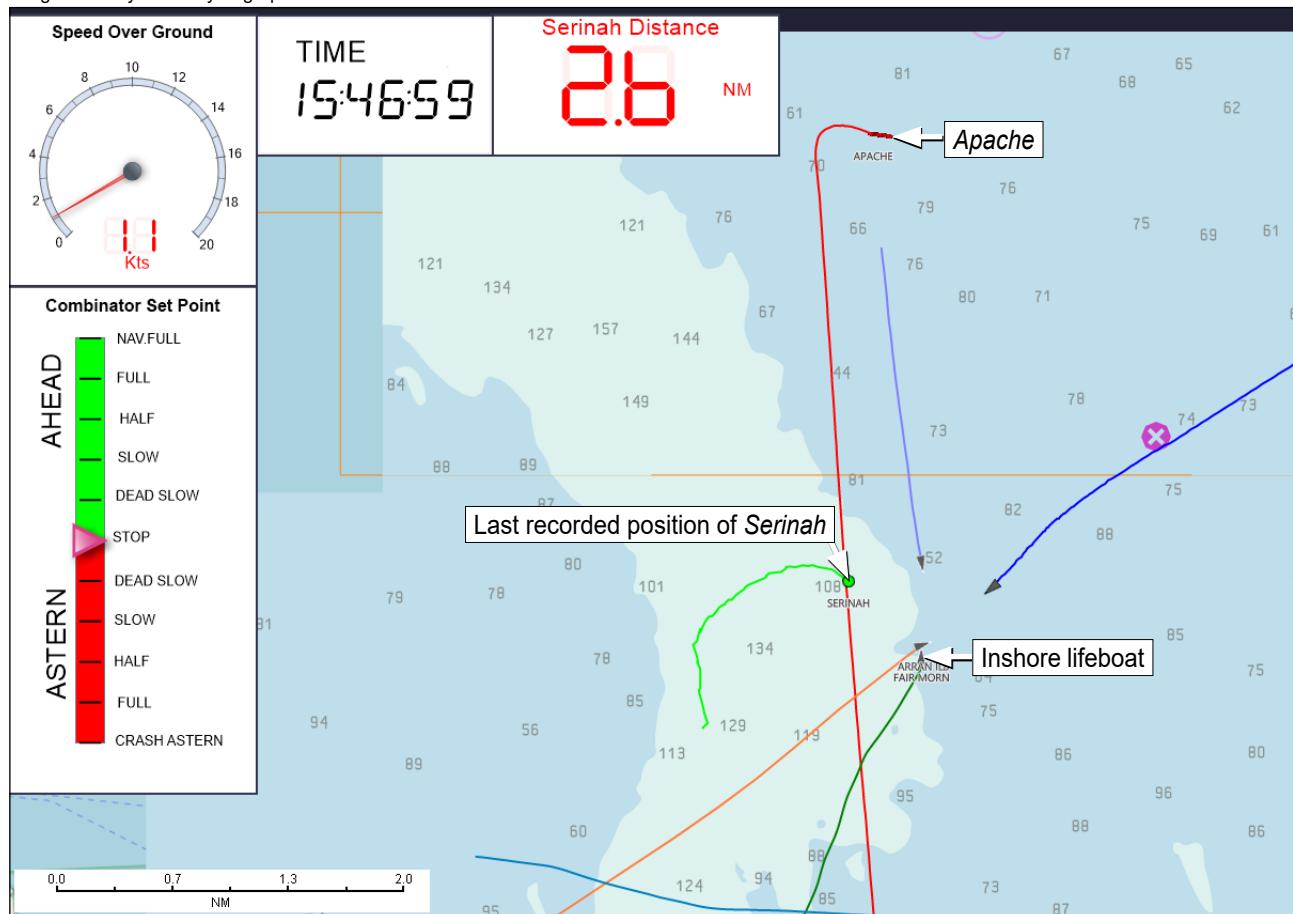
Figure 5: Positions of *Apache* and rescue vessels at 1546:59

At 1526, HMCG tasked the RNLI inshore lifeboat (ILB) based at Lamlash, Isle of Arran to assist. By 1530, *Apache* had launched its rescue boat and the craft headed south towards the liferaft, which had drifted about 0.8nm east from the collision site. At 1547, the ILB was the first vessel to reach the liferaft (**Figure 5**). All of *Serinah*'s crew boarded the Lamlash ILB, and were then transferred onto the Troon ALB to be taken to Troon harbour. After a medical assessment, and having tested negative for alcohol with Police Scotland, *Serinah*'s crew went home.

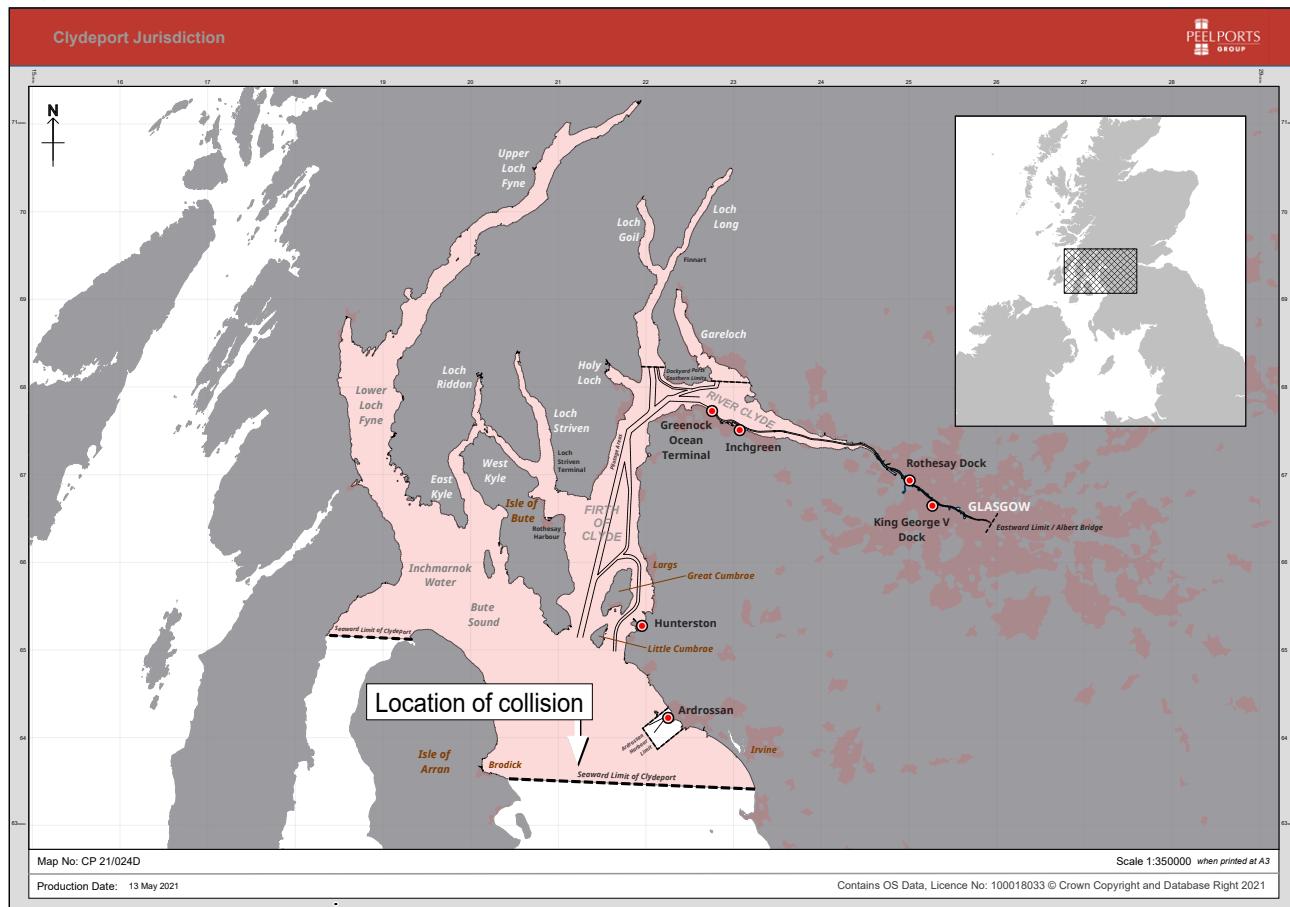
Figure 6: Clydeport Local Port Services jurisdiction area

Clydeport included about 50% of the Firth of Clyde and was managed with an LPS. The collision occurred inside the Clydeport LPS area (**Figure 6**).
