## Accident

| <b>Aircraft Type and Registration:</b> | Sonaca 200, G-LKDM | |
| <b>Date &amp; Time (UTC):</b> | 6 August 2025 at 1537 hrs | |
| <b>Location:</b> | Blackbushe Airport, Surrey | |

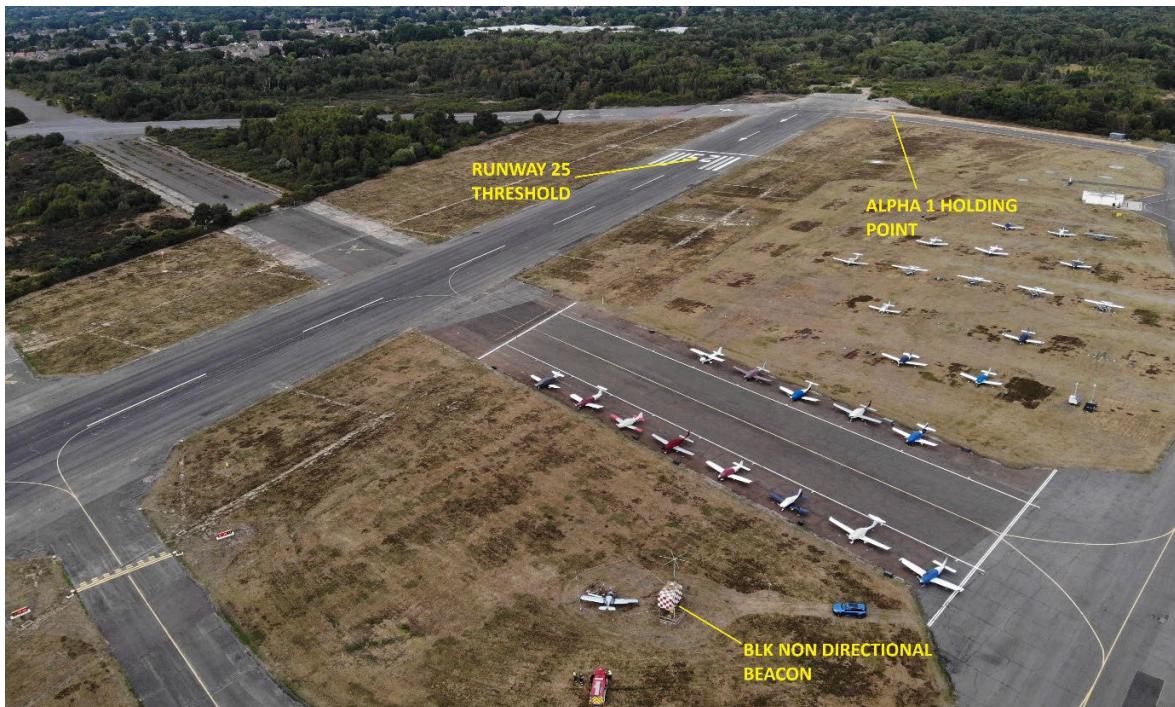
**Figure 2**  
Overview of accident site

The aircraft struck an antenna adjacent to the BLK Non-Directional Beacon (NDB) and came to rest approximately opposite to the intended departure direction (Figure 2).
