Accident

Aircraft Type and Registration:	Replica Percival Mew Gull, G-HEKL	
No & Type of Engines:	1 De Havilland Gipsy Queen I piston engine	
Year of Manufacture:	2013 (Serial no: PFA 013-14759)	
Date & Time (UTC):	18 April 2025 at 1400 hrs	
Location:	1 mile north-west of Great Massingham Airfield, Norfolk	
Type of Flight:	Private	
Persons on Board:	Crew - 1	Passengers - None
Injuries:	Crew - None	Passengers - N/A
Nature of Damage:	Damage to engine, cowling and landing gear, propeller strike	
Commander's Licence:	Private Pilot's Licence	
Commander's Age:	71 years	
Commander's Flying Experience:	2,681 hours (of which 397 were on type) Last 90 days - 27 hours Last 28 days - 15 hours	
Information Source:	Aircraft Accident Report Form submitted by the pilot plus further enquiries by AAIB

Synopsis

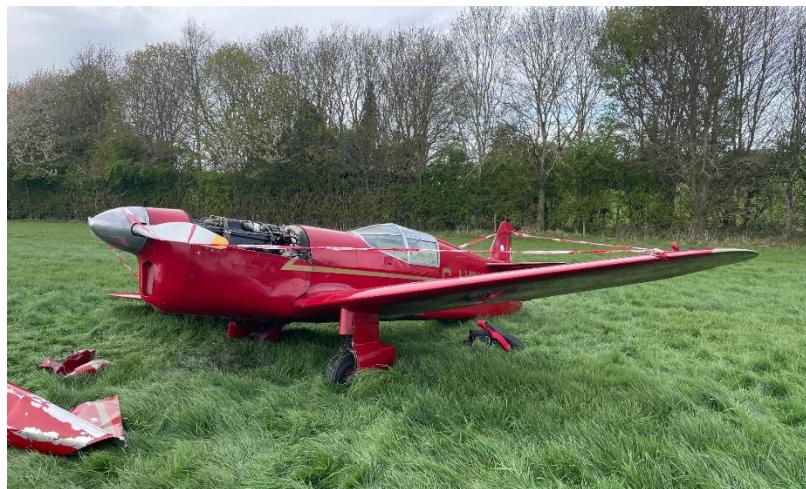
The aircraft came to rest in a field approximately 1 mile north-west of Great Massingham Airfield, sustaining significant structural damage following landing (Figure 1).

Figure 1
G-HEKL post-landing
