Accident

Aircraft Type and Registration:	Robinson R66, G-WBRN	
No & Type of Engines:	1 Rolls-Royce 250-C300/A1 turboshaft engine	
Year of Manufacture:	2023 (Serial no: 1223)	
Date & Time (UTC):	11 June 2025 at 0714 hrs	
Location:	Chalfont St Peter, Buckinghamshire	
Type of Flight:	Private	
Persons on Board:	Crew - 1	Passengers - None
Injuries:	Crew - None	Passengers - N/A
Nature of Damage:	Significant damage to empennage and rotor blade	
Commander's Licence:	Private Pilot's Licence	
Commander's Age:	64 years	
Commander's Flying Experience:	1,020 hours (of which 380 were on type) Last 90 days - 33 hours Last 28 days - 16 hours	
Information Source:	Aircraft Accident Report Form submitted by the pilot

Synopsis

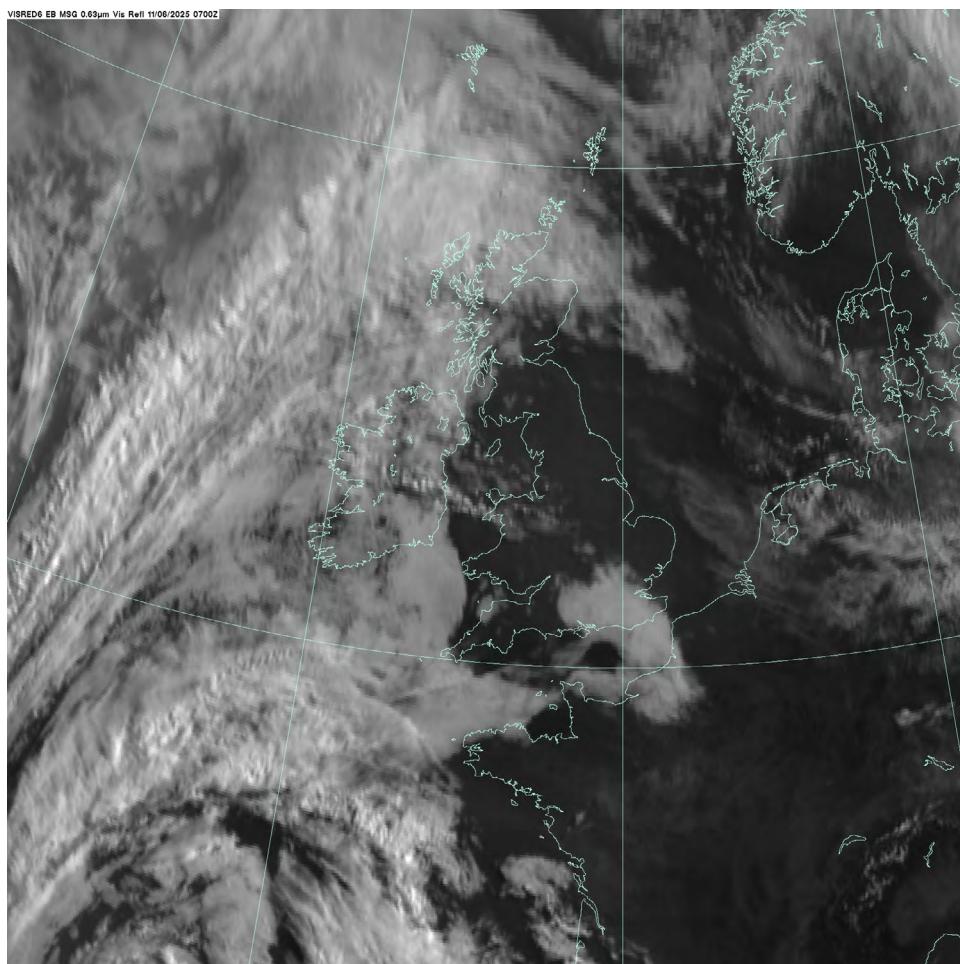
Figure 1
Visible satellite imagery valid 0700 hrs 11 June 2025

The weather in the UK was settled, with an area of high pressure covering the country giving good visibility and a light south-easterly wind. In the morning this gave rise to extensive low cloud in the south (Figure 1). This was forecast to gradually lift during the morning and break by midday.

The pilot believed from his ground observation that conditions had improved. A check of actual observations from aerodromes in the locality would indicate this was not the case, with both Heathrow Airport and RAF Northolt reporting extensive low cloud.

Denham Airfield is at an elevation of 215 ft amsl, which is higher than Northolt (126 ft amsl) and Heathrow (83 ft amsl). Northolt was reporting broken cloud between 500 and 800 ft agl, indicating that the cloud base in the locality of Denham was likely to be between 400 and 700 ft agl.

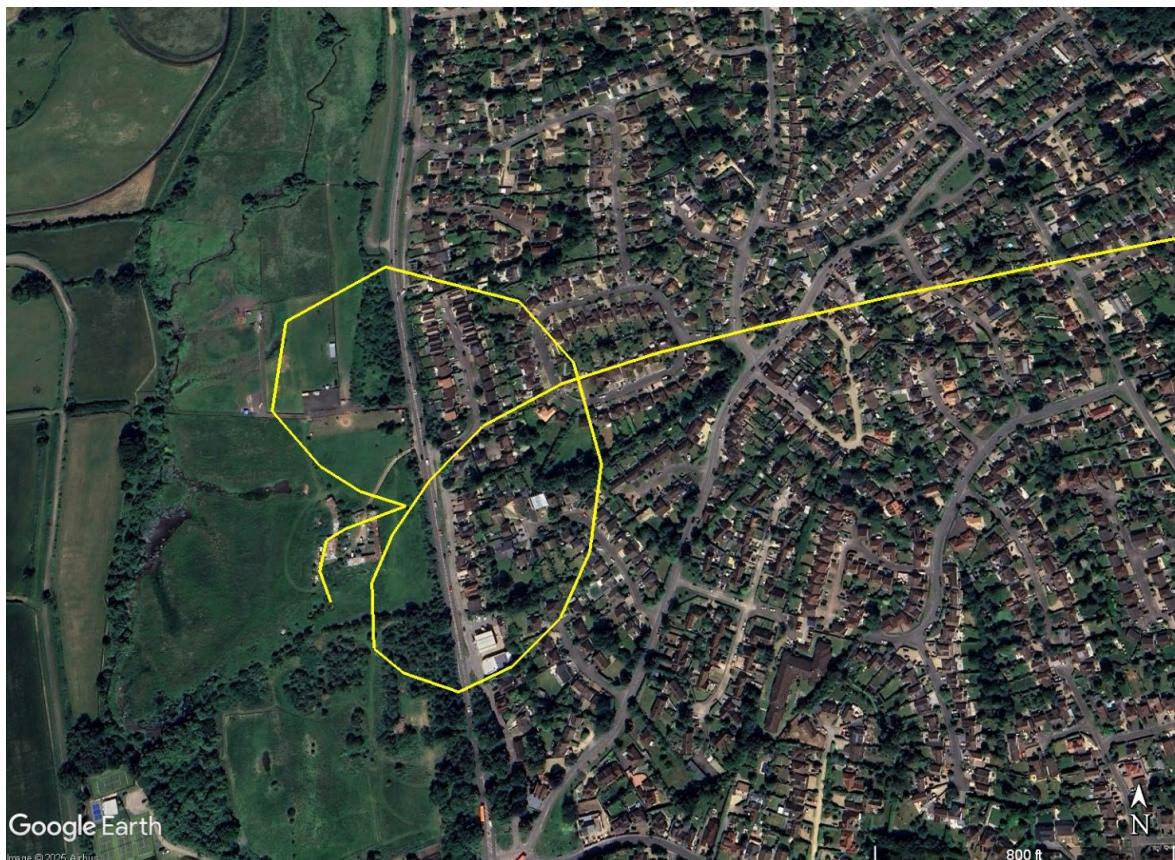
Figure 2
ADS-B flightpath data from FlightAware

The helicopter was now in a descending left turn with an increasing rate of descent (Figure 2). The pilot had intermittent sight of the ground, broke cloud at a low height, and arrived in a “disorganised state” over some fields next to a paddock with outbuildings. He decided to make a precautionary landing.

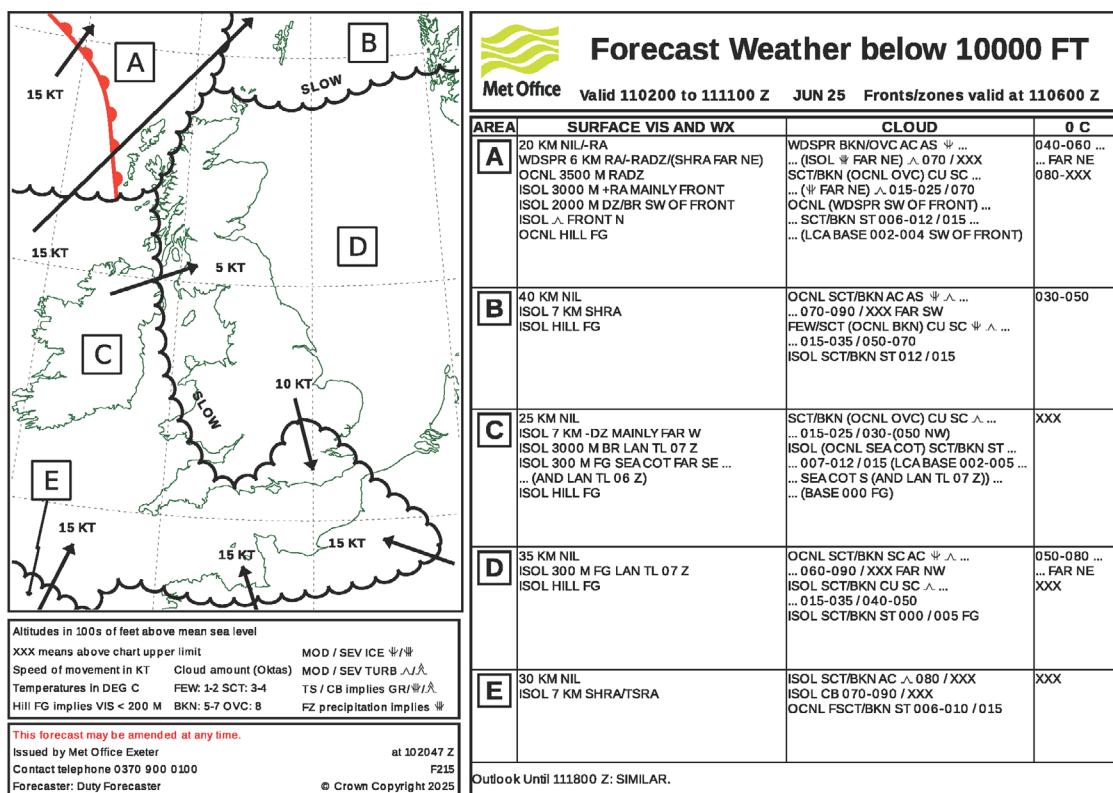
**Figure 3**

The flight was planned to be conducted within Area C and D of the Metform 215 (F215) Low Level Significant Weather Chart (Figure 3). The F215 chart covers a wide area and conveys the most likely meteorological conditions for the period. Guidance states that it is good practice to consult with observations along the route to obtain the fullest picture.

The high pressure system sitting over the UK was giving rise to areas of low cloud around the departure airfield which was due to lift and break. At the time of departure London Heathrow Airport (Heathrow), which is 10 nm from Denham, was reporting conditions as overcast cloud between 400 and 500 ft agl. RAF Northolt, only 3.5 nm from Denham, was reporting broken cloud between 500 and 800 ft agl.
