## Accident

<b>Aircraft Type and Registration:</b>	Robinson R66, G-WBRN	
<b>No &amp; Type of Engines:</b>	1 Rolls-Royce 250-C300/A1 turboshaft engine	
<b>Year of Manufacture:</b>	2023 (Serial no: 1223)	
<b>Date &amp; Time (UTC):</b>	11 June 2025 at 0714 hrs	
<b>Location:</b>	Chalfont St Peter, Buckinghamshire	
<b>Type of Flight:</b>	Private	
<b>Persons on Board:</b>	Crew - 1	Passengers - None
<b>Injuries:</b>	Crew - None	Passengers - N/A
<b>Nature of Damage:</b>	Significant damage to empennage and rotor blade	
<b>Commander's Licence:</b>	Private Pilot's Licence	
<b>Commander's Age:</b>	64 years	
<b>Commander's Flying Experience:</b>	1,020 hours (of which 380 were on type) Last 90 days - 33 hours Last 28 days - 16 hours	
<b>Information Source:</b>	Aircraft Accident Report Form submitted by the pilot

## Synopsis

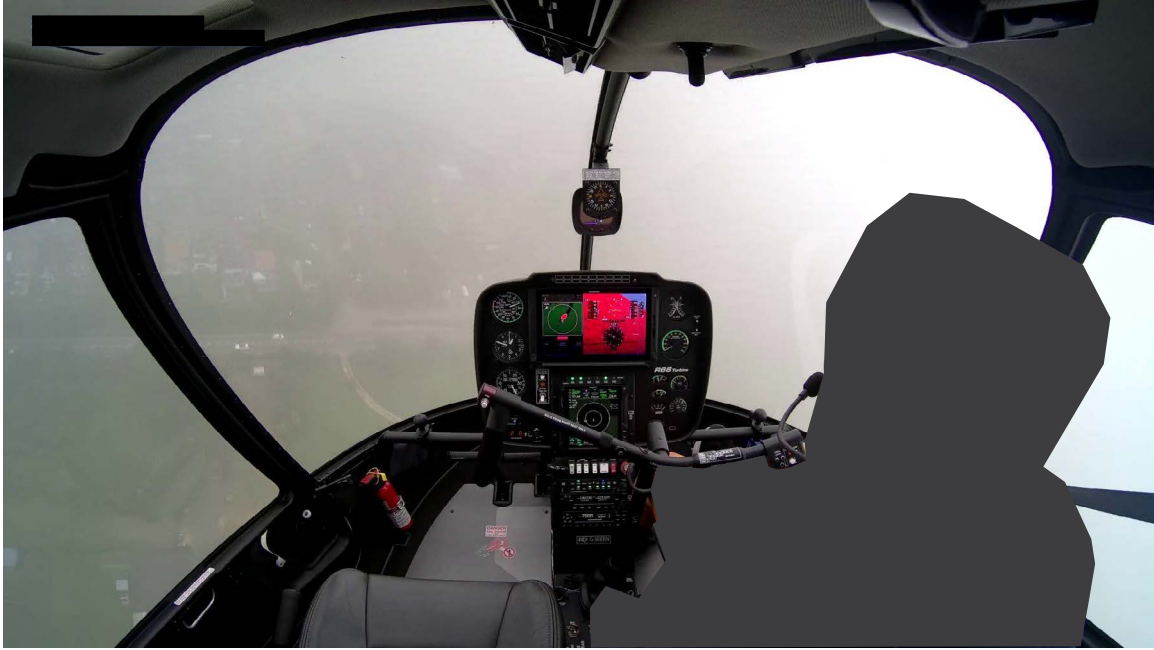
**Figure 2**

The helicopter pitched to 15° nose-up, climbed 250 ft, to approximately 1,450 amsl, and slowly banked left to 35° angle of bank (AOB). The nose then dropped below the horizon, and the helicopter entered a descending left turn. With a 25° nose-down attitude and 50° left AOB the pilot attempted to re-engage the autopilot, selecting SAS, HDG and ALT modes. Approximately five seconds later, the helicopter emerged from the base of the cloud at approximately 600 ft agl with a 2,000 ft/min rate of descent and an audio warning: "WARNING TERRAIN TERRAIN" (Figure 2).

Terrain warning

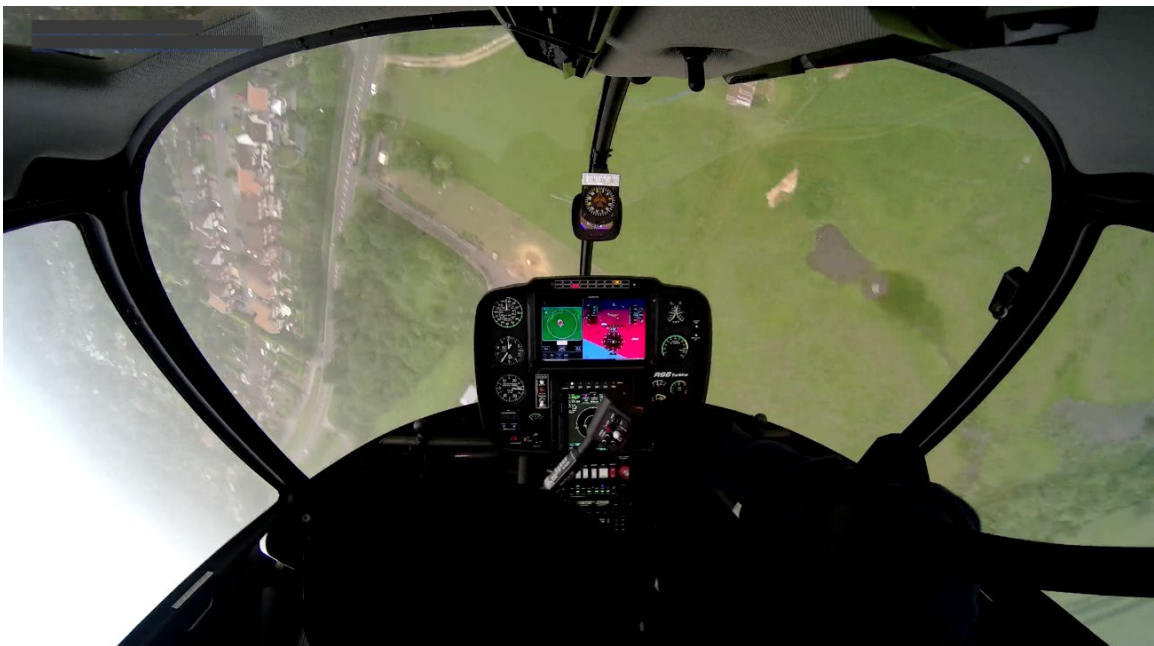
**Figure 3**

The pilot rolled level and pulled up, the HDG and ALT modes disengaged leaving the SAS mode light green, and the helicopter entered cloud again, pitching to 60° nose-up. The pilot pressed the SAS button again, which disengaged the autopilot system. The helicopter rolled right to approximately 170° AOB, the nose dropped rapidly, and the helicopter emerged from the base of the cloud near inverted at approximately 450 ft agl with 3,000 ft/min rate of descent (Figure 3).

Emerging from base of cloud nearly inverted

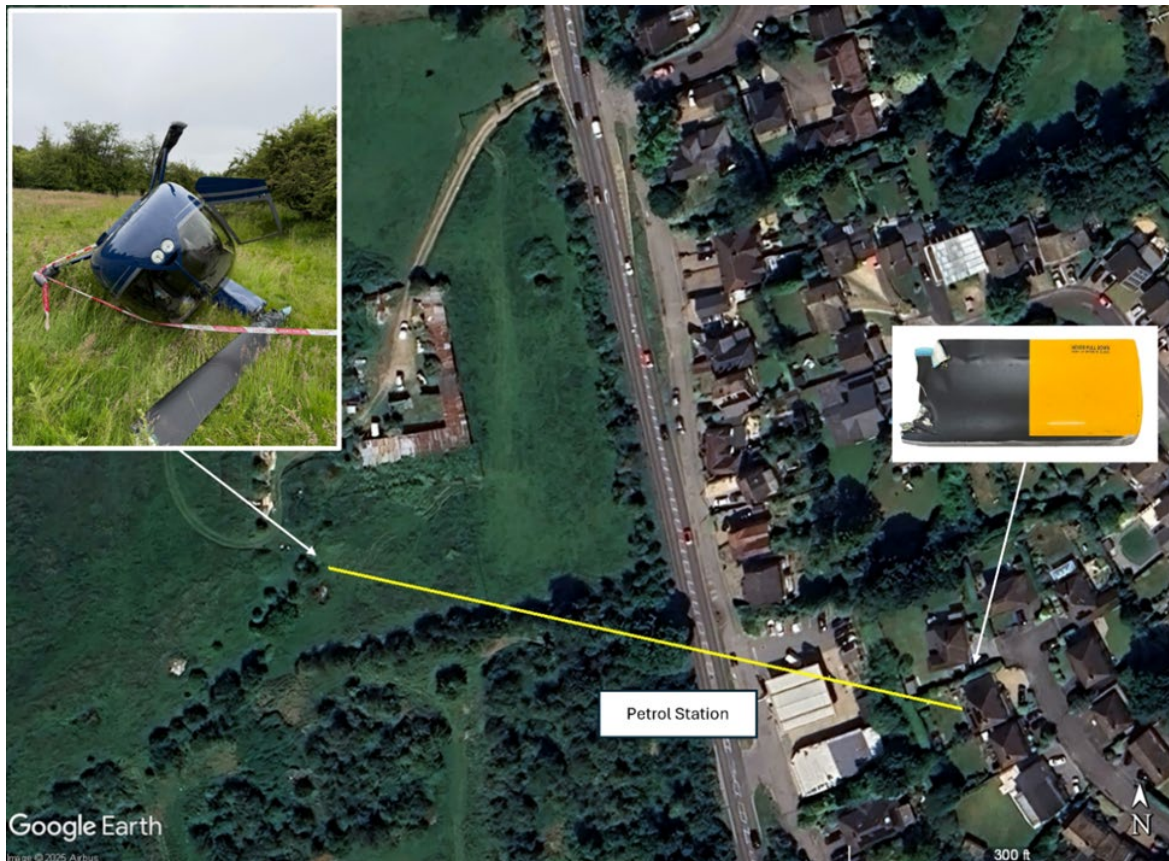
**Figure 5**

The main rotor blade struck the ground with high energy, chopping off the tail rotor and propelling a 70 cm section of blade tip, weighing 4.5 kg, nearly 180 m over a main road and a petrol station canopy and into a wisteria attached to the wall of a house (Figure 5). There was no damage caused to the house.

Trajectory of detached blade tip

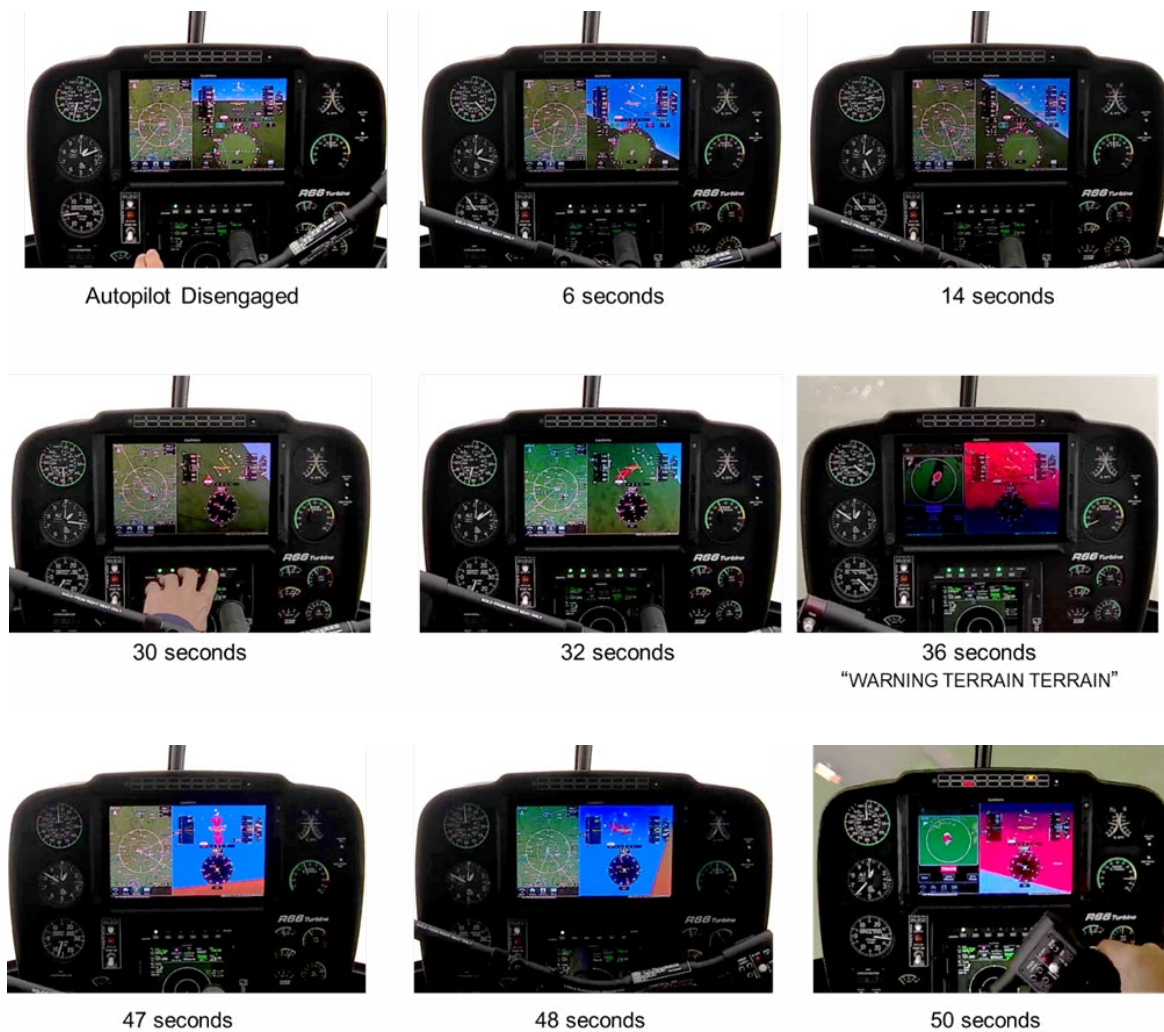
**Figure 6**

Figure 6 shows a sequence of images of the instrument panel during the loss of control.

Loss of control: sequence of events
