Serious Incident

Aircraft Type and Registration:	Velos V3	
No & Type of Engines:	2 Velos Rotors 6145N2 Brushless Motors	
Year of Manufacture:	2024 (Serial no: GBR-OP-C2Q99JT6BCAX)	
Date & Time (UTC):	17 March 2025 at 1709 hrs	
Location:	Onllwyn, Neath Port Talbot	
Type of Flight:	Training	
Persons on Board:	Crew - None	Passengers - None
Injuries:	Crew - None	Passengers - N/A
Nature of Damage:	Aircraft destroyed due to post-impact fire	
Commander's Licence:	Other	
Commander's Age:	44 years	
Commander's Flying Experience:	149 hours (of which 40 were on type) Last 90 days - 24 hours Last 28 days - 23 hours	
Information Source:	Aircraft Accident Report Form submitted by the pilot and further enquiries

Synopsis

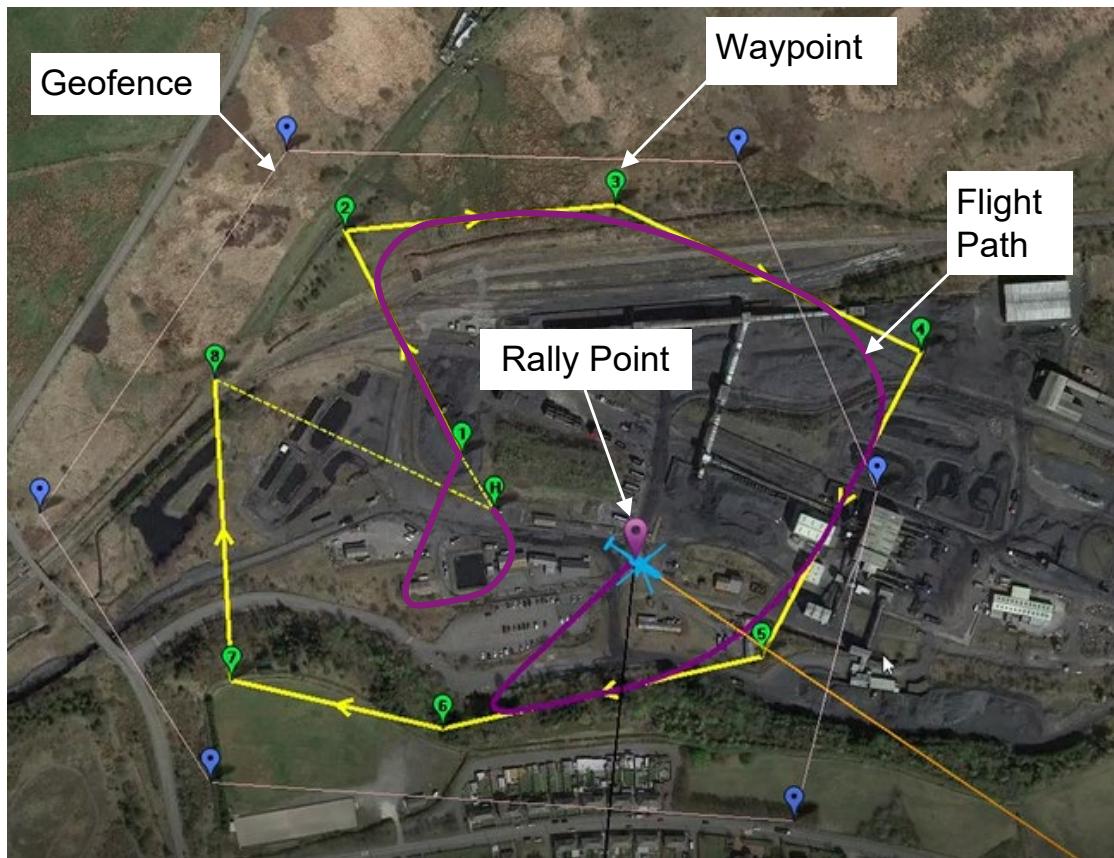
Figure 1
Mission flight overview

The mission for the flight was planned with eight waypoints, overlaid with a geofence that intersected between waypoints 4 and 5. The aim of the mission was to test the UA's response to breaching the geofence and was the first flight with a new ADS-B Mode S transponder fitted.

The UA took off and flew to waypoints 1 and 2. Between waypoints 2 and 3, there were two RADIO FAILSAFE errors, which cleared automatically, and the flight continued. The UA proceeded to waypoints 3, 4 and 5, breaching the geofence (Figure 1).

Shortly before reaching waypoint 6, another RADIO FAILSAFE error was displayed and cleared. The flight mode changed to RTL and the UA headed towards the pre-programmed 'Rally Point'.

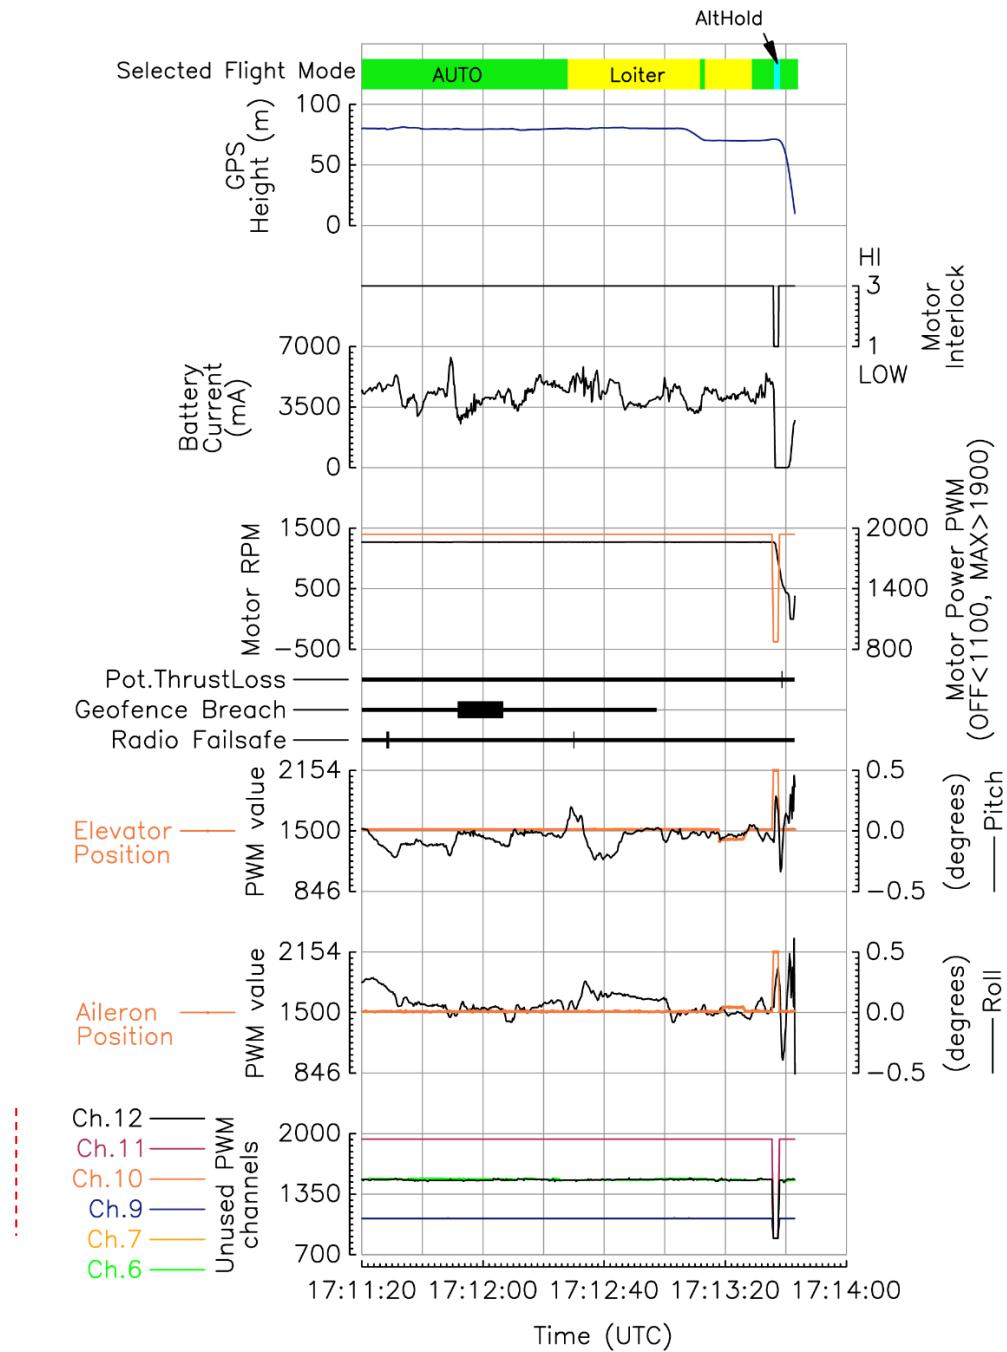
Figure 2
UAS accident flight data

Flight and control data from the accident flight was recovered from the CU, and is summarised in Figure 2.

The Motor Interlock remained at 'high' throughout the flight and the flight modes changed in line with expected pilot and autopilot commands (the second radio failsafe event triggered a change from AUTO to LOITER by the autopilot, displayed as RTL on the CU).

At 17:13:37 hrs the flight mode was changed from AUTO to ALT HOLD without input from the pilot. At the same time, Motor Interlock switched to LOW with an associated drop in Motor Power and the Motor RPM decayed. Battery current was briefly recorded as zero. 10 out of 12 data channels recorded values outside of the range that can be specified by the CU, including several channels not in use (Table 1). Channels 3 (collective) and 4 (yaw) were not affected.

Multiple data channels between the CU and the aircraft were affected at the same time, which exceeded the normal control parameters commanded by the CU. This resulted in the aircraft being unable to sustain flight.

Testing showed that if a loss of connectivity between the radio modem and the flight computer occurred, the last known values would have been held until connectivity was restored. As changes of input value occurred, and the effects were not consistent across all channels, it is likely that the aircraft's systems experienced a level of interference rather than a full loss of connectivity.

The aircraft had not suffered from system communication issues prior to the installation and use of the transponder. In the absence of being able to test the aircraft post-accident, it is likely that this was the source of interference.

The operator has taken the following actions for future flight operations:

- The remaining aircraft to be used in the trial will be re-fitted with a different transponder at 20 W output, capable of using either using the 978 or 1090 MHz bands.
- The command-and-control link hardware has been changed to provide a transponder/communications combination with proven capability tested by the equipment manufacturer.
