Report on the investigation of
a serious injury to a passenger on the sea safari rigid
inflatable boat

Lundy Explorer

at Ilfracombe, England

on 7 June 2023

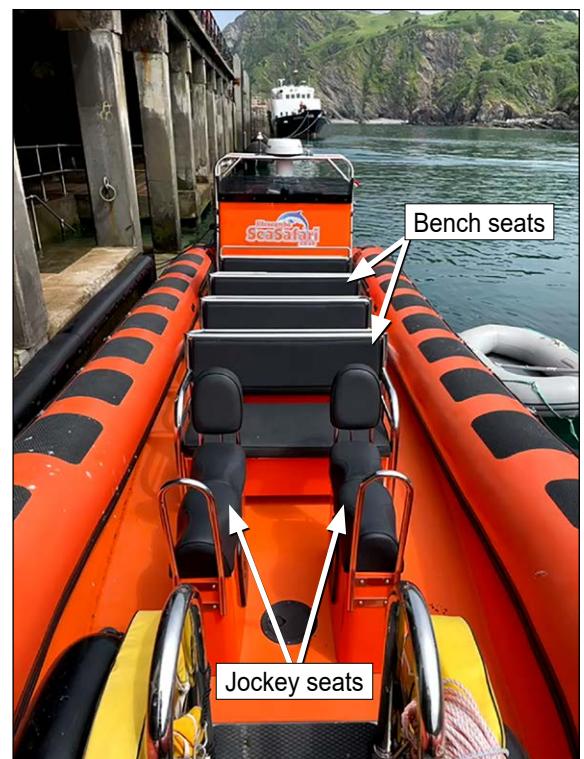
Figure 2: *Lundy Explorer* seating arrangement

The passengers went forward and sat together on the port jockey seat. The deckhand advised that they could each sit on a jockey seat so one passenger sat on the port side and the other on the starboard side (**Figure 2**). The remaining passengers sat on the bench seats.

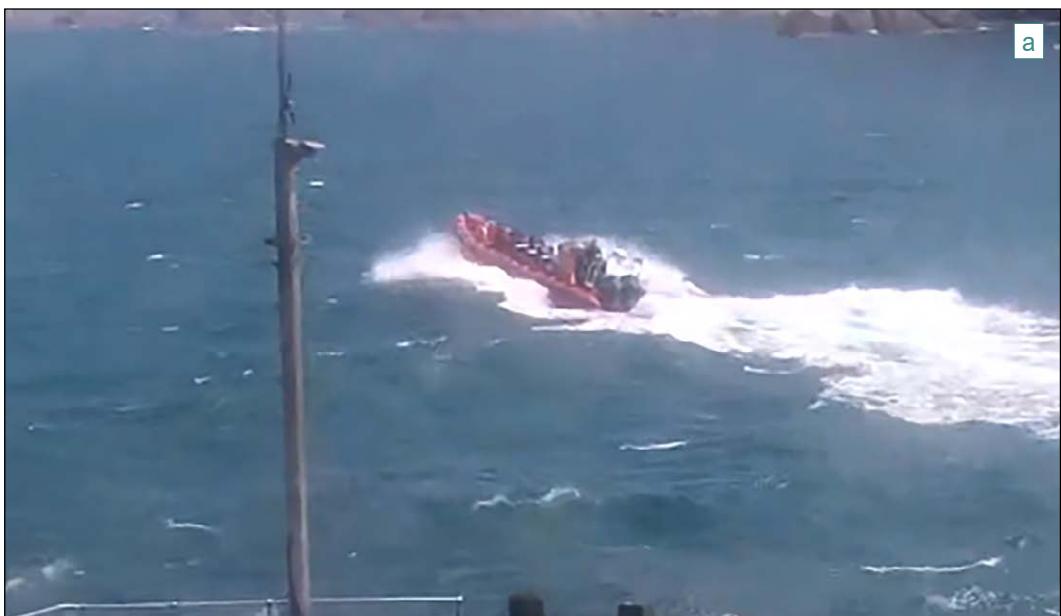
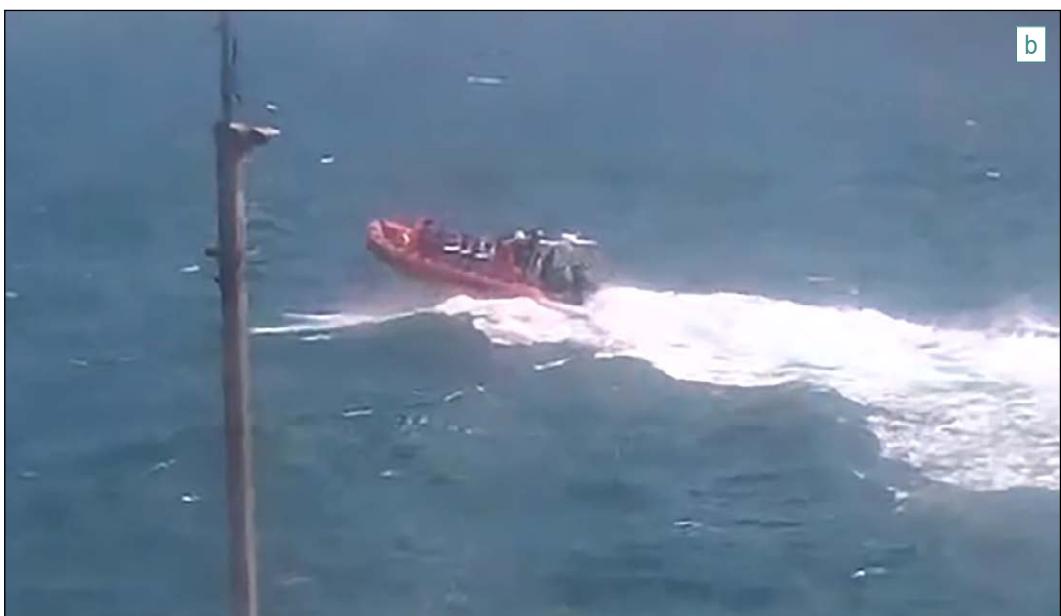
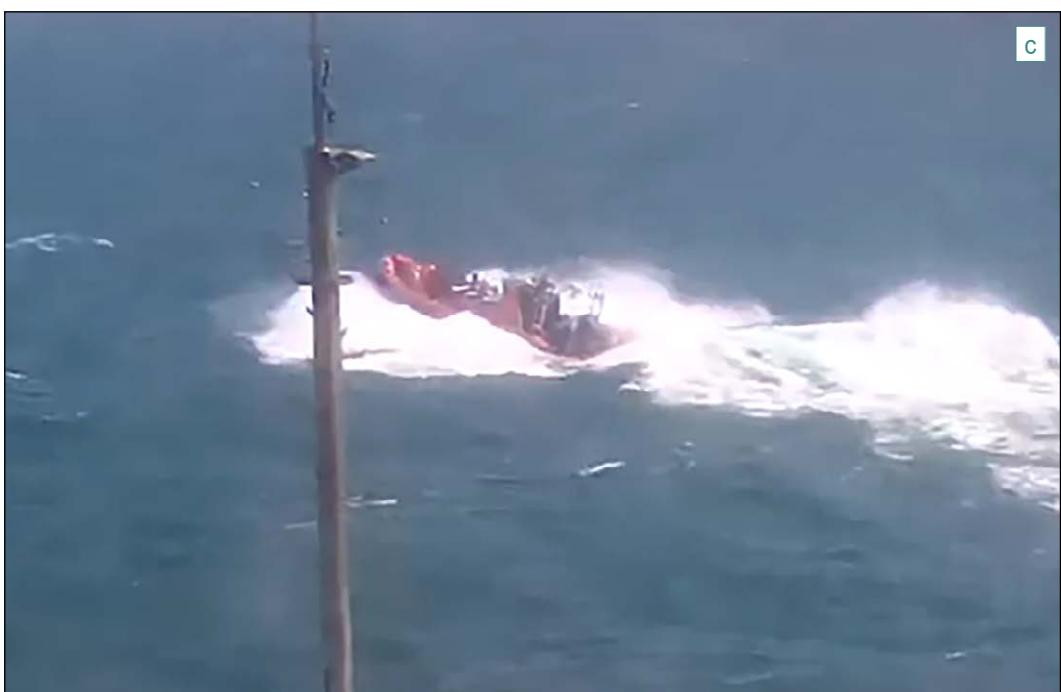
Figure 4: *Lundy Explorer* pitching as it heads out from the harbour

As *Lundy Explorer* rounded the pier to head into open water, the RIB pitched moderately (**Figure 4**); the skipper considered this to be normal and expected the RIB's movement to ease once it was clear of the harbour. The passengers, some of whom had been on previous trips, were initially unconcerned and considered the movement to be typical in the conditions.

Lundy Explorer's trip began as normal, and the skipper navigated the sea conditions after rounding the pier. The closed-circuit television images (see **Figure 4**) indicated *Lundy Explorer* was not planing and initially handled the wave heights without significant issue. However, the interaction of the easterly winds with the headland meant the conditions to the north of the harbour entrance were probably worse than

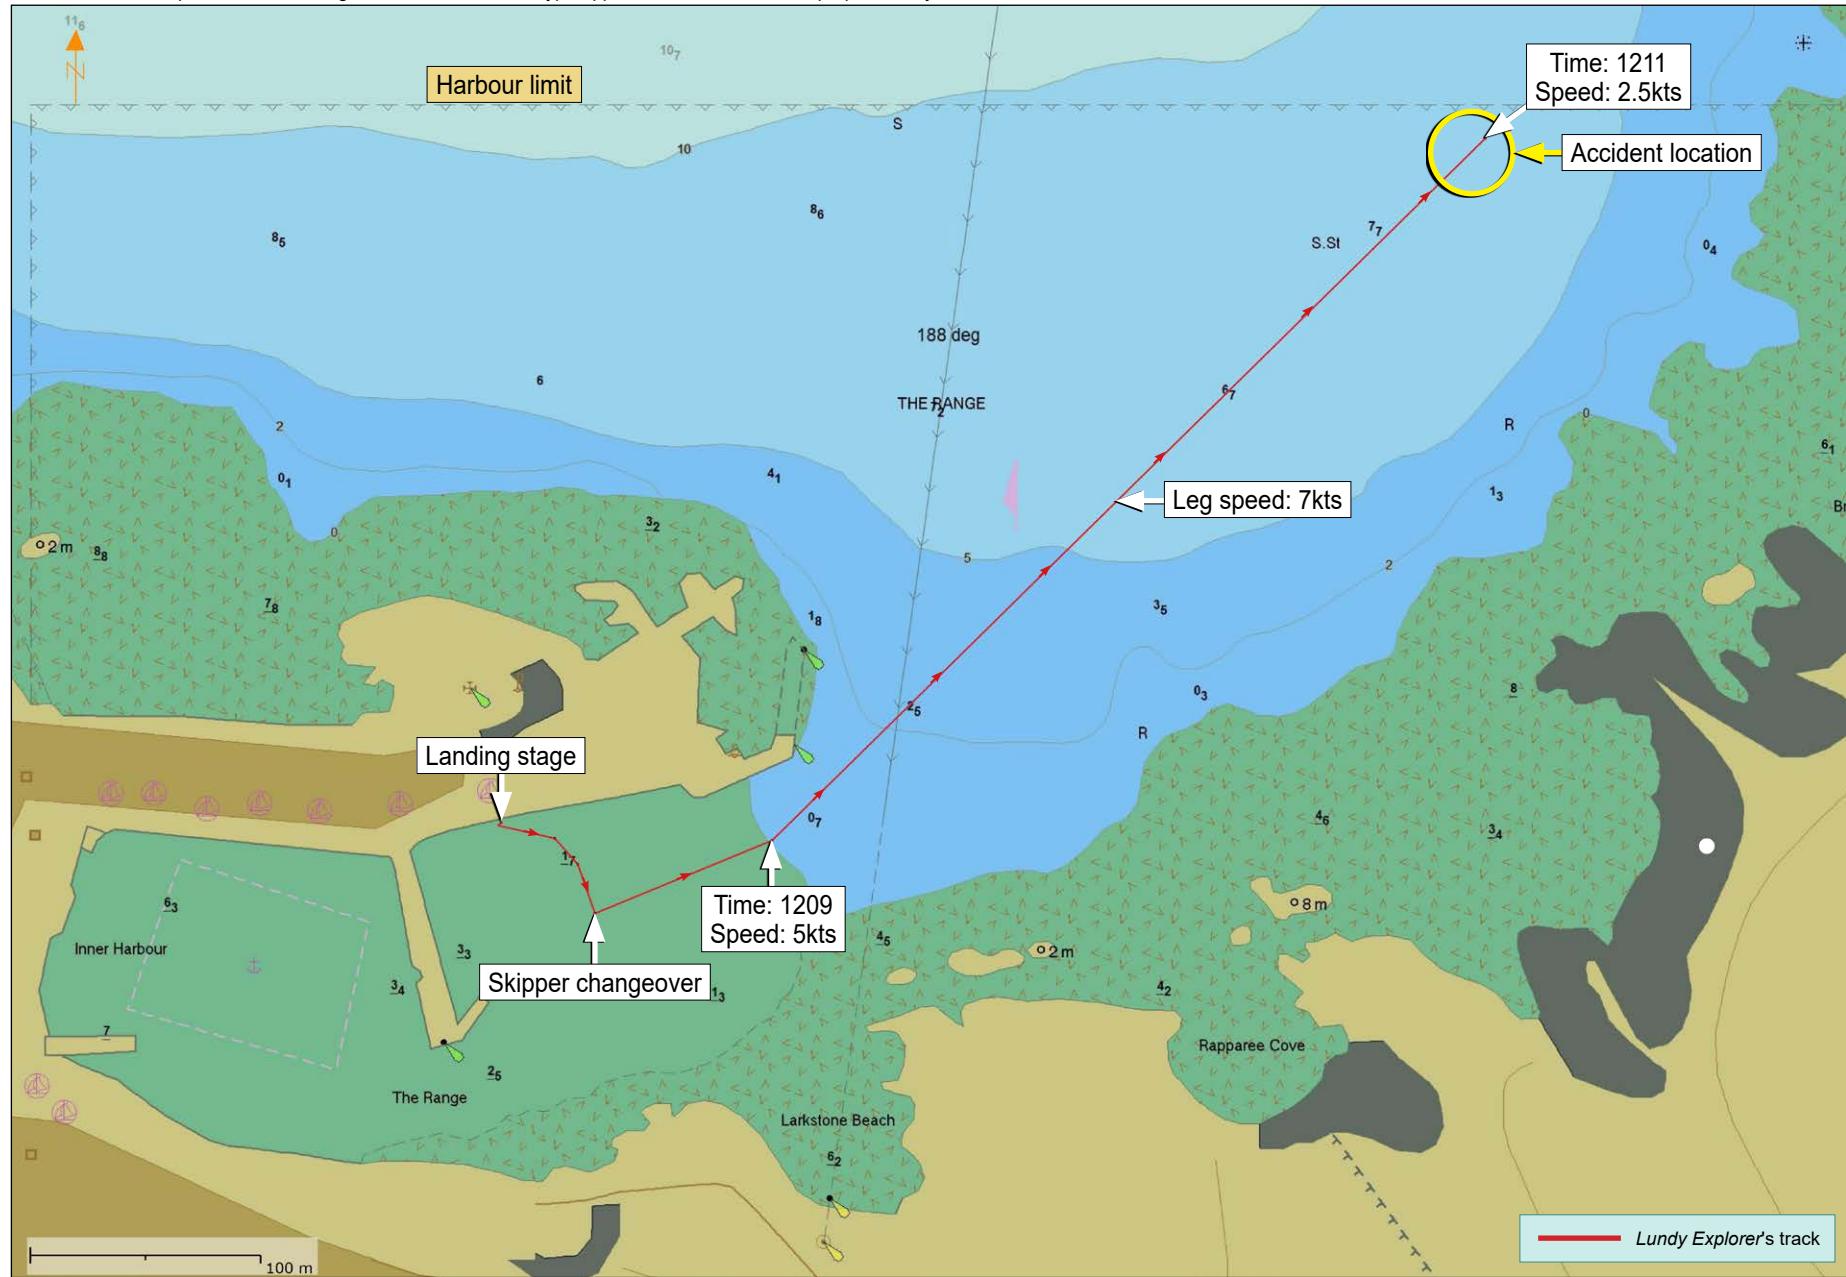
Figure 5: Lundy Explorer's position and general track rounding the pier to the accident location

At about 1211, *Lundy Explorer* encountered two high waves while still below planing speed¹. The skipper had been easing the engine's throttles as the bow reached a wave crest, then increasing the throttle as it descended. After a third high wave the bow landed on the water with force, bringing the RIB to a sudden stop. All the passengers were thrown forward and the passenger on the port side jockey seat fell off to the port side. The passenger on the starboard jockey seat struck their face heavily on the handhold in front of them. On the front bench seat, the passenger on the port side was badly jarred and winded and the passenger in the middle was shocked.

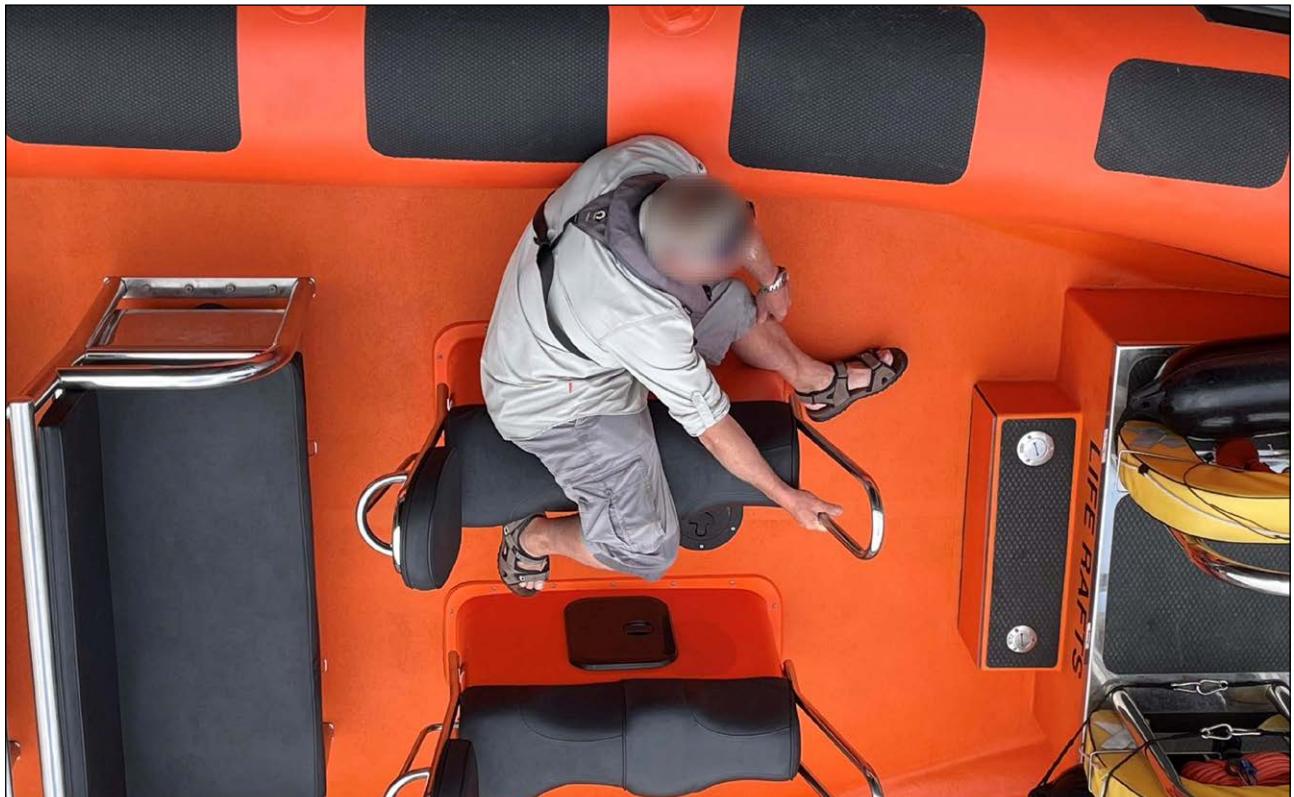
Figure 6: Reconstruction of the casualty's position after falling from the jockey seat

Two passengers immediately raised their arms to notify the skipper that there was a problem. A passenger on the aft bench seat shouted to the skipper that someone had fallen off. The dislodged passenger was wedged between the jockey seat pedestal and the RIB's sponson, in a twisted position with her right leg over the seat (**Figure 6**). The deckhand attended to the dislodged passenger, who said that she could not feel her legs. The deckhand was concerned that the casualty's position was unsafe and moved her right leg from the seat. The deckhand then attended to the two injured passengers on the bench seat.

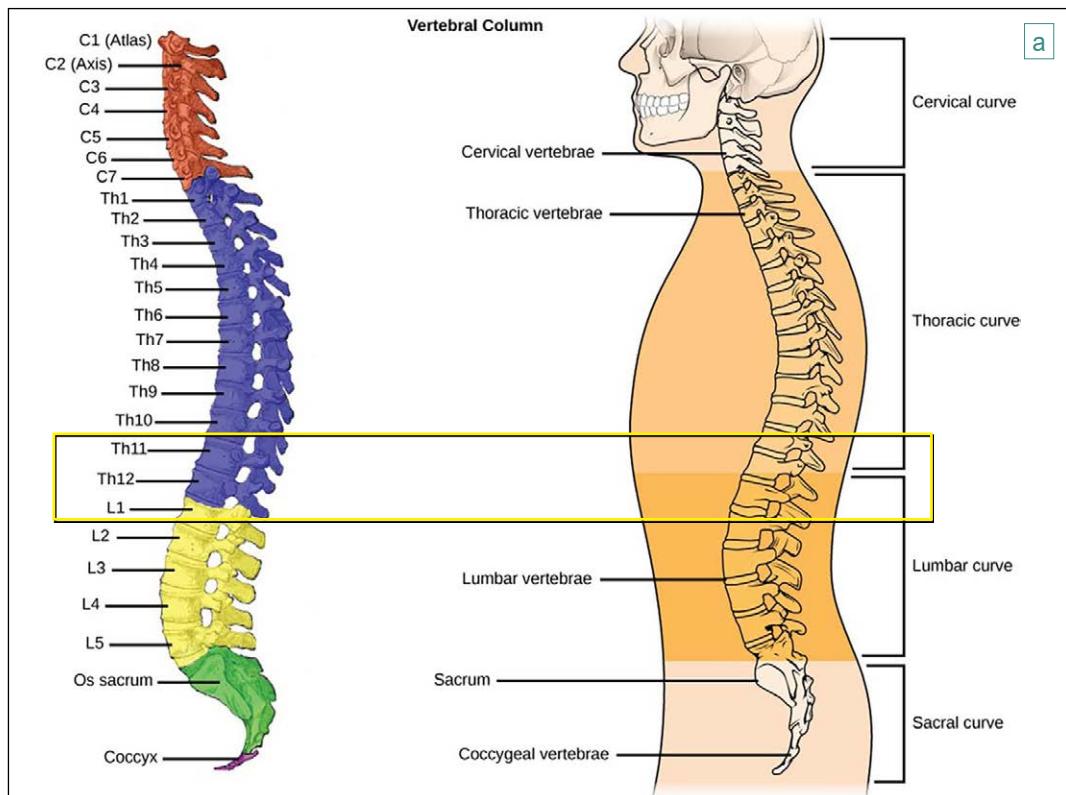
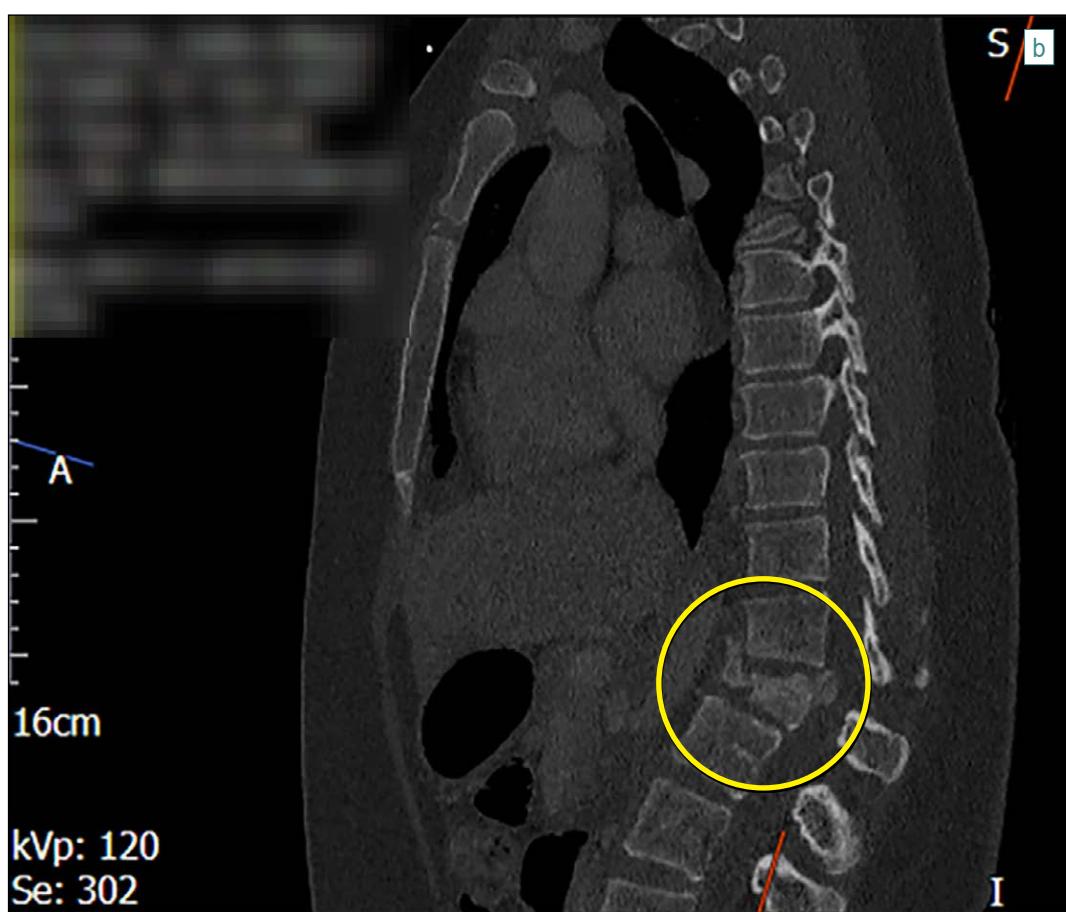
Figure 7: Location of T12 vertebra (a) and X-ray of the injury (b)

The casualty was a 28-year-old female in good health who was 1.72m tall and weighed 90kg. She sustained a wedge compression fracture to the T12 vertebra (**Figure 7**) and damage to her spinal cord, resulting in paralysis below the fracture. She had no pre-existing conditions, including osteoporosis, that would have

contributed to the injury. The injury was permanent. The hospital's consultant neurosurgeon advised that the injury was caused at the moment of impact and no additional damage due to post-accident movement was evident.

The injured passenger had no pre-existing health conditions that would have made her more vulnerable to an injury. It is likely that her displacement from the seat caused the large forces experienced to become misaligned with her spine and resulted in a shearing force, as described in the High Speed Craft Human Factors Engineering Design Guide. The shearing force resulted in a fracture of the T12 vertebra, damage to the spinal cord and permanent paralysis.

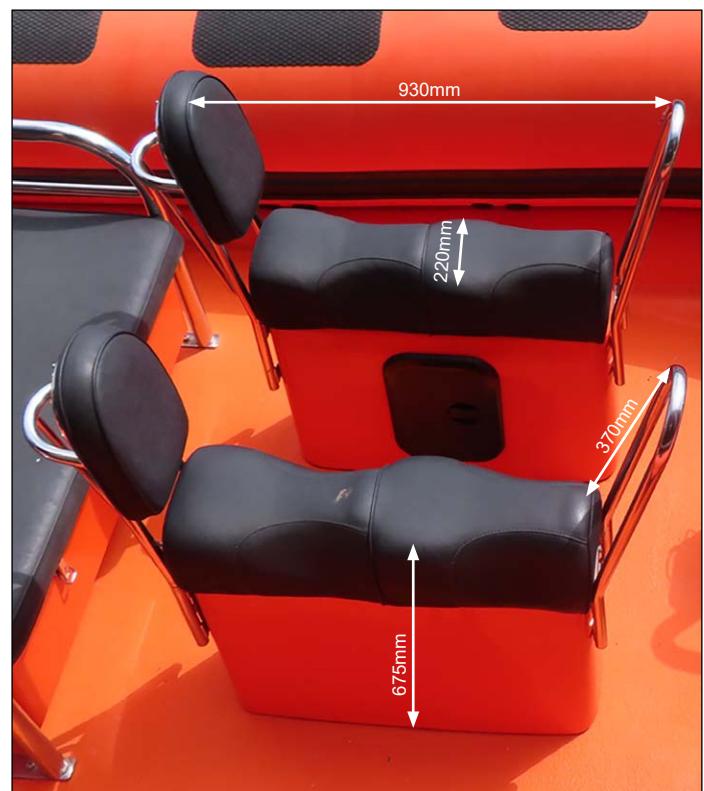
Figure 9: Jockey seat dimensions

Lundy Explorer's passenger seating arrangement comprised four rows of bench seats accommodating three passengers each and two twin occupancy jockey seats. The seats were cushioned with vinyl-covered generic foam. Not all of the 16 available seats needed to be occupied. The jockey seats had shallow moulded contours to indicate the seated positions for two people. There was a cushioned backrest for the rearmost passenger and an extended vertical handhold constructed from stainless steel tube with a round profile for the forwardmost passenger (**Figure 9**).

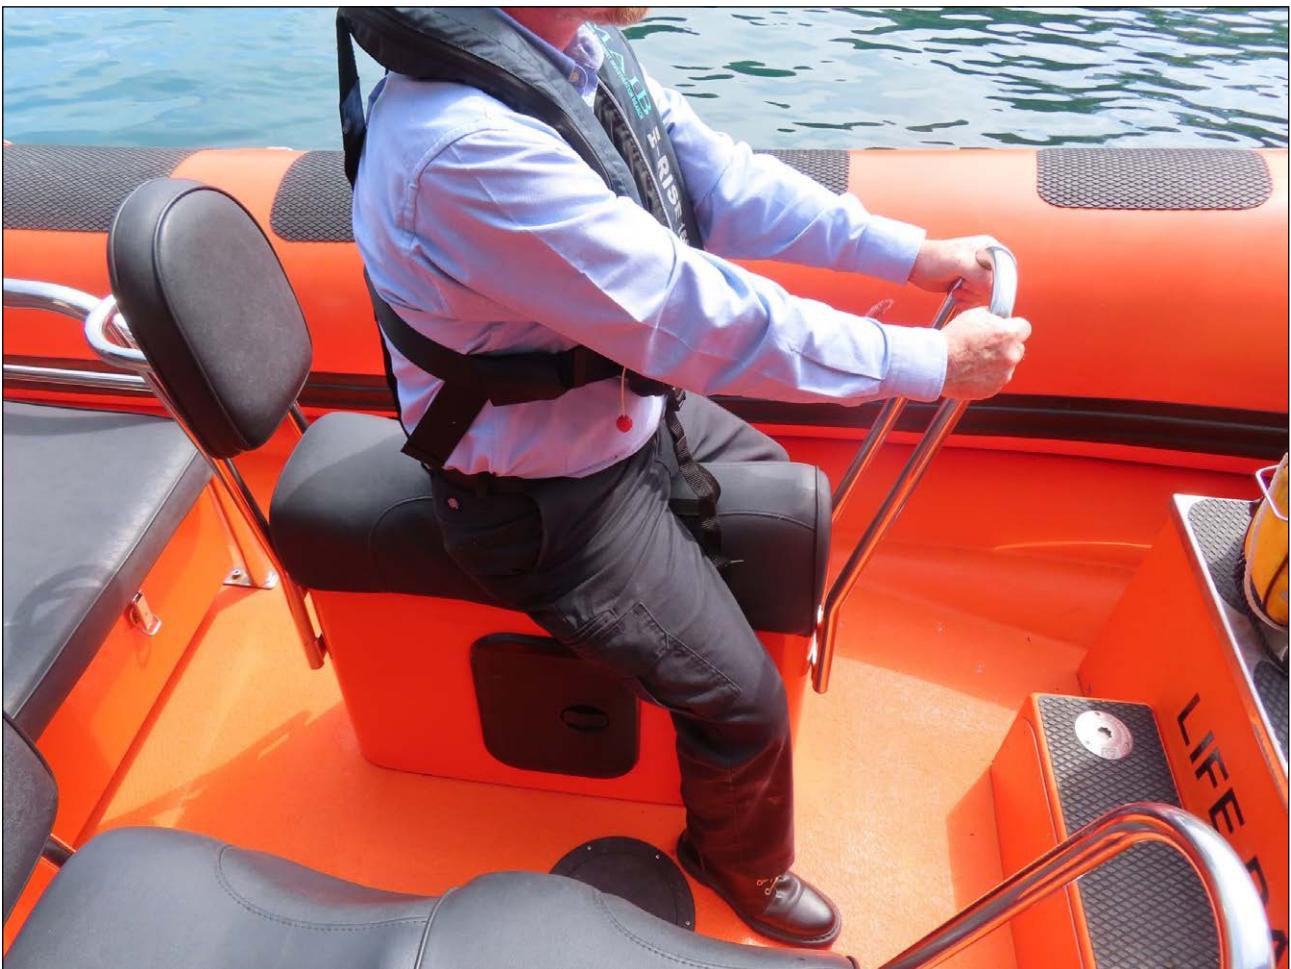
Figure 11: Reconstruction of the casualty's approximate position on the jockey seat

Lundy Explorer had capacity to seat the trip's 12 passengers on the four bench seats. When the passengers were embarked at the landing stages, two were told to move from a bench seat to the forward jockey seats as filling from the front was the usual method for seating them. The injured passenger's physiology allowed her to sit on the jockey seat with her feet on the deck and use her knees to brace against shock loads (**Figure 11**). However, the seat was not designed for single occupancy and lumber support could not therefore be provided by the seat's back rest if using the handhold. Consequently, the chances of being displaced from the jockey seats during rough conditions were increased.

The worst injury sustained on *Lundy Explorer* occurred on one of the forward jockey seats, where the highest forces were experienced during the rough sea conditions on the day of the accident.

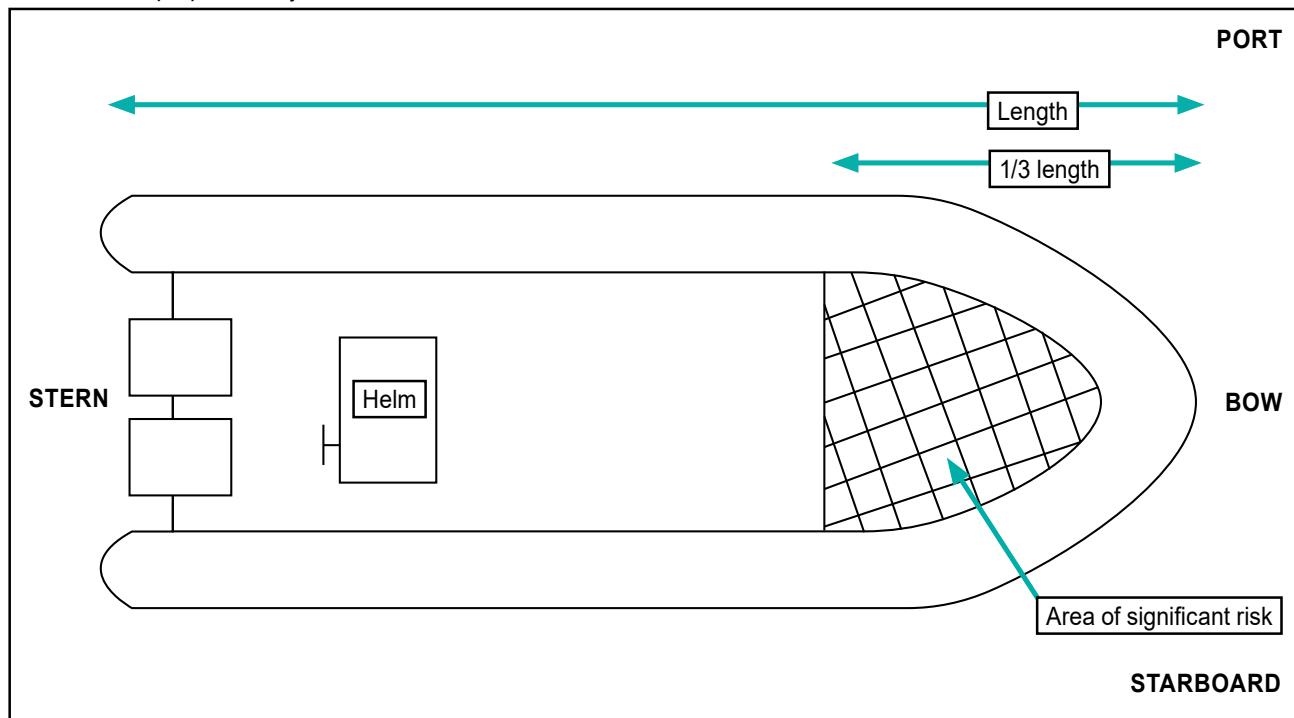
Figure 2: RIB outline highlighting the area of significant risk

Commercial passenger tours using RIBs, including sea safaris and thrill rides, have experienced a surge in popularity across the UK, with a corresponding increase in the occurrence of accidents. Since 2001, the MAIB has been notified of 54 accidents during RIB rides that have resulted in lower back injuries, 17 of which resulted in spinal fractures. Initial analysis of these previous accidents as part of this investigation indicates that passengers seated in the front third of a RIB's overall length (**Figure 2**) are exposed to a significantly higher risk of lower back injuries than those seated further back, as the vertical motions experienced are generally greater towards the bow.
