Report on the investigation of
the collision between the crude oil tanker **Apache** and
the stern trawler **Serinah (GH 116)**
in the Firth of Clyde, Scotland
on 25 April 2024

Apache and Serinah

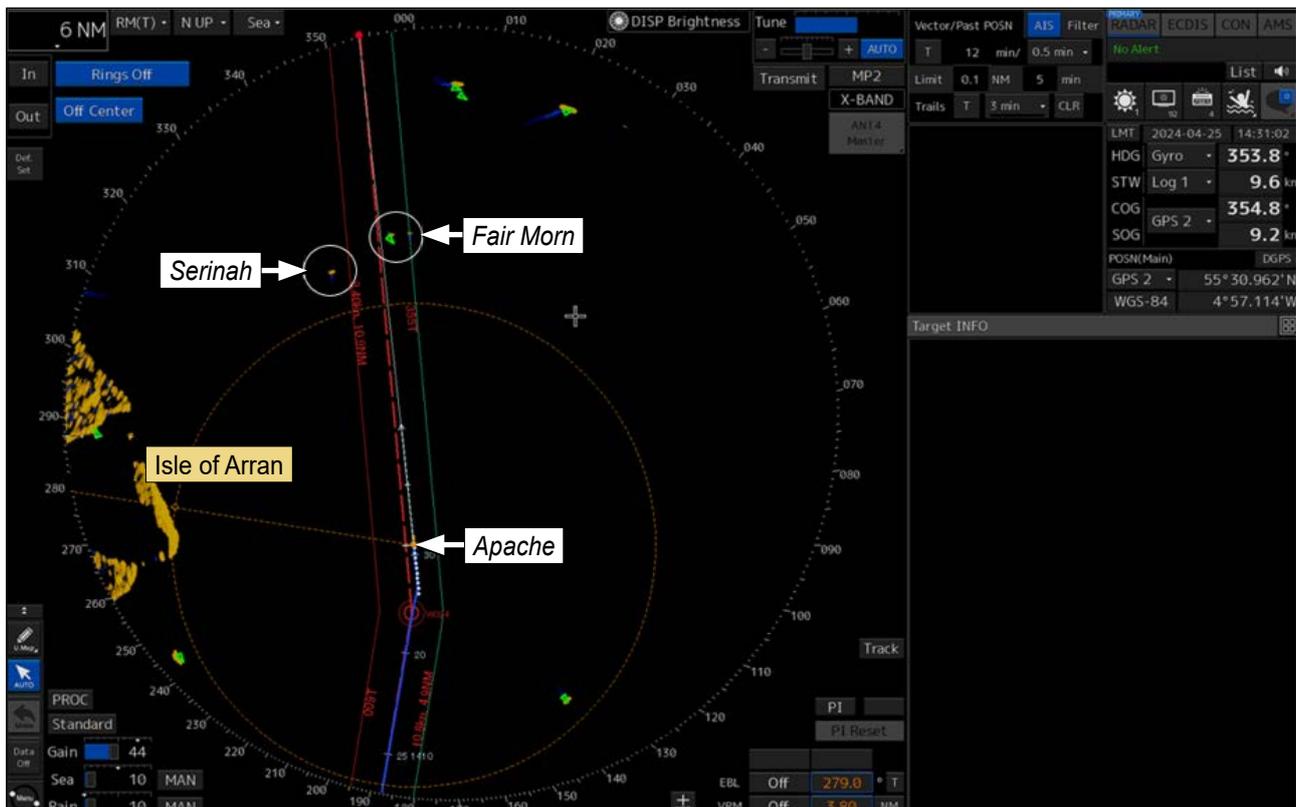
Figure 2: *Apache's* radar at 1431

Apache's X-band¹ radar was set to a range of 6 nautical miles (nm) with true trails selected. The vessel's S-band² radar was set to a 12nm range. The scale on *Apache's* Electronic Chart Display and Information System (ECDIS) corresponded to a range of 6nm. *Serinah* was visible on the radar at a distance of 4.4nm, fine on the port bow proceeding north on a parallel track to *Apache* (**Figure 2**). *Serinah* was visible to the bridge team on *Apache*. The fishing vessel *Fair Morn* was tracking to the south-east.

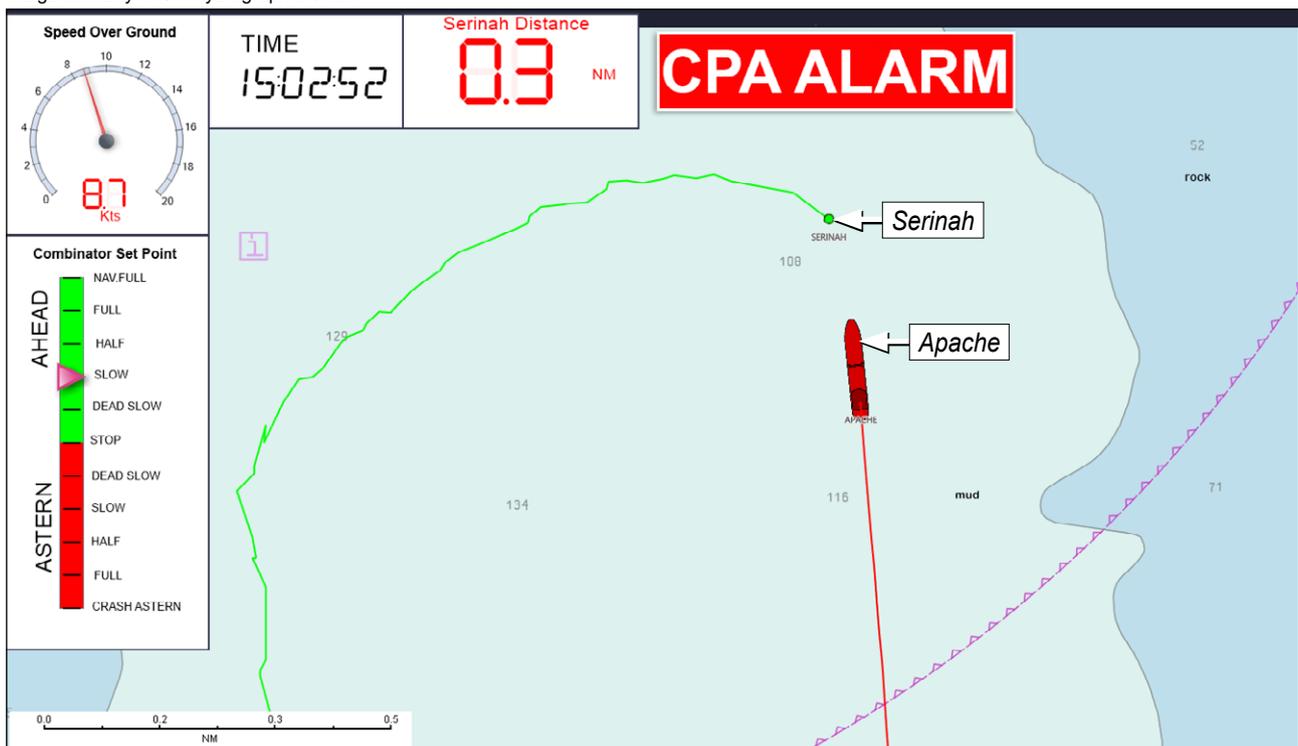
Figure 3: Positions of *Apache* and *Serinah* at 1502:52

By 1501, the two vessels were 0.6nm apart on a steady bearing with a risk of collision. At 1502:52 *Apache*'s 2/O acquired *Serinah* as a target on the radar (**Figure 3**). The closest point of approach (CPA) alarm immediately sounded, showing a CPA of 0.3nm with a time to closest point of approach (TCPA) of 1.49 minutes. After consulting with the master the 2/O sounded one long blast on *Apache*'s forward whistle. *Serinah* then disappeared from view under the bow of *Apache*, as the two vessels were about 100m apart.

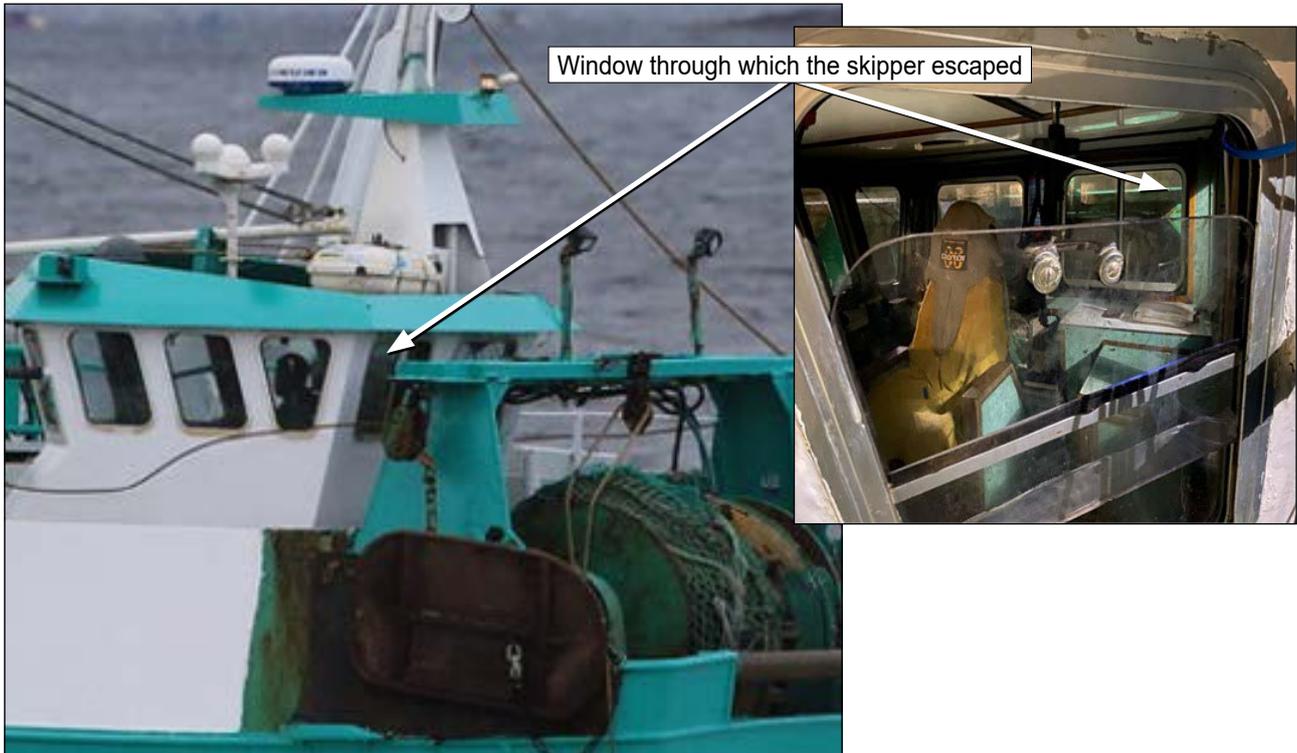
Figure 4: Aft windows in *Serinah*'s wheelhouse

Serinah's hull penetration was pushed underwater and the vessel started to flood. *Serinah*'s skipper was still in the wheelhouse and, seeing that the egress route through the accommodation was flooded, grabbed a personal flotation device (PFD) and climbed out of the wheelhouse through an aft window (**Figure 4**).

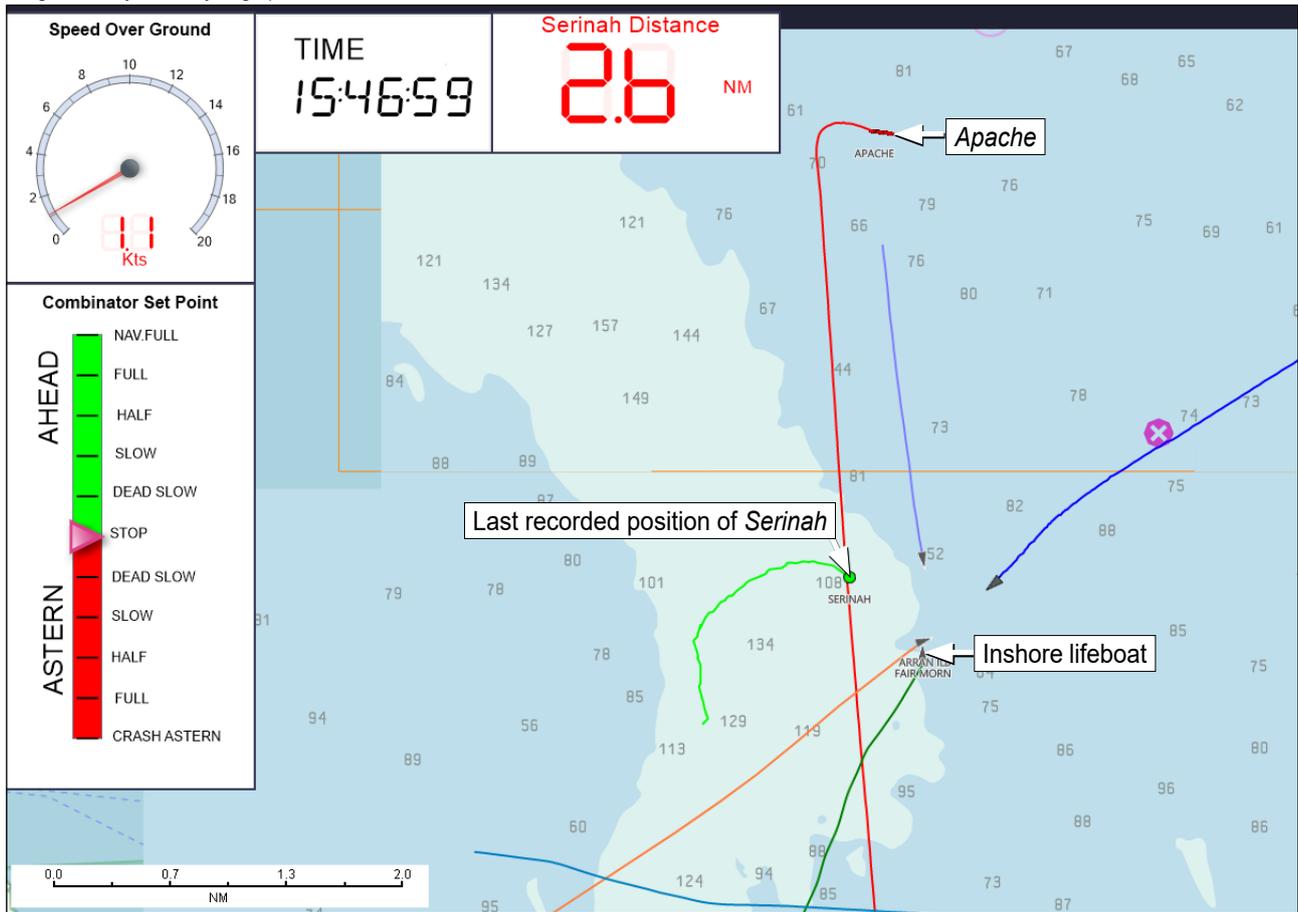
Figure 5: Positions of Apache and rescue vessels at 1546:59

At 1526, HMCG tasked the RNLI inshore lifeboat (ILB) based at Lamlash, Isle of Arran to assist. By 1530, *Apache* had launched its rescue boat and the craft headed south towards the liferaft, which had drifted about 0.8nm east from the collision site. At 1547, the ILB was the first vessel to reach the liferaft (**Figure 5**). All of *Serinah*'s crew boarded the Lamlash ILB, and were then transferred onto the Troon ALB to be taken to Troon harbour. After a medical assessment, and having tested negative for alcohol with Police Scotland, *Serinah*'s crew went home.

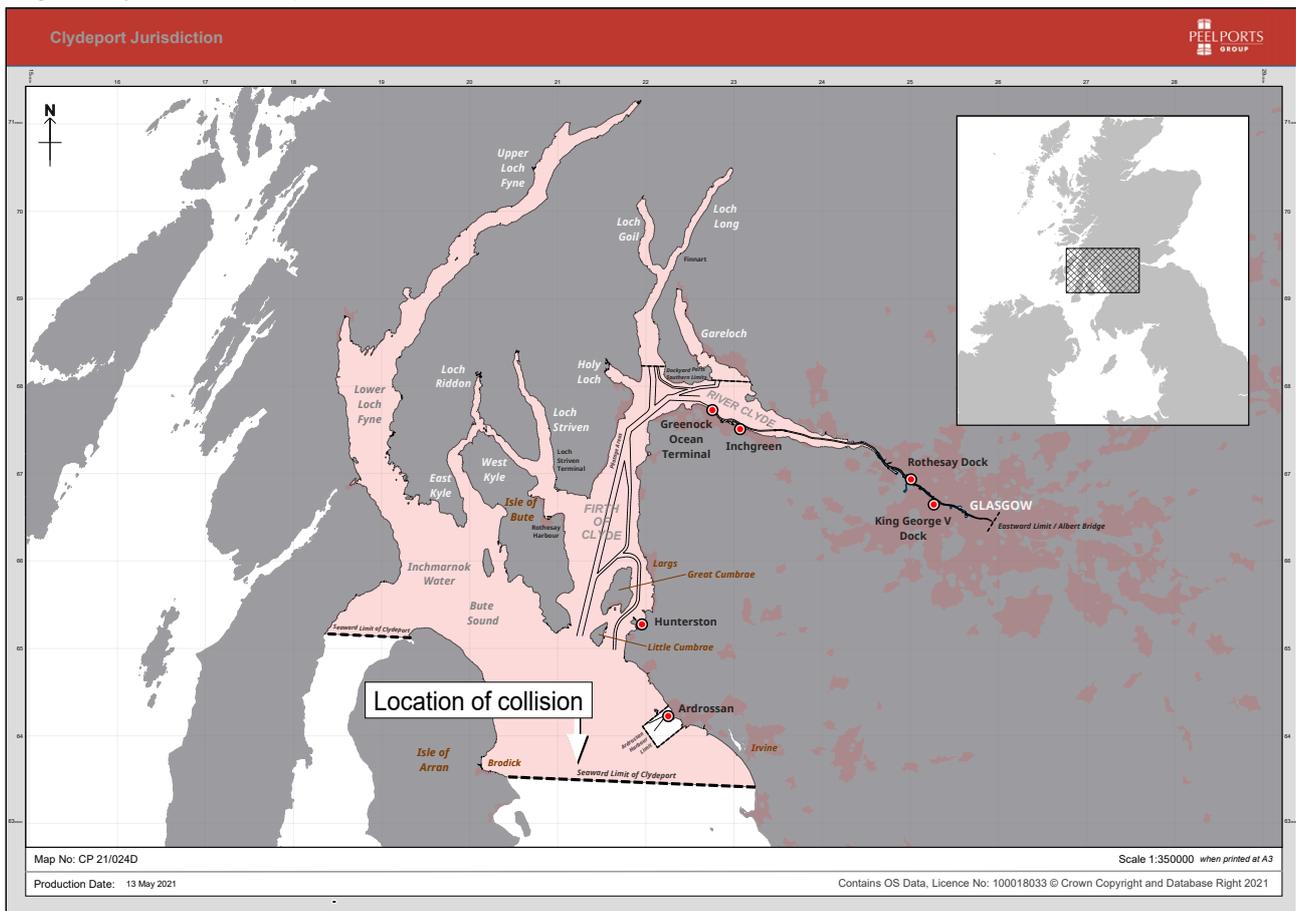
Figure 6: Clydeport Local Port Services jurisdiction area

Clydeport included about 50% of the Firth of Clyde and was managed with an LPS. The collision occurred inside the Clydeport LPS area (**Figure 6**).
