Report on the investigation of  
the collision between the bulk carrier  
***Polesie***  
and the general cargo ship  
***Verity***  
resulting in the sinking of *Verity* with five fatalities  
in the German Bight traffic separation scheme  
on 24 October 2023

**This investigation was carried out by the UK Marine Accident Investigation Branch (MAIB) on behalf of the Isle of Man Administration in accordance with the Memorandum of Understanding between the MAIB and the Red Ensign Group Category 1 registries of Isle of Man, Cayman Islands, Bermuda and Gibraltar.**

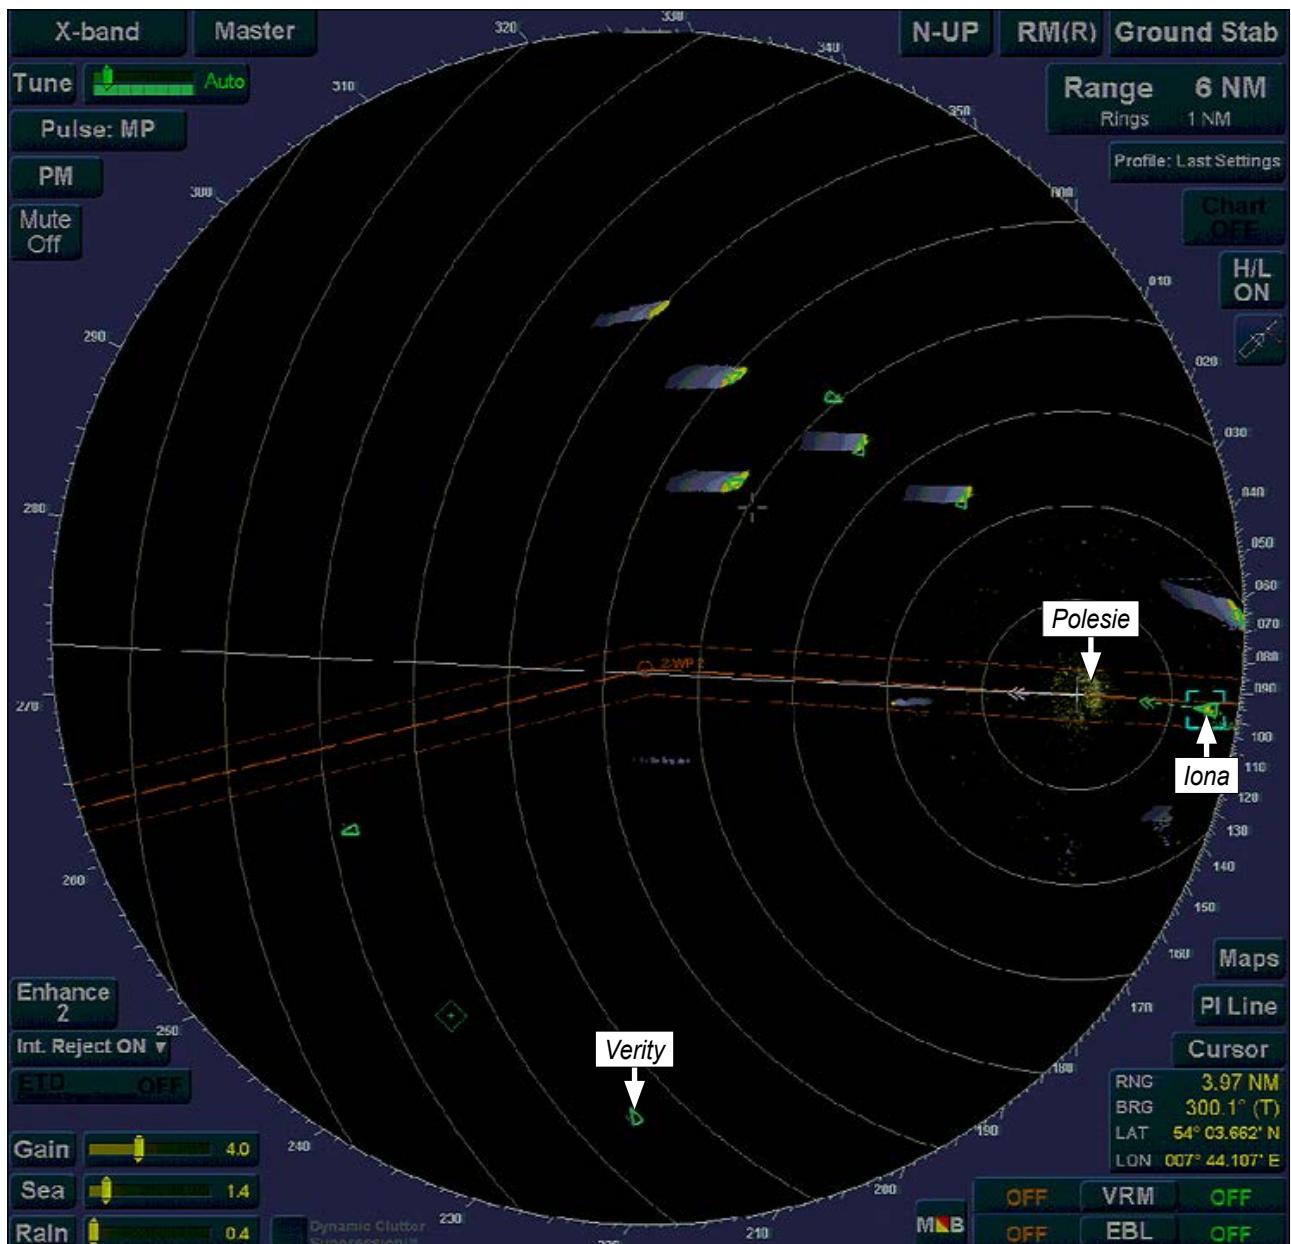
**Figure 4:** *Polesie* starboard radar display, 6nm range (offset) at 0419. *Verity* marking as AIS contact but not acquired by ARPA. 4.5nm to run to waypoint 2

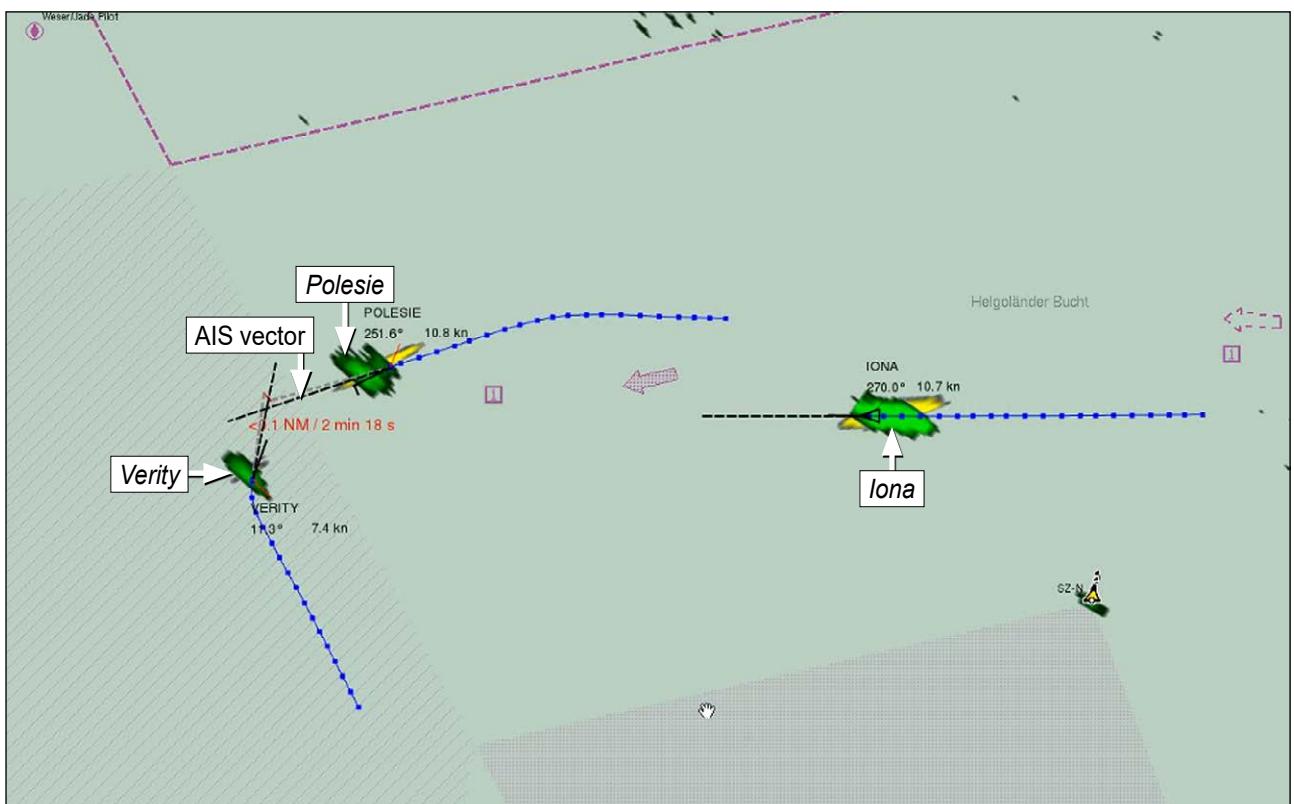
**Figure 9:** 0453:49 VTS display immediately before VTS supervisor calling *Polesie* and instructing it to turn to starboard. Distance between vessels less than 0.5nm

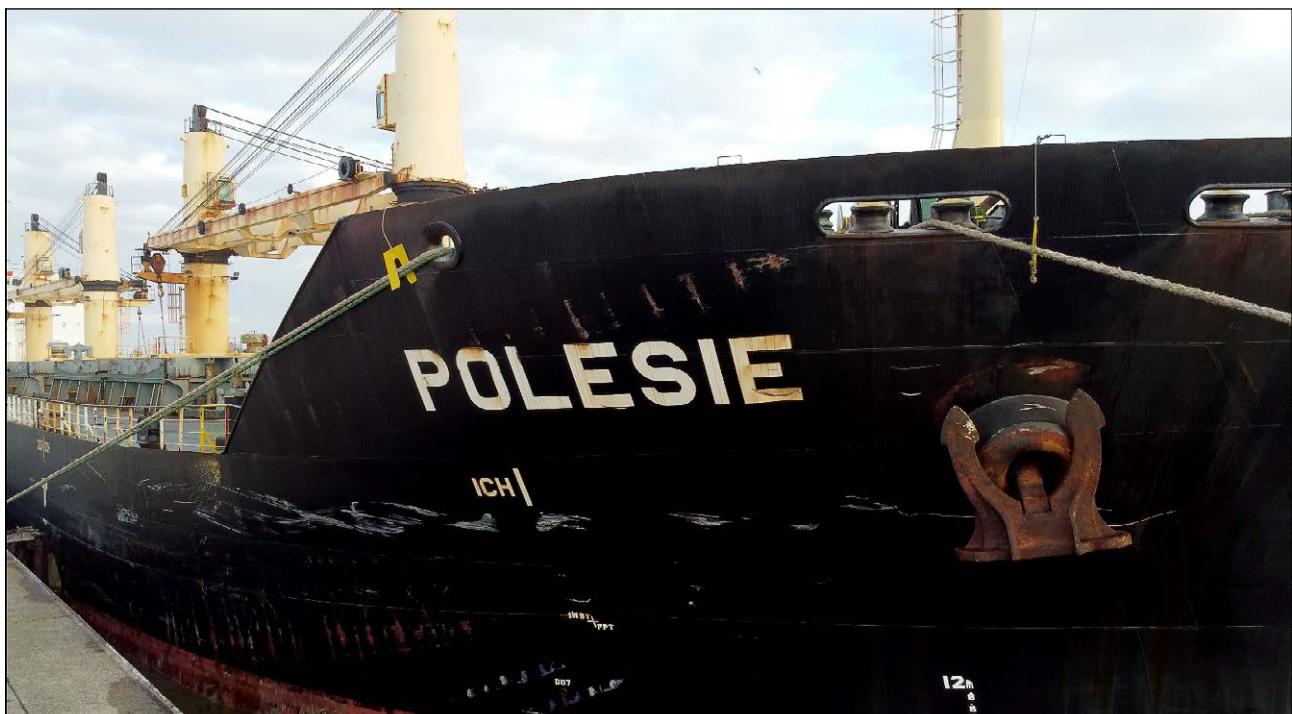
Following the collision, *Verity* was pushed around the bow and contacted the starboard anchor and the starboard side of *Polesie*'s hull (Figure 11). *Verity*'s speed reduced quickly as it scraped down the side of *Polesie*, on which the C/O had reduced the engine speed to half ahead.

Figure 11: Paint marks on *Polesie*'s anchor and bow

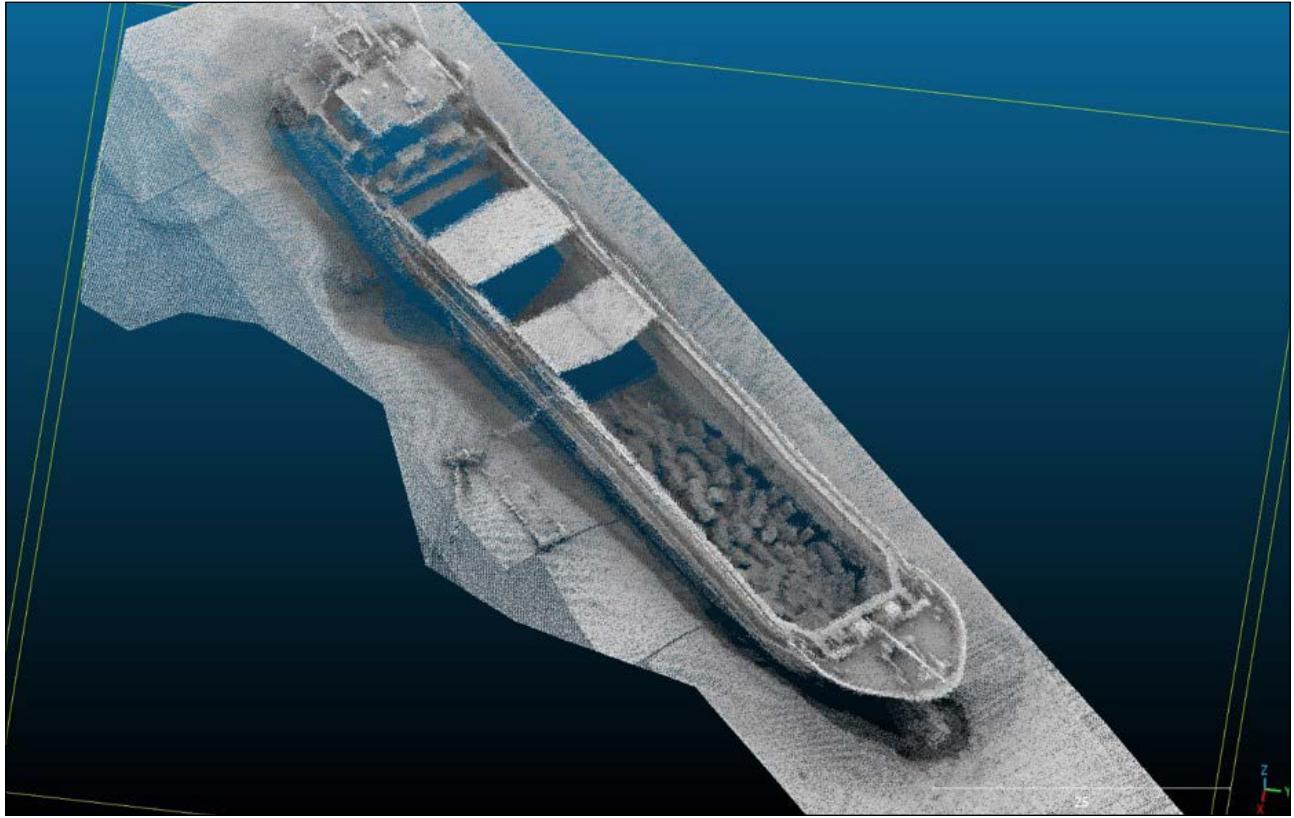
**Figure 12:** Side-scan sonar picture of *Verity* on seabed, showing shift of cargo and missing/collapsed hatch covers

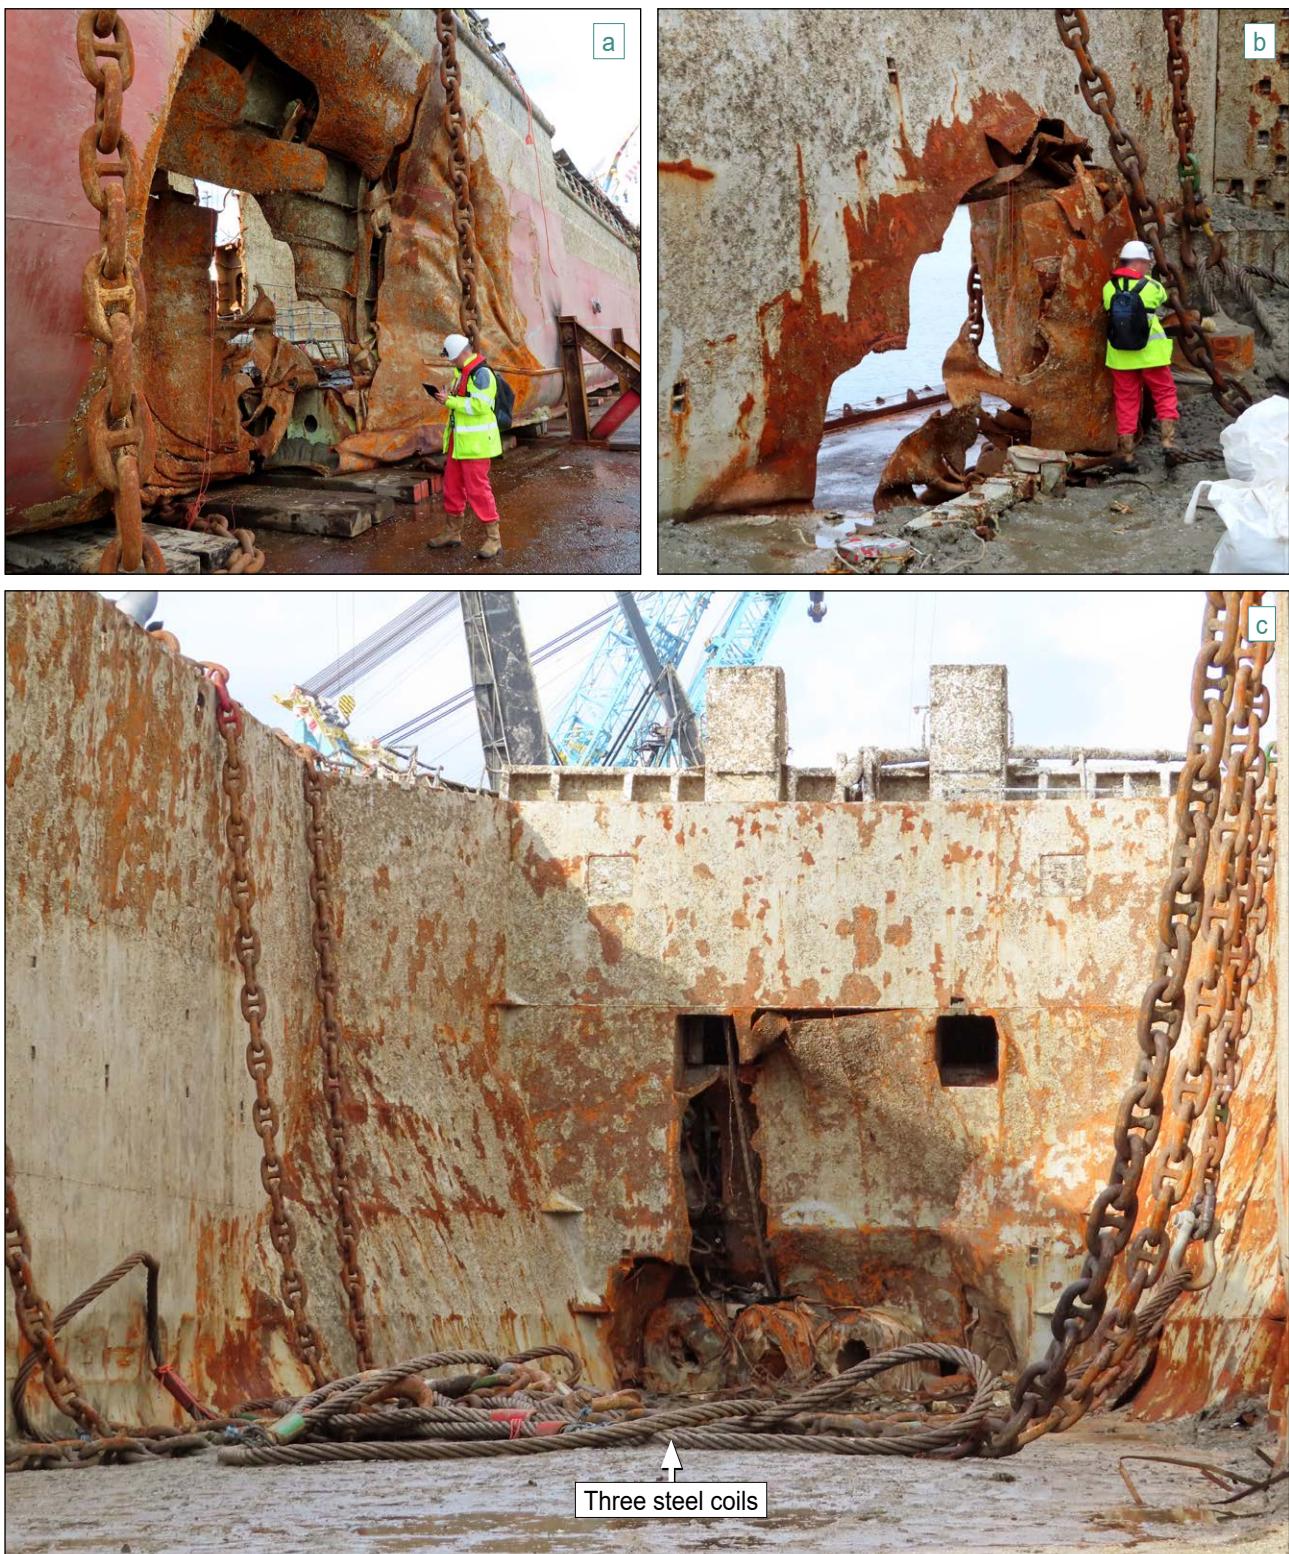
**Figure 13:** Damage to *Verity*'s hull (a and b) and steel coils in forward hold (c)

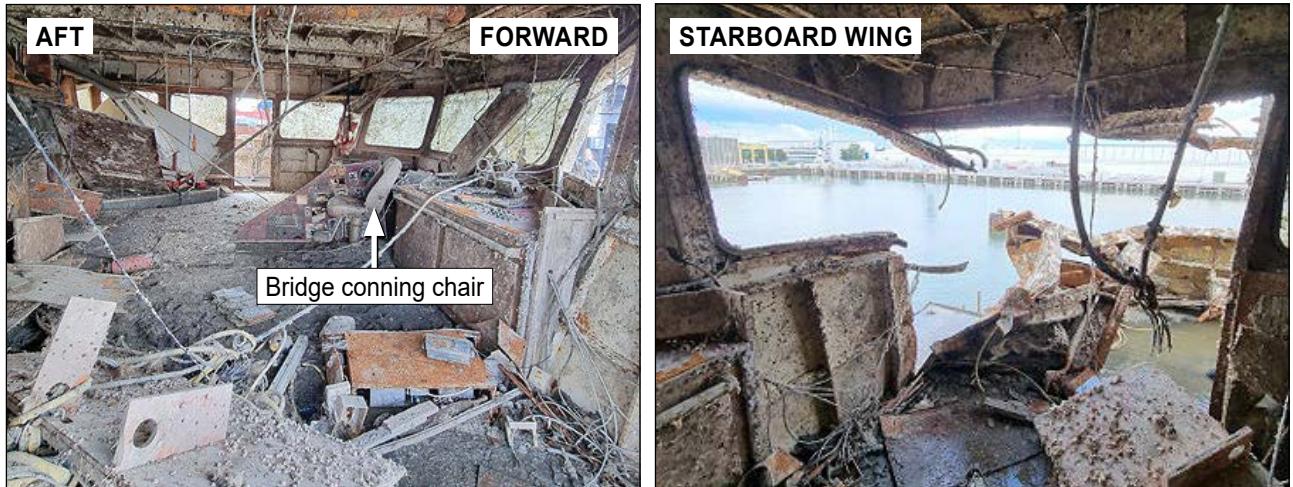
**Figure 14:** Bridge condition post-salvage and damage to starboard wing

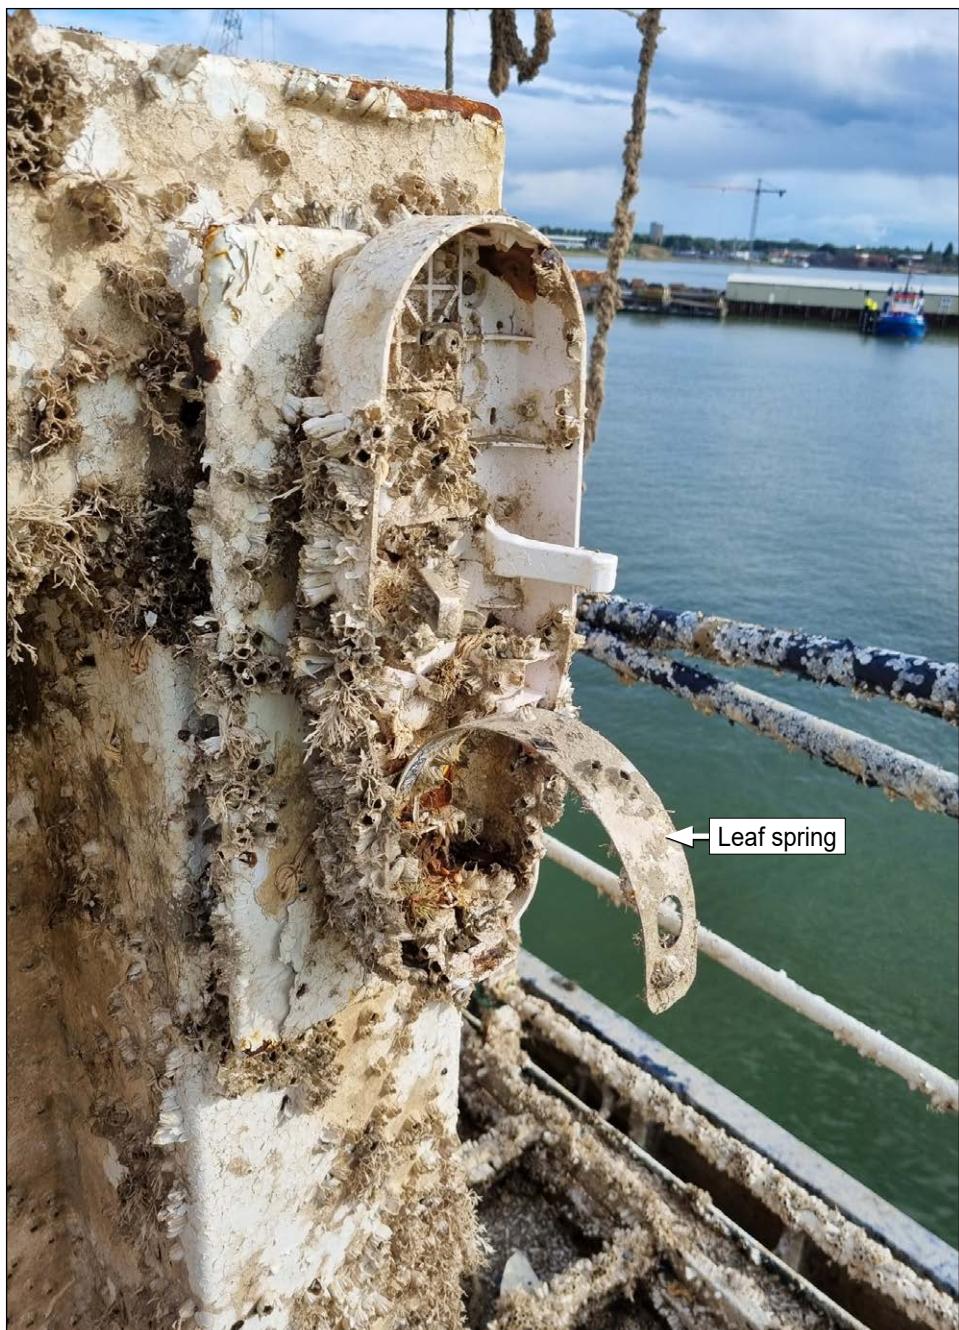
- The emergency position indicating radio beacon (EPIRB) was found on the aft deck. Its housing cover and hydrostatic release were absent and the leaf spring that ejected the EPIRB had activated (**Figure 15**). It could not be determined what had prevented the EPIRB from surfacing.
- The rescue boat was recovered on 18 November 2023.

**Figure 15:** EPIRB housing with cover missing and ejection leaf spring deployed
