# **AAIB Bulletin**

# **2/2026**

<b>Aircraft Type and Registration:</b>	Sonaca 200, G-LKDM	
<b>No &amp; Type of Engines:</b>	1 Rotax 914 F2 piston engine	
<b>Year of Manufacture:</b>	2022 (Serial no: 056)	
<b>Date &amp; Time (UTC):</b>	6 August 2025 at 1537 hrs	
<b>Location:</b>	Blackbushe Airport, Surrey	
<b>Type of Flight:</b>	Training	
<b>Persons on Board:</b>	Crew - 1	Passengers - None
<b>Injuries:</b>	Crew - 1 (Serious)	Passengers - N/A
<b>Nature of Damage:</b>	Right wing extensively damaged and canopy shattered. Nose landing gear broken off. Damaged beyond economic repair	
<b>Commander's Licence:</b>	Student	
<b>Commander's Age:</b>	23 years	
<b>Commander's Flying Experience:</b>	20 hours (of which 20 were on type) Last 90 days - 20 hours Last 28 days - 4 hours	
<b>Information Source:</b>	Aircraft Accident Report Form submitted by the pilot

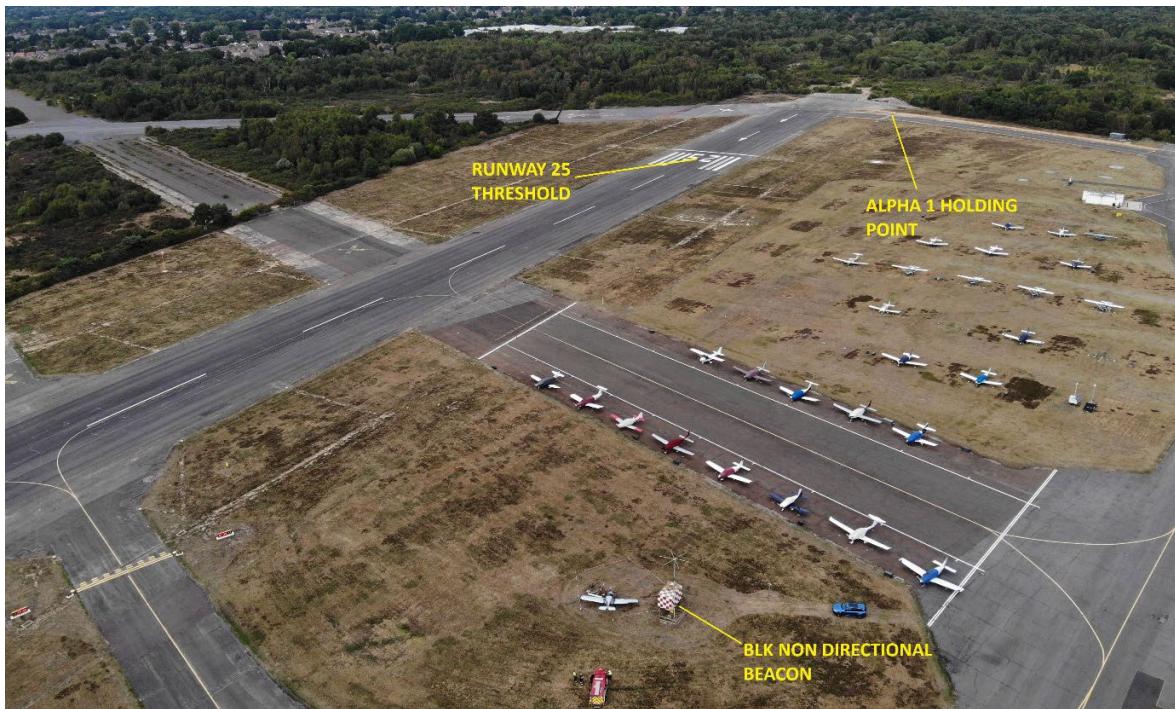
The aircraft struck an antenna adjacent to the BLK Non-Directional Beacon (NDB) and came to rest approximately opposite to the intended departure direction (Figure 2).

**Figure 2**  
Overview of accident site

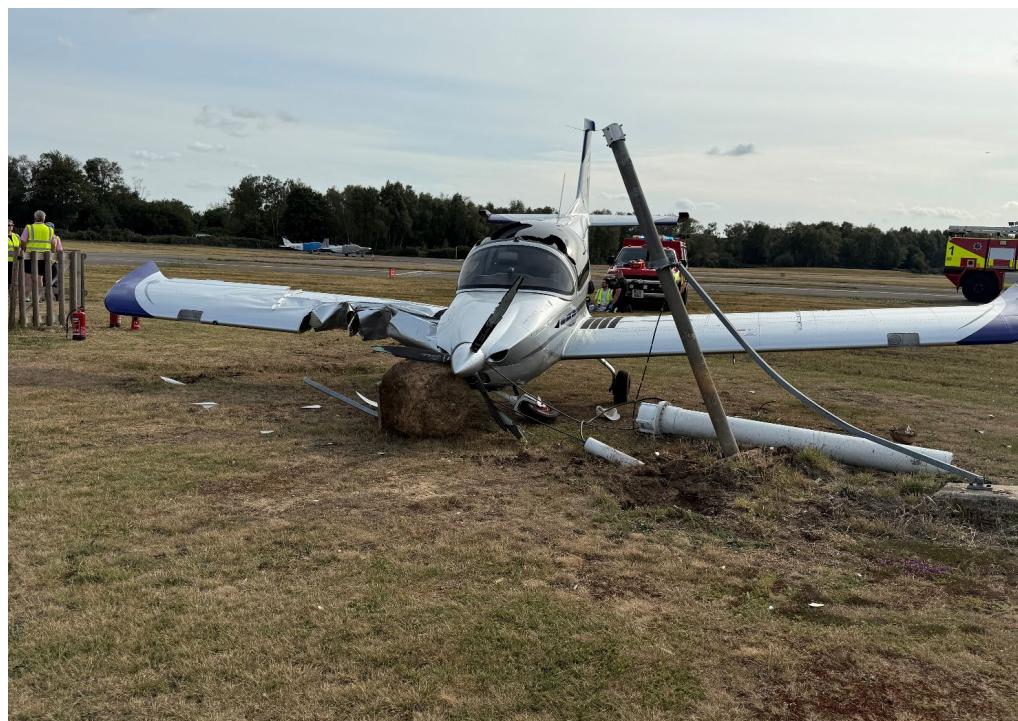
The right wing was severely damaged, the canopy shattered, and the nose landing gear broke off. The extent of the damage is shown in Figure 3.

**Figure 3**  
Aircraft damage

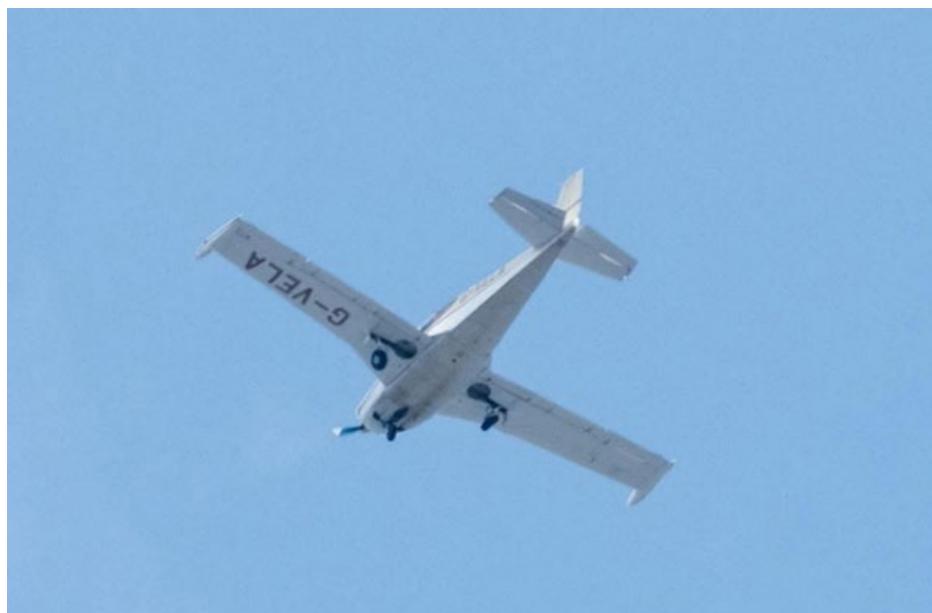
**Figure 1**

The remainder of the flight was uneventful and as they neared Knottishall the pilot started to configure the aircraft for landing. When he selected the landing gear down there was no response and this was confirmed by the absence of gear down indicator lights. He recycled the landing gear and again there was no movement indication. He attempted this for a second time with no result. At this point he decided to maintain height and turn away from the airfield and manually lower the landing gear. Before doing so he ensured the landing gear was selected down and pulled the circuit breaker to open. He then wound the manual crank handle to lower the landing gear. He was aware the handle requires 29 rotations to fully lower the landing gear but after 10 or 11 turns the handle jammed and would not move. The pilot was now unclear as to the landing gear position and was also concerned that additional attempts would cause system damage and more of a problem. After further discussion with his passenger, the pilot decided that it was prudent to divert to Norwich Airport with its higher level of emergency facilities. He declared a PAN and flew to Norwich. In addition, while in transit, he made an assessment, as far as possible, of the aircraft electrical system in case the landing gear problem was caused by an electrical power generation or distribution malfunction. He requested, and carried out, a low pass at Norwich and observers in the control tower informed the pilot the landing gear appeared to be only partially down (Figure 1).

Landing gear partially extended as seen by the observers at Norwich

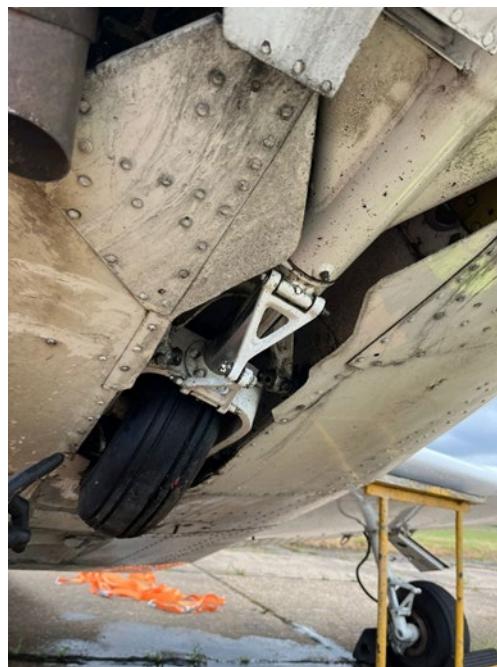
The aircraft was recovered and the landing gear system examined. The nose landing gear assembly was jammed but partially protruding from its bay. It appeared to have been pushed back into its bay on landing. The nosewheel was also off-centre (Figure 2).

**Figure 2**  
Off-centre jammed nosewheel

This was found to have been caused by the steering centring pin, within the steering control quadrant becoming mis-positioned outside its guide bar mechanism so that it did not properly engage in the quadrant, meaning the nosewheel was not centred correctly.

The nose gear appeared to have partially extended in flight on approach to Knettishall. However, the uncentred nosewheel, on retraction after takeoff from Turweston, is suspected to have adversely affected the electrical actuation system linkages and motor. This caused the seizure and overload, which explained the electrical overheating smell of burning.

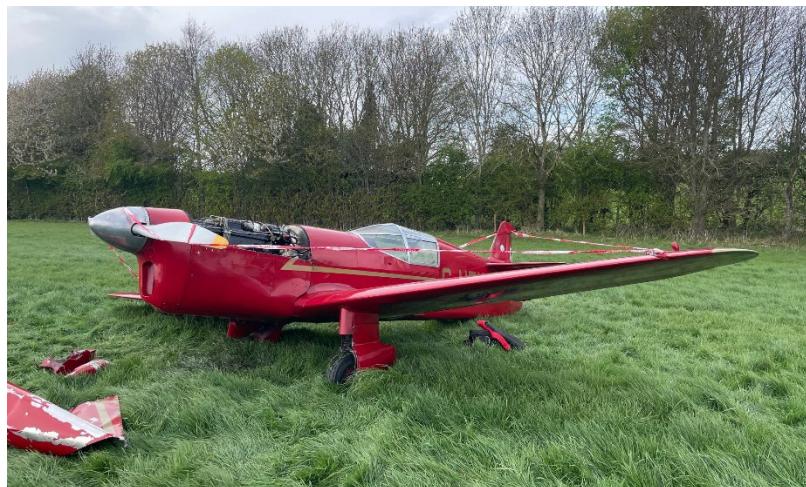
The aircraft came to rest in a field approximately 1 mile north-west of Great Massingham Airfield, sustaining significant structural damage following landing (Figure 1).

**Figure 1**  
G-HEKL post-landing

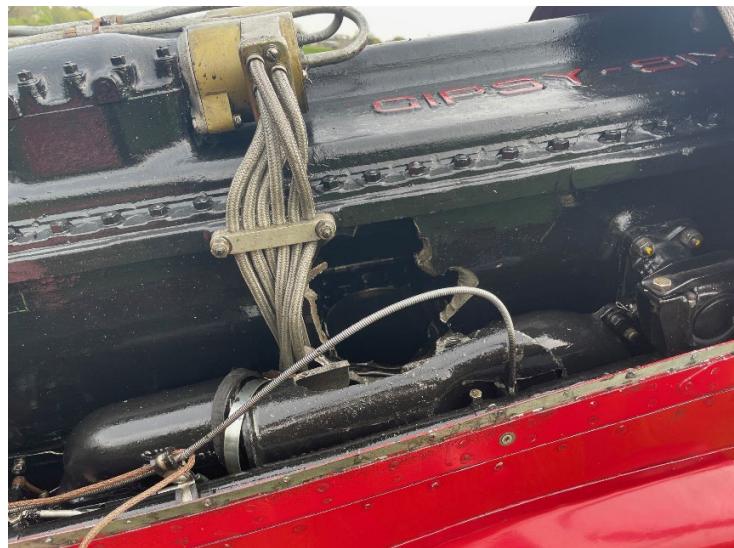
The engine had a large hole in the right side of the crankcase (Figure 2), and No 3 piston and connecting rod were missing.

**Figure 2**  
Crankcase damage

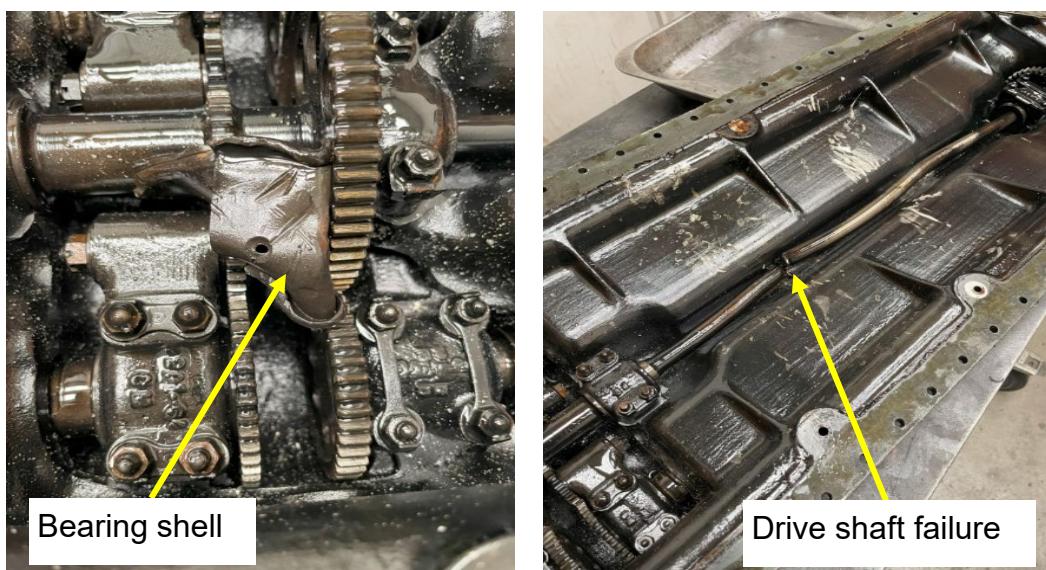
A piece of big end bearing shell was lodged in the magneto and distributor gears, and the attached quill drive shaft had failed in torsion (Figure 3).

**Figure 3**  
Magneto and distributor gears, and drive shaft

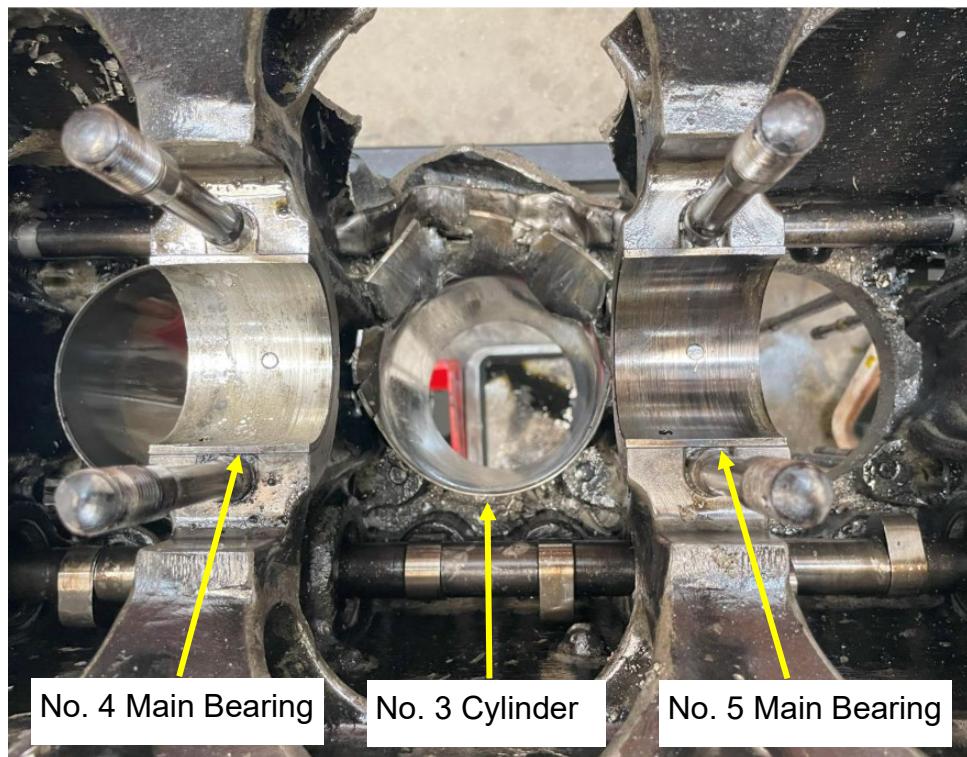
The main bearings are numbered 1-8, from the front to rear of the engine. Nos 1, 3, 4, 6 and 7 showed various stages of surface wear and heat damage, while Nos 2 and 8 were undamaged. No 5 was severely overheated and had suffered a complete loss of its inner surface layer of white metal. The bearing cap was cracked in several places. The bearing cap bolts for Nos 3, 4 and 5 were found to be only finger-tight despite having their split pins and locking tabs in place.

**Figure 4**  
Main bearing, cylinder and crankcase damage

No 3 cylinder was significantly damaged from being struck by the piston (Figure 4). None of the cylinder heads showed visible internal damage, but No 3 exhaust tappet was stuck in the open position by particles of white metal.

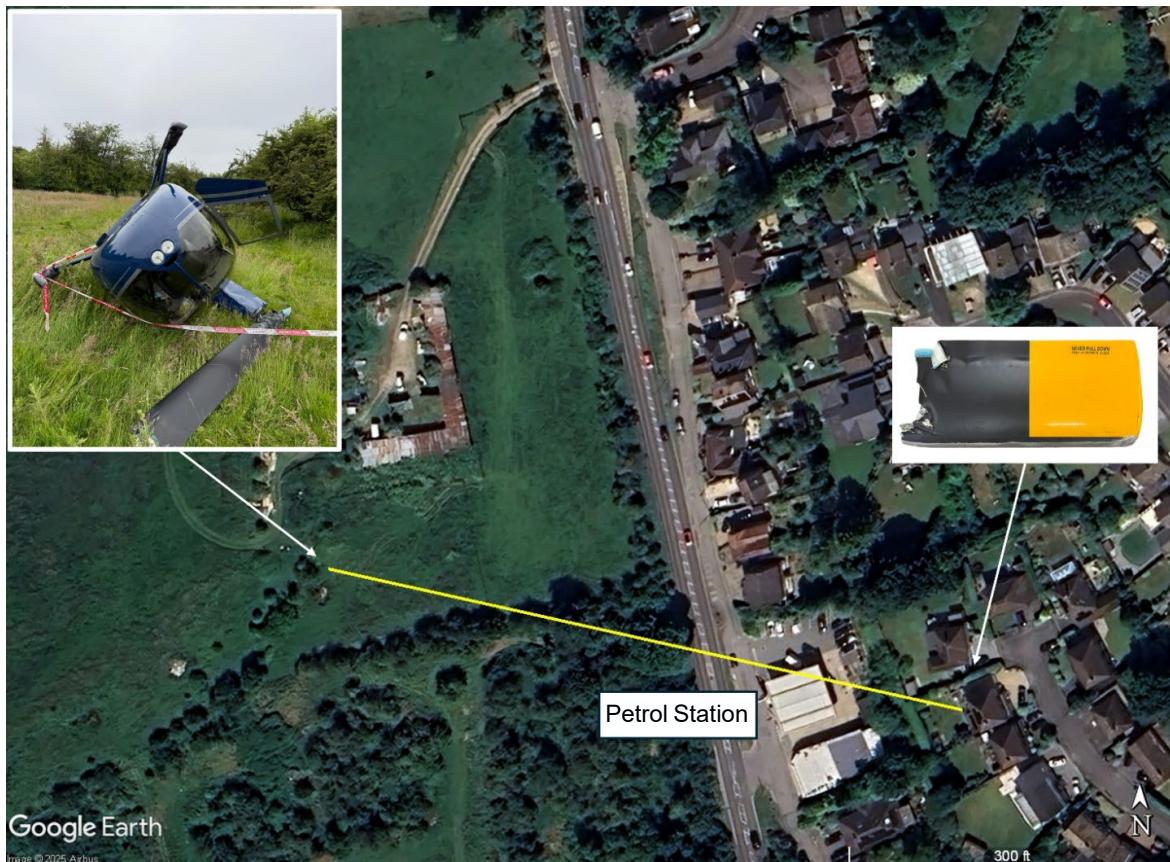
**Figure 4**  
Trajectory of detached blade tip

The main rotor blade struck the ground with high energy, sufficient to propel a section of blade tip weighing 4.5 kg nearly 180 m. There was no damage caused to the house.
