Serious Incident

Aircraft Type and Registration:	Boeing 737-8K5, G-TAWD	
No & Type of Engines:	2 CFM56-7B27E turbofan engines	
Year of Manufacture:	2011 (Serial no: 37265)	
Date & Time (UTC):	20 October 2023 at 1153 hrs	
Location:	Leeds Bradford Airport	
Type of Flight:	Commercial Air Transport (Passenger)	
Persons on Board:	Crew - 6	Passengers - 195
Injuries:	Crew - None	Passengers - None
Nature of Damage:	Main landing gear tyres and nosewheel tyres damaged. Left nosewheel inner axle bearing destroyed	
Commander's Licence:	Airline Transport Pilot's Licence	
Commander's Age:	41 years	
Commander's Flying Experience:	14,250 hours (2,800 hours on type) Last 90 days - not known Last 28 days - 88 hours	
Information Source:	AAIB Field Investigation

Synopsis

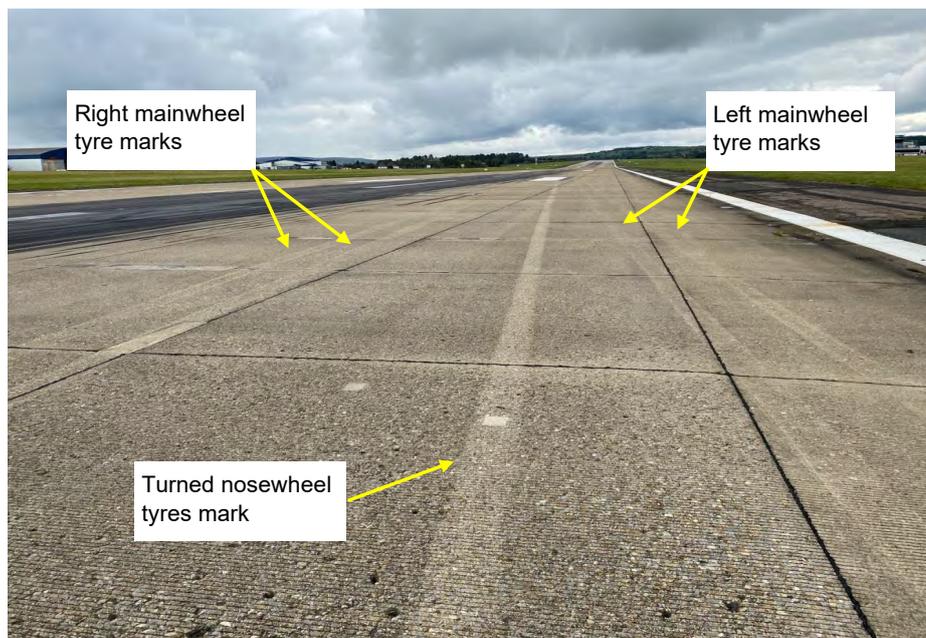
Figure 4

The mainwheel and nosewheel tyres left light 'cleaned' marks on the runway surface which became visible after the surface had dried (Figures 3 and 4). The marks began approximately level with taxiway Lima, and continued until G-TAWD left the runway. The nosewheel track changed from two clear tyre marks to a single tyre mark at approximately 840 m after touchdown, where it continued for more than 200 m until the aircraft left the runway. The change in mark indicates that the nosewheels were turned to one side instead of in the direction of the aircraft's travel.

Runway tyre marks facing direction of travel

The 'cleaned' runway tyre markings are typically only associated with reverted rubber hydroplaning. However, no evidence of reverted rubber was found on the mainwheel or nosewheel tyres, which requires locked wheels to occur, nor were there corresponding 'melted' rubber deposits on the runway. The runway marks suggest that the surface temperature underneath all the tyres was high enough to turn some of the water on the runway's surface into steam but not high enough, nor combined with locked wheels, to cause rubber reversion.

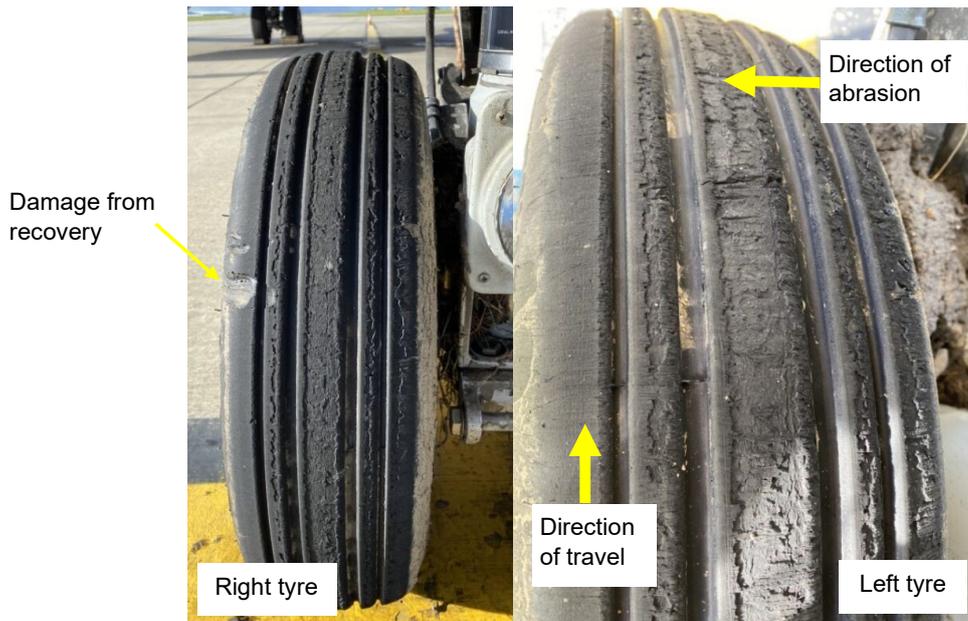
Both nosewheel tyres had abrasion surface damage around their entire circumference. The type, direction and quantity of damage indicates it occurred when the nosewheels were turned nearly perpendicular to the direction of travel (to the right), and that the wheels were still rotating (Figure 7). Neither nosewheel tyre showed damage corresponding to a locked wheel condition or rubber reversion in the un-abraded sections of their surface.

Figure 7
Nosewheel tyre damage

The nosewheel tyre damage is consistent with abrasion scrubbing from being turned to an angle nearly perpendicular to the direction of travel whilst the tyres were rotating and in contact with the runway; also demonstrated by the runway marks left by the nosewheel tyres. The angle of the nosewheels could only be achieved by use of the tiller rather than rudder pedal steering alone, and this corresponds with the commander's account of events.

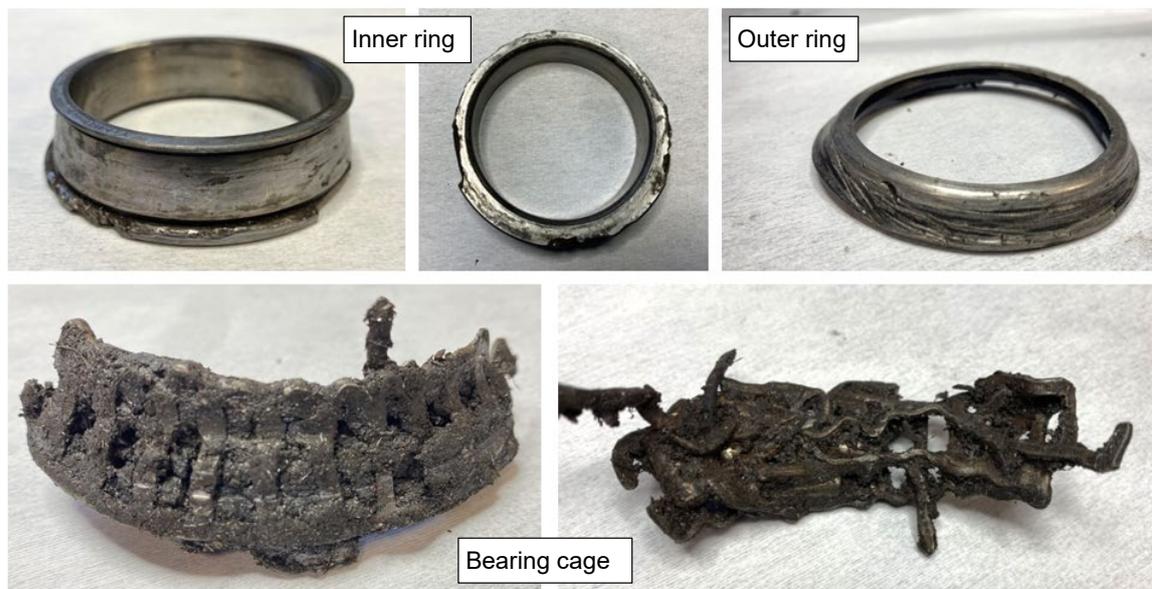
Figure 8

The left nosewheel was removed which revealed that the inner axle bearing had failed (Figure 7), while the outer axle bearing was undamaged. Each nosewheel has an inner and an outer axle bearing which are replaced on condition and do not have a fixed service life. This bearing was fitted during a routine wheel overhaul in September 2022.

Prior to removal, the left nosewheel had significant play on the axle but was free to rotate. It is probable that the play of the nosewheel on the axle occurred during the recovery process as, had it been present during the landing roll, significant damage to the outer bearing and further damage to the wheel and axle would have been expected.

Left inner nosewheel bearing components

It was not confirmed when the nosewheel bearing began to fail, but it is likely that it occurred during the rollout at LBA and was contributory to the vibration through the rudder pedals, as felt by the crew. Both crew members recalled the "judder" as being significant and unusual, and the CVR recording contained a confirmatory sound during this period. The PF recalled the vibration increasing as he increased right rudder pedal input, effectively limiting the amount of rudder he felt he could apply. However, no evidence was found that the bearing failure did, in fact, limit rudder pedal or rudder movement.
