AAIB Bulletin

12/2024

Aircraft Type and Registration:	Boeing 737-8K5, G-TAWD
No & Type of Engines:	2 CFM56-7B27E turbofan engines
Year of Manufacture:	2011 (Serial no: 37265)
Date & Time (UTC):	20 October 2023 at 1153 hrs
Location:	Leeds Bradford Airport
Type of Flight:	Commercial Air Transport (Passenger)
Persons on Board:	Crew - 6 Passengers - 195
Injuries:	Crew - None Passengers - None
Nature of Damage:	Main landing gear tyres and nosewheel tyres damaged. Left nosewheel inner axle bearing destroyed
Commander's Licence:	Airline Transport Pilot's Licence
Commander's Age:	41 years
Commander's Flying Experience:	14,250 hours (2,800 hours on type) Last 90 days - not known Last 28 days - 88 hours
Information Source:	AAIB Field Investigation

Aircraft Type and Registration:	Rotorsport UK Cavalon, G-CKYT	
No & Type of Engines:	1 Rotax 914-UL piston engine	
Year of Manufacture:	2018 (Serial no: RSUK/CVLN/027)	
Date & Time (UTC):	12 November 2020 at 1250 hrs	
Location:	Farmland between Avoch and Munloch, Black Isle	
Type of Flight:	Solo training flight	
Persons on Board:	Crew - 1	Passengers - None
Injuries:	Crew - 1 (Fatal)	Passengers - N/A
Nature of Damage:	Aircraft destroyed	
Commande

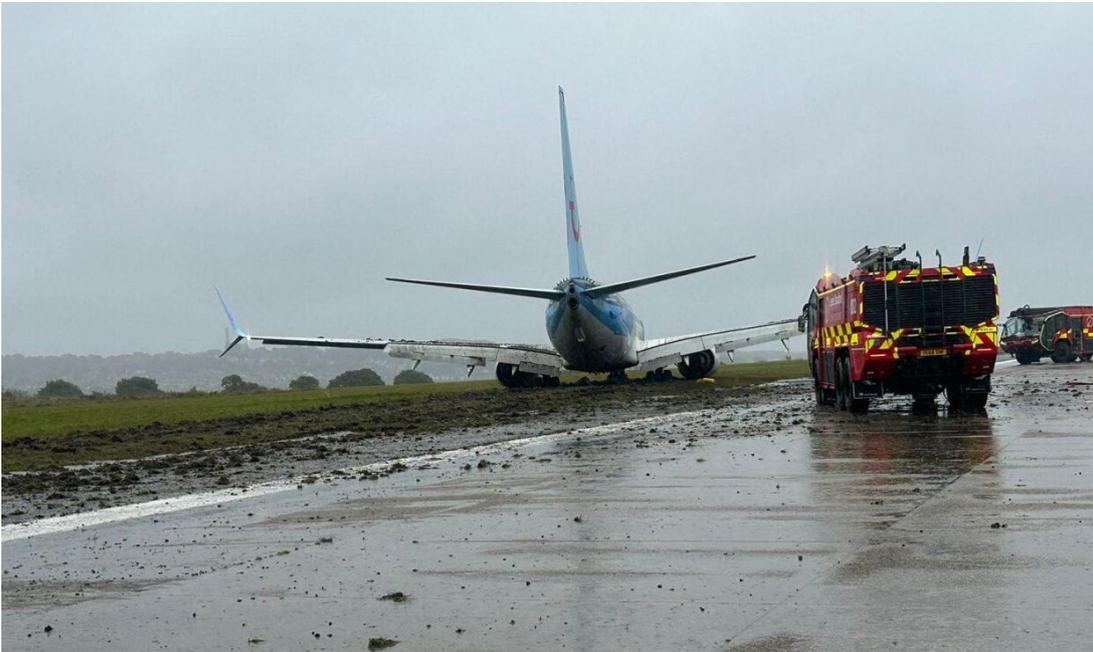
Figure 1
Aircraft final position

The aircraft came to a stop six seconds later in muddy ground approximately 150 m beyond the D taxiway exit (Figures 1 and 2). The crew followed normal shutdown procedures to secure the aircraft. There were no injuries reported by passengers or crew.

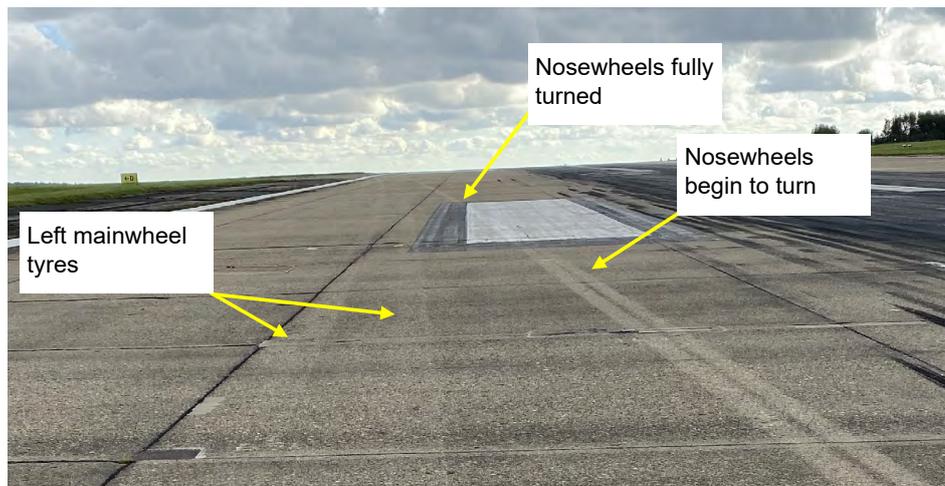
Figure 3
Runway tyre marks in direction of travel

'Steam-cleaned' tyre marks can indicate the presence of reverted rubber hydroplaning.

The 'cleaned' runway tyre markings are typically only associated with reverted rubber hydroplaning. However, no evidence of reverted rubber was found on the mainwheel or nosewheel tyres, which requires locked wheels to occur, nor were there corresponding 'melted' rubber deposits on the runway. The runway marks suggest that the surface temperature underneath all the tyres was high enough to turn some of the water on the runway's surface into steam but not high enough, nor combined with locked wheels, to cause rubber reversion.

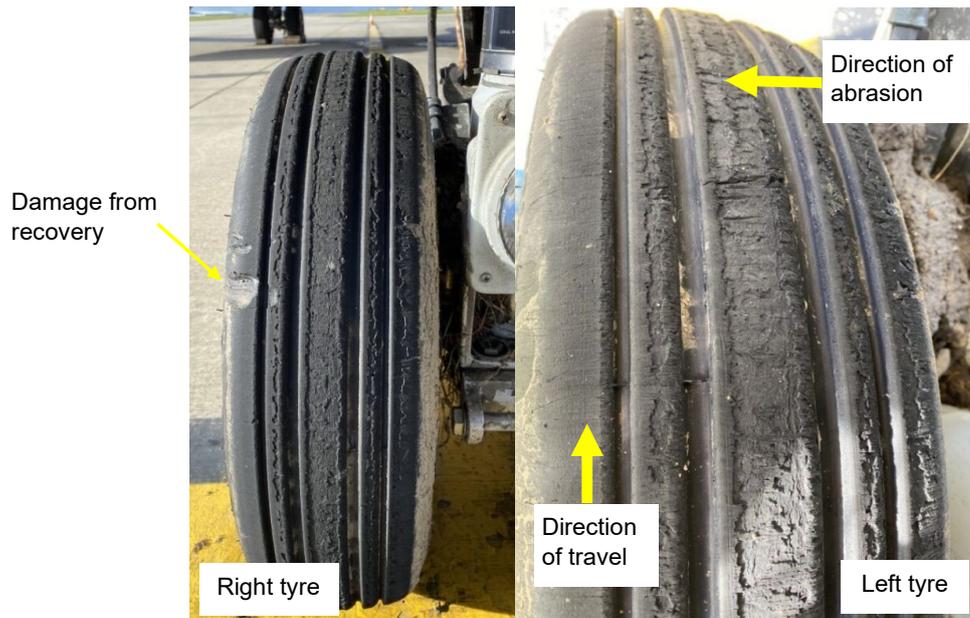
Figure 7
Nosewheel tyre damage

Both nosewheel tyres had abrasion surface damage around their entire circumference. The type, direction and quantity of damage indicates it occurred when the nosewheels were turned nearly perpendicular to the direction of travel (to the right), and that the wheels were still rotating (Figure 7). Neither nosewheel tyre showed damage corresponding to a locked wheel condition or rubber reversion in the un-abraded sections of their surface.

The nosewheel tyre damage is consistent with abrasion scrubbing from being turned to an angle nearly perpendicular to the direction of travel whilst the tyres were rotating and in contact with the runway; also demonstrated by the runway marks left by the nosewheel tyres. The angle of the nosewheels could only be achieved by use of the tiller rather than rudder pedal steering alone, and this corresponds with the commander's account of events.

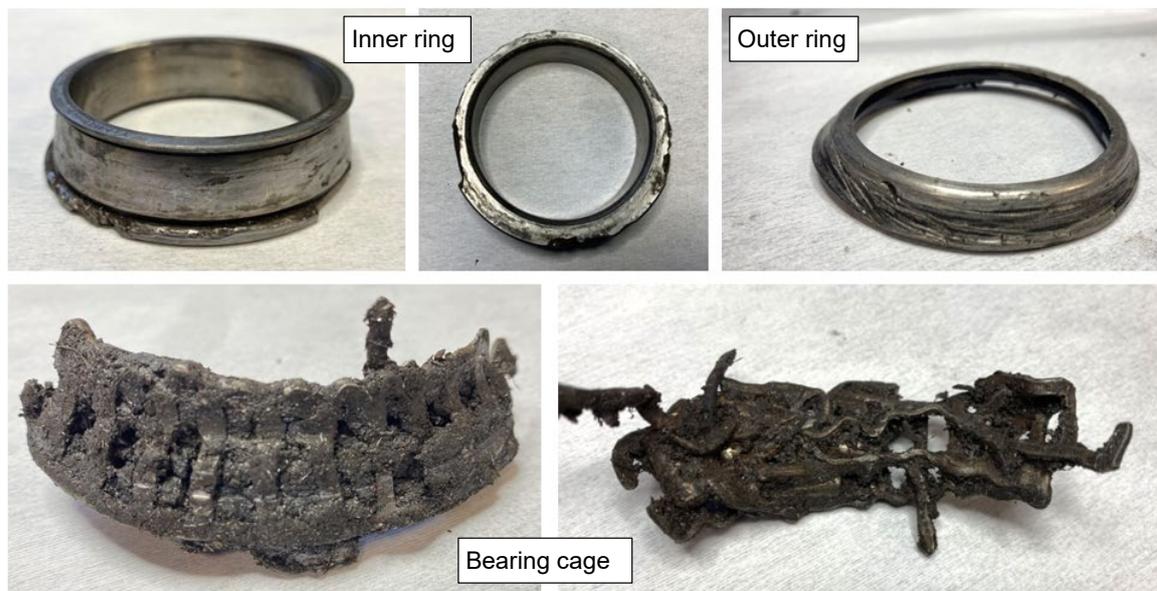
Figure 8

The left nosewheel was removed which revealed that the inner axle bearing had failed (Figure 7), while the outer axle bearing was undamaged. Each nosewheel has an inner and an outer axle bearing which are replaced on condition and do not have a fixed service life. This bearing was fitted during a routine wheel overhaul in September 2022.

Prior to removal, the left nosewheel had significant play on the axle but was free to rotate. It is probable that the play of the nosewheel on the axle occurred during the recovery process as, had it been present during the landing roll, significant damage to the outer bearing and further damage to the wheel and axle would have been expected.

It was not confirmed when the nosewheel bearing began to fail, but it is likely that it occurred during the rollout at LBA and was contributory to the vibration through the rudder pedals, as felt by the crew. Both crew members recalled the "judder" as being significant and unusual, and the CVR recording contained a confirmatory sound during this period. The PF recalled the vibration increasing as he increased right rudder pedal input, effectively limiting the amount of rudder he felt he could apply. However, no evidence was found that the bearing failure did, in fact, limit rudder pedal or rudder movement.

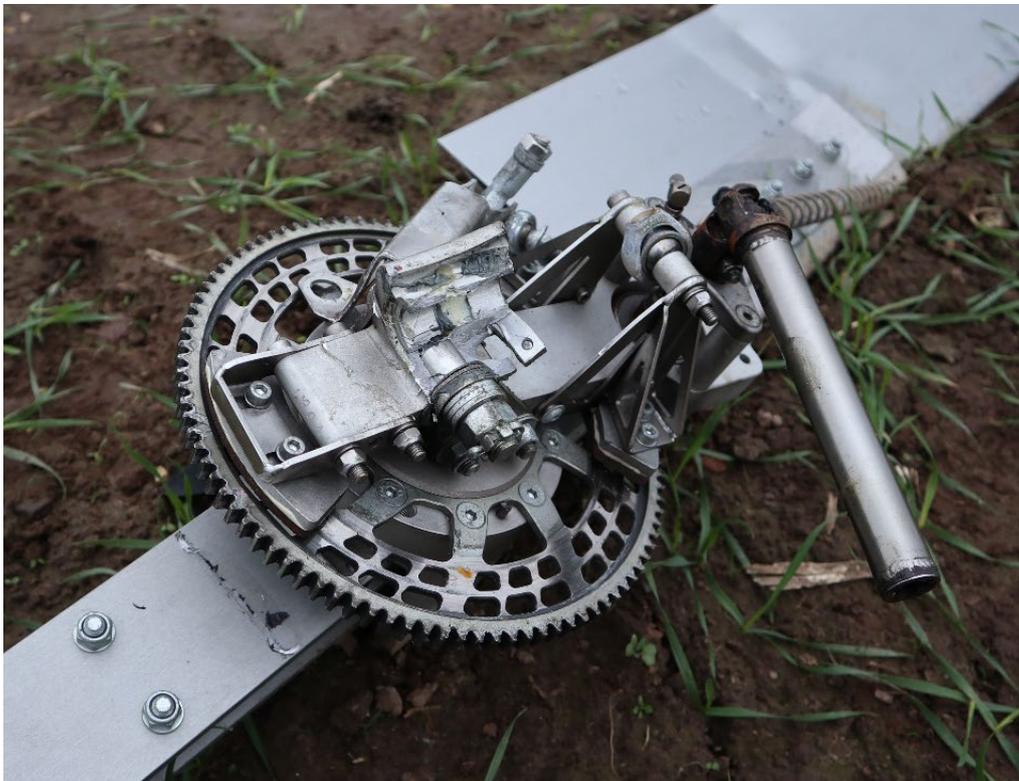
Figure 13

The gimbal block had failed where two cracks joined. One ran vertically through the roll bolt hole and down the length of the block. The other fracture surface ran horizontally through the centre of the pitch bolt hole for half the width of the gimbal block until it met the vertical fracture surface. The pitch bolt was retained in place and secured the largest section of the gimbal block to the rotor head (Figure 13). The other smaller section of gimbal block was missing and despite an extensive search, could not be located on the accident site or the surrounding fields.

Rotor head showing gimbal block failure, rotor blade deformation and teeter stop contact mark

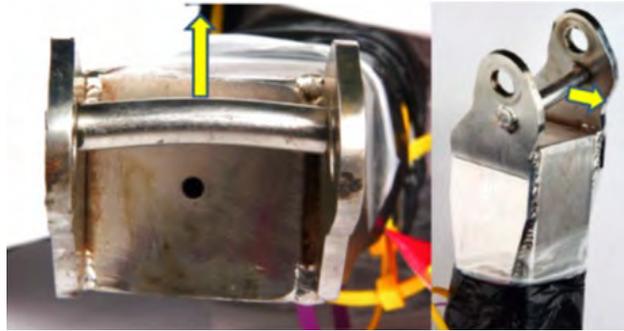
Figure 14

The roll bolt remained fitted to the top of the mast section. The roll stop bar in the mast had deformed to become curved, rather than straight (Figure 14).

Deformation of mast roll stop bar (with roll pivot bolt removed)

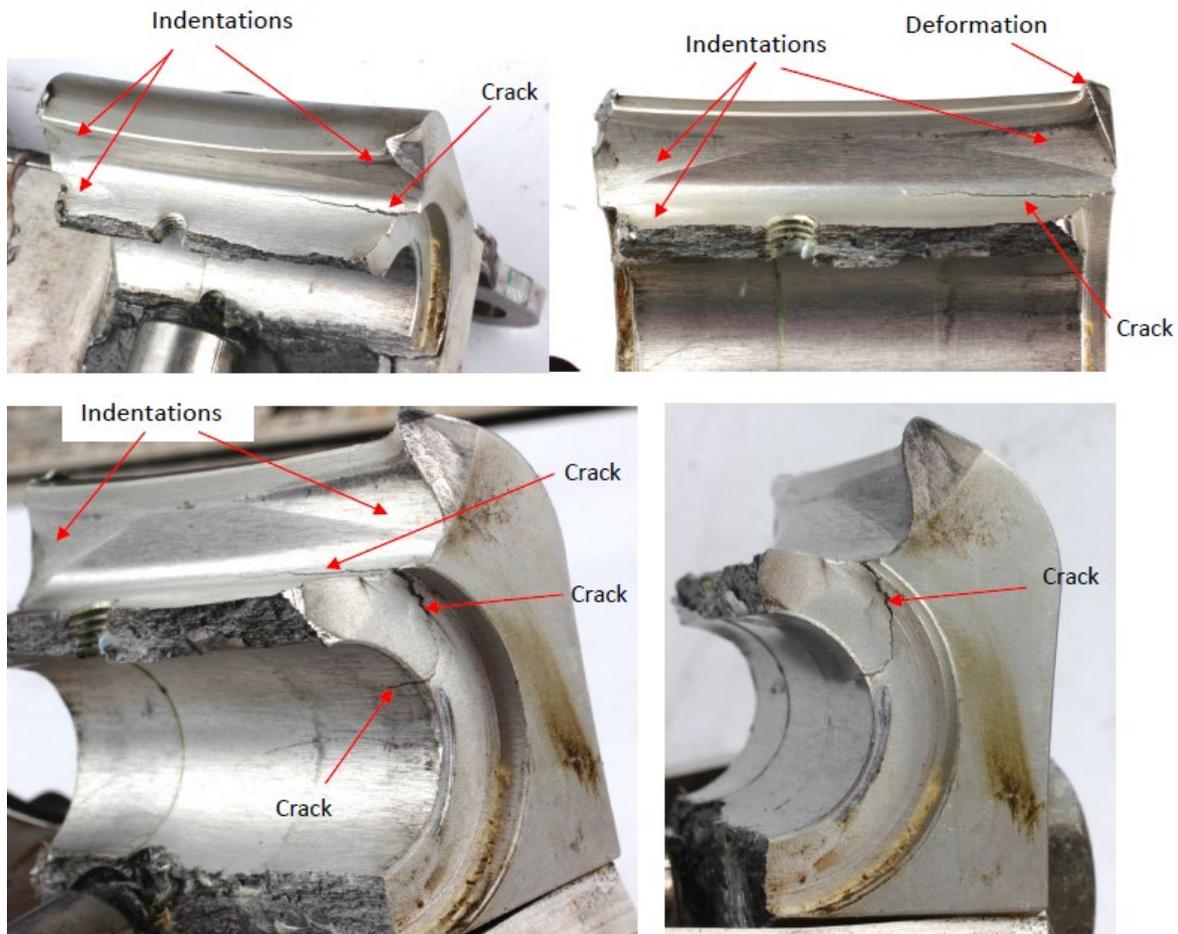
Figure 16

The rotor bridge, gimbal block and mast were removed from the wreckage and sent for metallurgical analysis. Detailed inspection of the gimbal block showed evidence of additional cracks at one end of the block. There was also a curved indentation in the side wall at each end of the channel that acted as a roll stop (Figure 16). The extent of the missing material is shown in Figure 17.

Additional cracks and deformation of the gimbal block

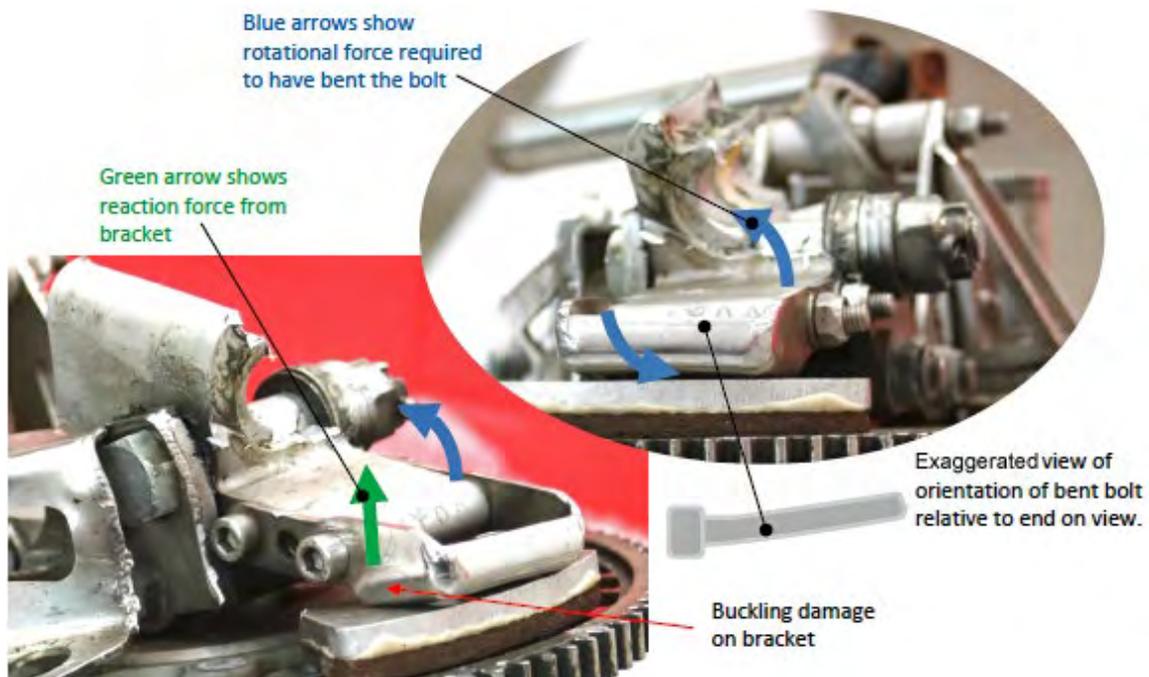
Figure 19

The side plates which attached the gimbal block to the rotor bridge on both sides were significantly distorted and the bolt holes were elongated. The bolts and bracket attaching the front brake pad assembly to the gimbal block were also distorted, indicating a rotational force on the gimbal block (Figure 19).

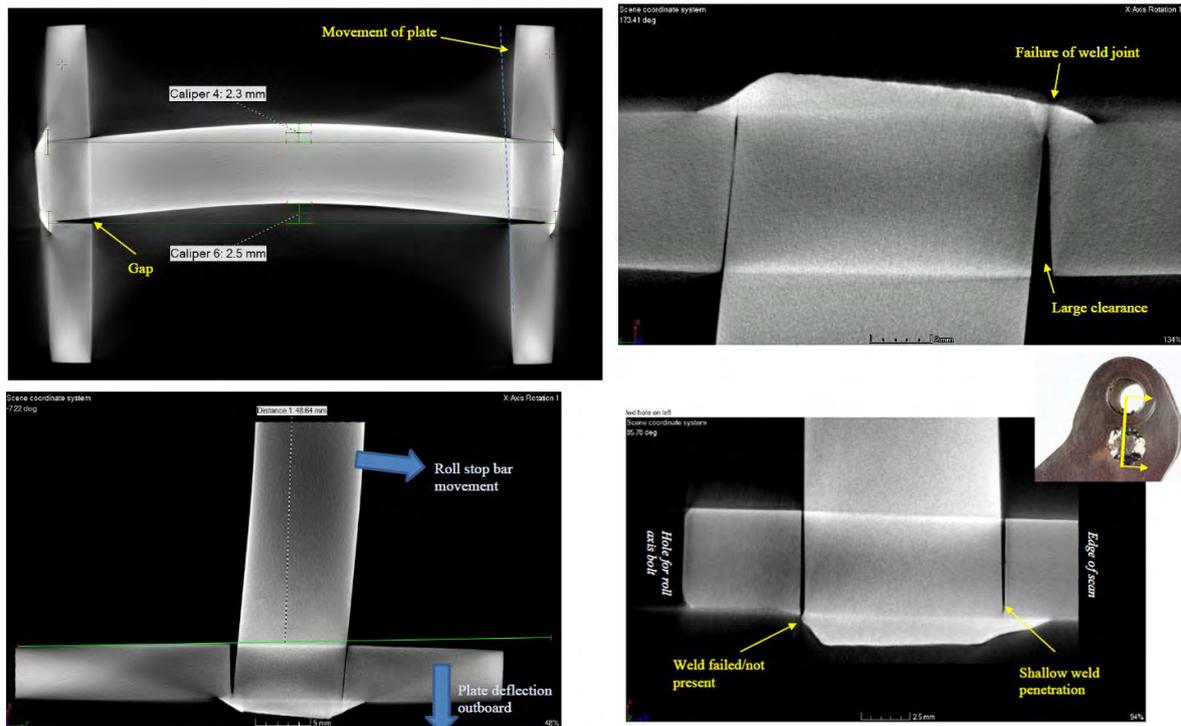
Figure 20

A CT¹¹ scan was carried out on the mast, which confirmed the extent of the roll stop bar distortion and the distortion from vertical of the side plates which supported the bar and the roll pivot bolt. The orientation of the bend in the bar was consistent with the indent marks on the gimbal block. It also showed that the end welds fixing the roll stop bar in the side plates were surface welds on the exterior of the plates, with very little penetration into the plate material. The welds on both sides of the plate had failed or on one side the weld may not have extended across the hole in the plate originally (Figure 20).

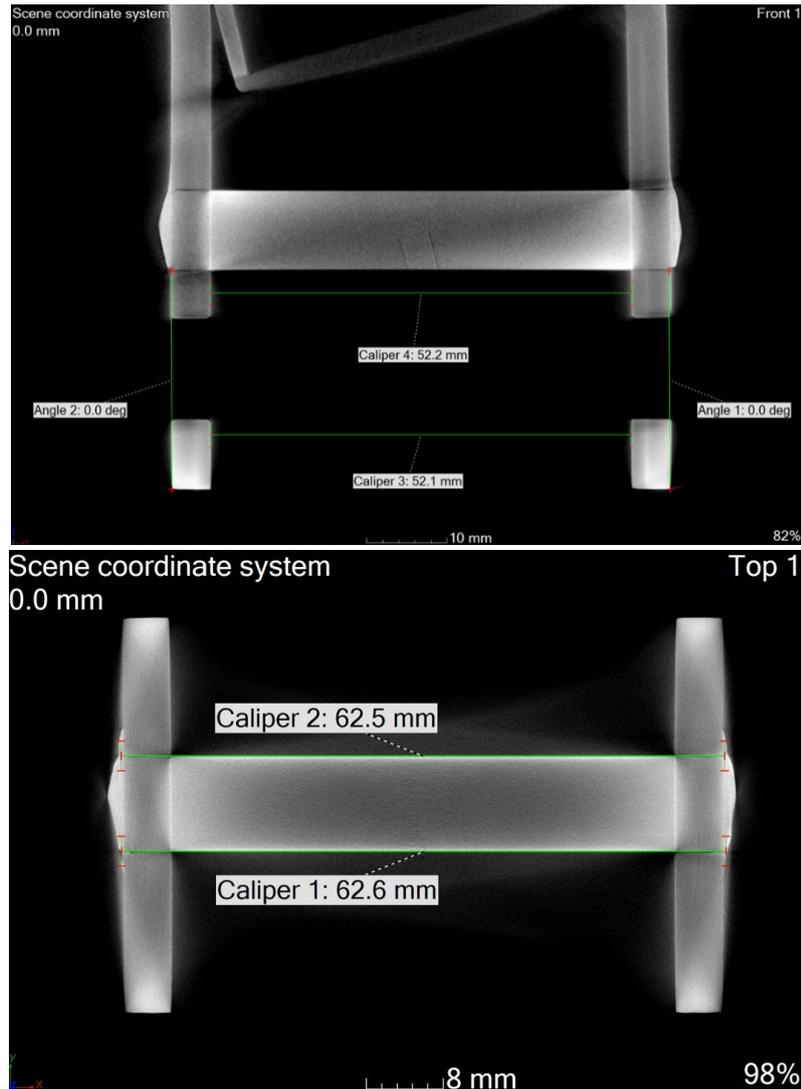
In order to assess the geometry of the mast interface found on G-CKYT, a new production mast was purchased directly from the manufacturer for comparison. This mast had not been used in operation. It was CT scanned to determine the interface dimensions and weld penetration on the roll stop bar. Figure 25 shows that the internal distance between the side plates is 52.2 mm, which was within the drawing tolerance. It also confirmed that the side plates were flat and aligned at 90° to the roll stop bar, which was straight, but the bar measured 62.5 mm, rather than the specified 65 mm.

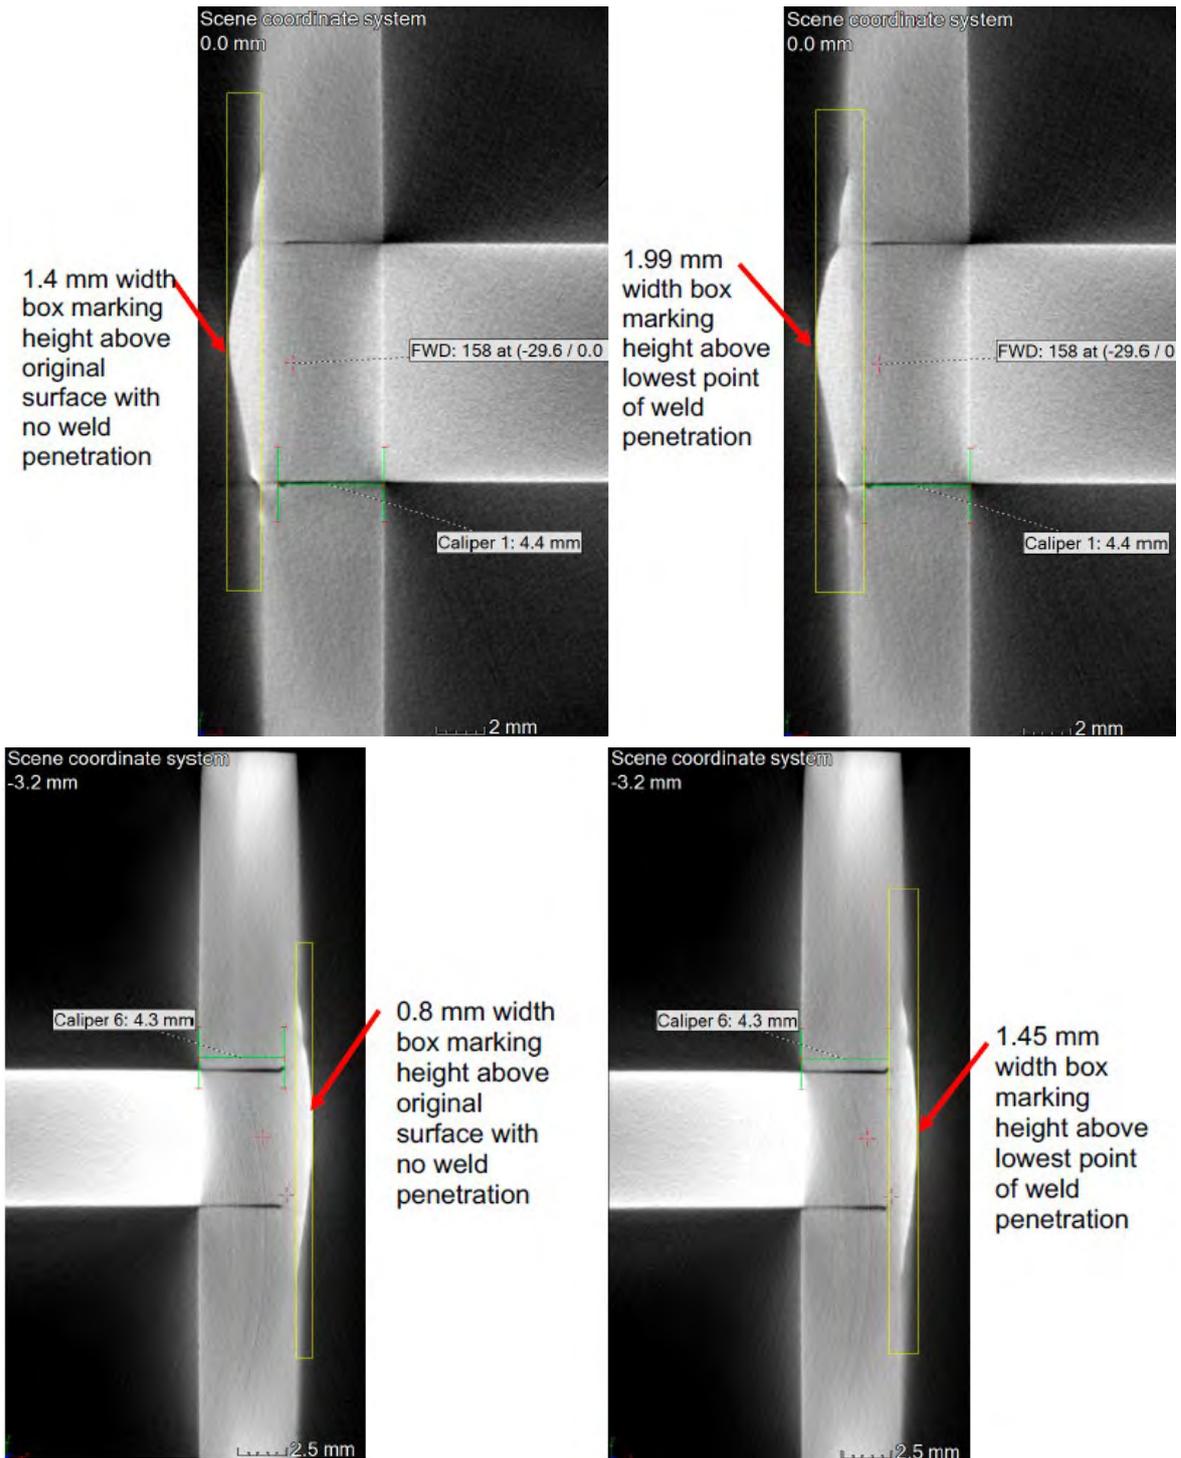
Figure 26

Measurements taken from the scan showed that the roll stop bar at its highest points extended beyond the external face of the side plates by 1.4 mm on the aft side and 0.8 mm on the forward side, although the measurement dropped significantly away from the peak. The weld depth at its deepest penetration was 1.99 mm and 1.45 mm respectively on each side, but this also varied significantly across its diameter (Figure 26).

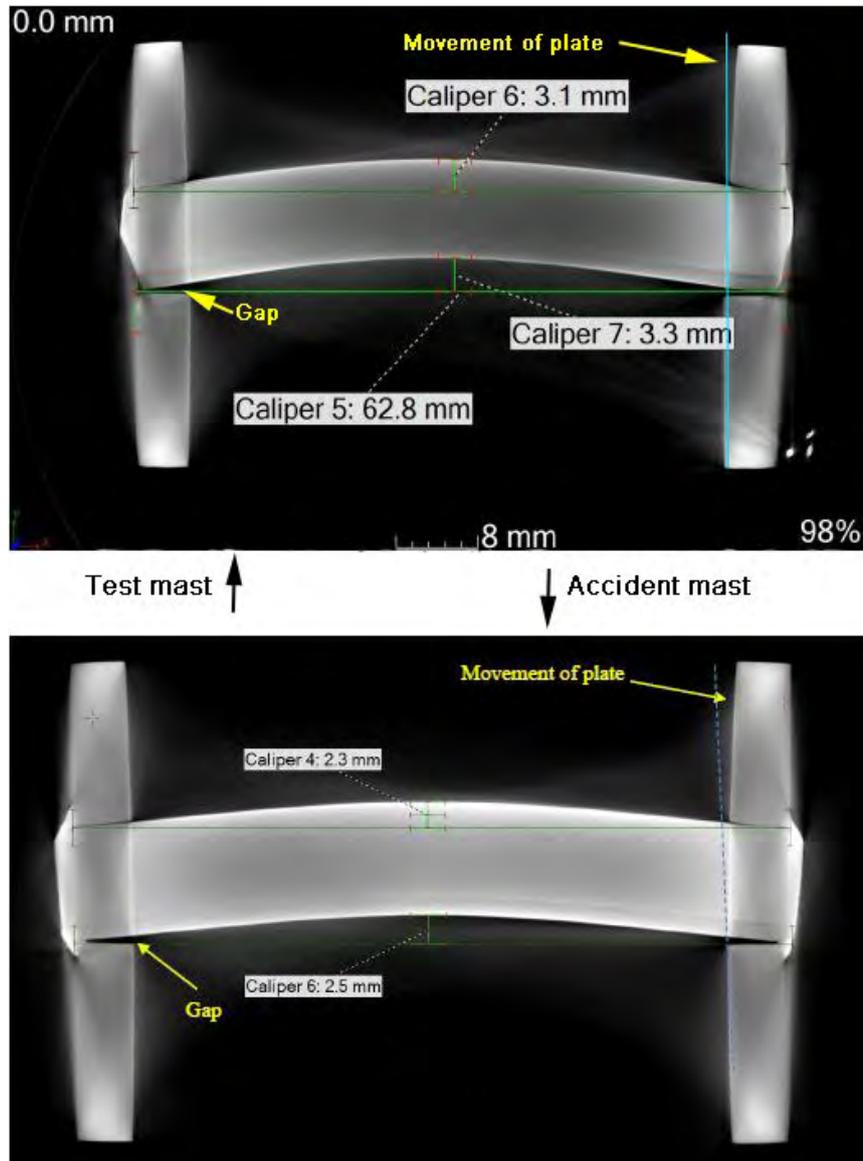
Figure 31

CT scans of the mast following the test confirmed that the bar had deformed slightly more than the accident mast, with the displacement from straight at the centre measuring 3.3 mm compared to 2.5 mm on the accident mast. The side plates were deformed outwards similar to the accident mast and the roll stop bar welds had failed on both sides, producing the same large gaps between the bar and the plate locating hole on the concave side of the bar (Figure 31).

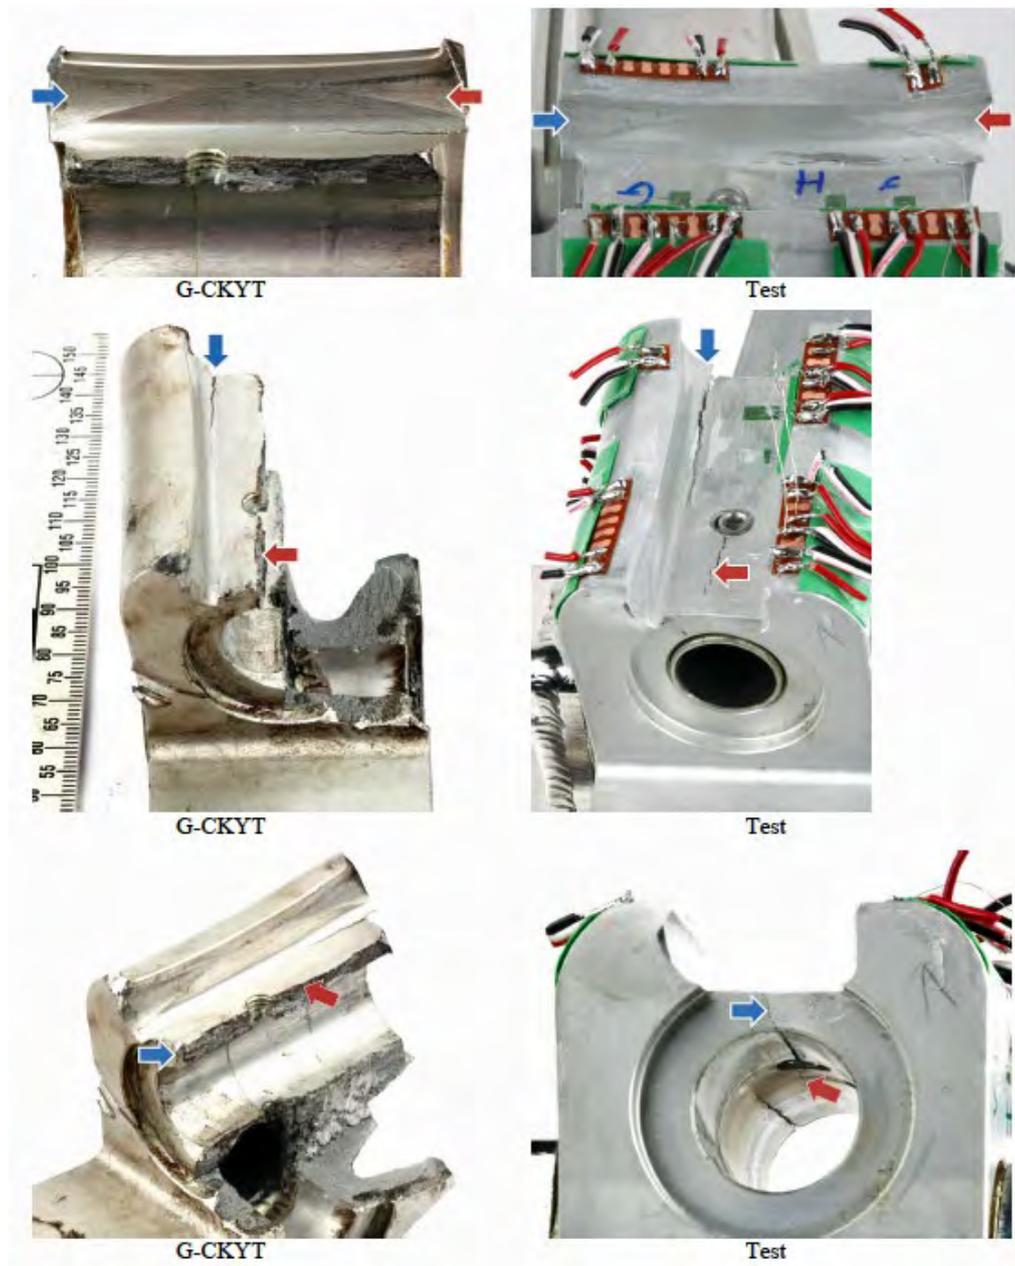
The gimbal block had also failed in a similar manner to the accident block, though as the force applied was only in the horizontal plane, only the vertical cracks were present. However, they were located in the same positions and had progressed to similar extents. Figure 32 shows this by highlighting the same cracks with the same-coloured arrows. It also shows the identical indentation marks and distortion left on the side of the channel by the roll stop bar.

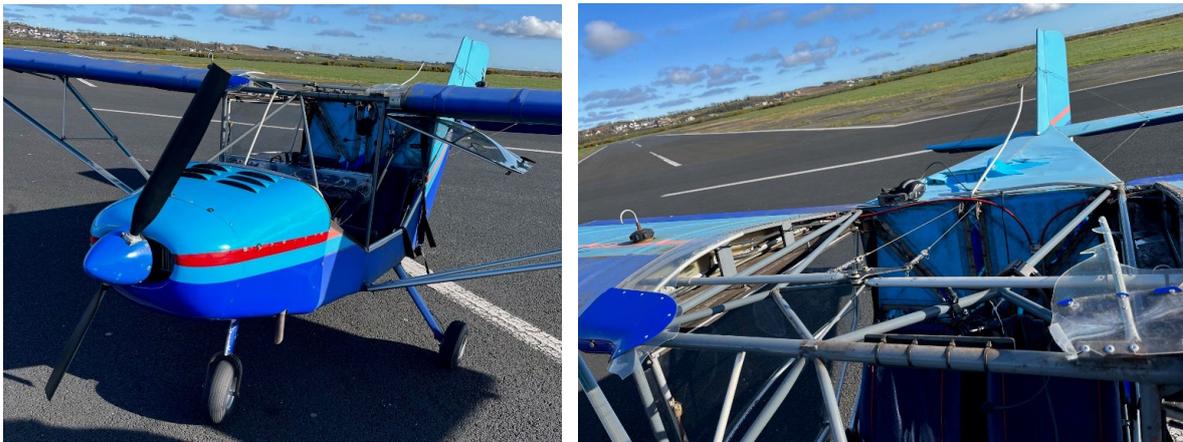
The owner said that the windscreen and skylight broke into numerous pieces and the majority had departed from the aircraft. The right door was damaged, and the Dacron fuselage material was torn in a few areas where it had been hit by broken parts. Figures 1 and 2 show the aircraft and some of the damage after landing.
