Rail Accident Investigation Branch

Rail Accident Report

Derailment of a freight train at Audenshaw, Greater Manchester 6 September 2024

Report 10/2025
December 2025

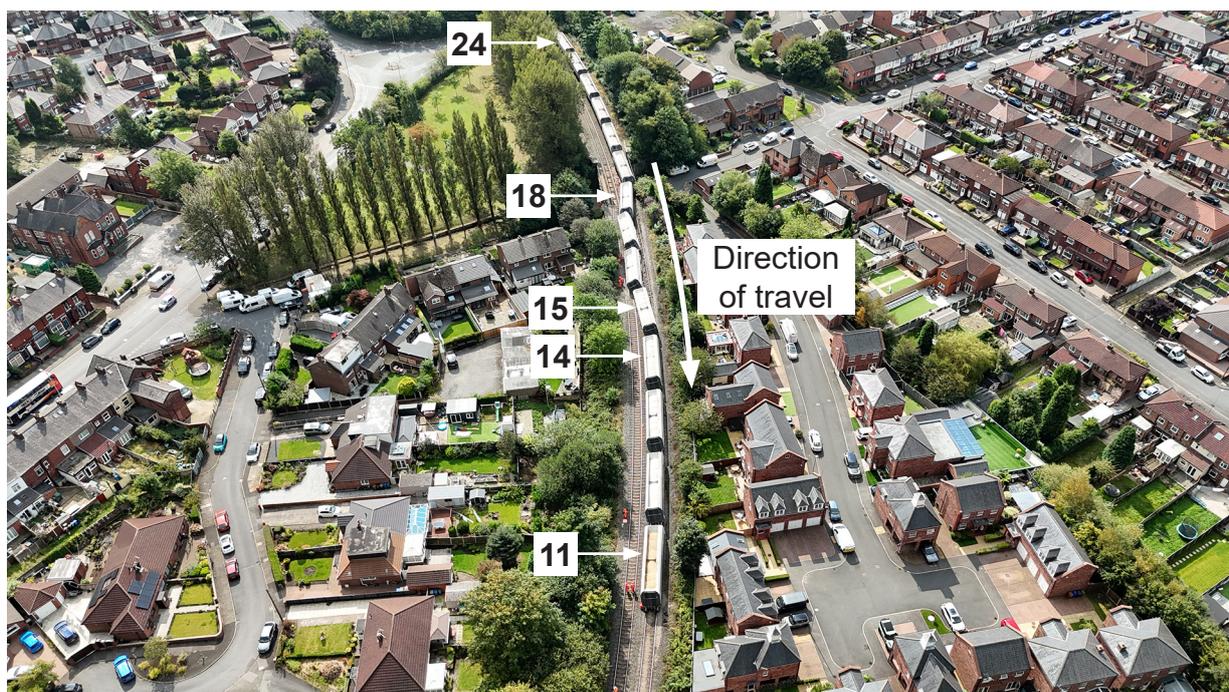
- 5 The bridge is approximately 14 metres long. The derailment happened between 2.4 and 4.8 metres from the start of the bridge and was caused by widening of the gauge (the distance between the rails), which allowed the right-hand wheels of the leading bogie of wagon 11 to drop between the rails. This caused the left-hand wheels of the wagon's leading bogie to flange climb over the left rail as the derailed wheels on the right-hand side became constrained. The right-hand wheels of the trailing bogie also dropped between the rails, with its left-hand wheels causing the rail to roll over. Wagons 12 to 14 all derailed to the left in a similar manner. As wagon 15 crossed the bridge, the right-hand rail broke underneath it at a welded joint. The rear wheels of wagons 15 and those of wagons 16 to 18 derailed to the right, initially running on the bridge deck before digging into the ballast, once they had passed over the bridge (figure 2).

Figure 2: The derailed wagons.

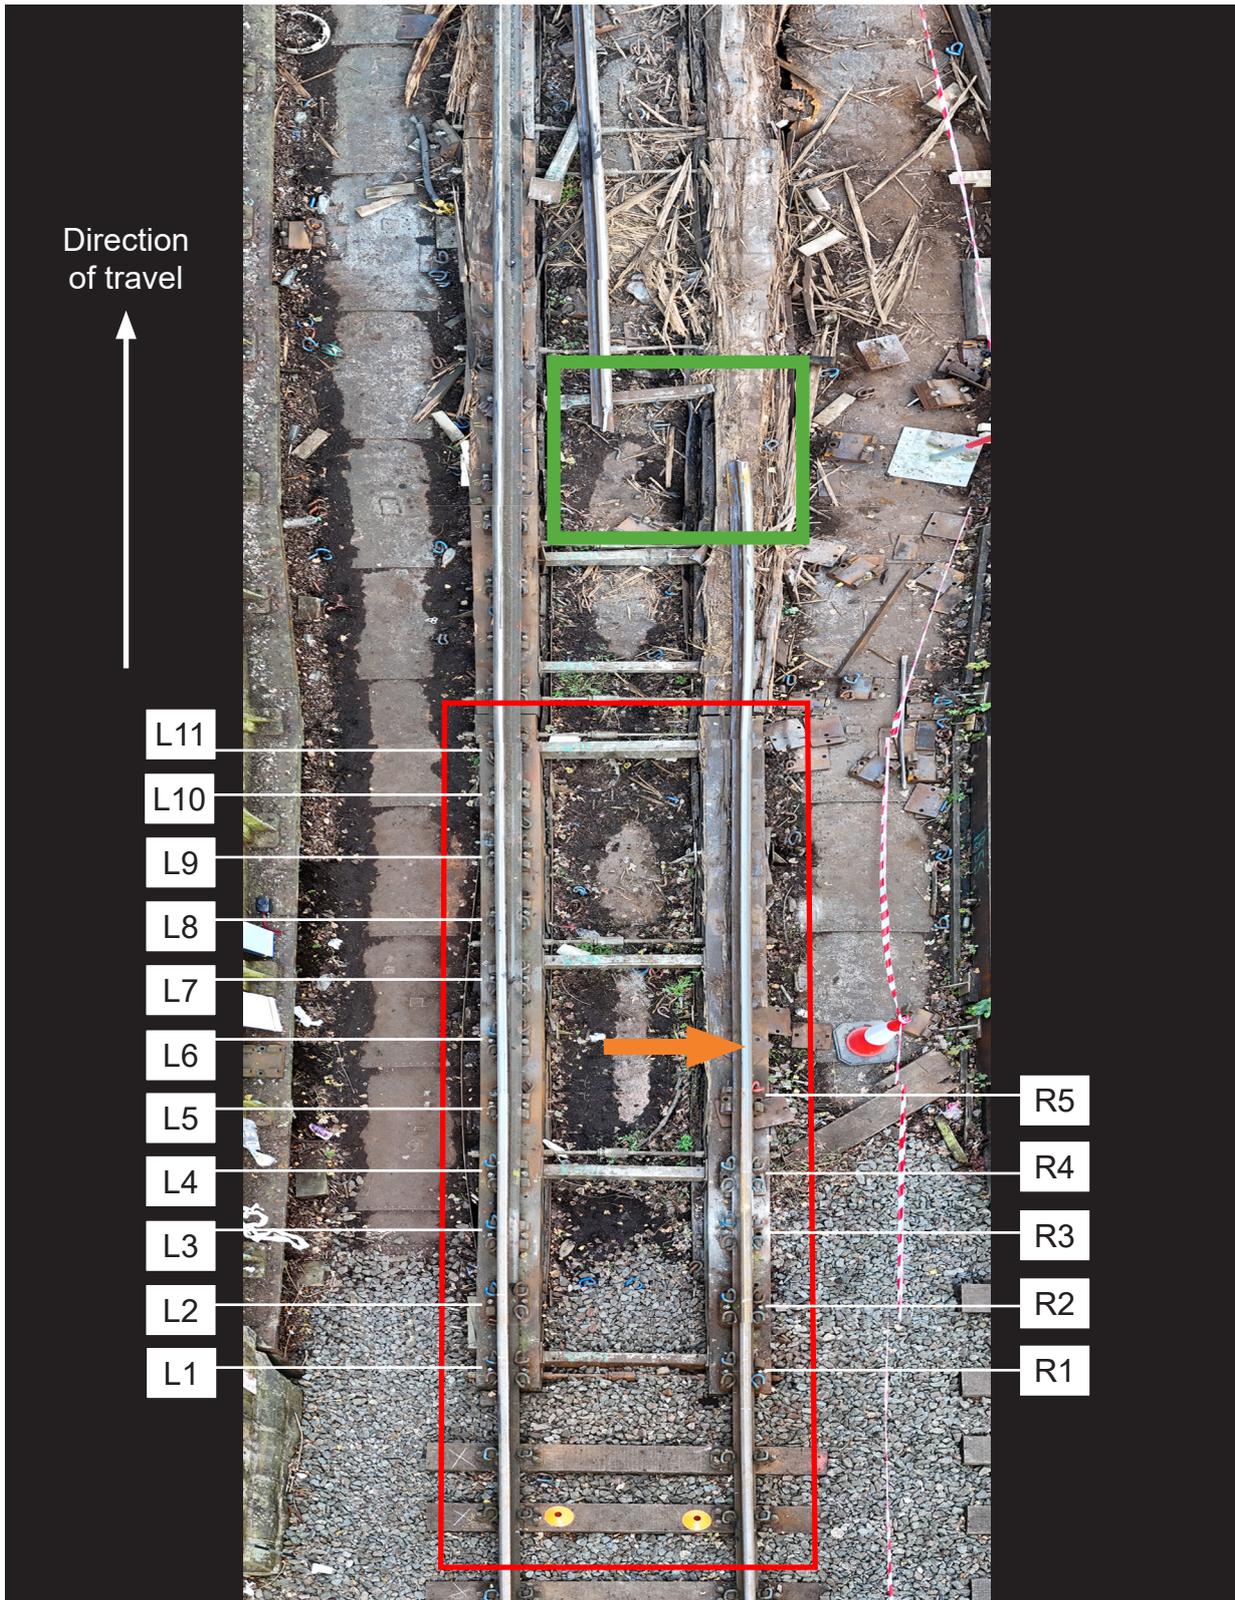
- 42 The wheels of the leading bogie of wagon 15 followed the same path until the right-hand rail broke under the wagon at a welded rail joint (green box in figure 7). Consequently, the unrestrained wheels of the rear bogie of wagon 15 derailed to the right. These wheels ran off the longitudinal bearers and onto the bridge deck, puncturing holes in it and causing debris to fall onto the footpath below. Continuing forward, these derailed wheels ran off the bridge and onto the ballast on its far side, continuing to run to the right of the original track's position.

Figure 7: Area of the LBS showing the point of derailment (arrow) and the location of the broken rail welded joint (green box). The red box indicates the track section that was removed from site for the detailed examinations. (Note: all baseplates beyond R5 were displaced during the derailment).

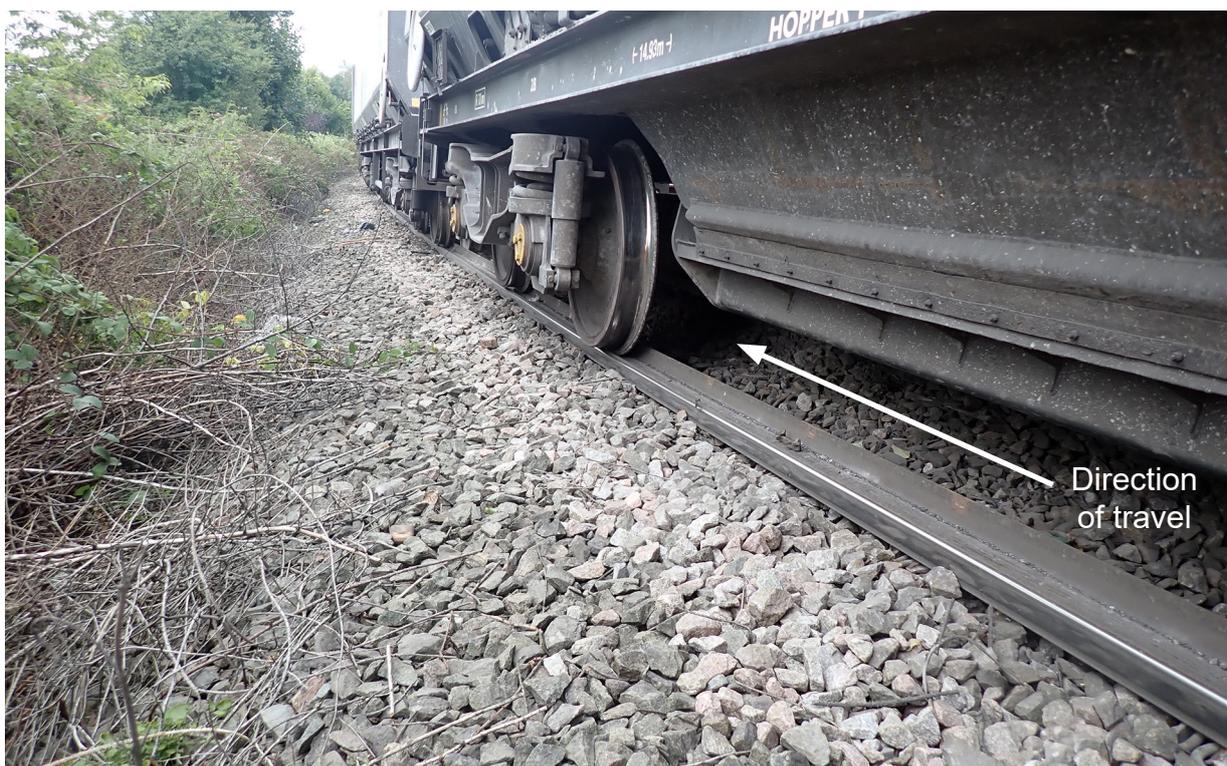
- 41 The wheels of the trailing bogie of wagon 11 followed the same path, but instead of climbing over the left-hand rail, these wheels caused the rail to overturn, rolling it free from its rail clips. The left-hand wheels then ran along the web of the overturned rail (figure 8). The following wagons 12 to 14 all derailed in the same way, with their left-hand wheels also running along the web of the overturned rail.

Figure 8: The overturned left-hand rail.

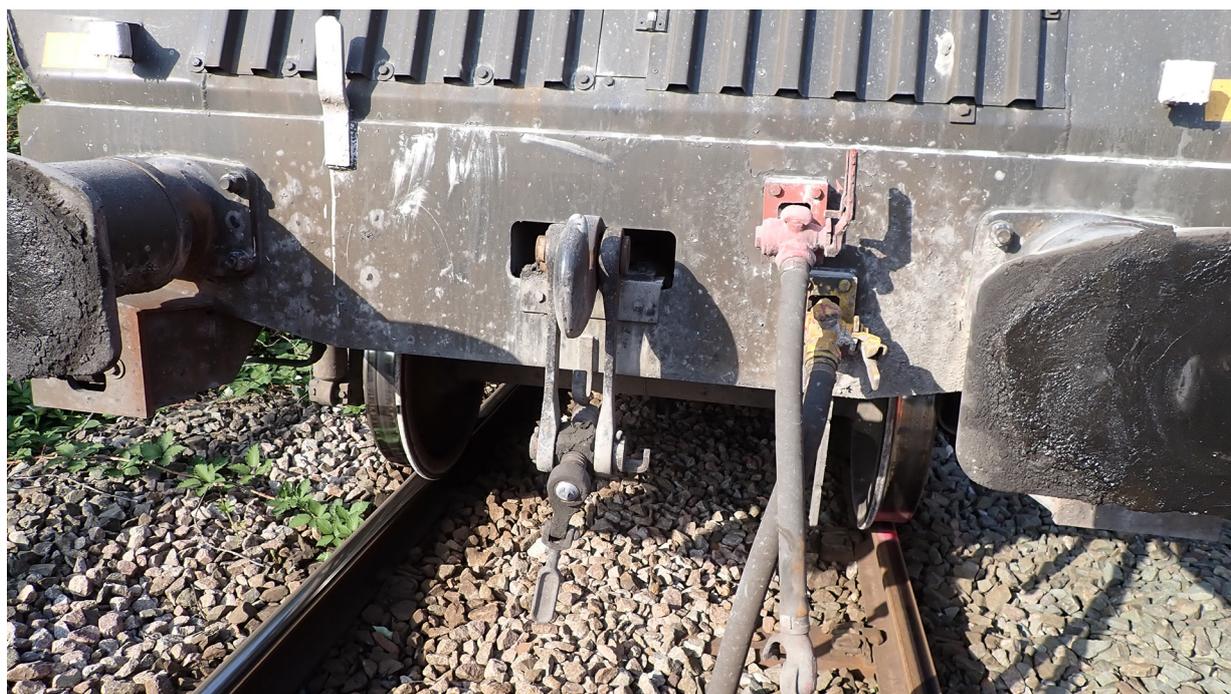
Figure 9: The broken coupling between wagons 10 and 11.

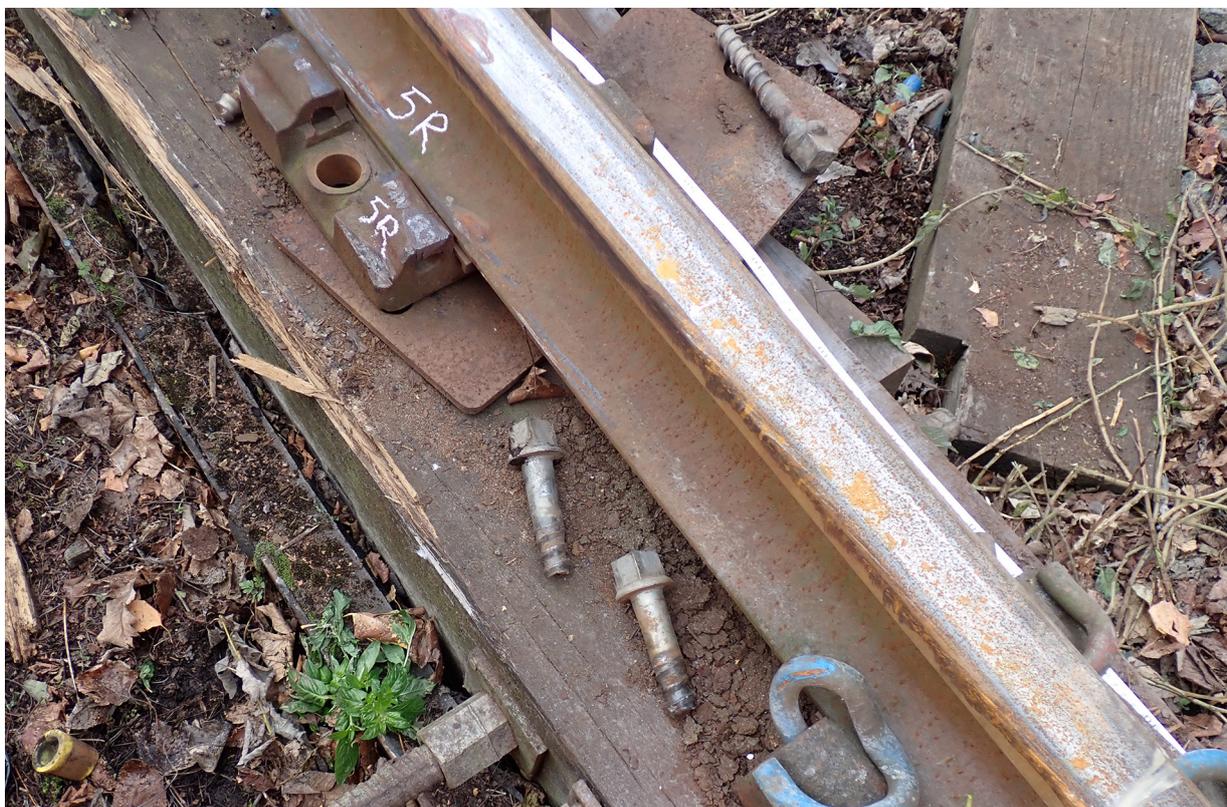
- 62 Each baseplate position was examined, with a record made of the components still in place and their condition. RAIB found that in some of the locations where the baseplate was still present, the screws had broken, but their upper portions remained in place within their ferrules and the associated baseplates' bossed holes. Some of these broken screws were so tightly wedged in the baseplate that they required a spanner to remove them. These upper portions of screws, together with those recovered from the debris scattered on the bridge deck close to the section on which the derailment initiated (a total of 22 components), were sent to an external organisation to be metallurgically examined to identify the mode of failure (figure 10).

Figure 10: Broken screws recovered from the debris on the bridge.

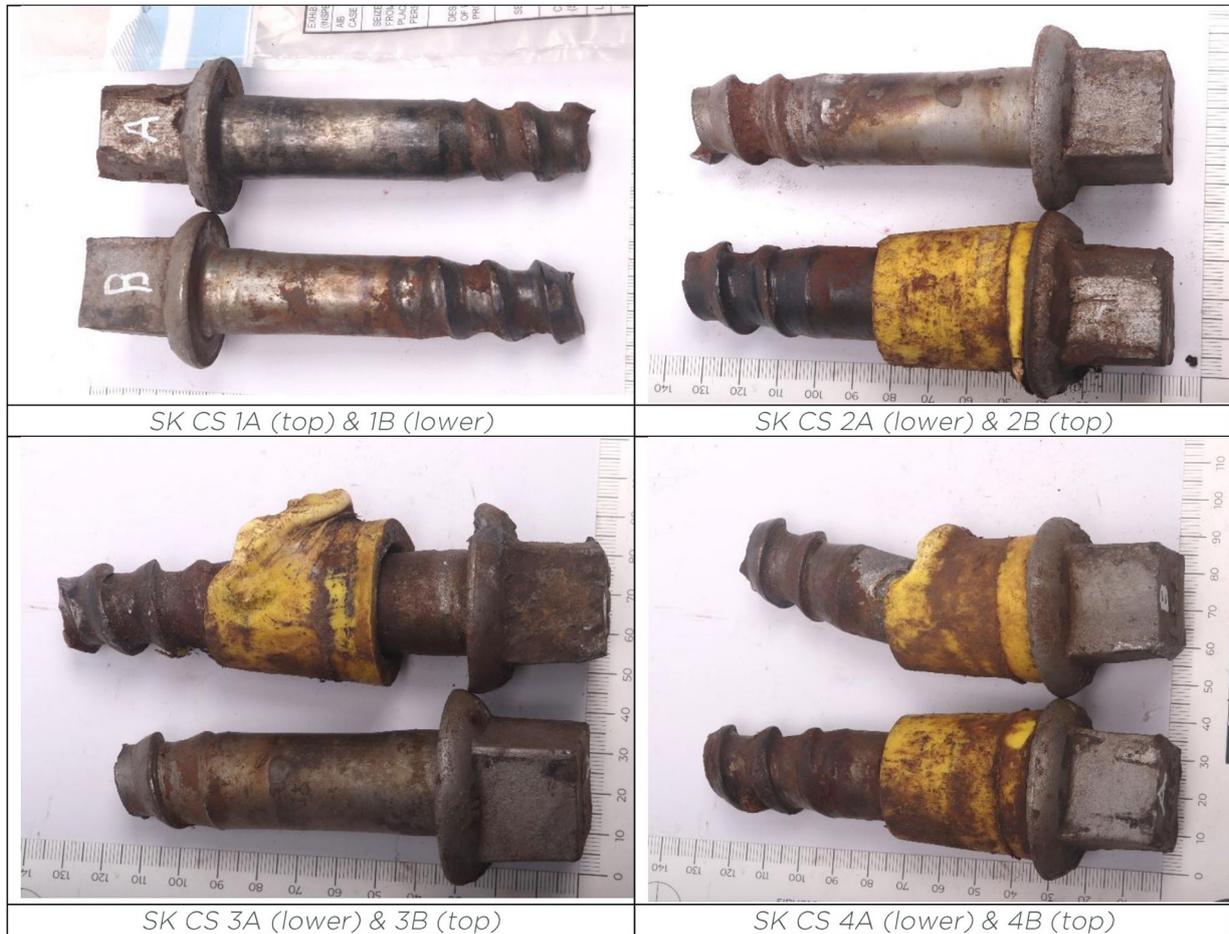
- 63 All the upper portions examined had failed within the first three threads close to where the plain shank ends and the threaded section begins (paragraph 24 and figure 11). The planes of all the fractures were below the upper surface of the bearer. There was also evidence of bending deformation on some of the screws.

Figure 11: Examples of broken upper portions of screws before metallurgical examination.

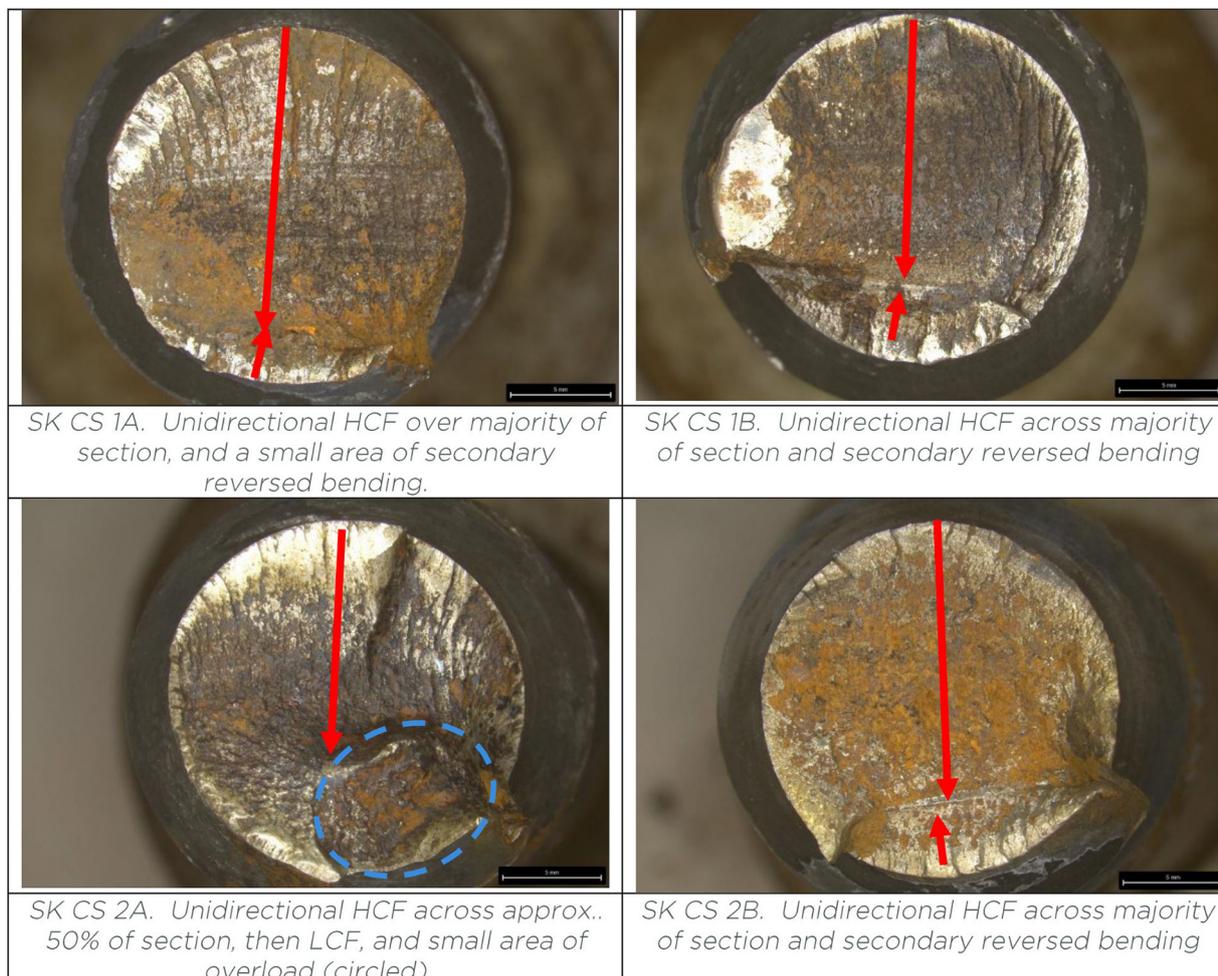
- 65 Although it was not possible from this examination to determine the ages or the sequence of the screw failures, the presence of HCF, LCF and overload failure shown on figure 12 indicates that there had been concurrent fatigue crack growth activity in all the samples examined. There was also evidence of reversed bending in most of the samples.

Figure 12: Fracture face examination showing reversed bending fatigue in three of the four samples shown, and one with signs of fatigue followed by final overload failure.

- 66 The presence of LCF followed by final overload failure in some of the screws (figure 12, lower left) indicates that the load and hence the stresses in these screws had increased once those exhibiting HCF were either partially or fully fractured. This then led to more rapid fatigue crack growth (that is, higher load and fewer loading cycles) in those showing LCF which subsequently broke by overload failure. This shows that some screws were in a deteriorated condition before the arrival of train 6J46.

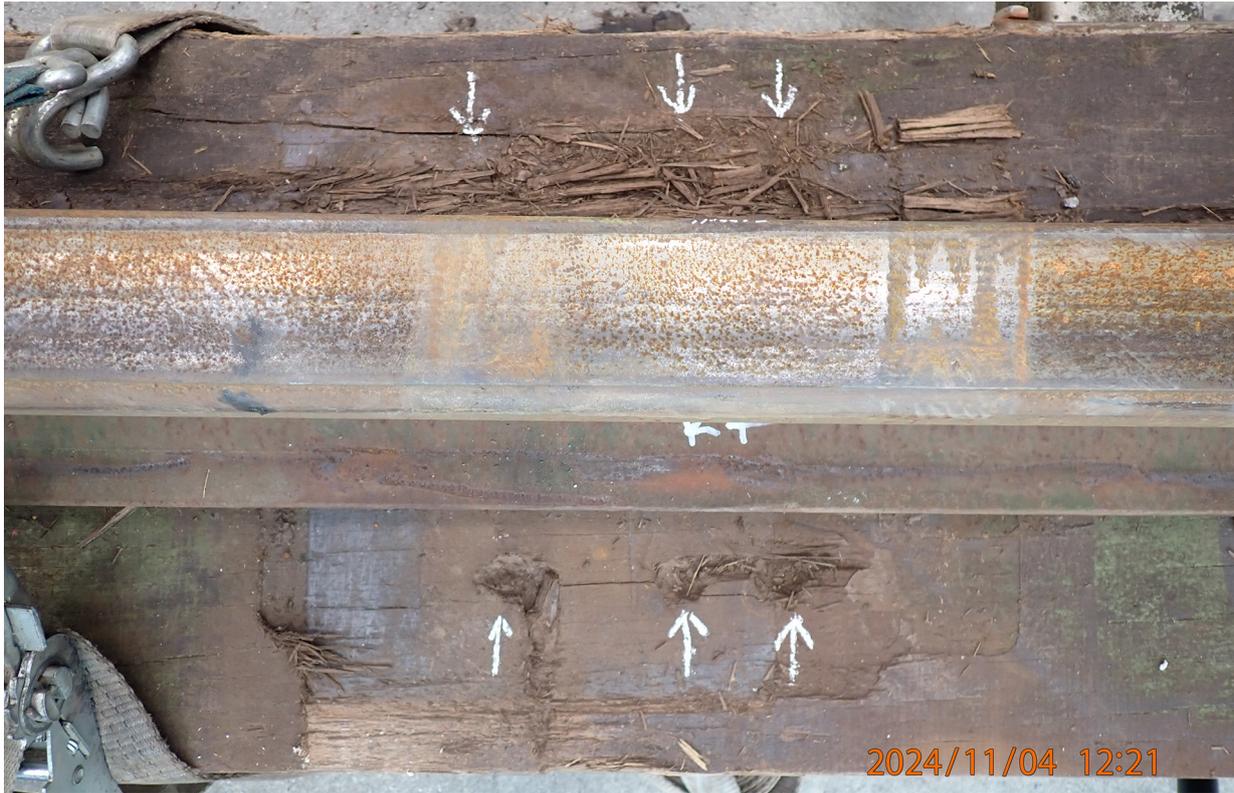
- 67 The examinations found that at baseplate positions R5 to R9 on the right-hand rail and at baseplate position L6 on the left-hand rail there were indications of multiple holes in the bearers (figure 13). Both the use of a metal detector and X-ray images confirmed the presence of lower screw portions at the majority of these locations, with some holes where no screw was present (figure 14). This showed that there had been previous screw failures and replacements before the fitting of the screws which were in place at the time of the derailment.

Figure 13: The R7 baseplate position showing evidence of previous screw holes.

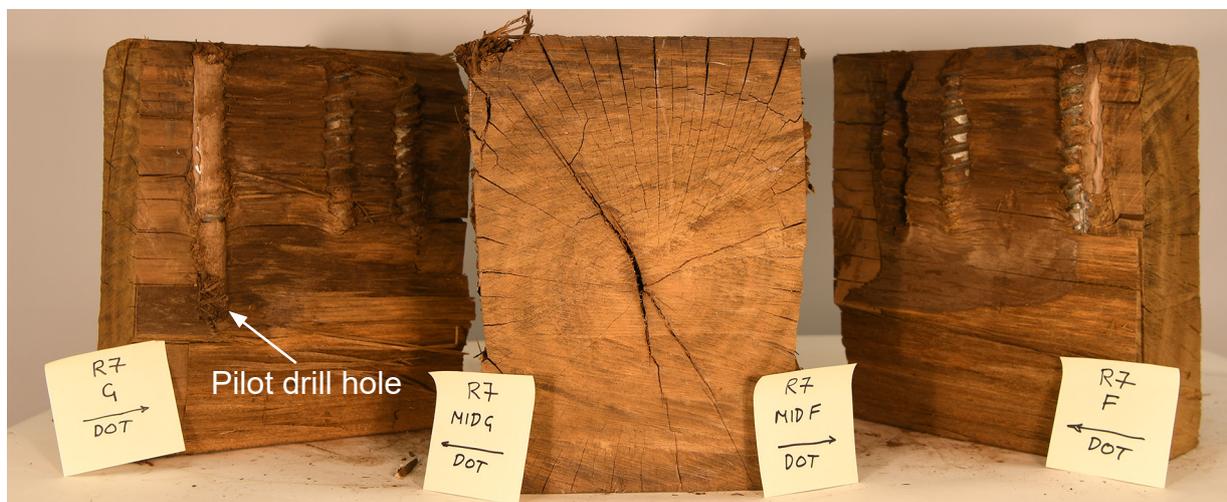
Figure 15: Cross sections of the bearer at the R7 baseplate location revealing the lower portions of broken screws.

- 69 The timber cross section at the R7 baseplate location is shown in figure 15. This is representative of the other cross sections examined. On each side of the bearer, where the baseplate had been located (the baseplate was not present due to derailment damage during the accident), there were three distinct drilled holes. A deeper pilot hole can be seen in one location. There is also wood grain deformation at the tip of one of the screws (central hole in figure 16), indicating that that hole had not been drilled to a sufficient depth. There was also evidence that both LSA and the shorter AS screws had been used at some time.

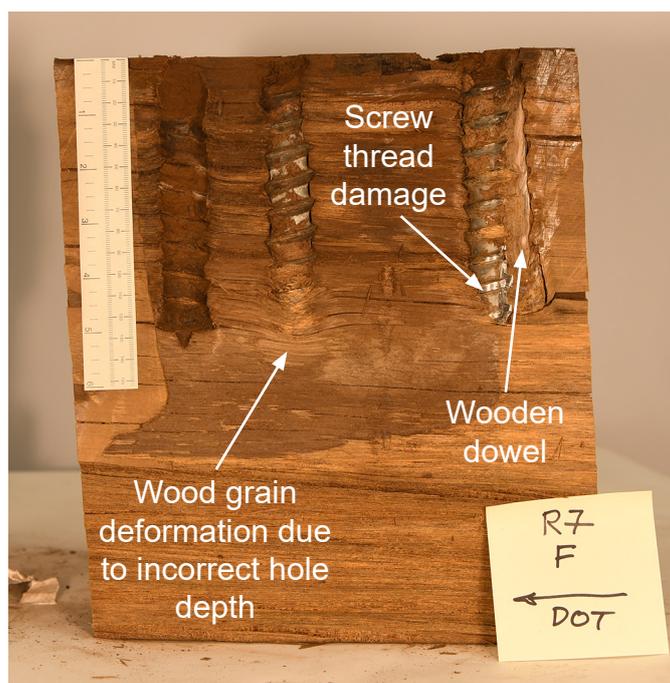
Figure 16: The screws and holes found within the sectioned R7 baseplate location.

- 72 It was noted that the drilled holes were very close to one another, sometimes breaking into each other. There is a requirement within standards to have a minimum distance between adjacent holes (see paragraph 206).

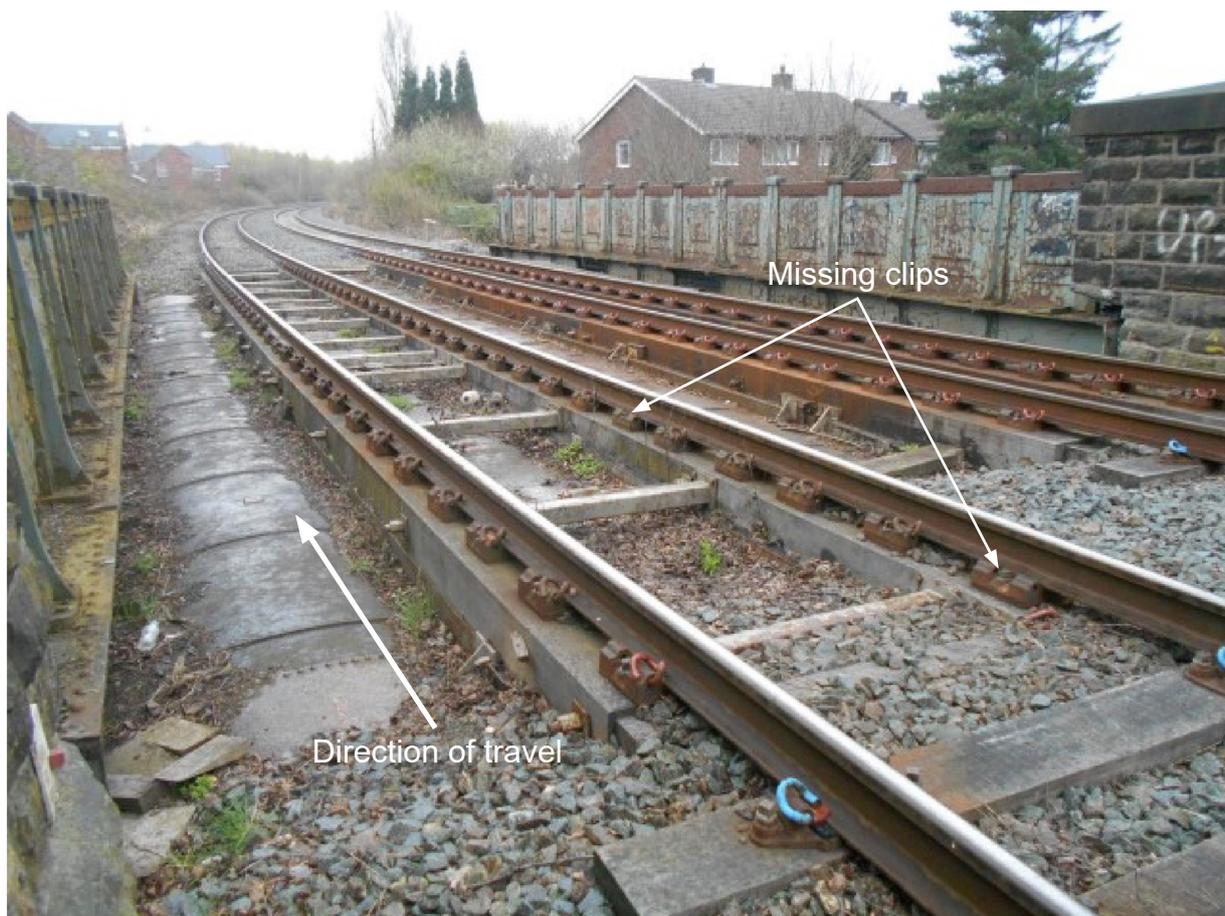
- 75 Figure 17 shows an image of the bridge deck and LBS within a structure examination report dated April 2016. It shows that, on the down line, there was some ballast migration at the leading end of the LBS and that the baseplates were originally clipped with only two clips per plate (and a few of the rail clips had been highlighted as missing).

Figure 17: The LBS on bridge 3 during a structure examination in April 2016 (courtesy of Network Rail with RAIB annotations).

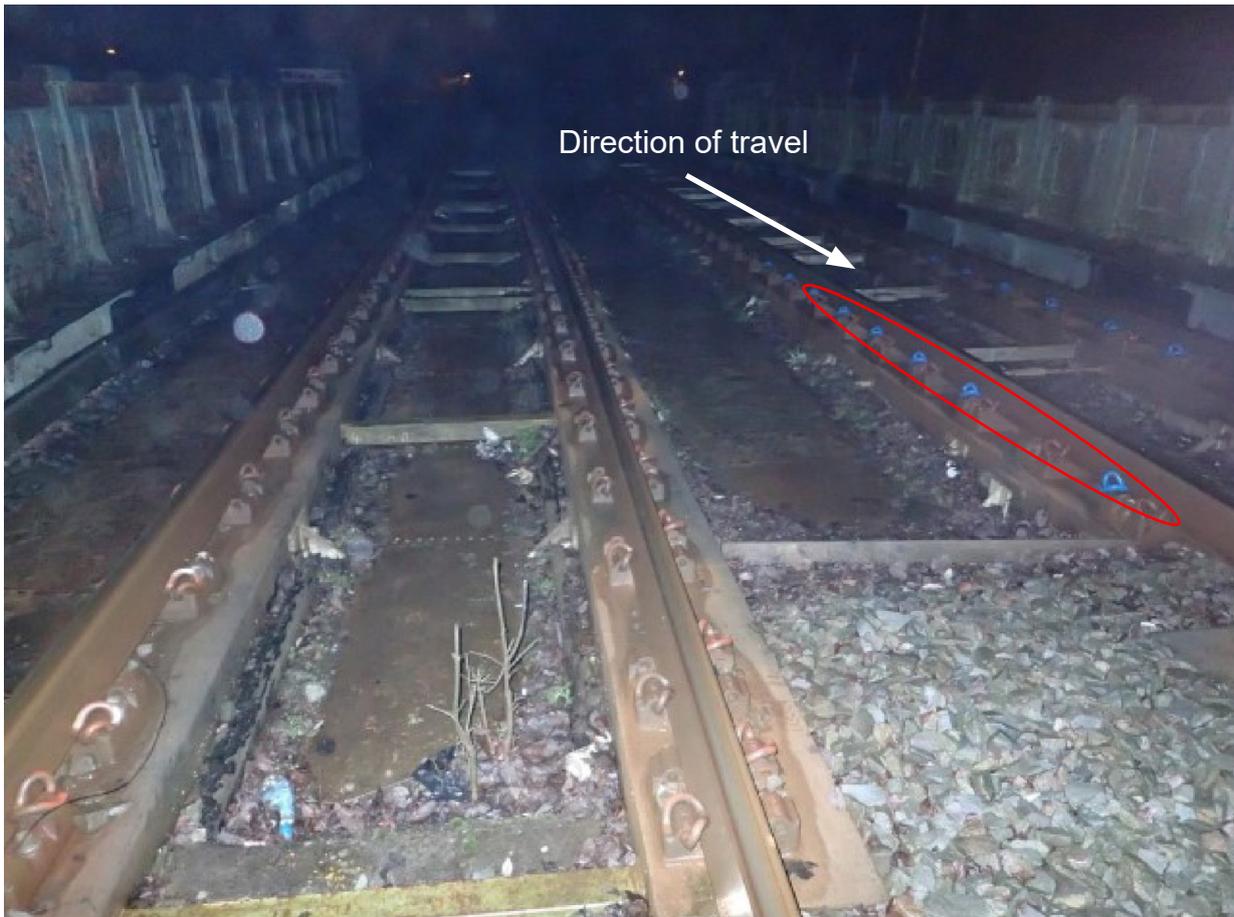
Figure 18: The LBS on bridge 3 during a structure examination in January 2018 showing additional rail clips on baseplates at the north end of the down line (courtesy of Network Rail with RAIB annotations).

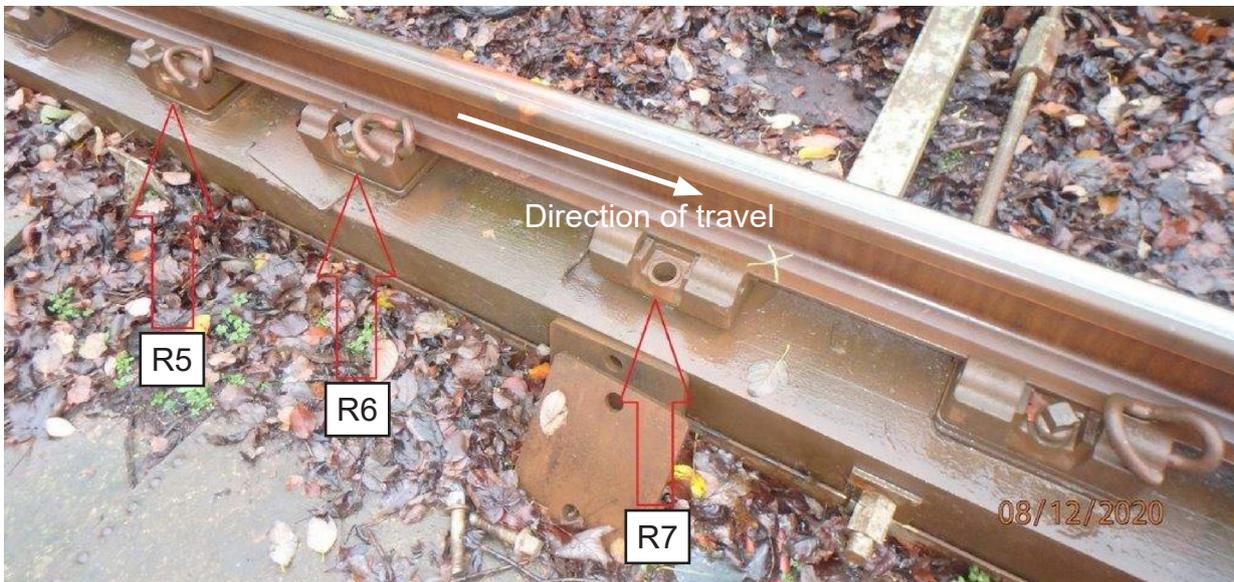
- 77 In December 2020, a structures examination identified broken screws, missing clips and displaced steel packing pieces on the right-hand rail of the down line (figure 19). This was at the south end of the bridge where the derailment took place in September 2024. Figure 19 has been annotated by RAIB to indicate baseplate positions R5, R6 and R7. This is the same location at which the derailment of train 6J46 was initiated by gauge spread.

Figure 19: The leading section of the right-hand bearer on bridge 3 observed during a structures examination of the bridge in December 2020 showing baseplates with missing rail clips, evidence of broken screws and displaced steel packing pieces (courtesy of Network Rail with RAIB annotations).

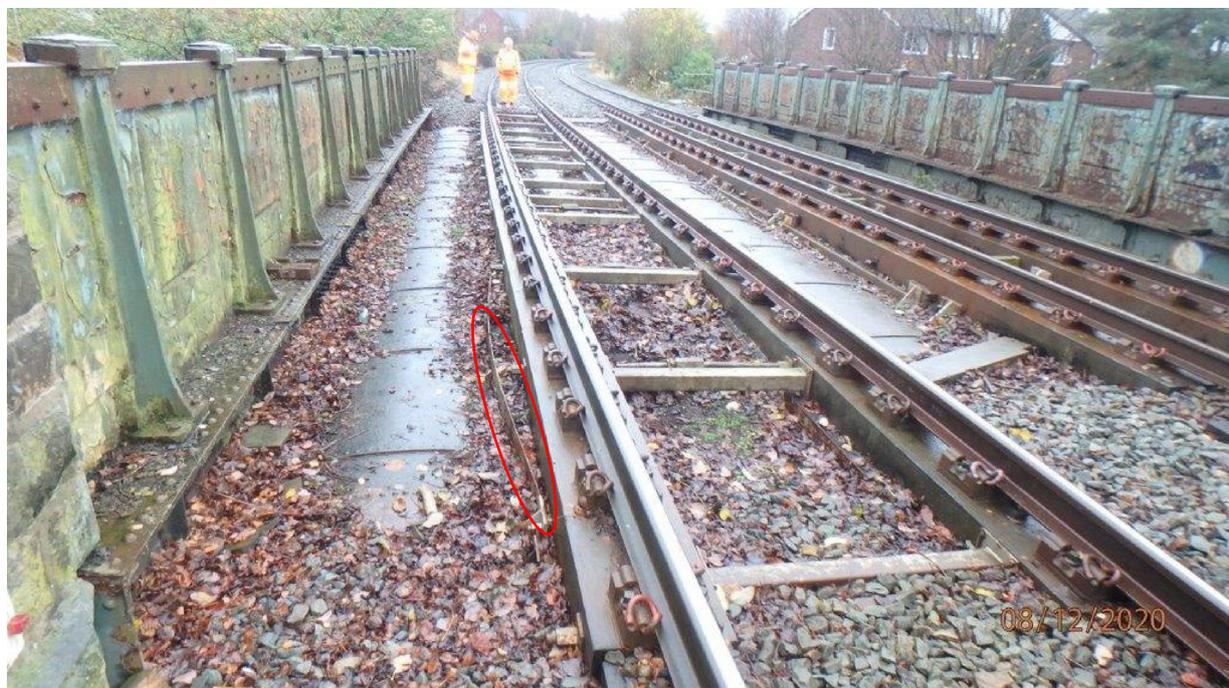
- 80 Another observation made during the structures examination in December 2020 related to the deflection in the steel strip on the cess (left-hand) bearer (figure 20). Following the derailment, RAIB found that there was no cleat fixed to the bridge deck at the mid-span of the bowed strip (nor were there any signs that there had ever been one). When the leading section of the LBS was removed from the bridge, it was found that the plywood packing pieces under the bearer had shifted towards the left causing the bow in the steel strip (figure 21). The inserts in figure 21 also show the stack of 13 plywood packing pieces recovered from a single vertical section between the bridge deck and the bearer, together with a broken vertical restraint rod from the far end of the right-hand bearer of the first LBS section recovered from site.

Figure 20: The leading section of the down line on bridge 3 observed during a structure examination in December 2020 showing the bowed steel strip and the location of the missing cleat (courtesy of Network Rail with RAIB annotations).

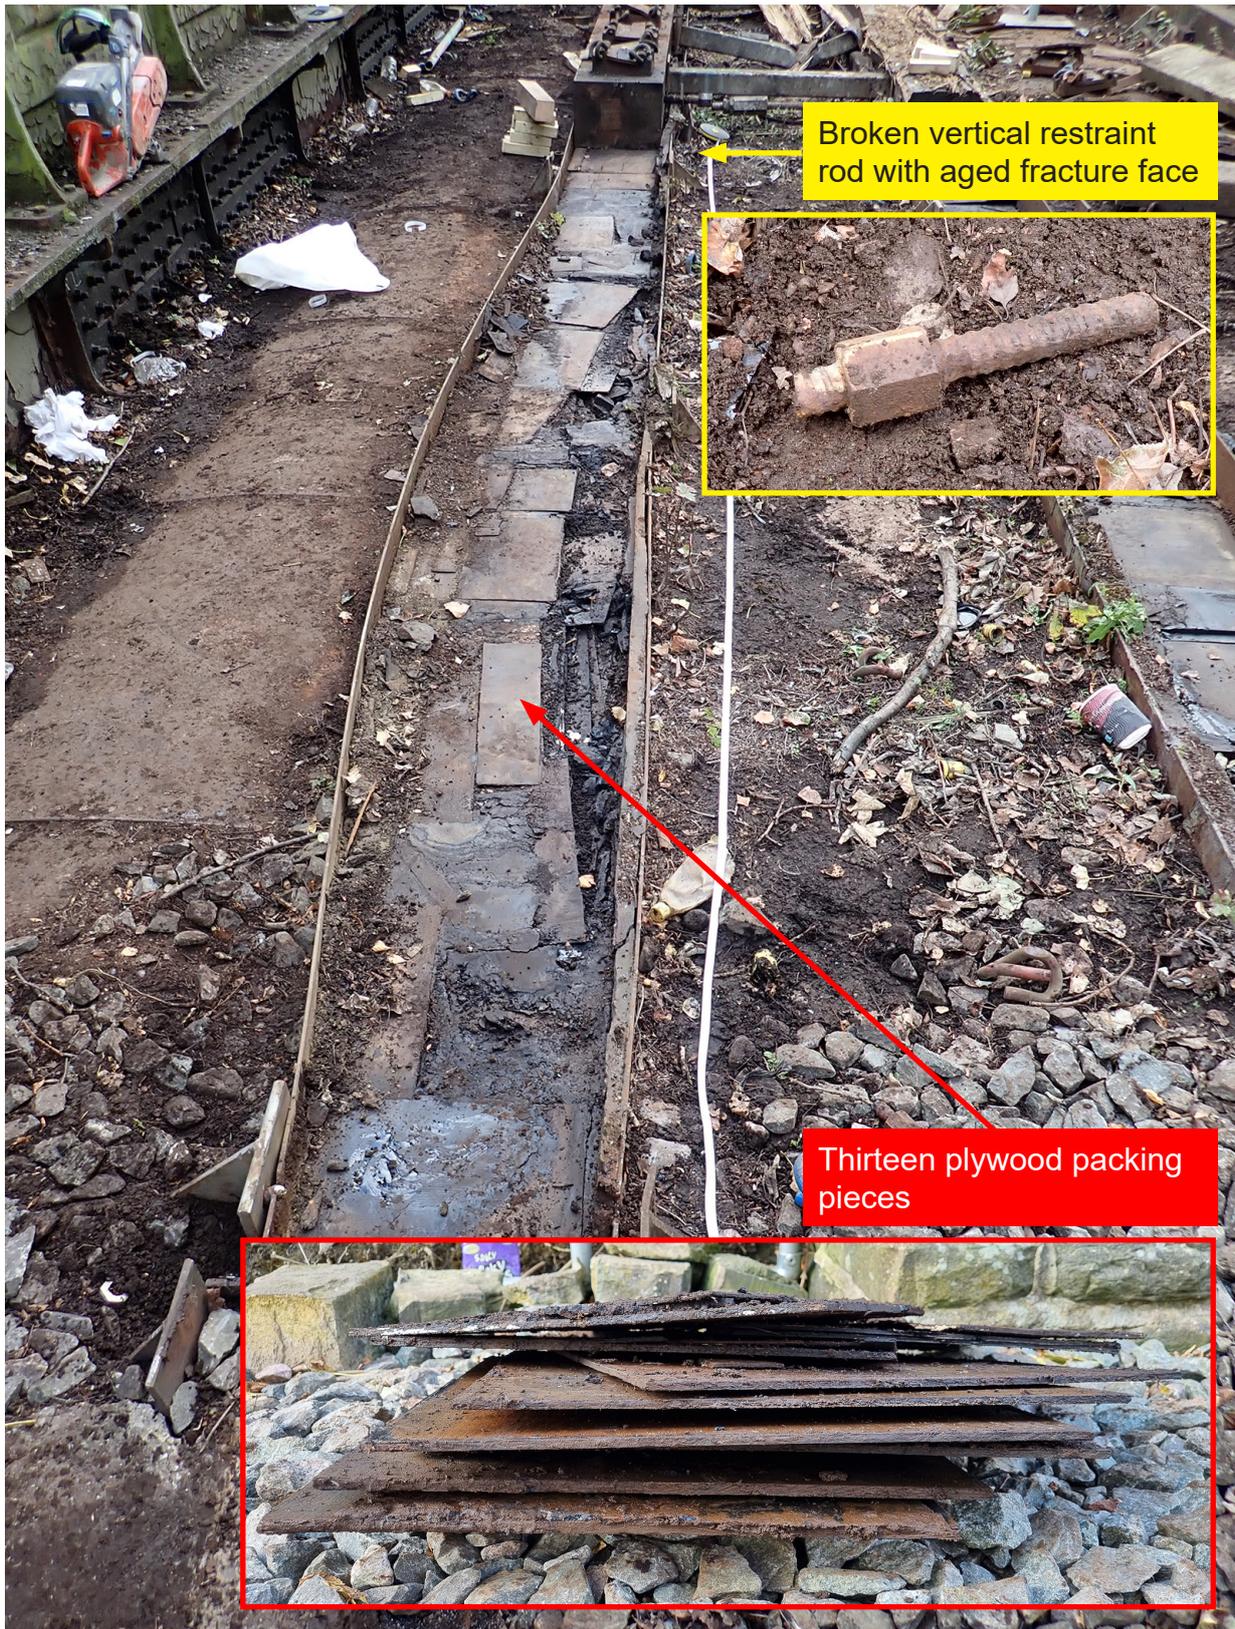
Figure 21: The leading section of the down line cess-side bearer on bridge 3 following removal of the bearer and rail.

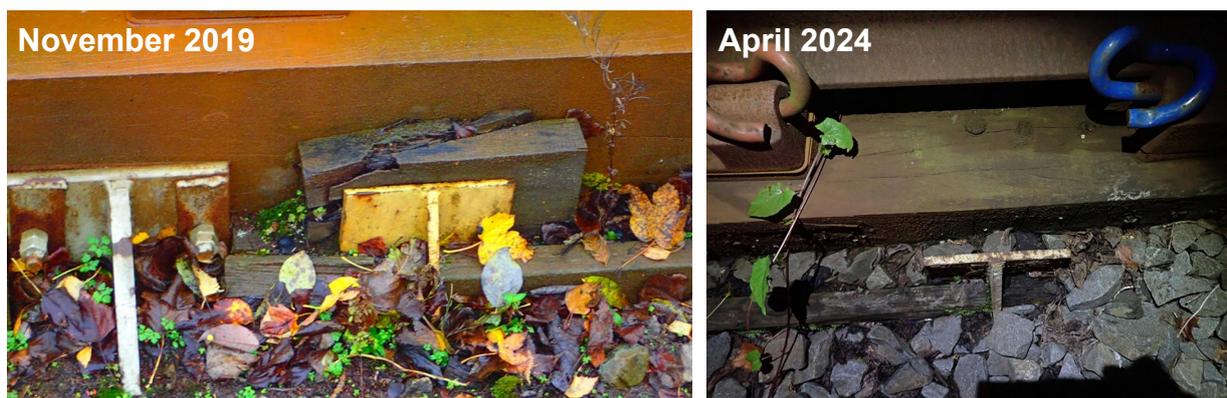
- 81 The movement of the plywood packing pieces together with the aged fracture of the vertical restraint rod at the end of the bearer suggest that there had been differential vertical deflection between the LBS and the bridge deck. This, and the lack of cleat on the cess side of the steel strip allowed the many plywood packing pieces (which were found to be damp and slippery following the accident) to slide to the left. There are no records from Guide Bridge depot regarding the bowed strip or the broken rod at around that time. The bowed strip and broken rod are not mentioned in the inspection records during the months before the derailment.
- 82 Many of the structures inspection reports over this time noted missing or rotten wooden wedges (figure 22). RAIB also observed this at some of the cleat locations during its time on site.

Figure 22: Photographs from structure examination reports on two dates showing the typical states of the wooden wedges between the cleats and the bearer sides (courtesy of Network Rail with RAIB annotations).

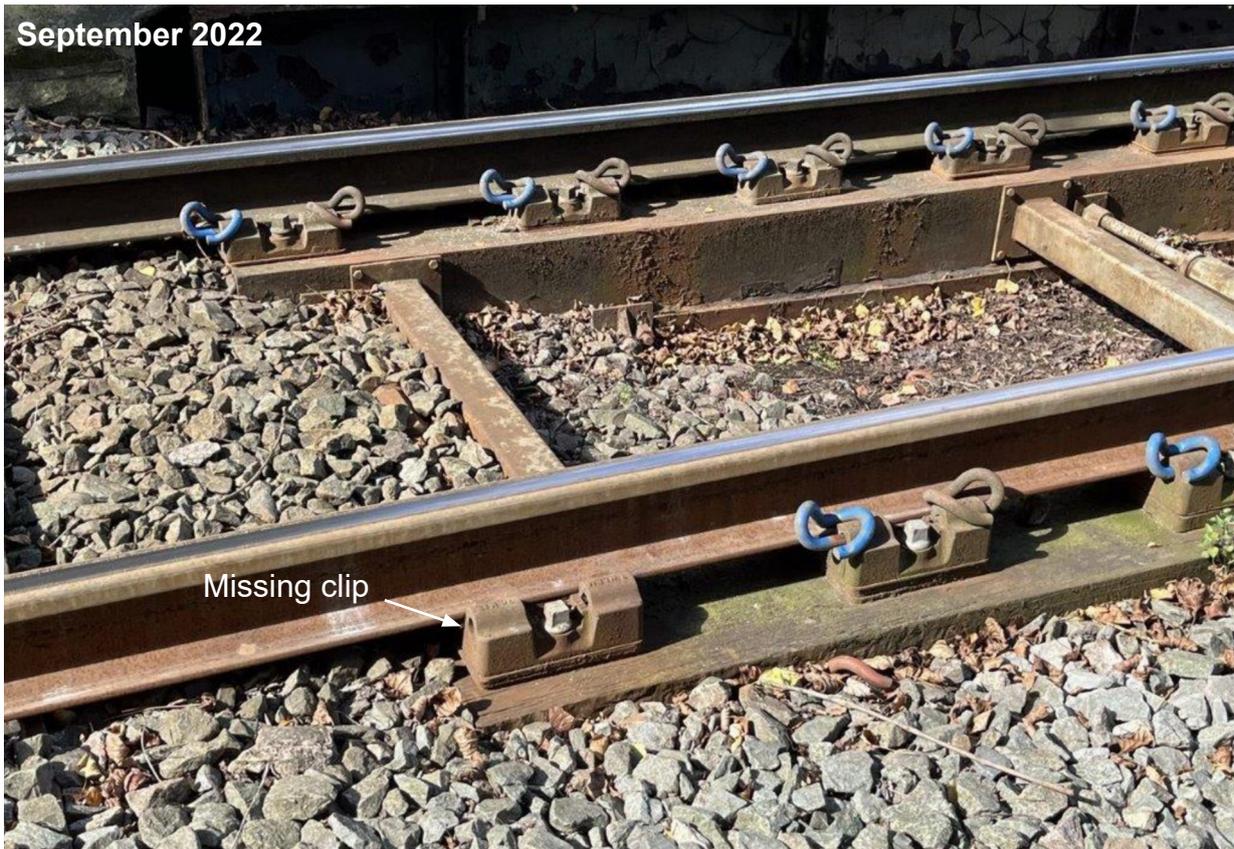
Figure 23: The presence of additional clips on the baseplates and missing clips from the baseplate at position R1 observed during a structure examination report in September 2022 (courtesy of Network Rail with RAIB annotations).

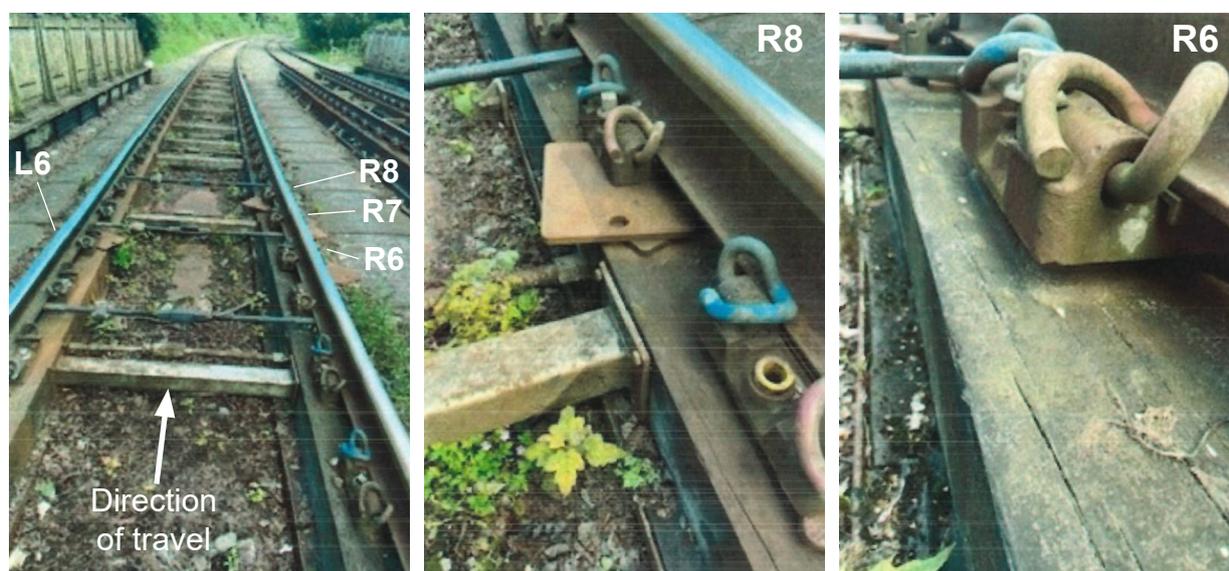
- 87 Attached to this SVI report were some photographs (figure 25). Witness evidence states that these were taken at the time of this inspection. The left image shows the south end of the down line, and three gauge tie bars can clearly be seen. The centre and right images show locations with evidence of broken screws. These are at adjacent baseplate locations to those that had failed in 2020 (paragraph 77) and were in the same area as the screw failures which led to this later derailment.

Figure 25: The down line as observed on the 9 August 2023 SVI report showing gauge tie bars fitted and displaced steel packing plates (courtesy of Network Rail with RAIB annotations).

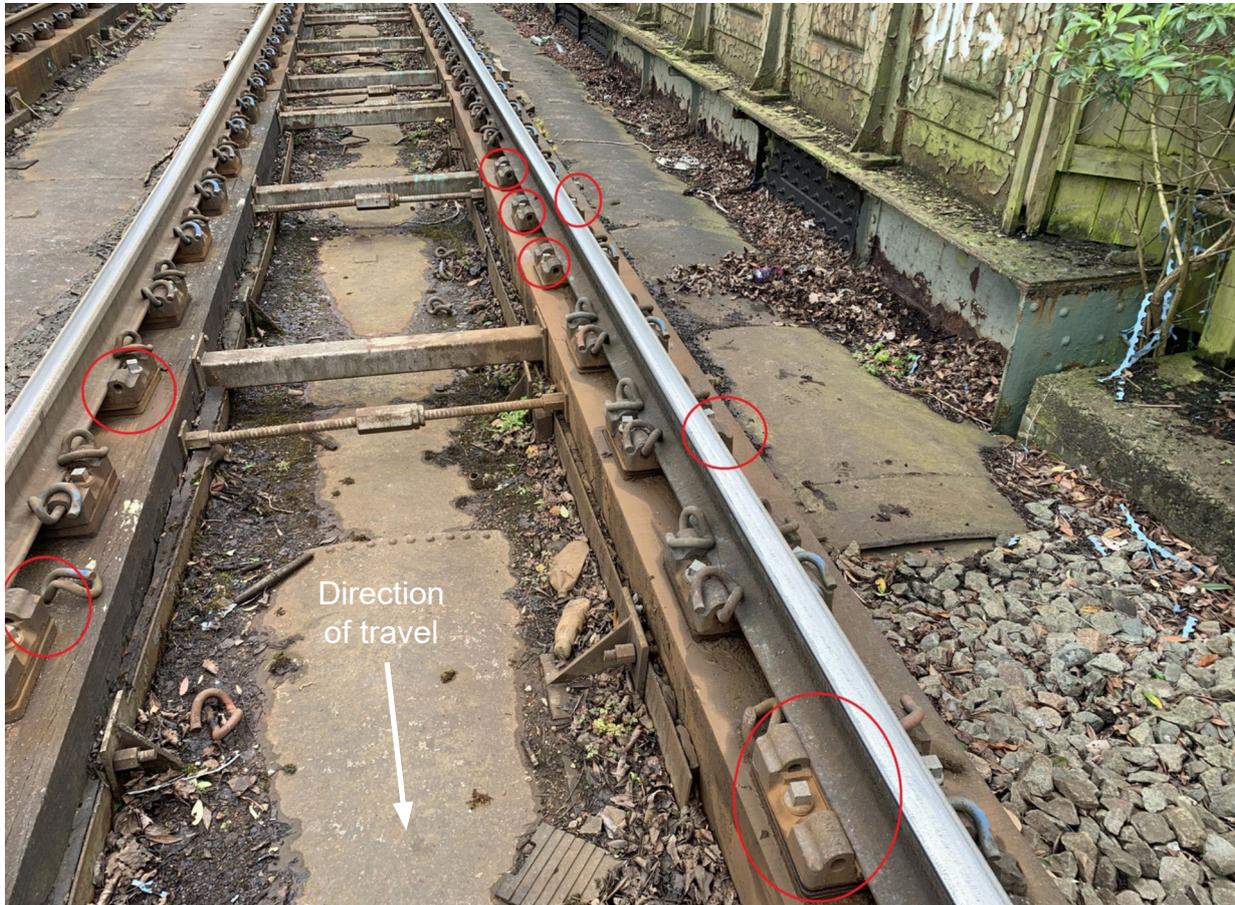
90 Between August 2023 and the derailment in September 2024, there were repeated instances of rail clips coming loose, even though additional clips had been fitted throughout the LBS. A structures examination in April 2024 recorded that clips were again missing at the north end of the LBS (figure 26). The ringed annotations on the image were added by the structure's inspector.

Figure 26: The LBS as observed during a bridge examination report in April 2024 showing the missing rail clips at the north end of the down line (courtesy of Network Rail with RAIB annotations).
