Rail Accident Investigation Branch

Rail Accident Report

Derailment of a freight train at Audenshaw, Greater Manchester 6 September 2024

Report 10/2025
December 2025

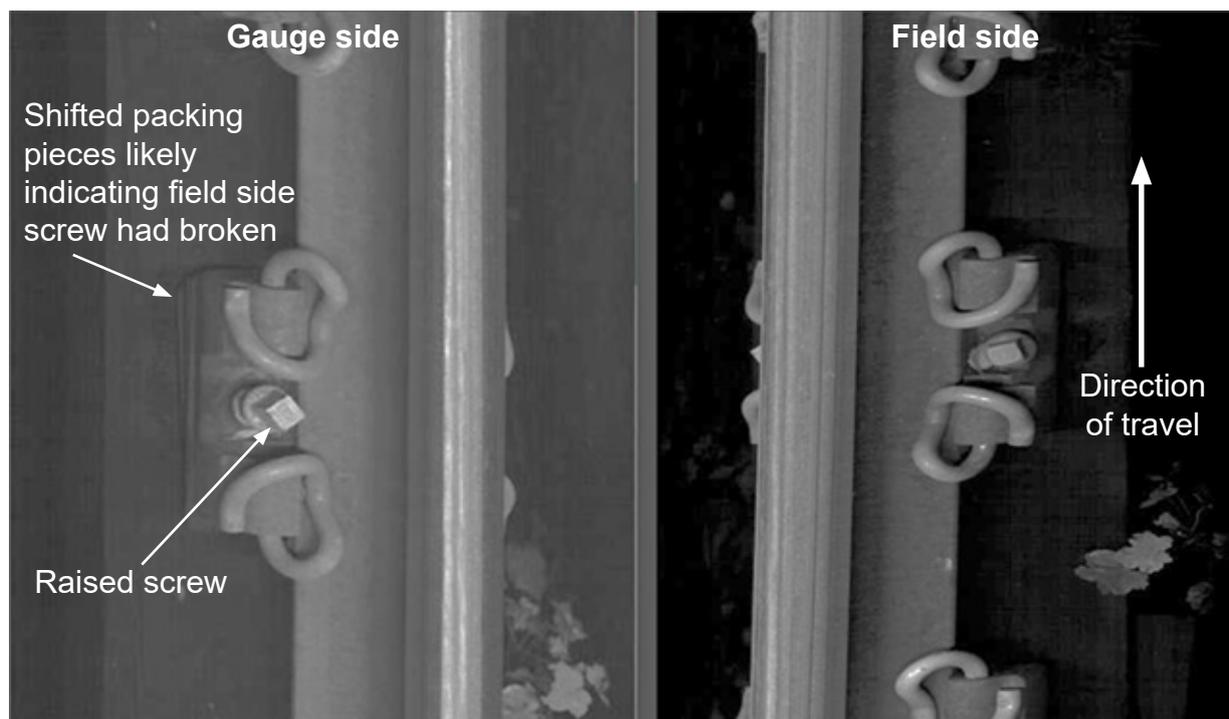
- 91 Images captured by the plain line pattern recognition (PLPR) track inspection train during the last track geometry recording run on 28 August 2024 also recorded the presence of missing rail clips and the automatic pattern recognition system alerted the delivery unit to this (see paragraph 155).
- 92 RAIB's detailed examination of the PLPR images showed the packing pieces under baseplate R6 had possibly shifted and the screw appeared to be raised (figure 27). This image likely indicates that the screw on the field side may have been broken. However, the PLPR system is not capable of automatically detecting these failures (see paragraph 149).

Figure 27: Baseplate R6 image from a PLPR train in August 2024 (courtesy of Network Rail with RAIB annotations).

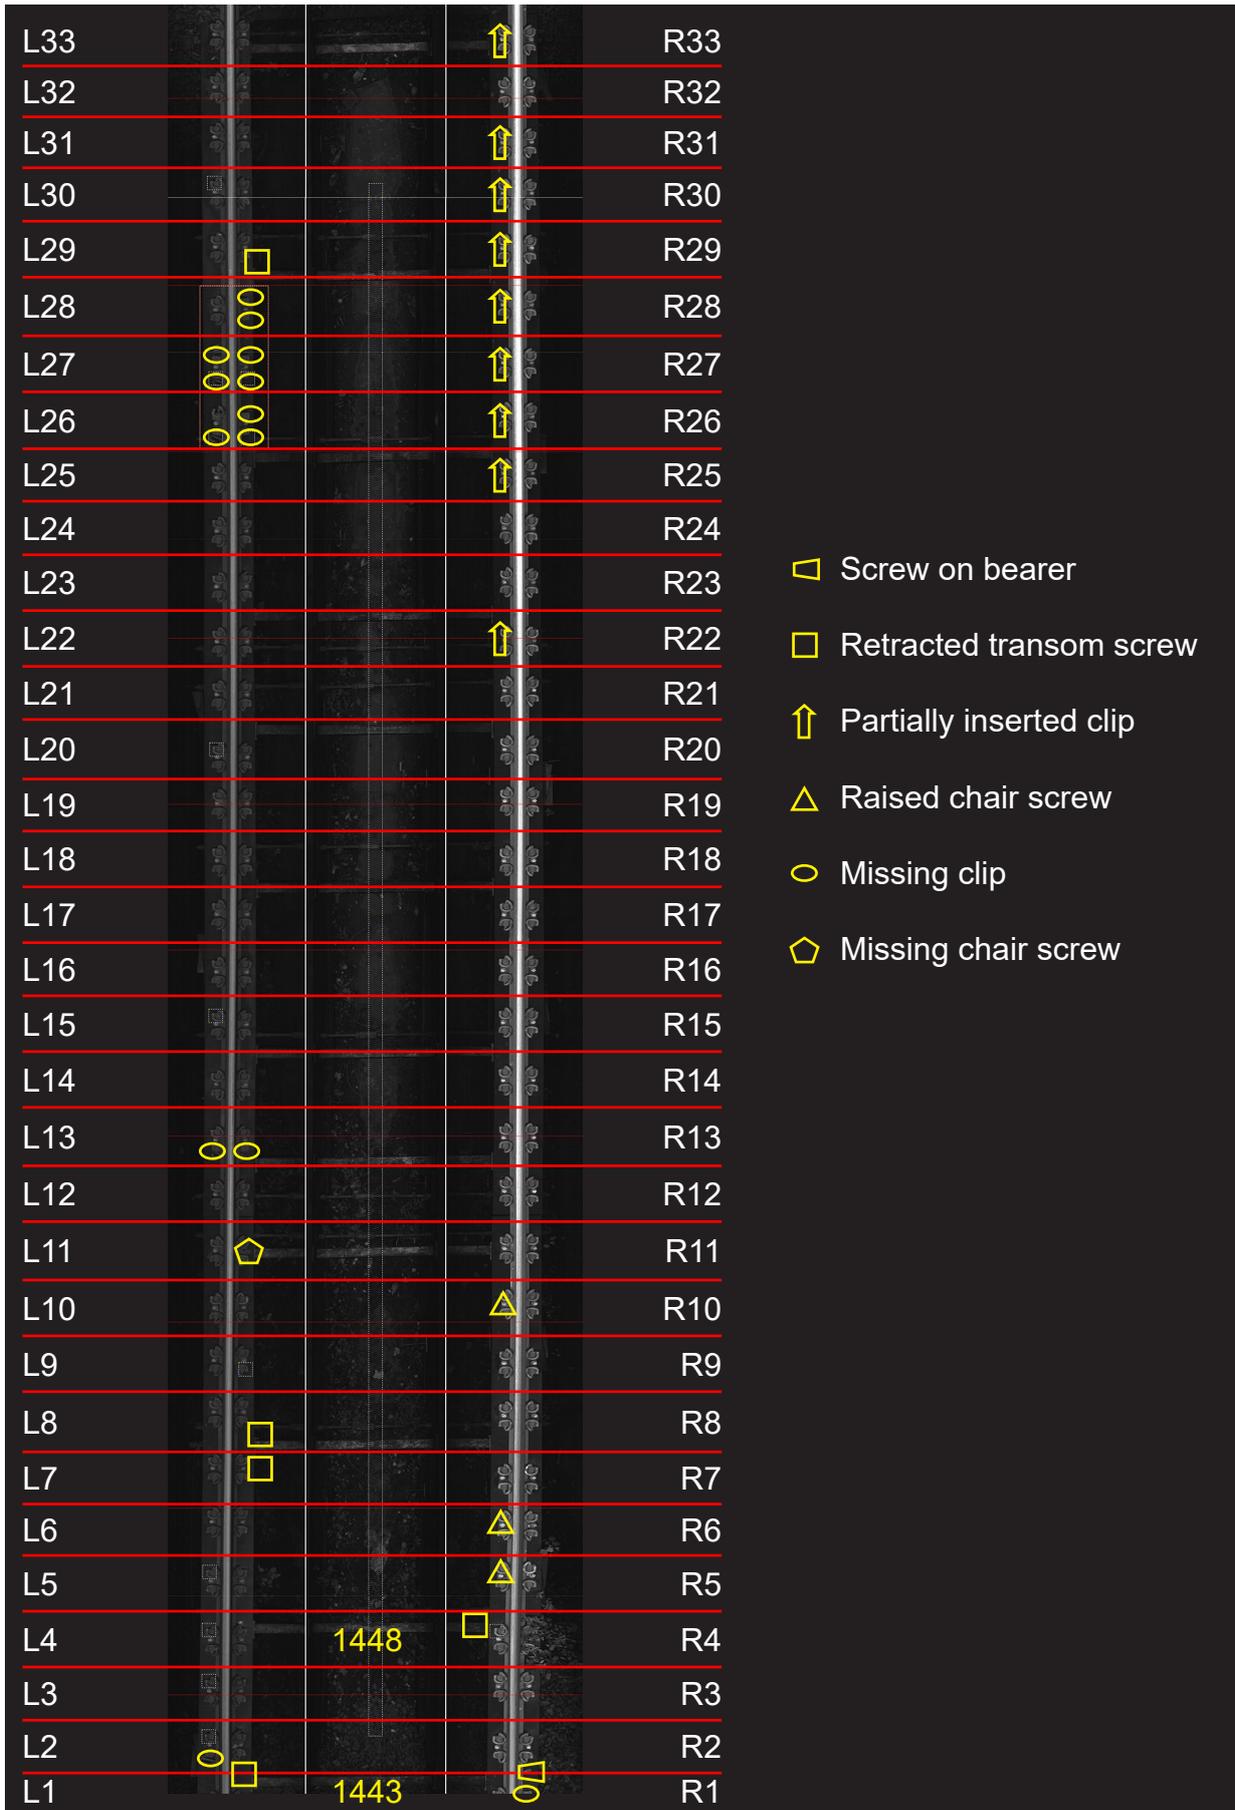
- 157 RAIB examination of the detailed images captured by the cameras of the PLPR system 9 days before the accident revealed missing and raised screws (figure 27), along with the missing rail clips which had been reported by the system (figure 33). From this, and considering the aged condition of the screw fracture faces, it is very likely that some of the screws were already broken 9 days before the derailment.

Figure 33: Composite of the full LBS using images from PLPR (courtesy of Network Rail with RAIB annotations).

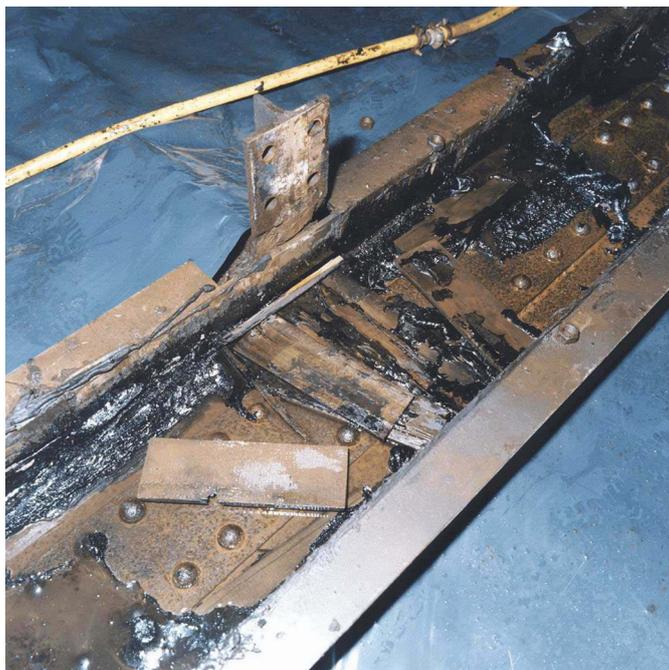
Figure 36: Failed 1997 LBS installation at Althorpe (from business process document NR/SP/TRK/9003 courtesy of Network Rail).

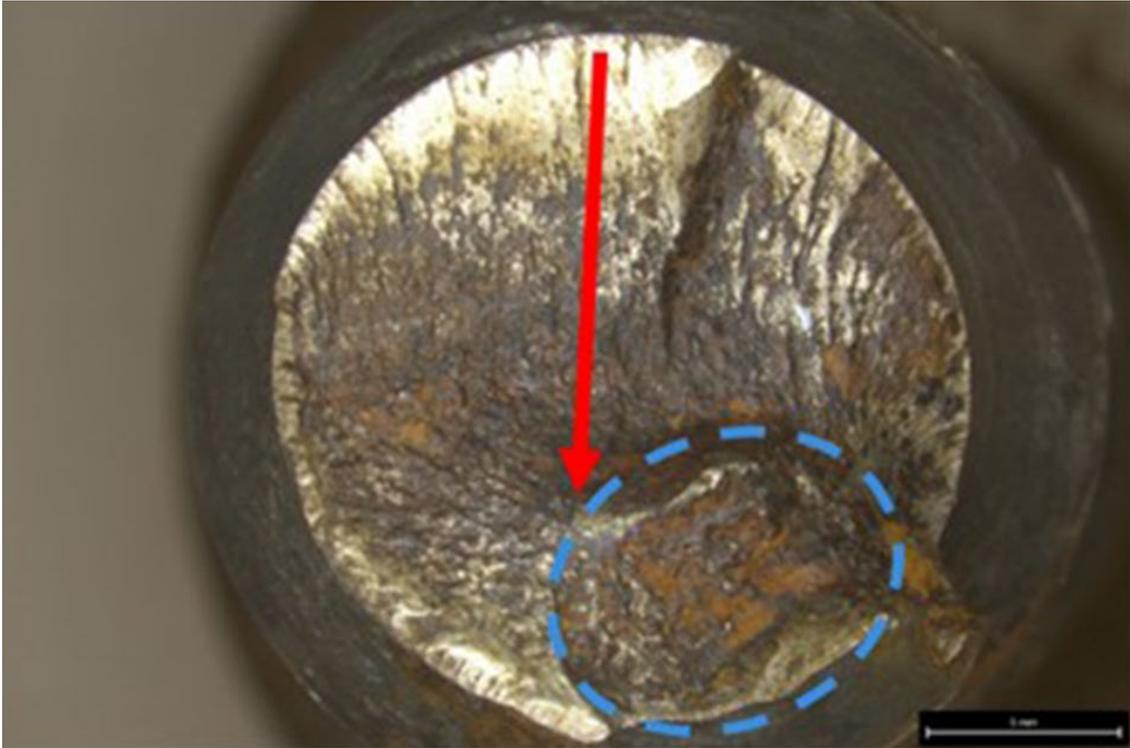
Figure 1: Fracture face of the upper portion of a recovered screw with indications of unidirectional high-cycle and low-cycle bending fatigue and a small area of overload (circled).

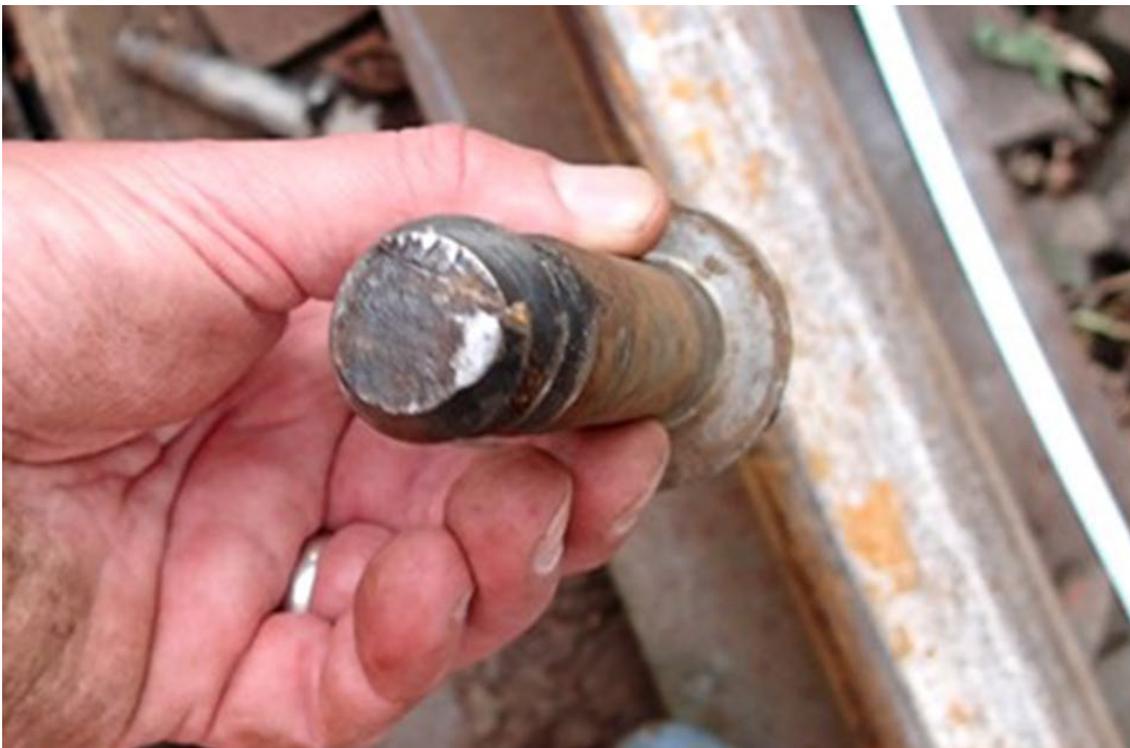
Figure 2: One of the recovered top portions of a screw with signs of historical fracture and subsequent failure by overload (bright area).
