Maritime &  
Coastguard  
Agency

# SS Richard Montgomery: Survey report 2025

October 16<sup>th</sup> 2025

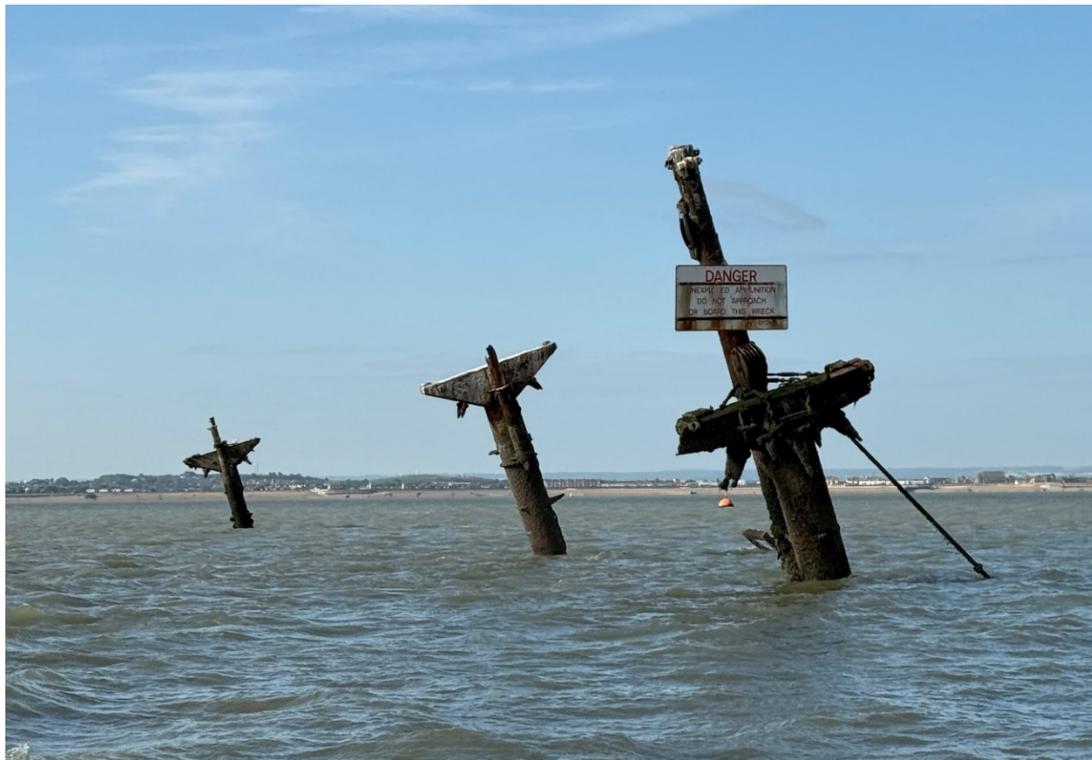
- 2.1.4** The vessel remains on Sheerness middle sand, lying in two sections in its own scour pit and sitting on exposed bedrock which is believed to be London clay. The SSRM lies across the tide, and all three masts are visible above the water at all states of the tide (see Figure 2).

*Figure 2. Photograph of the three masts of SSRM seen during low tide.*

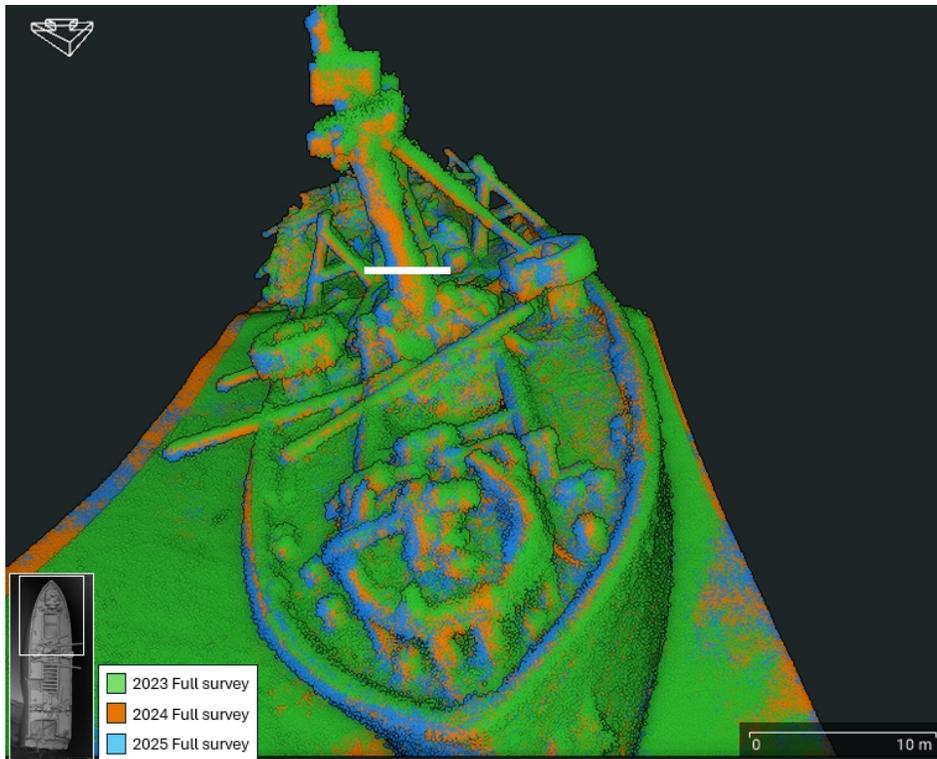
- 1.3.1 The forward section of the wreck tilts towards the east. This is an ongoing development and the increase in tilt can be seen over several years.
- 1.3.2 Six Key Areas and 97 features over the wreck have been used to compare changes over the years to quantify the change and deterioration. All areas but Key Area 6 show little to no change. Key Area 6 has collapsed between 2024 and 2025.
- 1.3.3 Comparing the 2024 and 2025 full surveys, the surrounding seabed has depth changes around +/-0.3 m, with local areas reaching up to 2.5m change. In the immediate surroundings of the wreck, the largest depth change is seen at the aft with 0.8 m depth increase.
- 1.3.4 In the surveyed surrounding seabed, 159 targets have been noted in previous surveys with an additional 9 targets identified during the 2025 full survey.

Figure 8. Point cloud view of increased tilt of forward section. The white line represents the horizontal cross section in Figure 9.

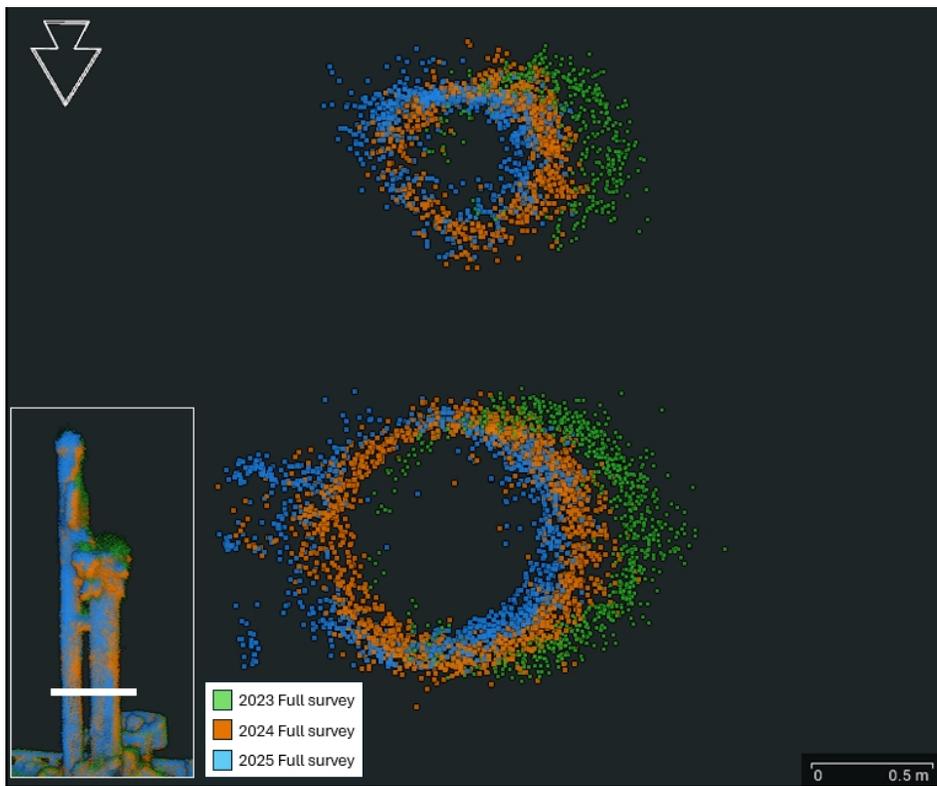
Figure 9. Horizontal cross section MBES points of the masts of the forward section of the wreck. The image shows the increased tilt observed between full surveys of 2023, 2024, and 2025.

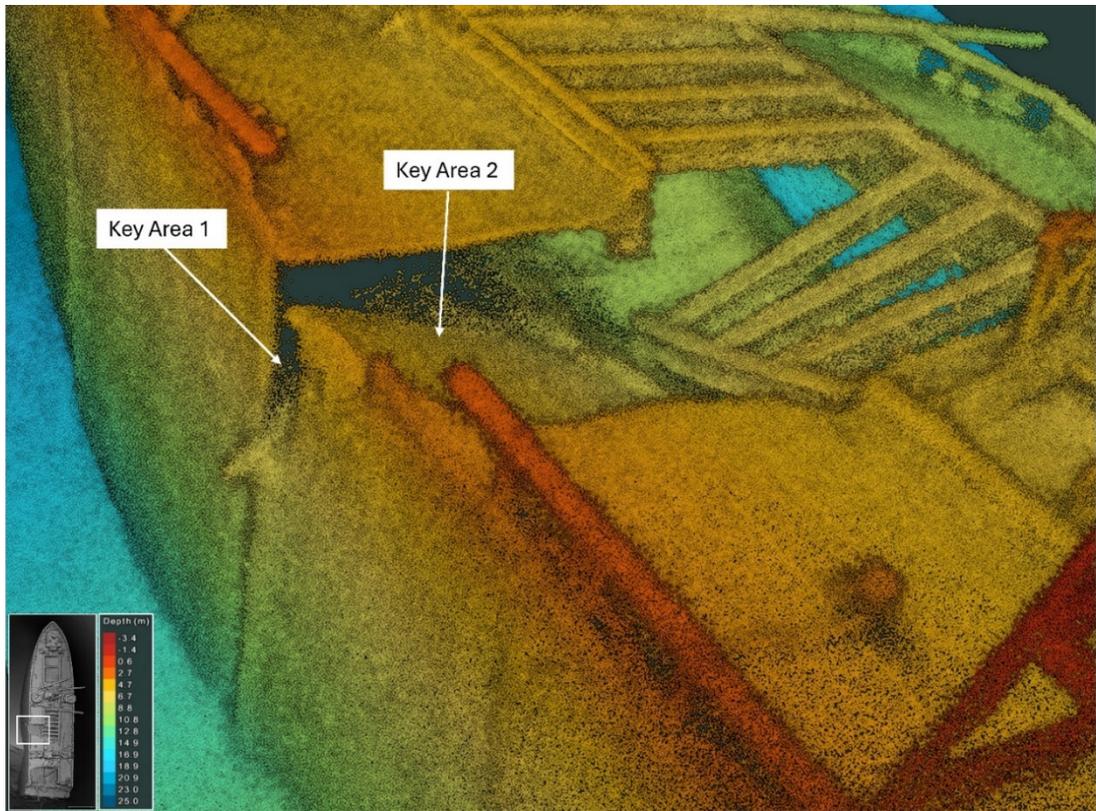
- 4.2.2 Key area 1 & 2 (ID04 & ID08)– Crack in the hull and collapse of cargo hold deck (port side)**
- 4.2.3** The forward section of the Richard Montgomery is seriously hogging almost exactly halfway along the No. 2 Hold Hatch. This hogging has resulted in a crack appearing on the upper part of the port side while the lower part of the starboard side is significantly buckled giving the appearance that the forward part of the wreck is splitting in two and pivoting about the starboard rim of Hold 2. The flexing of the upper deck has caused a portion of the upper deck and half of the Hold 2 hatch cover supports to collapse through into the ‘tween deck space (Figure 10).

Figure 10. Point cloud image of key areas 1 and 2.

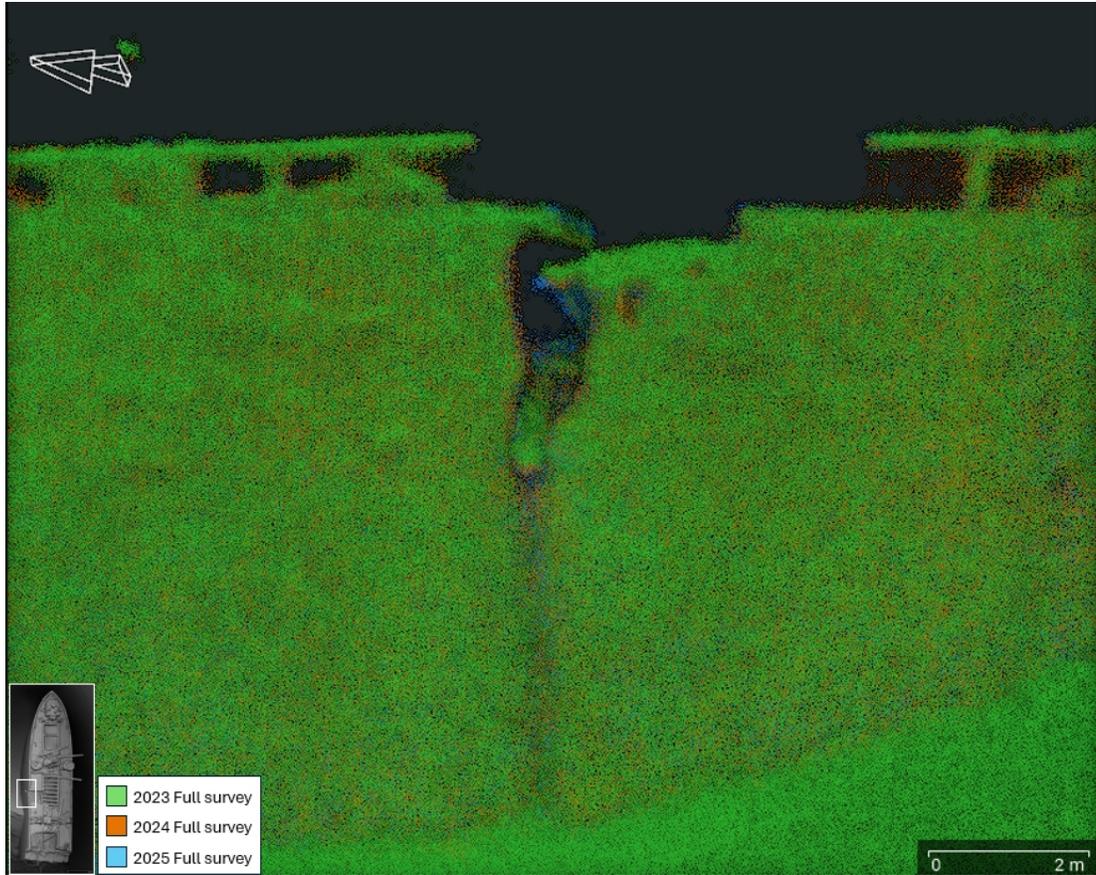
- 4.2.4** The crack in the hull is well defined in the full surveys of 2023, 2024, and 2025 (Figure 11). There is no apparent change to the crack between the three surveys.

Figure 11. Point cloud cross section comparison of the wreck showing Key Area 1, the crack in the hull.

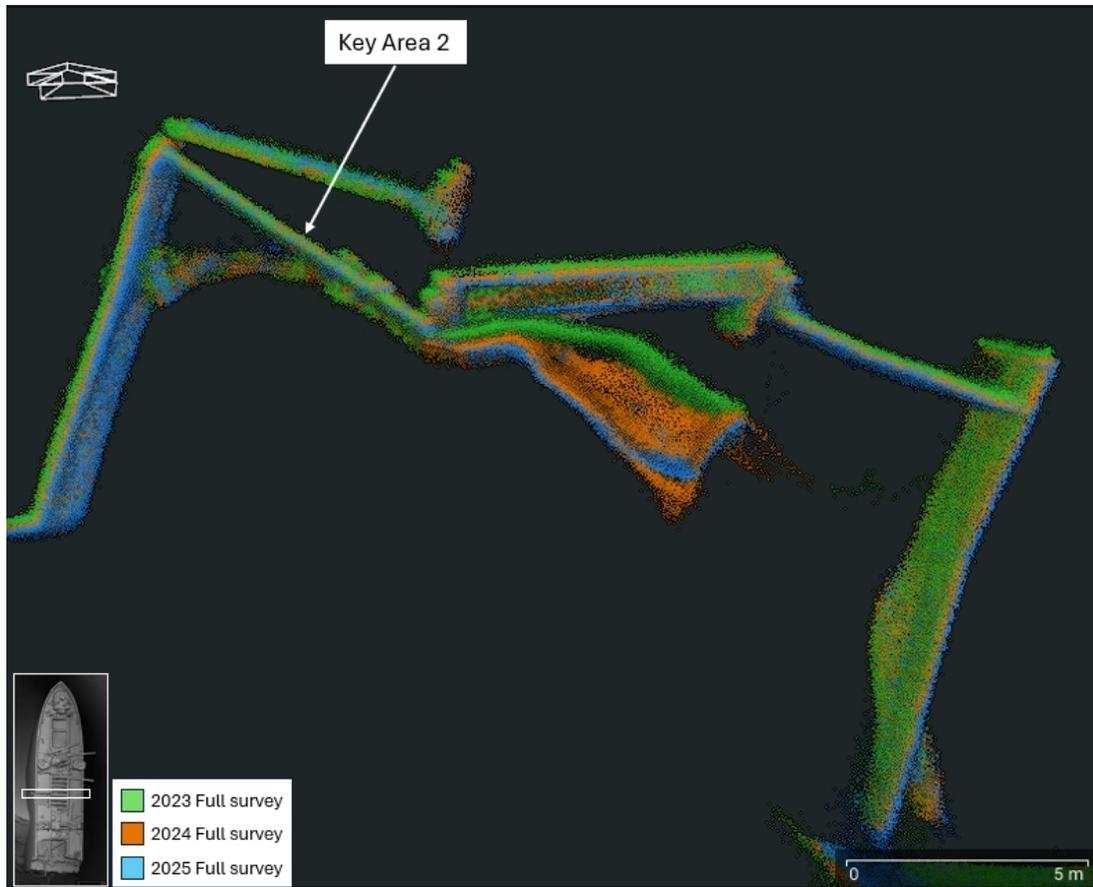
- 4.2.5** Overlaying the 2023, 2024, and 2025 full survey data on a cross section shows the extent of the upper deck collapse (Figure 12).

Figure 12. Point cloud cross section of the wreck showing Key Area 2, the collapsed cargo deck of Hold 2. The collapsed upper deck shows no difference between the 2023, 2024, and 2025 full surveys.

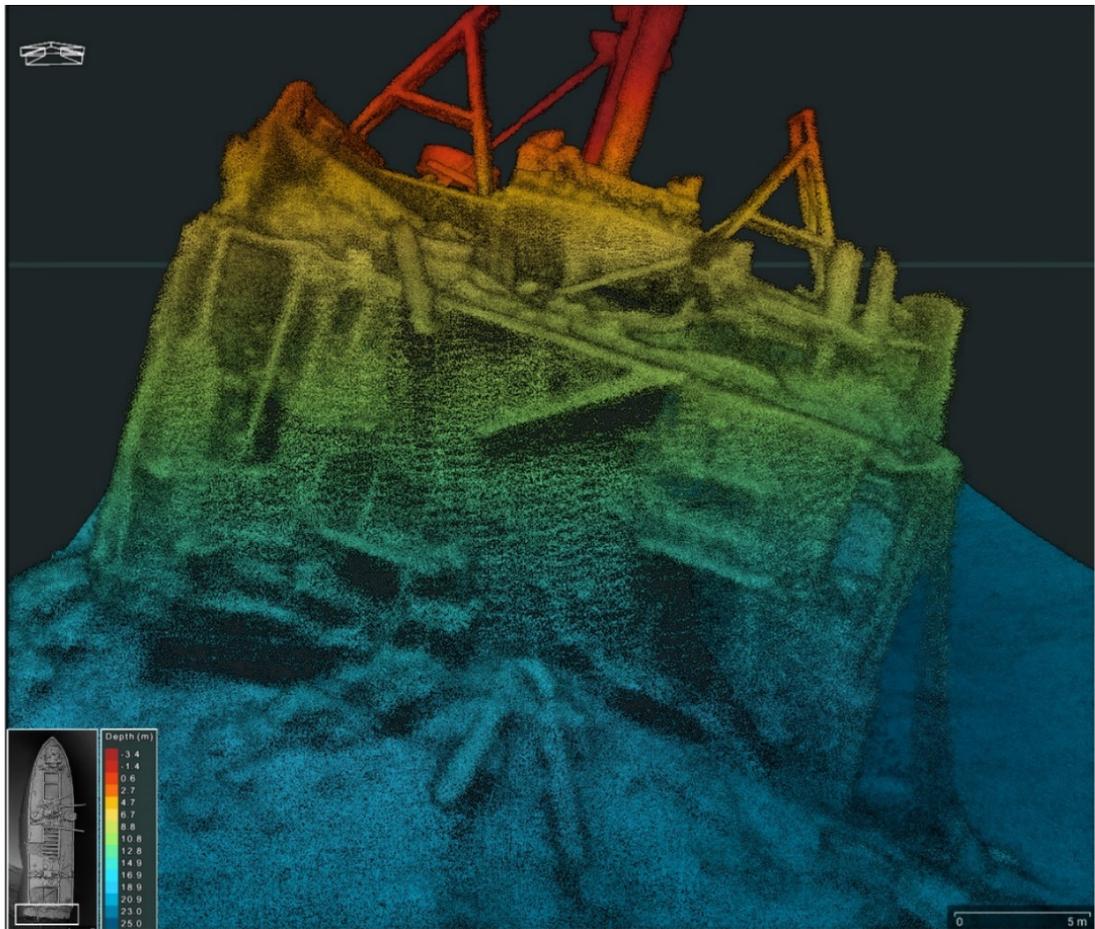
4.2.7 Figure 13 shows the apertures on the bulkhead at the aft end of the forward section. No structural differences were found between the 2023, 2024, and 2025 full surveys (Figure 14).

Figure 13. Point cloud image of the aperture from 2025 full survey (aft end, forward section), key area 3.

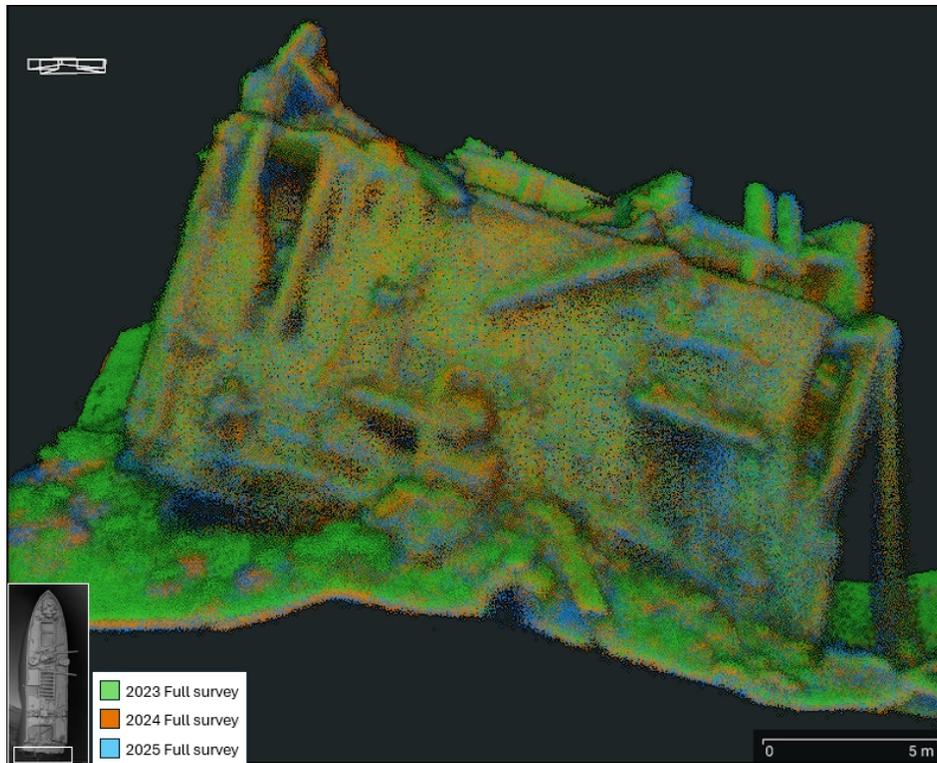
Figure 14. Comparison of aperture in the bulkhead to rear of hold 3 with data from full surveys of 2023, 2024, and 2025.

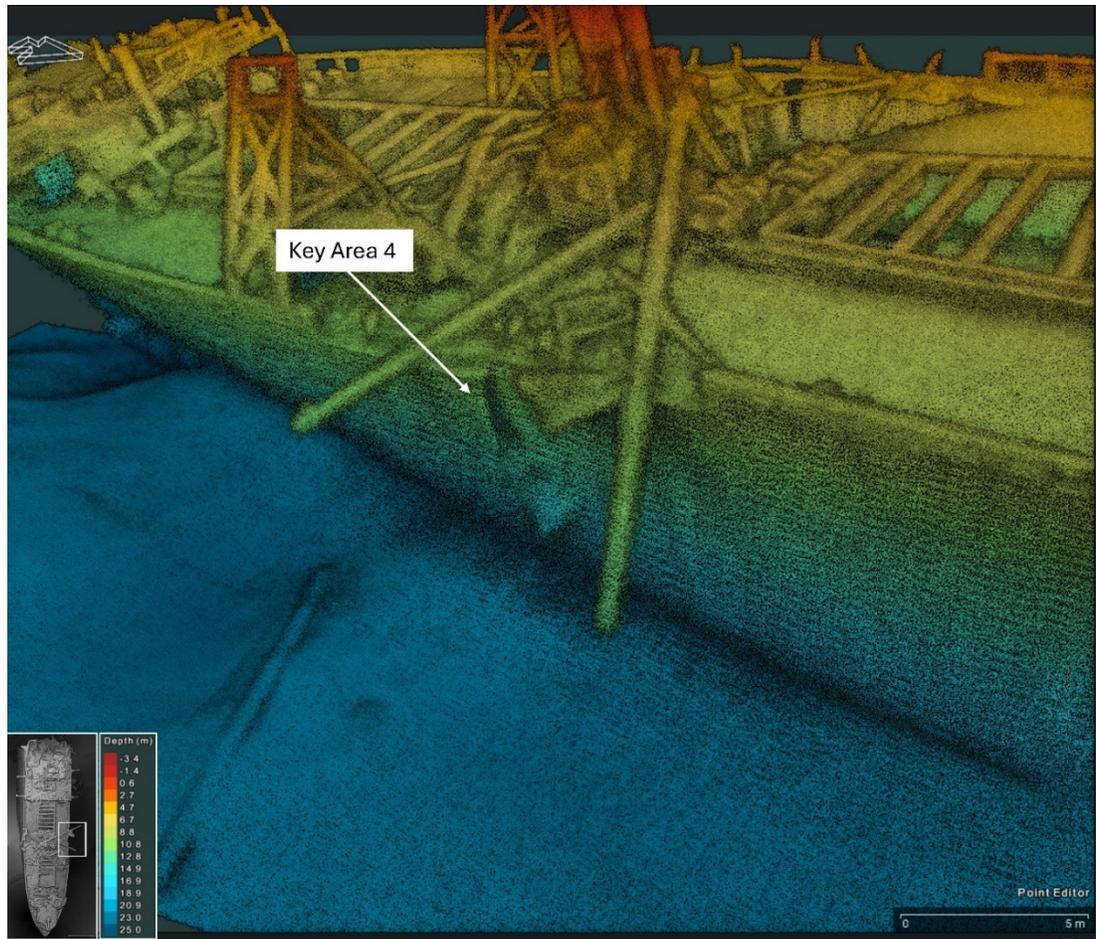
Key areas 4 and 5 represent the two ends of the same feature, namely a transverse crack across the rear hull section (Figure 15 and Figure 16). No notable differences can be seen between the 2023, 2024, and 2025 full and surveys (Figure 17 and Figure 18).

Figure 15. Point cloud image of the split in the hull, Key Area 4, 2025 full survey.

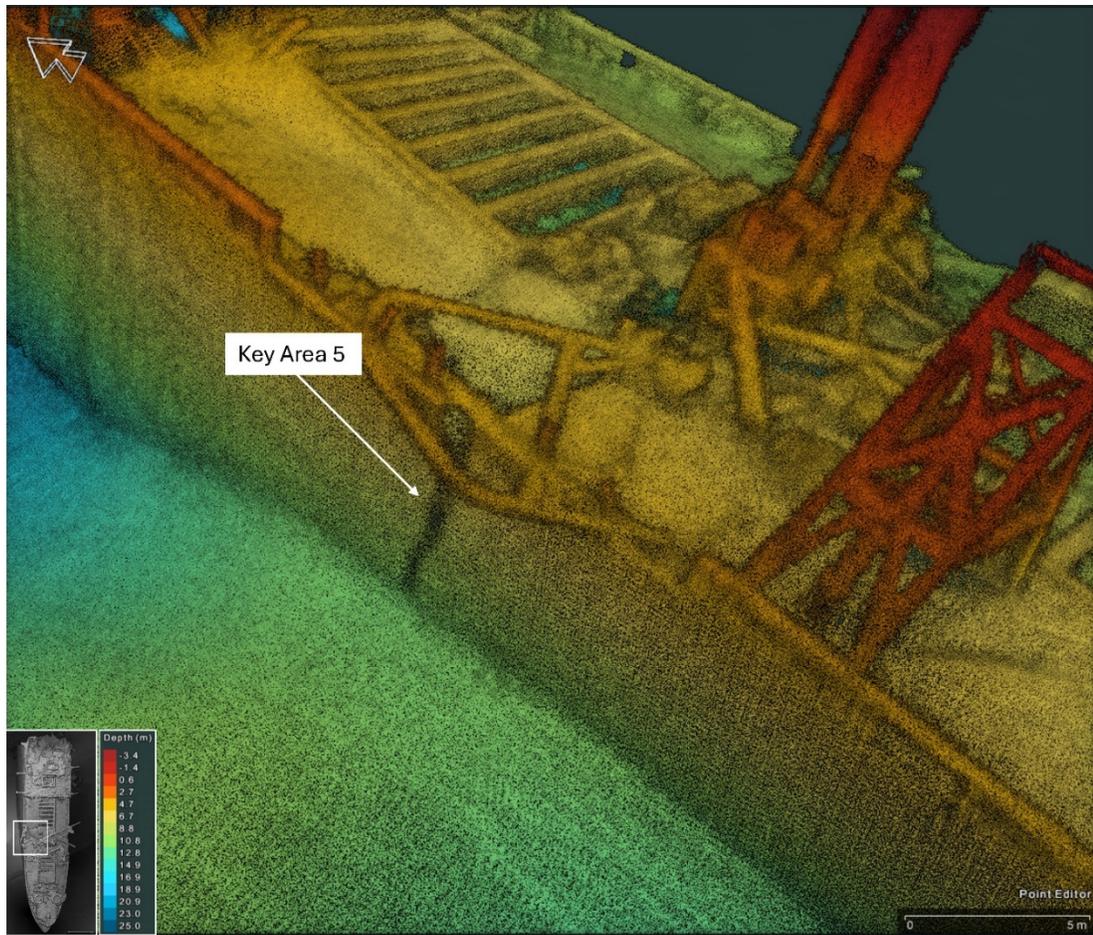
Figure 16. Point cloud image of the split in deck, key area 5, 2025 full survey.

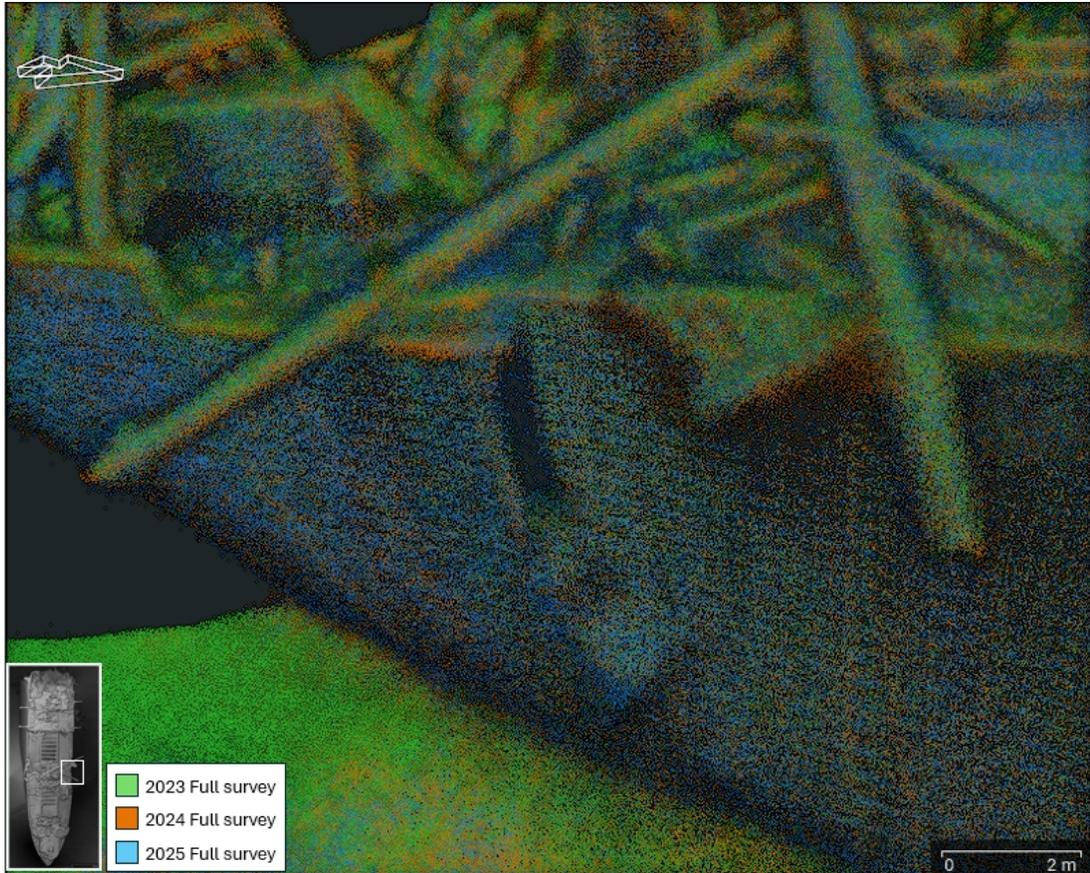
Figure 17. Point cloud view of key area 4 – the split in the hull. No difference can be seen between the 2023, 2024, and 2025 full surveys.

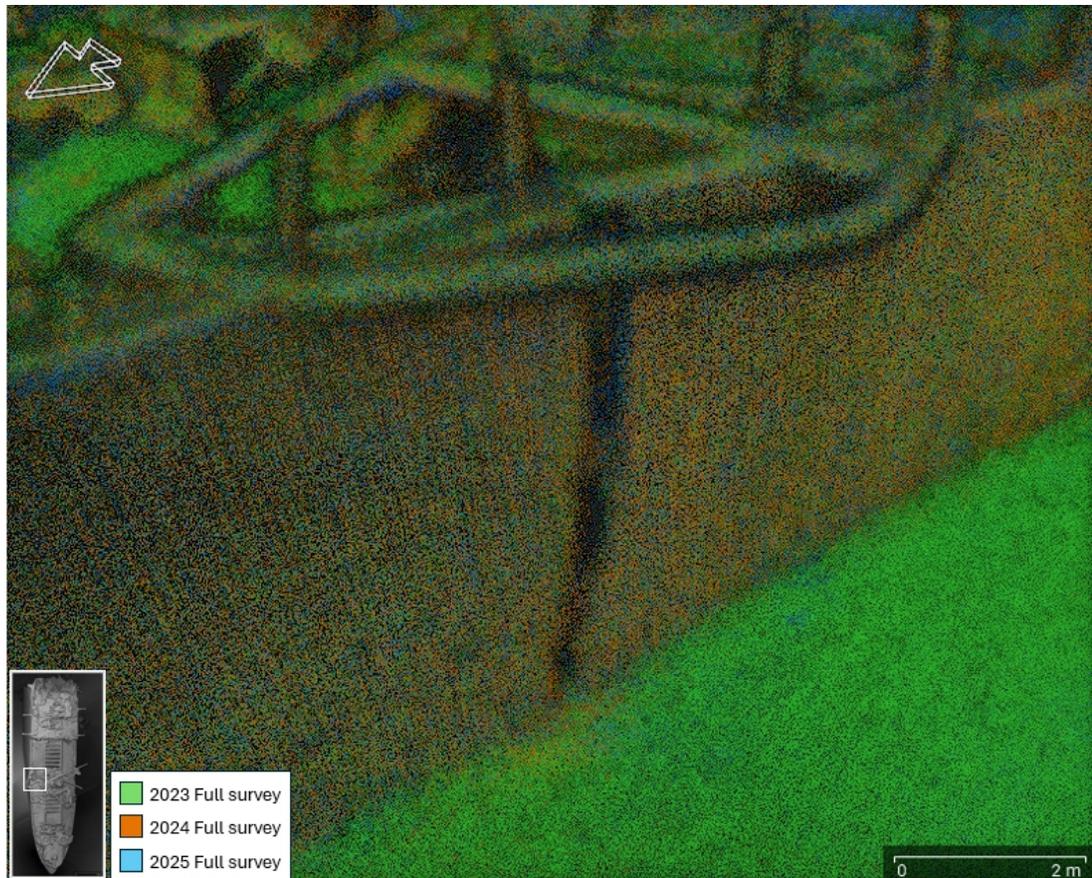
Figure 18. Point cloud view of key area 5 – the split in the hull and split in the deck. No difference can be seen between the 2023, 2024, and 2025 full surveys.

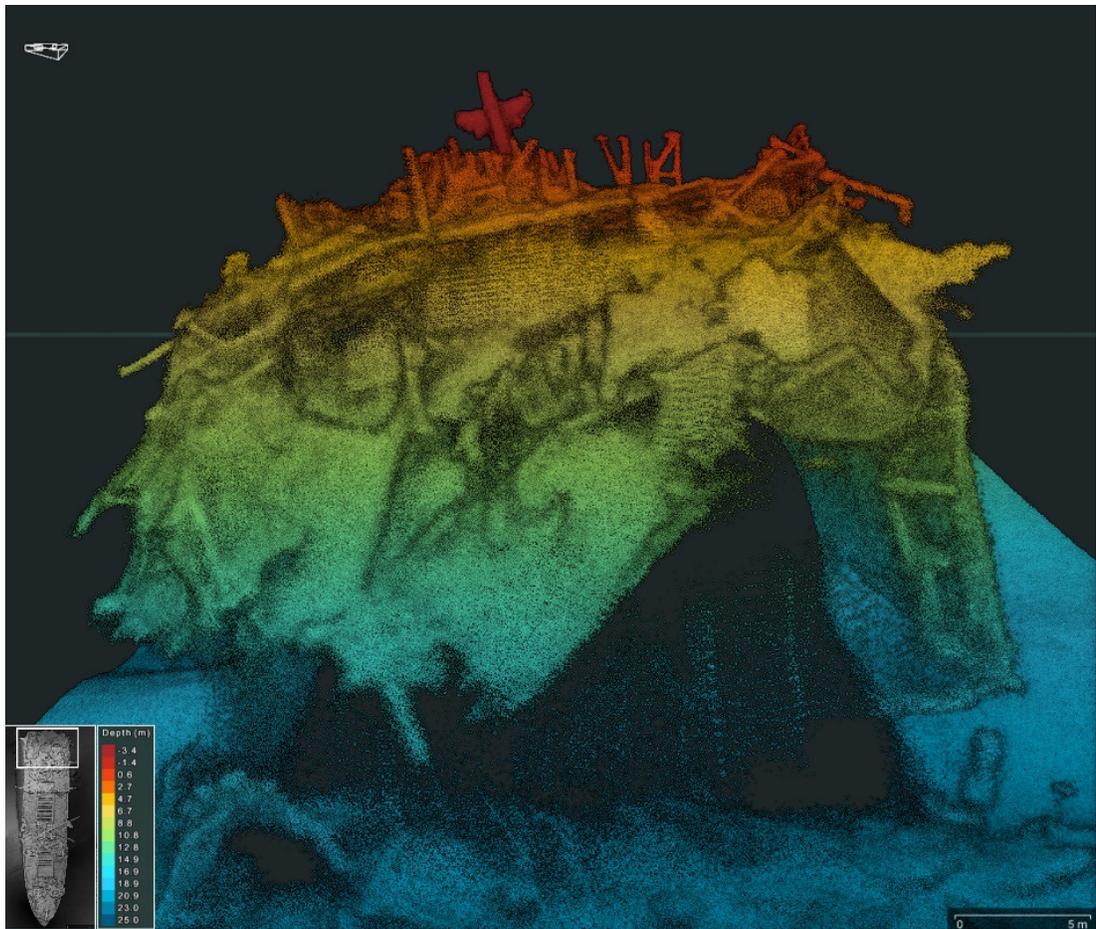
4.2.10 Key area 6 (Figure 19) was left unsupported when the ship broke in two back in 1944. Consequently, it has been badly affected by wave and current action and is steadily collapsing and falling into the gap between the two halves of the vessel (Figure 22). This area has shown significant degradation in earlier surveys, and a significant further collapse has occurred between the 2024 and 2025 full surveys, with a total displacement of 2 m, and a vertical displacement of 1.2 m between point A and B (Figure 20). Several objects on deck have been displaced (Figure 21).

Figure 19. Point cloud image of the collapsing bridge area, Key area 6.

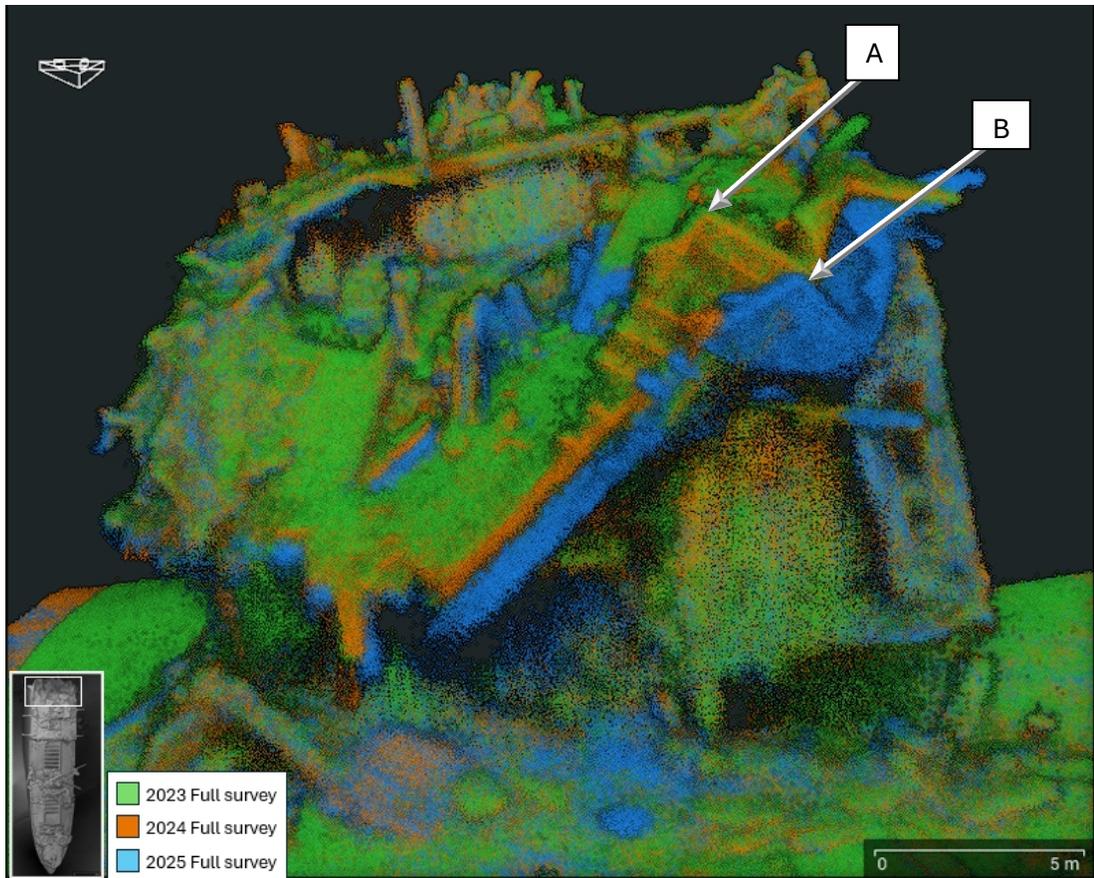
Figure 20. Point cloud view of key area 6 showing a further collapse of the deck, most significant between the 2024 (A) and 2025 (B) full surveys. Total displacement is 2.0 m, with a vertical displacement of 1.3 m.

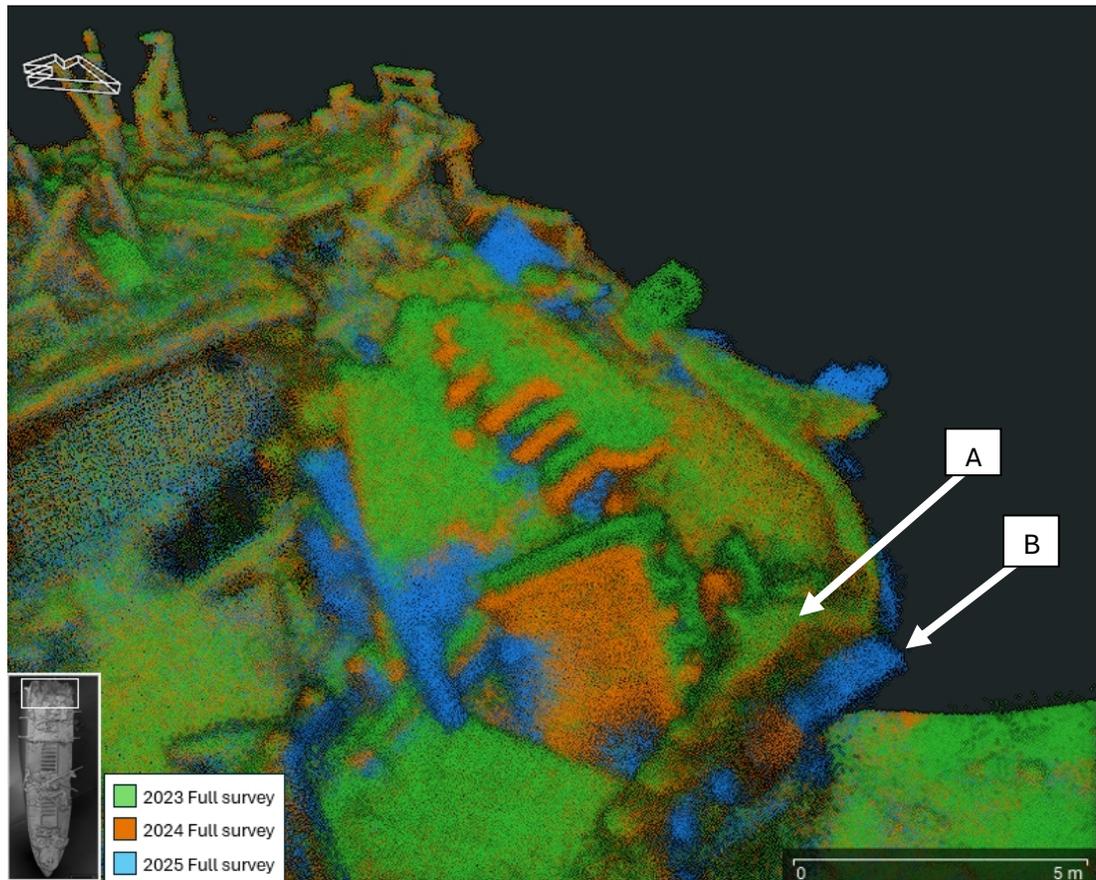
Figure 21. Point cloud view of Key area 6. Deck collapsing with displacement of several objects. Points A and B from Figure 20 for reference.

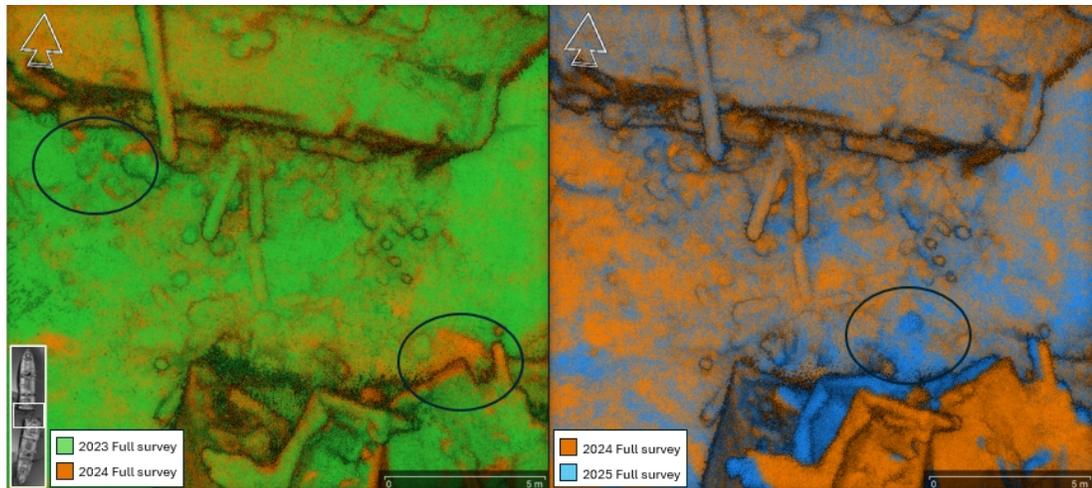
- 4.3.1 There have been smaller changes between the 2023, 2024, and 2025 full surveys, highlighted in black circles in Figure 22. The changes show a displacement of some debris, but also potential burial or removal of objects.
- 4.3.2 The area between the two black lines (Figure 23) outlines the seabed between the bow and stern sections. The degree of change is displayed with a difference model between full surveys of 2023 and 2025. The changes can either indicate a removal of an object, or a displacement of an object, as well as a change in depth of the sediment surface.

Figure 22. Point cloud image of the area between the two bow and stern sections of SSRM. The black circles show where a change has occurred between full surveys of 2023 and 2024 (left), and 2024 and 2025 (right).

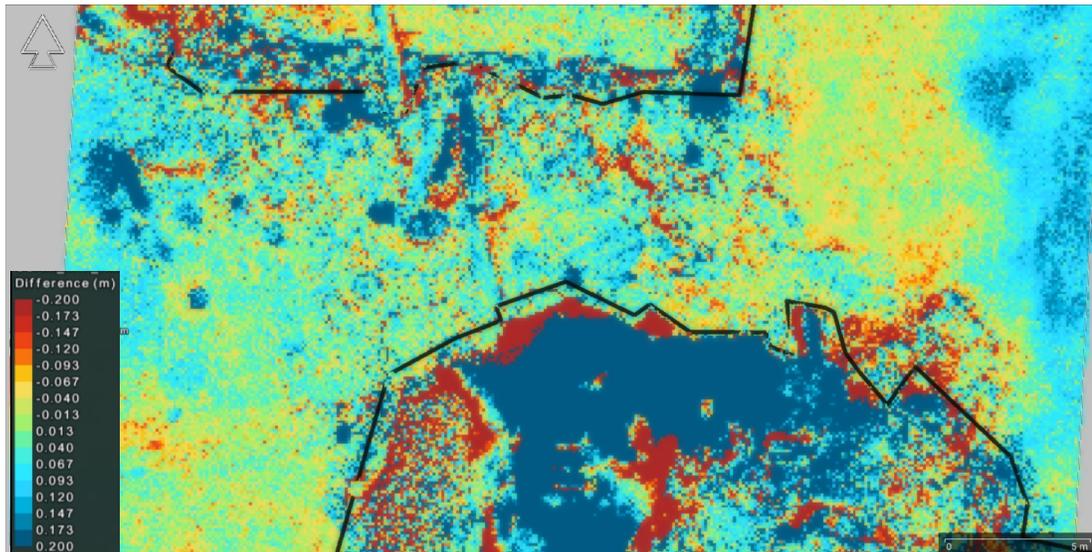
Figure 23. Difference model showing the difference in depth between the 2023 and 2025 full surveys. Between the two black lines is the area between the forward and the aft section, containing debris from the wreck.

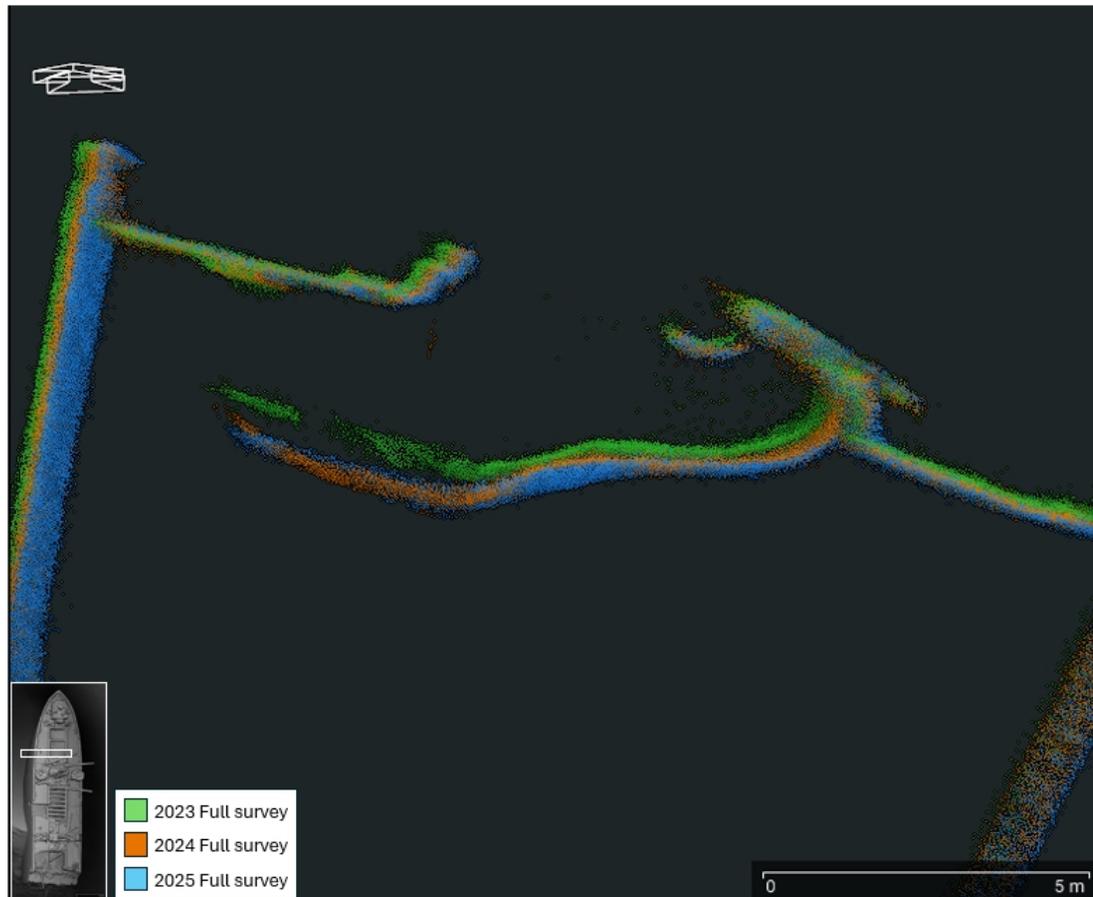
**4.4.7** The hatch cover is missing as are all but one of the hatch cover supports. Sediment has settled in the 'tween deck space to a considerable depth, filling the starboard side almost to the top of the starboard side hatch coaming. The port side remains clear above the horizontal from the starboard hatch coaming. There are some undulations in the sediment surface between 2023, 2024, and 2025 full surveys, with the most prominent change in depth in the aft end of Hold 1 happening between 2023 and 2024 (Figure 24).

Figure 24. Cross section through the hull at the aft end of hold 1.

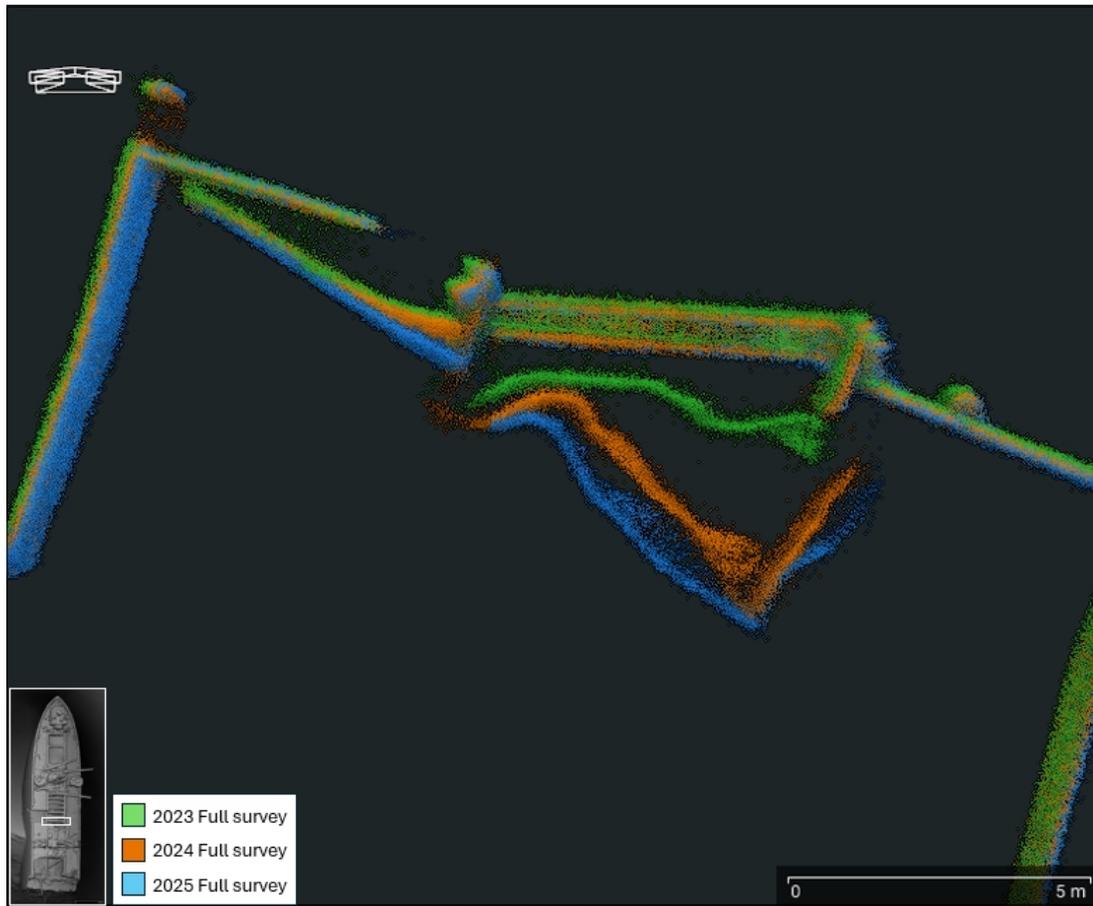
4.4.10 There has been a significant drop in the ‘tween deck between 2023 and 2024, as well as 2024 and 2025 full surveys (Figure 25 and Figure 26). The drop in the ‘tween deck is in the aft end of Hold 2, in connection to the area where the forward section of the wreck splitting in two (see section 4.2.3).

Figure 25. Point cloud cross section of the wreck showing the collapsed cargo Hold 2 deck and hatch supports. The collapsed deck is in connection with the area where the collapse of the forward part of the wreck is splitting in two (see section 4.2.3).

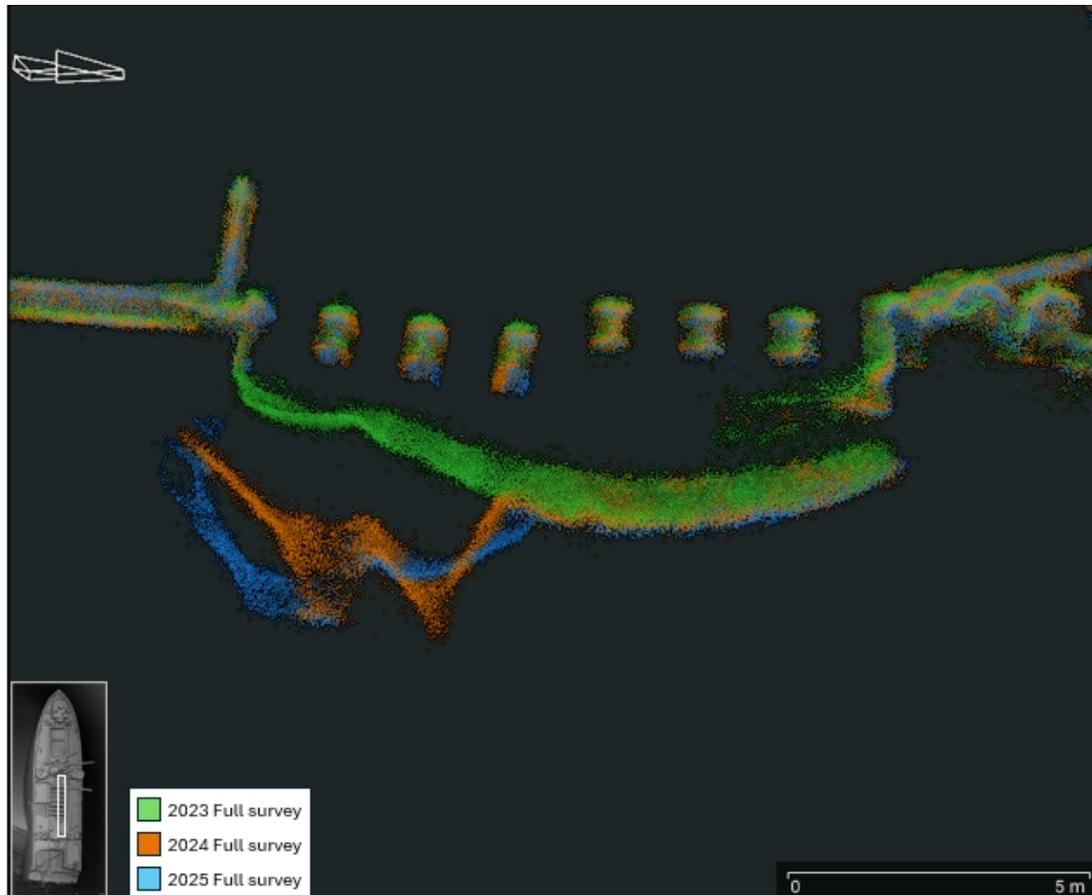
Figure 26. Point cloud cross section of the wreck showing the collapsed cargo Hold 2 deck and hatch supports. The collapsed deck is in connection to the area where the collapse of the forward part of the wreck is splitting in two.

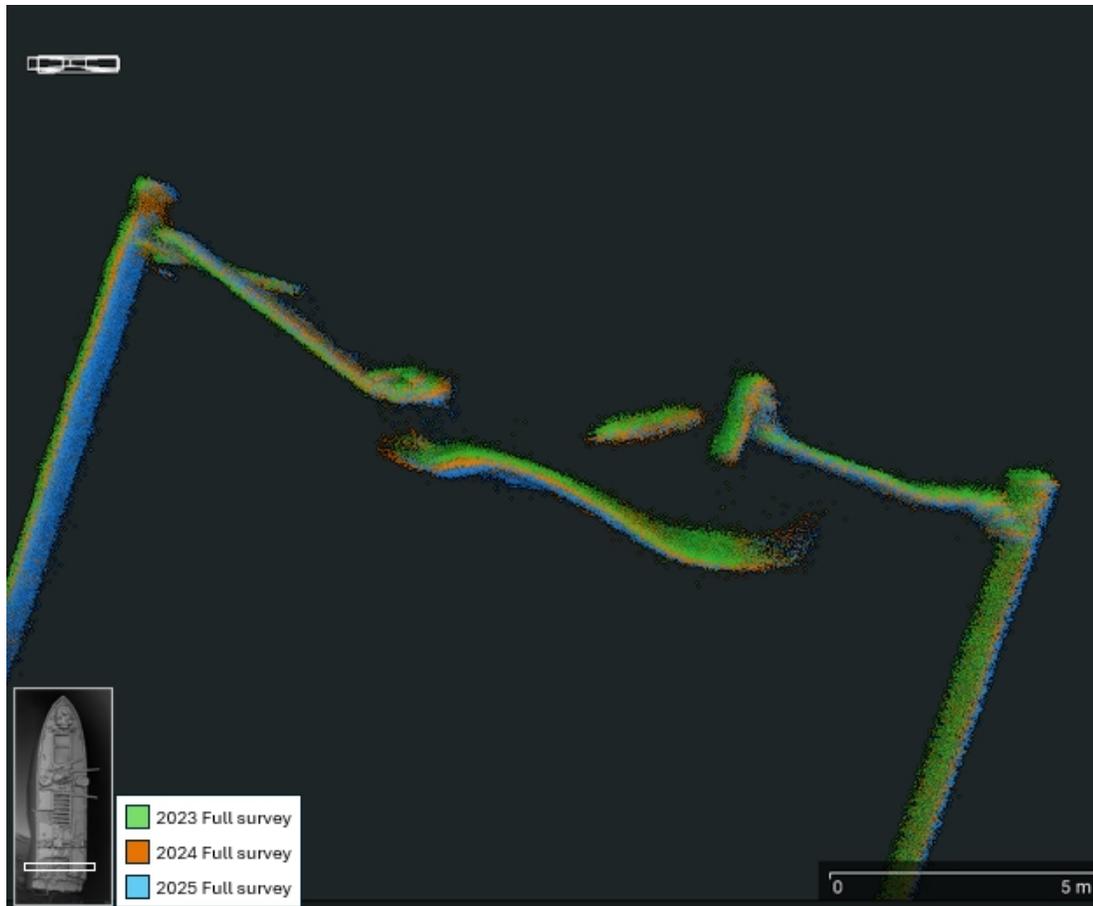
4.4.13 Sediment accumulation is largely limited to the forward part that still retains the protection of the upper deck. Except for some undulating, there are no large difference of the sediment depth in Hold 3 (Figure 27).

Figure 27. Cross section through the hull at the middle of Hold 3.

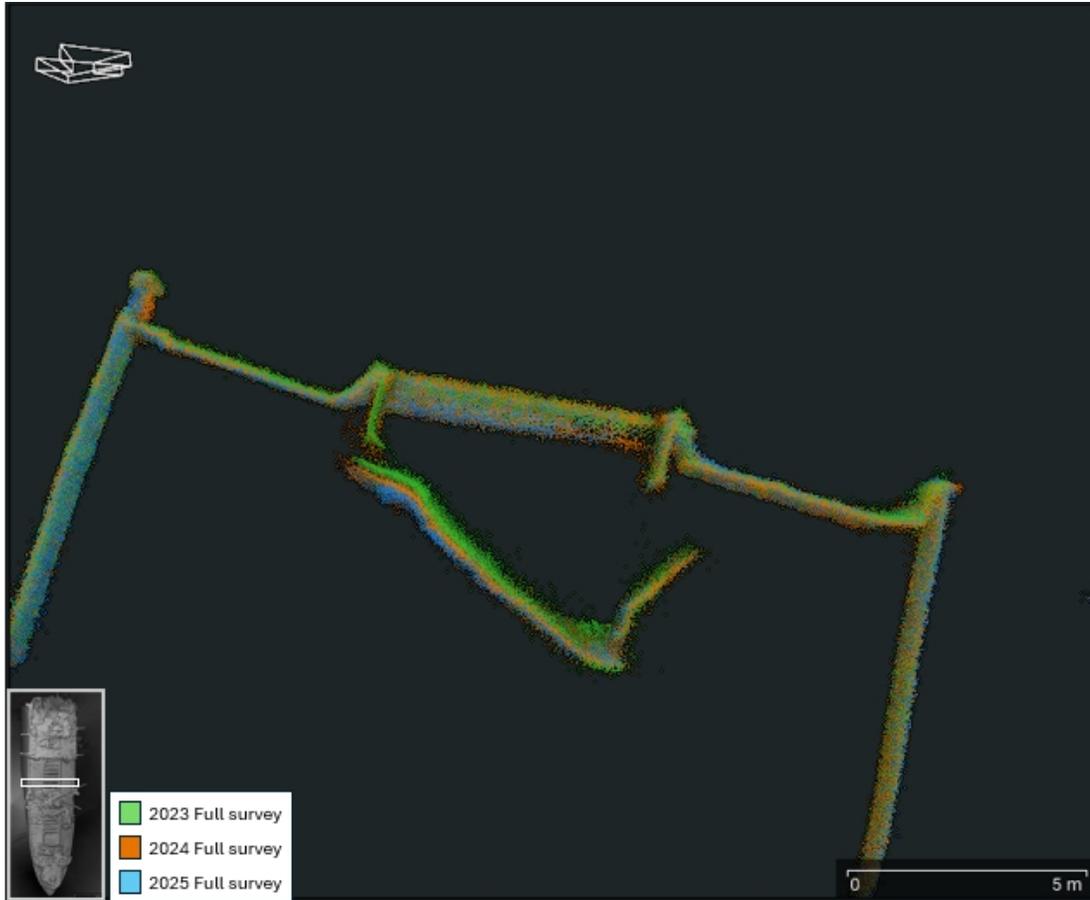
4.4.16 The surface and sediment level in the forward part of hold 4 is largely unchanged between the 2023, 2024, and 2025 full surveys (Figure 28).

Figure 28. Cross section through the hull at the aft end of hold 4.

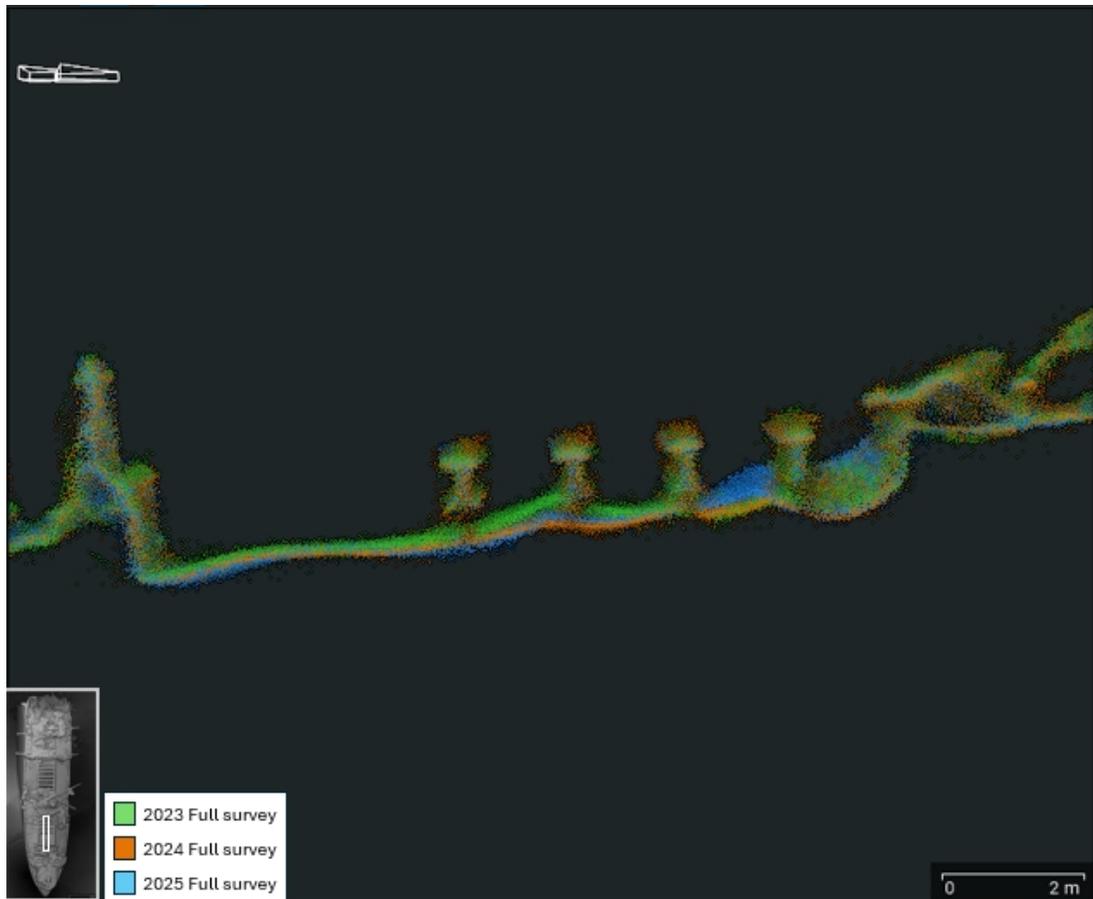
4.4.18 Hold 5 is the rear most hold. The forward four of the six hatch cover supports remain in place. There is no indication that the second deck nor the lower hatch cover have collapsed. A slight shift is observed in the sediment between the surveys (Figure 29).

Figure 29. Cross section through the hull at the forward end of Hold 5 showing a slight shift in sedimentation between 2023, 2024, and 2025 full surveys.
