Maritime &  
Coastguard  
Agency

# SS Richard Montgomery: Survey report 2025

October 16<sup>th</sup> 2025

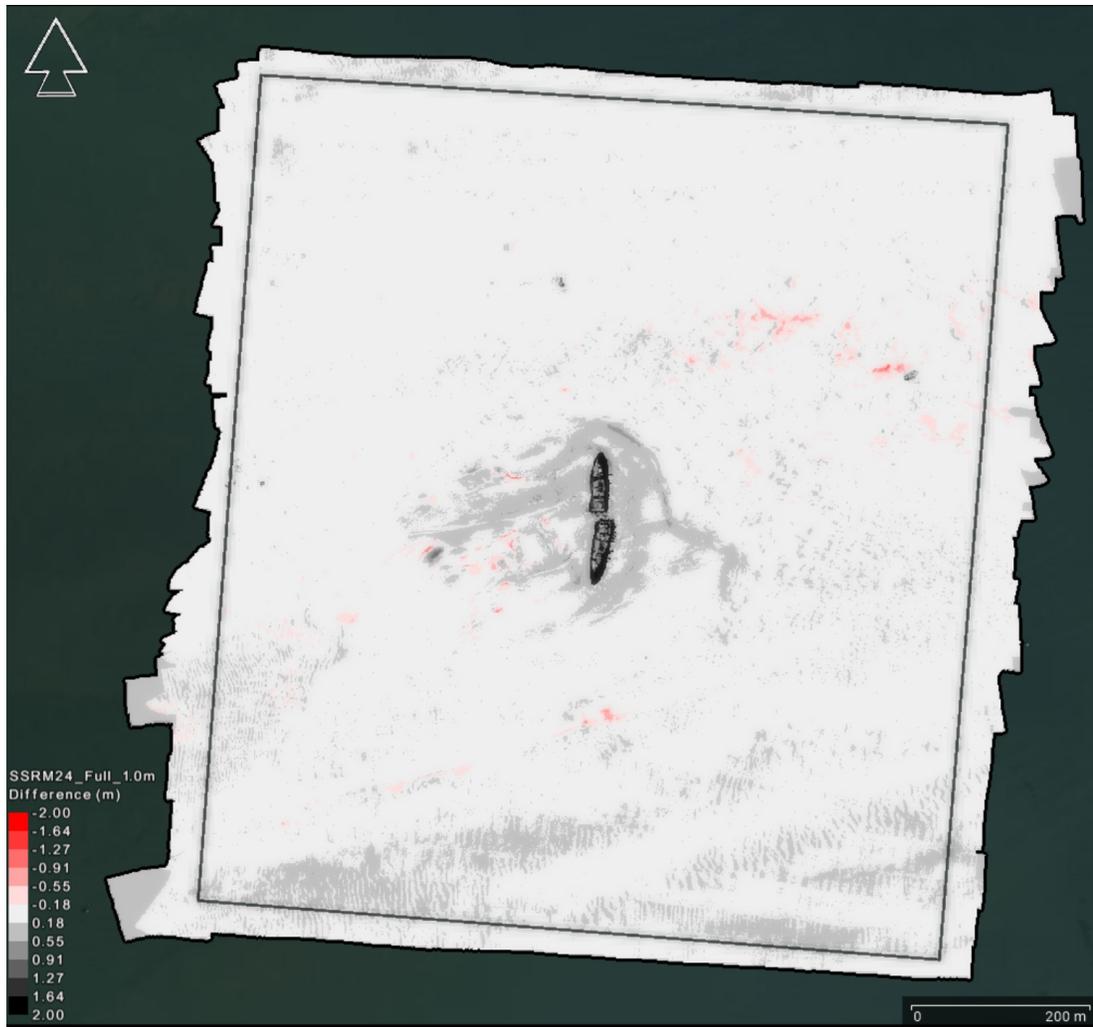
- 5.1.3** The change in depth between the years 2024 and 2025 is visualized in Figure 31. Most of the surrounding seabed have depth changes within +/-0.3 m, with more local areas reaching up to 2.5 m difference.
- 5.1.4** In the immediate surrounding of the wreck, the largest change between the 2024 and 2025 Full Survey data can be seen at the aft of the wreck where there is a depth increase of approximately 1.4 m (Figure 32). Comparing the 2023 and 2025 data, the greatest change is seen on the western side of the front section with a depth increase of approximately 2 m (Figure 33).

Figure 31. Difference model showing the depth changes between the 2024 and 2025 full surveys. Areas in gray have a reduced depth and areas in red have an increase in depth in 2025 compared to 2024.

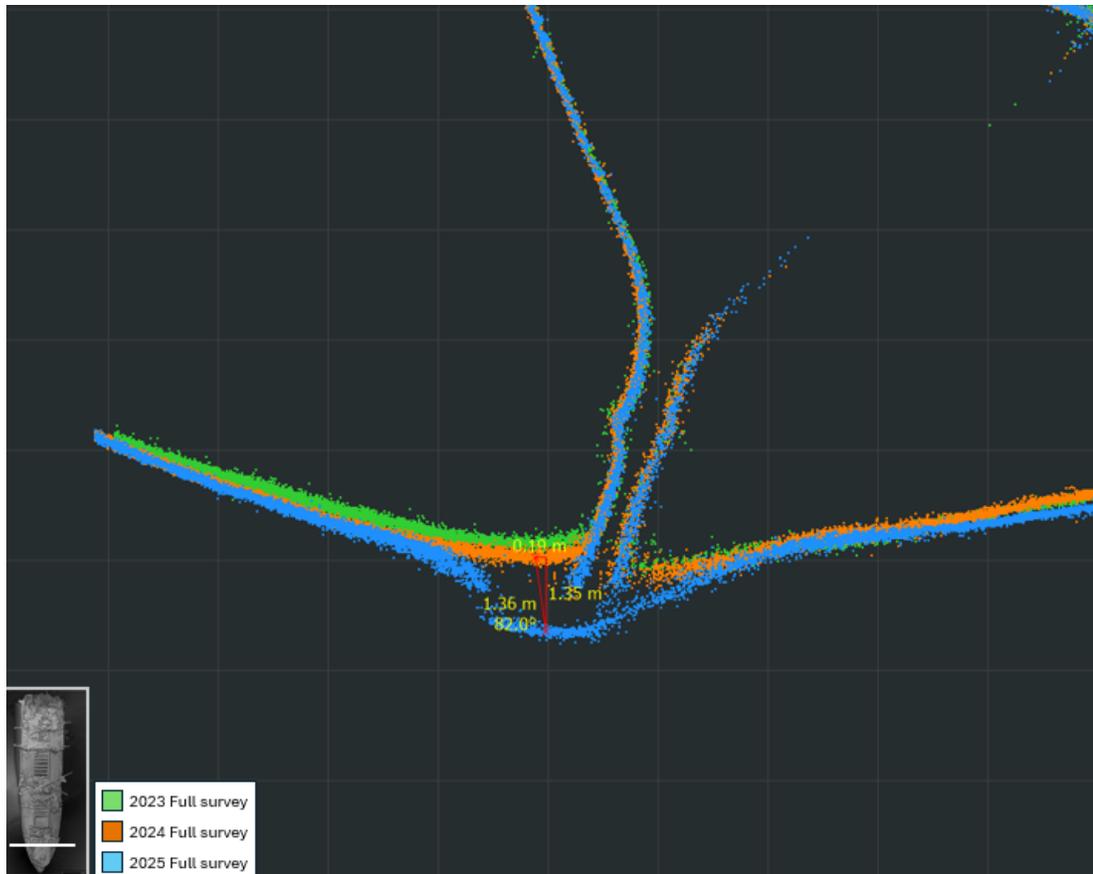
Figure 32. Cross section by the aft section of the wreck where depth difference in the immediate surroundings of the wreck is the greatest at 1.3 m between 2024 and 2025 full surveys.

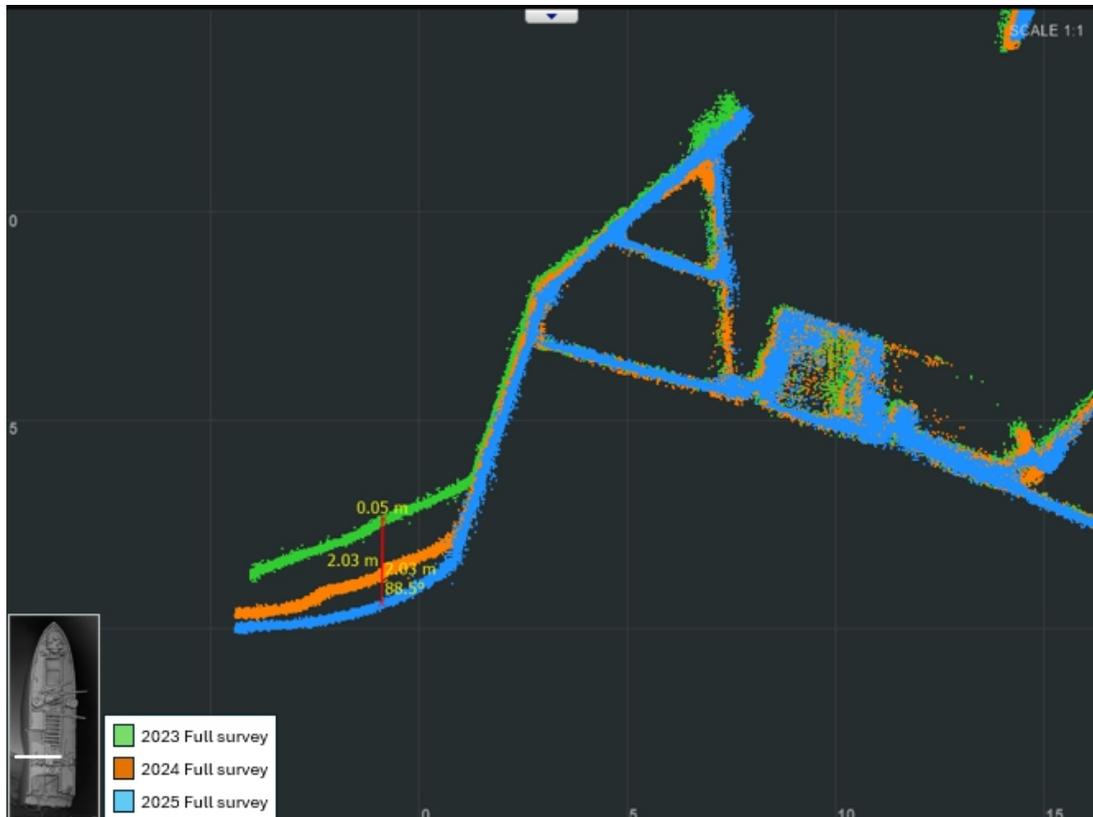
Figure 33. Cross section where depth in the immediate surroundings of the front section of the wreck has increased by 2 m between 2023 and 2025.

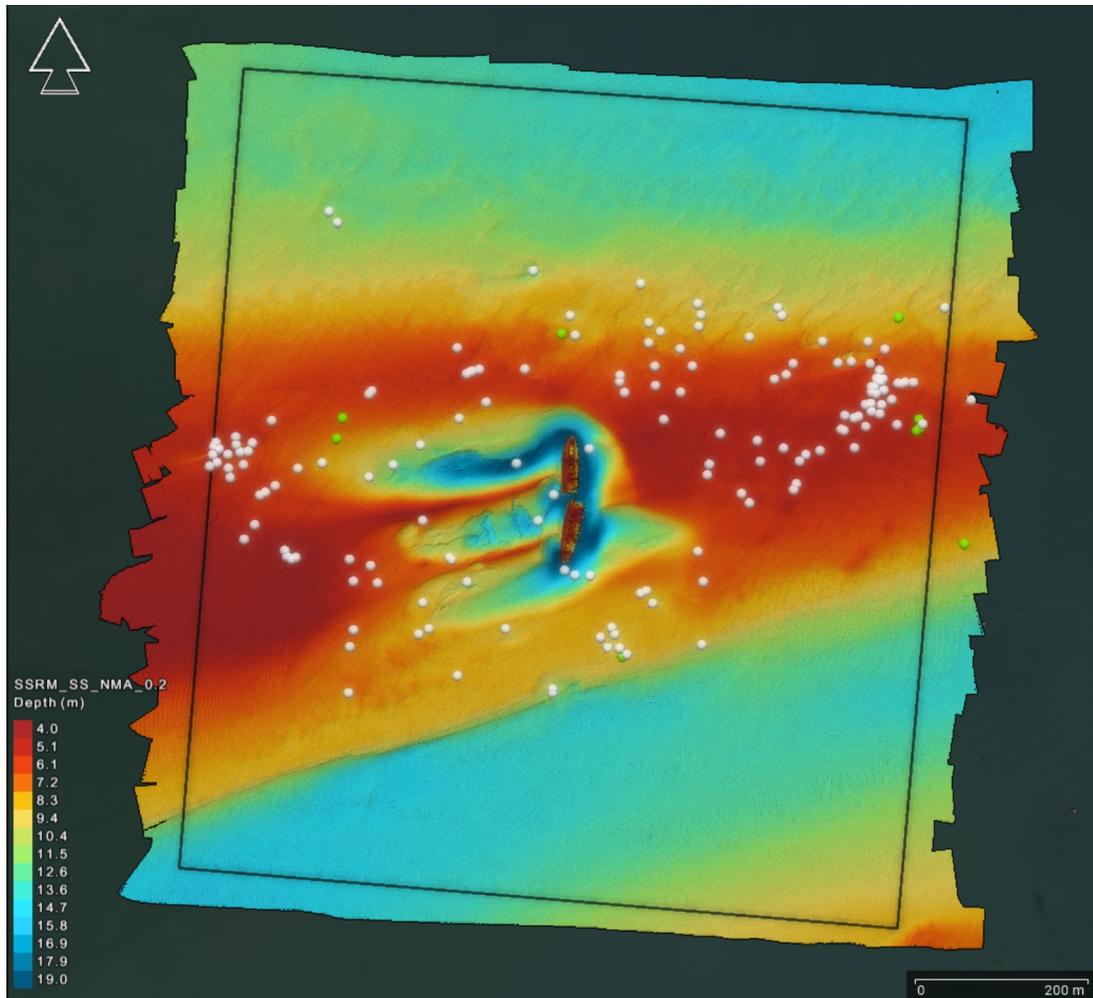
**5.2.1** The 159 targets from 2024 target list were compared with the bathymetry of this year out of which 100 targets were present, 18 targets were listed as plausible, and 38 targets were not visible in the data of 2025. A further 9 targets were identified and added to the list, resulting in 109 present targets of the now 168 targets listed in Appendix B – Gazetteer of Observations (Figure 34).

Figure 34. The SSRM survey area with seabed contacts, 2024 contacts in white, 2025 new contacts in green.
