Report on the investigation of
the collision between the bulk carrier

Polesie

Verity

resulting in the sinking of *Verity* with five fatalities
in the German Bight traffic separation scheme

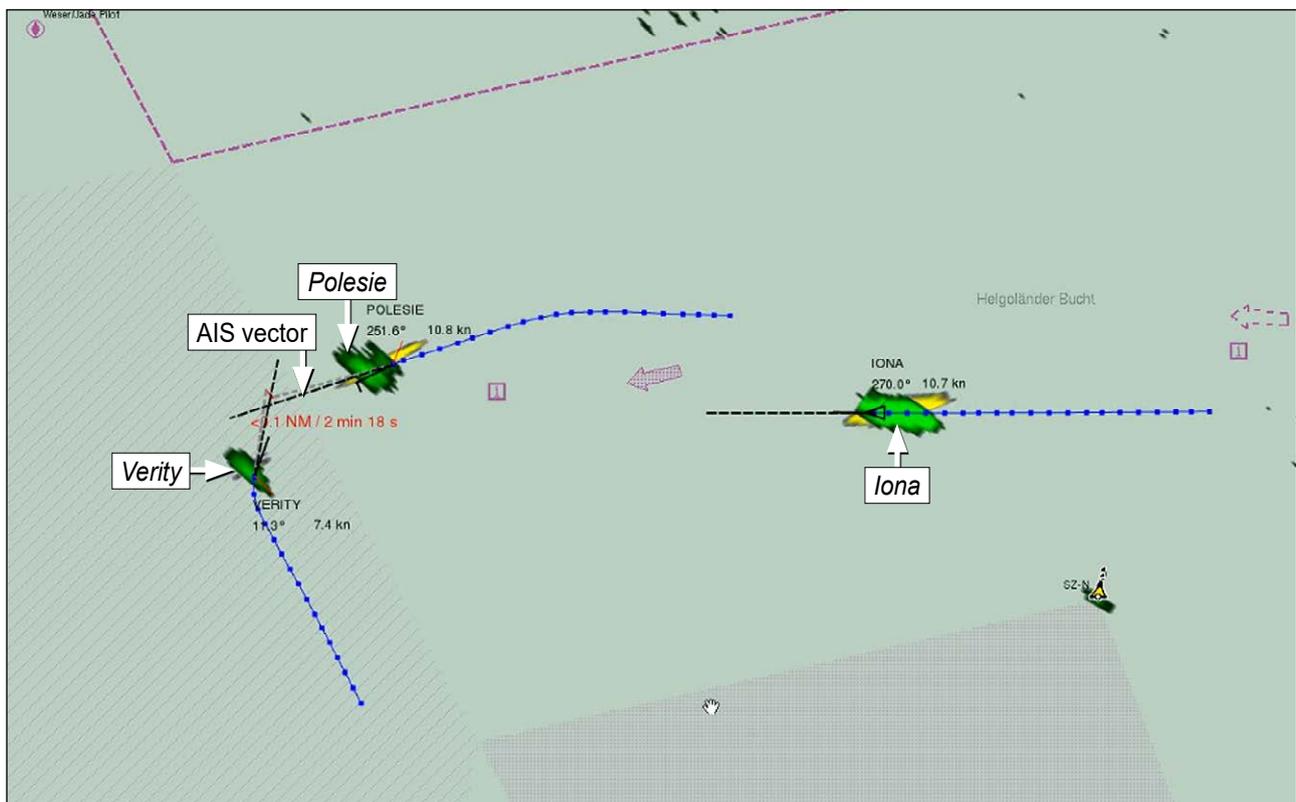
Figure 9: 0453:49 VTS display immediately before VTS supervisor calling *Polesie* and instructing it to turn to starboard. Distance between vessels less than 0.5nm

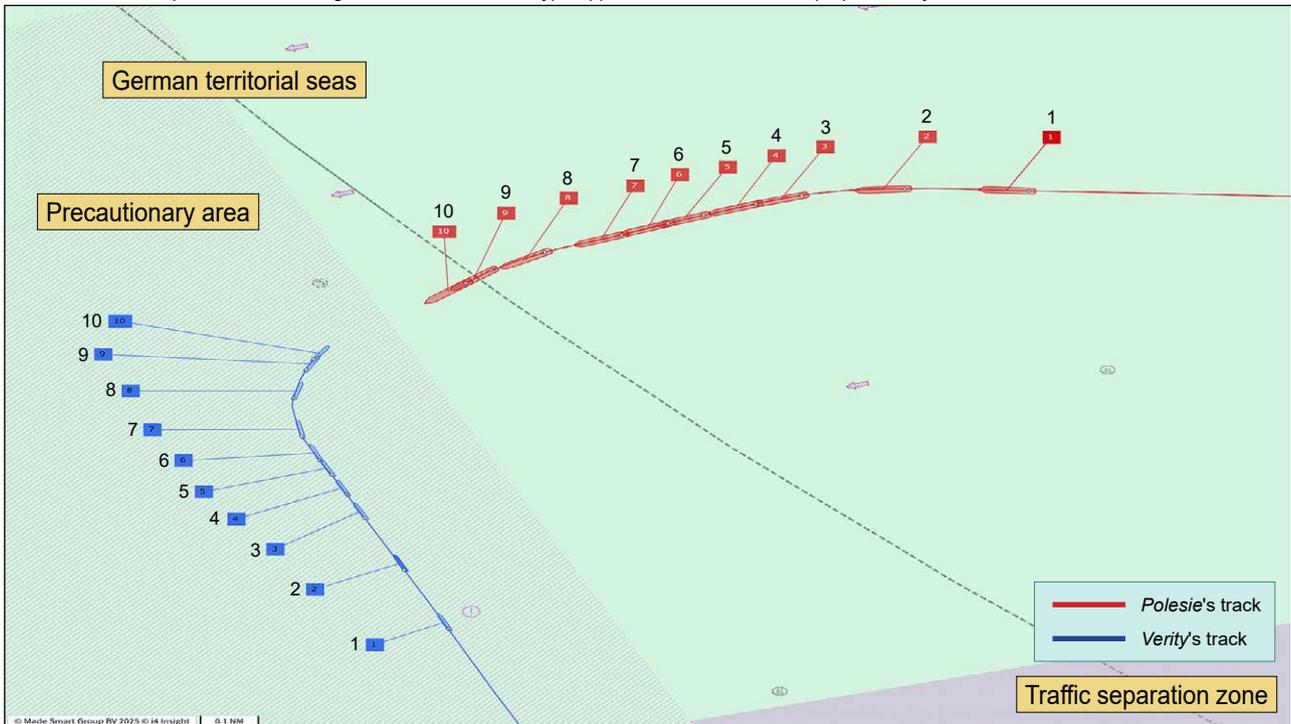
At 0454:18, 9 seconds after their reply to VTS, *Polesie's* C/O had switched to manual steering and put the vessel's rudder hard to starboard. Coincidentally, *Polesie* entered international waters. *Verity* was slowly altering course to starboard almost right ahead of *Polesie* at about 0.4nm (**Figure 10**).

Figure 10: Made Smart Group reconstruction of relative positioning of both vessels between 0048 and 0454

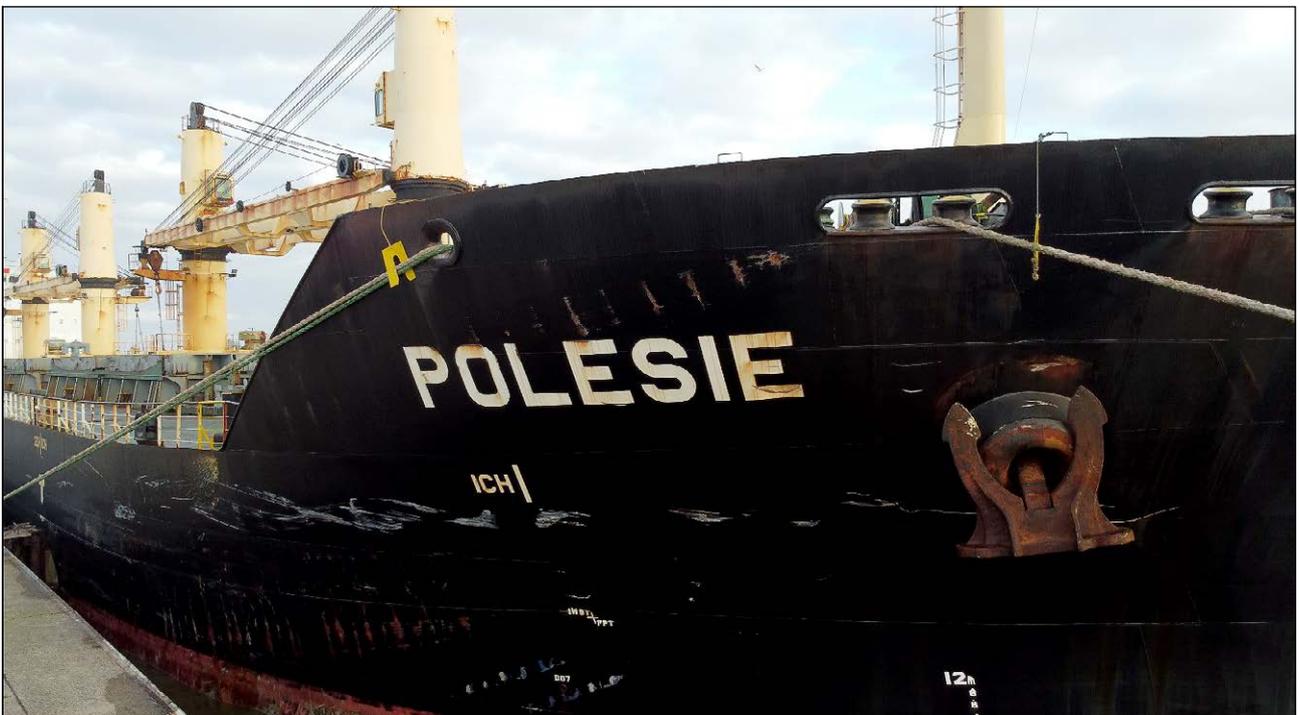
Following the collision, *Verity* was pushed around the bow and contacted the starboard anchor and the starboard side of *Polesie's* hull (**Figure 11**). *Verity's* speed reduced quickly as it scraped down the side of *Polesie*, on which the C/O had reduced the engine speed to half ahead.

Figure 11: Paint marks on *Polesie's* anchor and bow

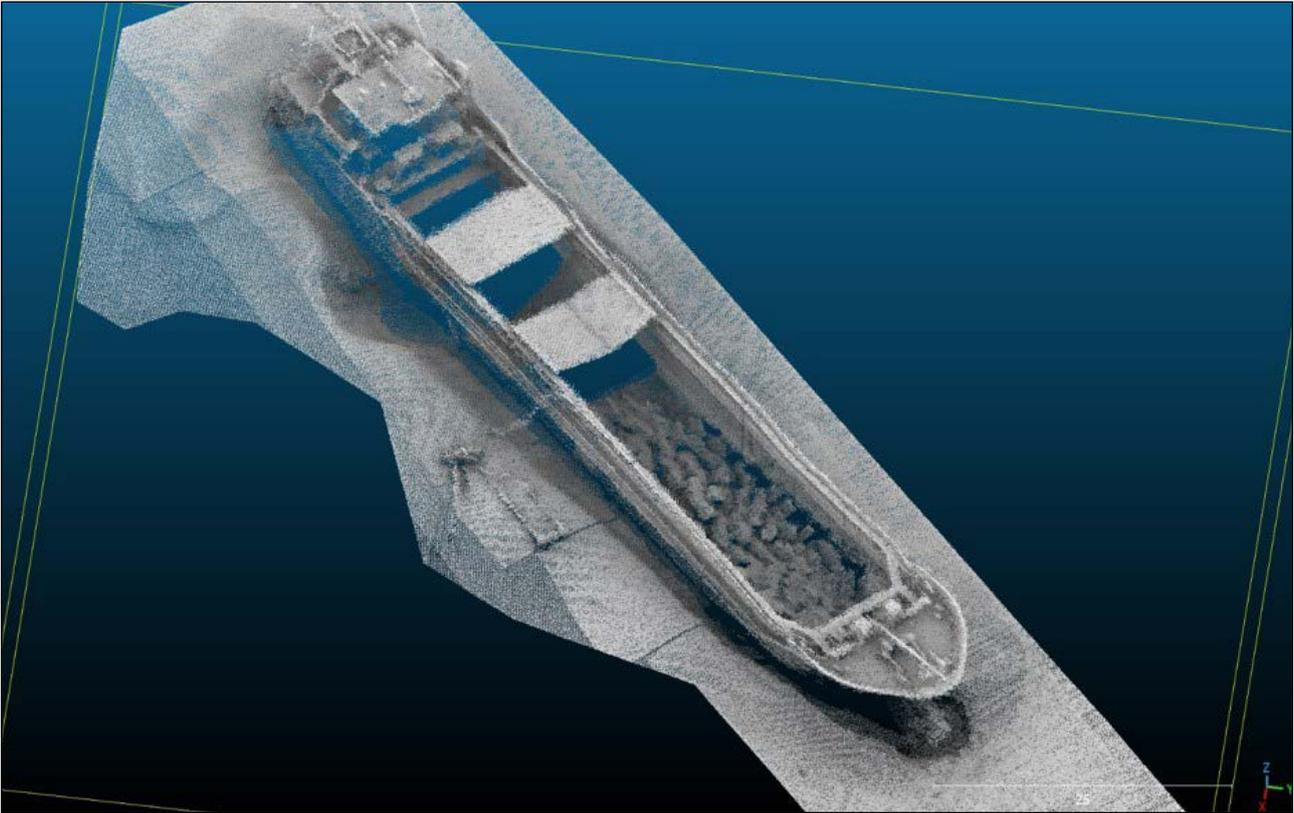
Figure 12: Side-scan sonar picture of *Verity* on seabed, showing shift of cargo and missing/collapsed hatch covers

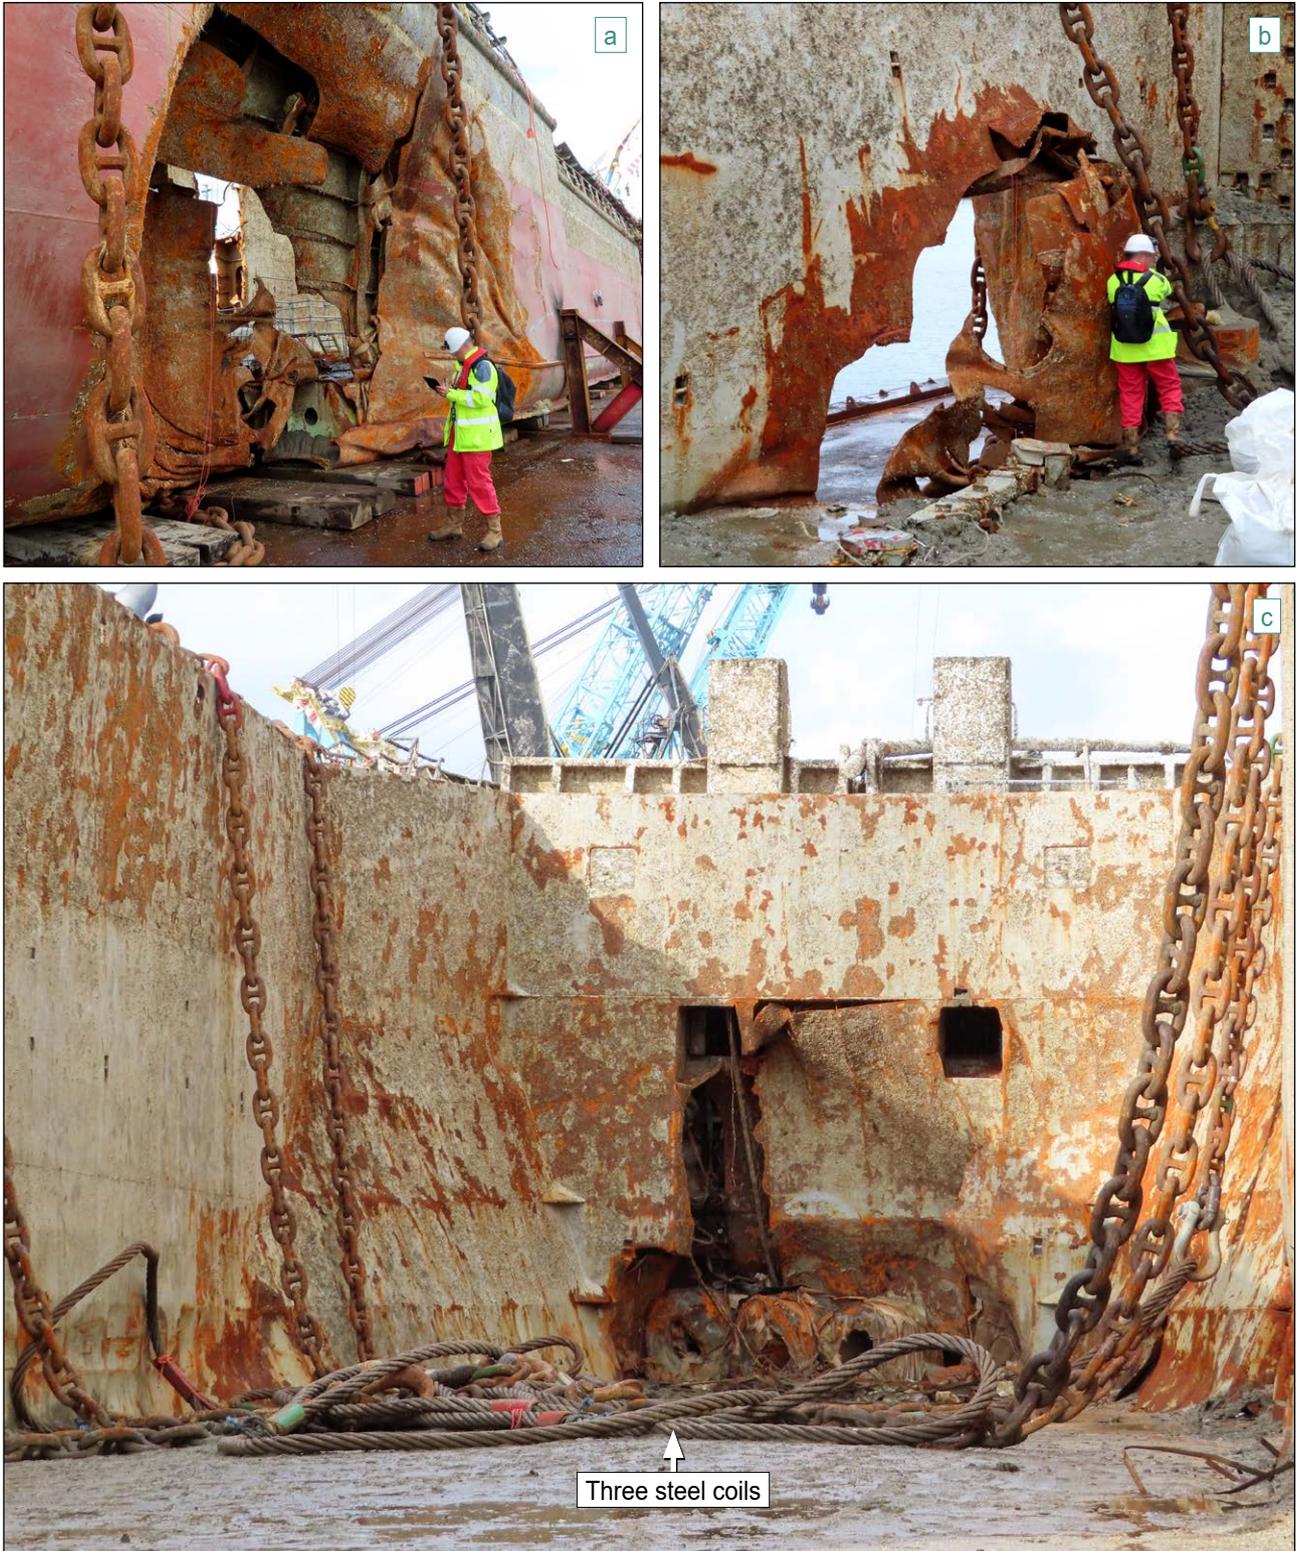
Figure 13: Damage to *Verity's* hull (a and b) and steel coils in forward hold (c)

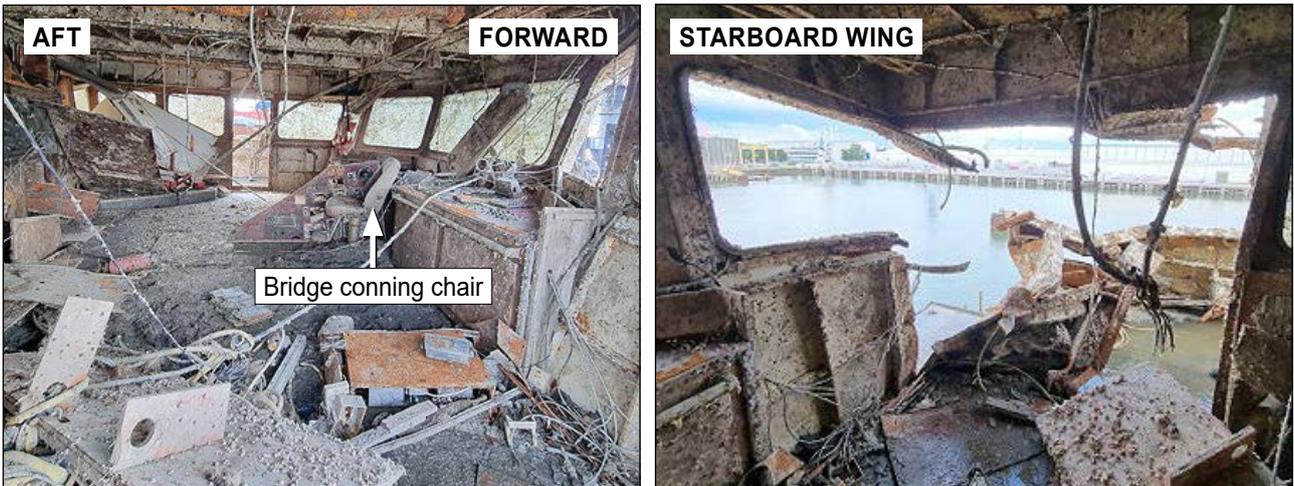
Figure 14: Bridge condition post-salvage and damage to starboard wing

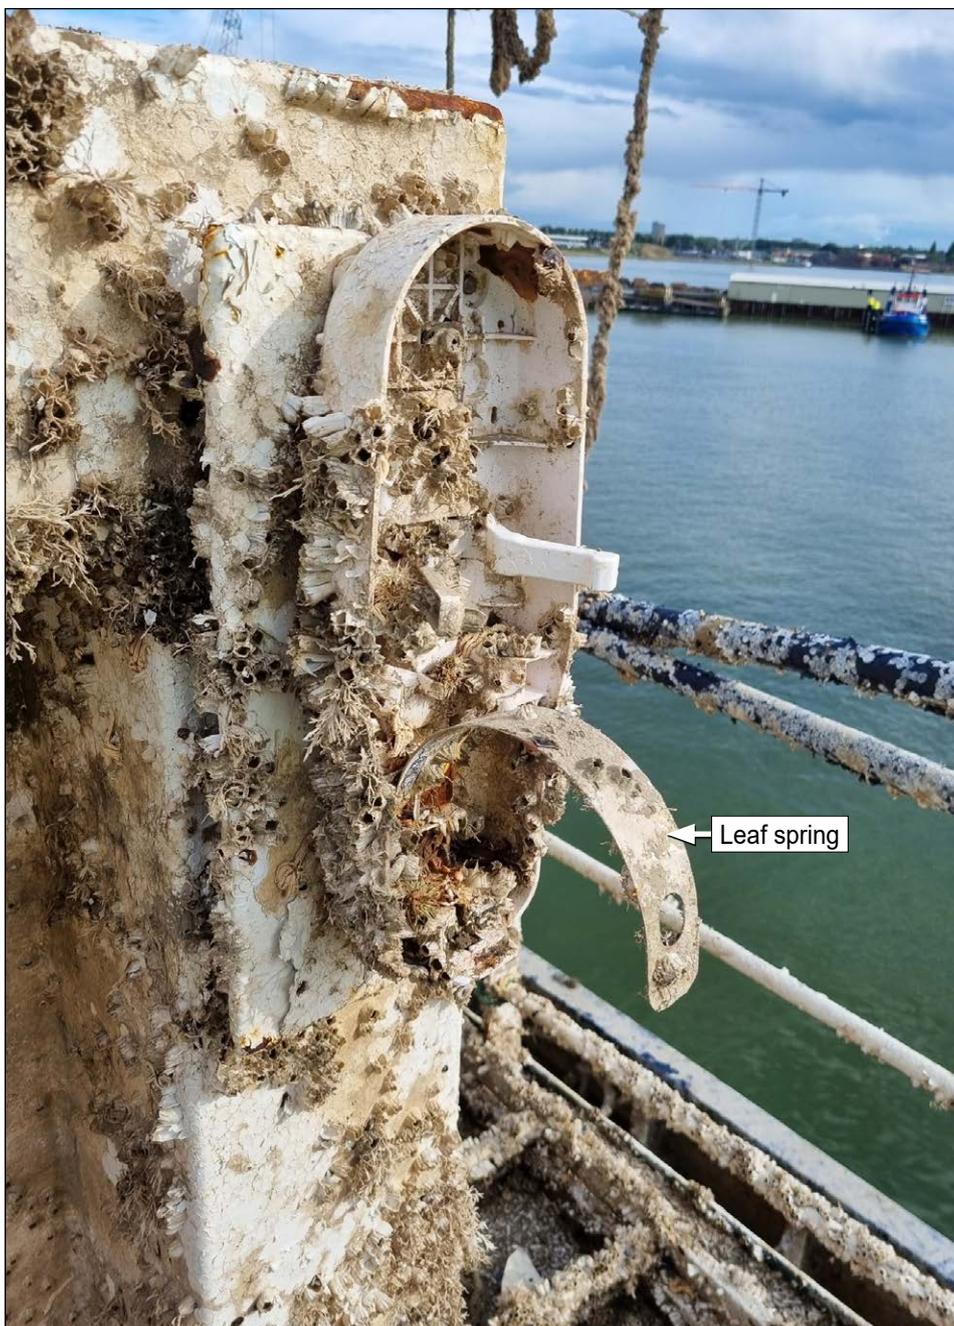
- The emergency position indicating radio beacon (EPIRB) was found on the aft deck. Its housing cover and hydrostatic release were absent and the leaf spring that ejected the EPIRB had activated (**Figure 15**). It could not be determined what had prevented the EPIRB from surfacing.
- The rescue boat was recovered on 18 November 2023.

Figure 15: EPIRB housing with cover missing and ejection leaf spring deployed
