Serious Incident

Aircraft Type and Registration:	ATR 42-500, G-LMRC	
No & Type of Engines:	2 Pratt & Whitney Canada PW127E turboprop engines	
Year of Manufacture:	1996 (Serial no: 480)	
Date & Time (UTC):	27 August 2022 at 1018 hrs	
Location:	During climb 14 nm north-east of Aberdeen Airport	
Type of Flight:	Commercial Air Transport (Passenger)	
Persons on Board:	Crew - 3	Passengers - 25
Injuries:	Crew - None	Passengers - None
Nature of Damage:	None	
Commander's Licence:	Airline Transport Pilot's Licence	
Commander's Age:	39 years	
Commander's Flying Experience:	4,900 hours (of which 243 were on type) Last 90 days - 147 hours Last 28 days - 36 hours	
Information Source:	AAIB Field Investigation

Synopsis

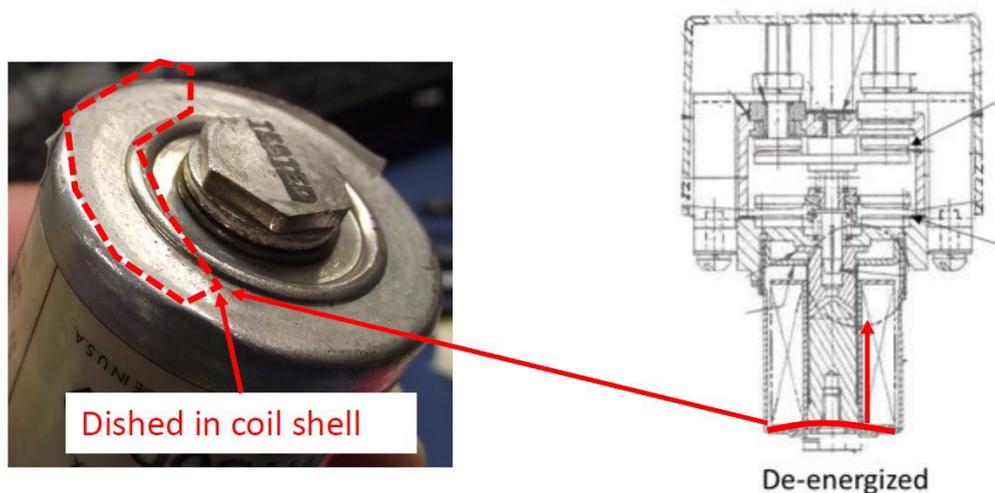
Figure 9

Internal examination of the contactor revealed that the coil had significant black discolouration from heat; however, the coil resistance was in the normal range so according to the component manufacturer it would have provided sufficient force to move the contact plates to make adequate contact. Plunger 'stall testing' revealed that the plunger was moving normally and smoothly and the contact surfaces only had slight wear. The significant finding was from internal measurements which revealed that there was insufficient stroke of the plunger caused by a geometric upwards shift of the plunger stop by about 0.4 mm – this was preventing sufficient downwards movement when the coil was energised. A close external examination of the coil casing revealed that it was dished inwards (Figure 9). This was the only damage found that could explain the 0.4 mm upwards shift of the plunger stop.

1PA contactor from G-LMRC showing dished in coil shell

The component manufacturer carried out some tests to determine if the 'dished in' shell damage could be caused by a hammer or mallet. Tests were carried out with a 113 g (4 oz) hammer and a 170 g (6 oz) mallet. After three strikes with the hammer, only 0.1 mm of upwards core movement was measured and there was no visible damage to the coil shell. However, after one strike with the mallet, 0.3 mm of upwards core movement was measured, and after two strikes 0.55 mm was measured, which was more than the 0.4 mm seen on the contactor from G-LMRC. Similar 'dished in' damage of the coil shell was also observed after strikes with the mallet.

The contactor failure was caused by the fact that the plunger stop had shifted upwards by about 0.4 mm, preventing sufficient downwards stroke of the contacts when the coil was energised. This upwards shift was most likely a consequence of impact damage to the coil casing which was seen to be dished in. Testing on another contactor revealed that striking the top of the coil casing with a mallet could produce similar dished-in damage and a similar upwards shift in the plunger stop. The cause of this damage could not be determined but it is possible that the contactor had been dropped or possibly hit with a mallet during troubleshooting. The aircraft operator's maintenance records did not reveal any issues with this contactor so if it had been hit, it may have been by a previous operator.
