Rail Accident Investigation Branch

# Rail Accident Report

## Passenger trapped and dragged at Ealing Broadway 24 November 2024

Report 01/2026  
March 2026

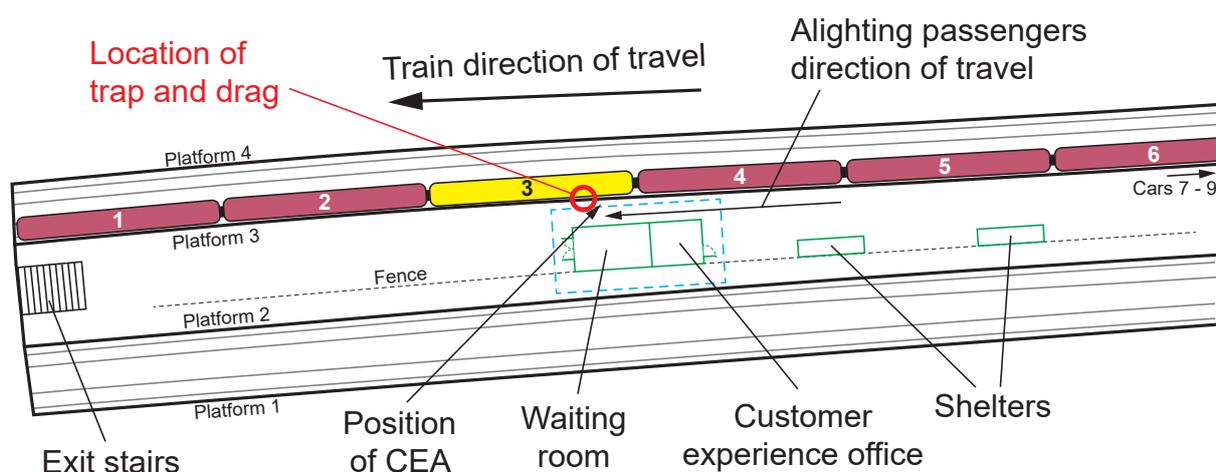
- 49 By the time the train had come to a stop in platform 3 at its correct position, the CEA had positioned themselves by the rear doors of car 3 (figure 8). The driver released the doors, which opened, and passengers began to alight from the length of the train, making their way towards the platform exit near the front of the train. Passengers from the middle and rear of the train had to walk through a narrowed section between the platform edge and the waiting room building to reach the exit (figure 10). This area was adjacent to cars 3 and 4.

Figure 8: Diagram showing train 9N68 stationary on platform 3.

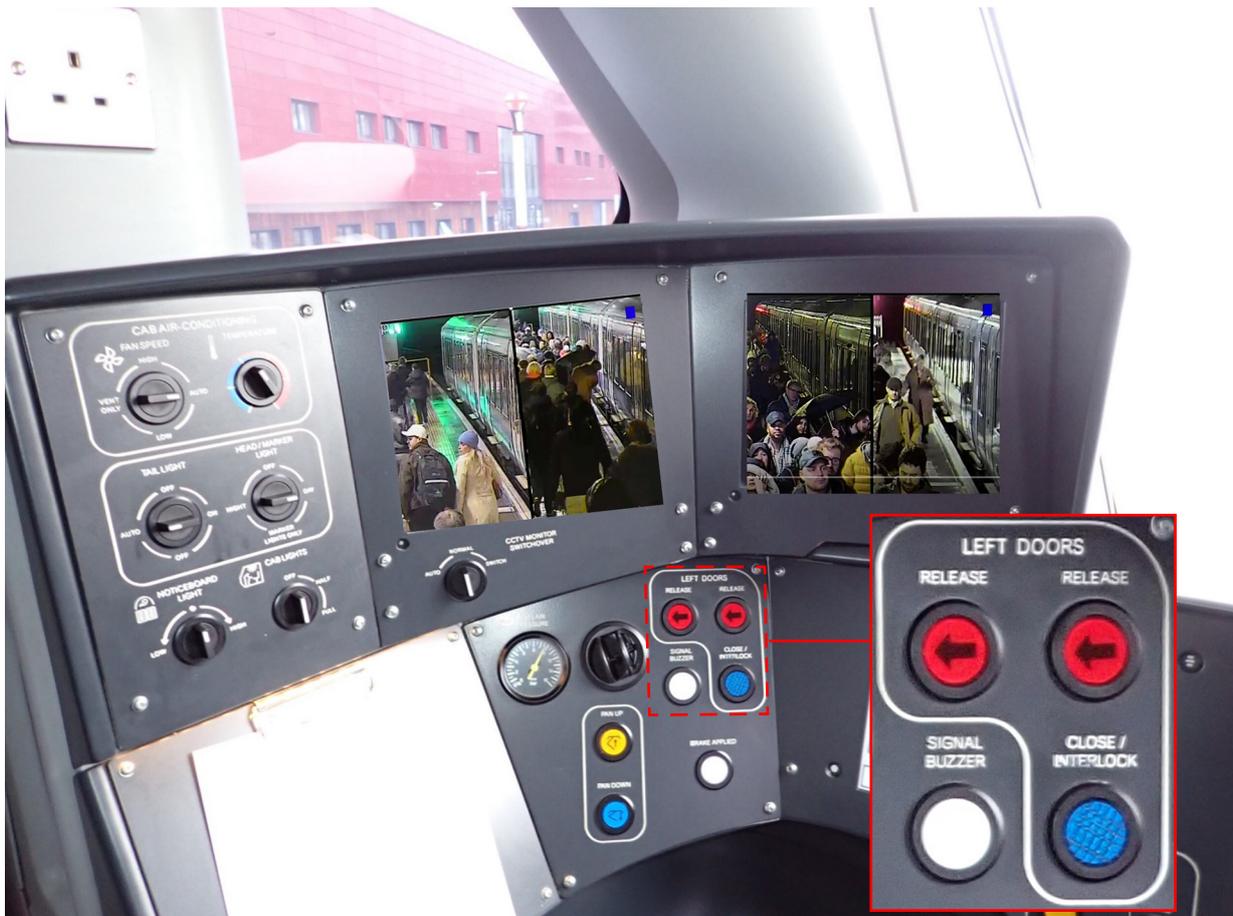
- 77 In the driver's cab, a maximum of eight camera images may be displayed to show the entire length of the train while it is in the platform. The monitors become active once the driver operates the doors open controls and remain enabled until the train has departed and moved 10 metres or exceeded a speed of 3 mph (5 km/h). The actual number of camera images provided to the driver is dependent on the DOO CCTV assessment for each platform.
- 78 At platform 3 at Ealing Broadway station, four images are provided to the driver on the monitors (figure 9), compared to the eight images provided to the driver on platform 4. The additional cameras on platform 4 were provided as a result of the CCTV assessment identifying an additional risk due the curvature of that platform.

Figure 9: Still taken from the DOO CCTV recordings, superimposed by RAIB onto a photograph of the monitors in the driver's cab (photo taken during daylight hours).

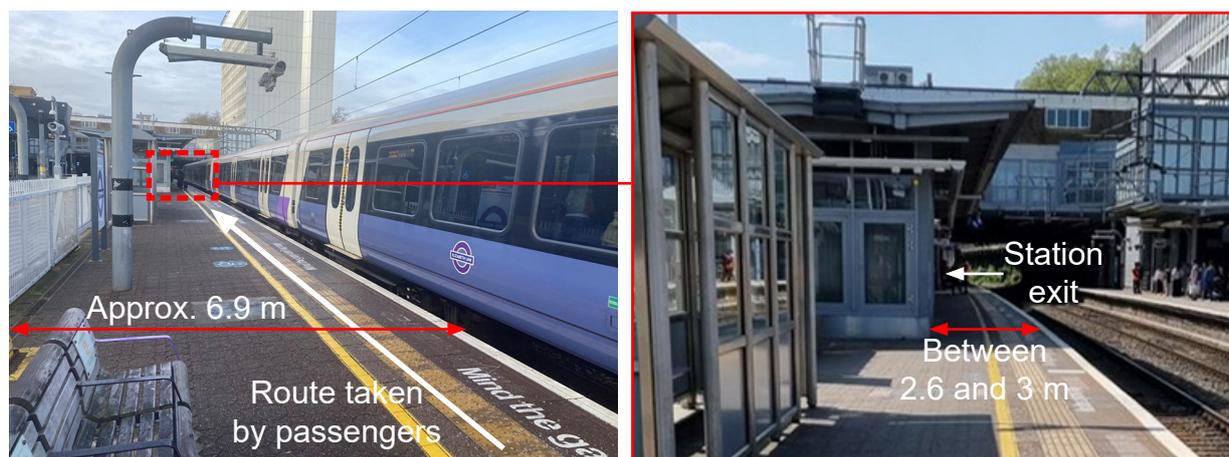
80 Passengers who had alighted from other cars also started to make their way along the platform, with a constant flow coming from the middle and rear portions of the train towards the exit. As they moved down the platform, the reduced width in the area around the waiting room created a 'pinch point', and the platform at the rear of car 3 became heavily congested with passengers (figure 10). As well as increasing congestion, the flow of passengers moving towards and through the narrower section (figure 16) made it difficult for passengers at the rear of car 3 to join the flow of passengers leaving the station, and for some passengers on the platform to board the train.

Figure 10: The route taken by passengers and the changes in platform width.

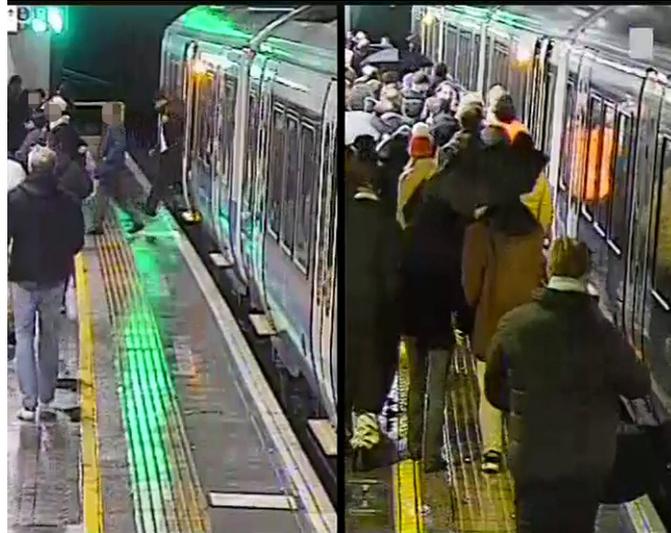
- The heavily congested section of the platform adjacent to the waiting area partially obscured the driver's view of the rear doors of car 3 and affected their ability to distinguish which passengers were moving to leave the station and which passengers were waiting to board this car.

Figure 11: Images from DOO CCTV showing passengers leaving car 1 (left image) and congestion around car 3 (right image) (courtesy of MTREL).

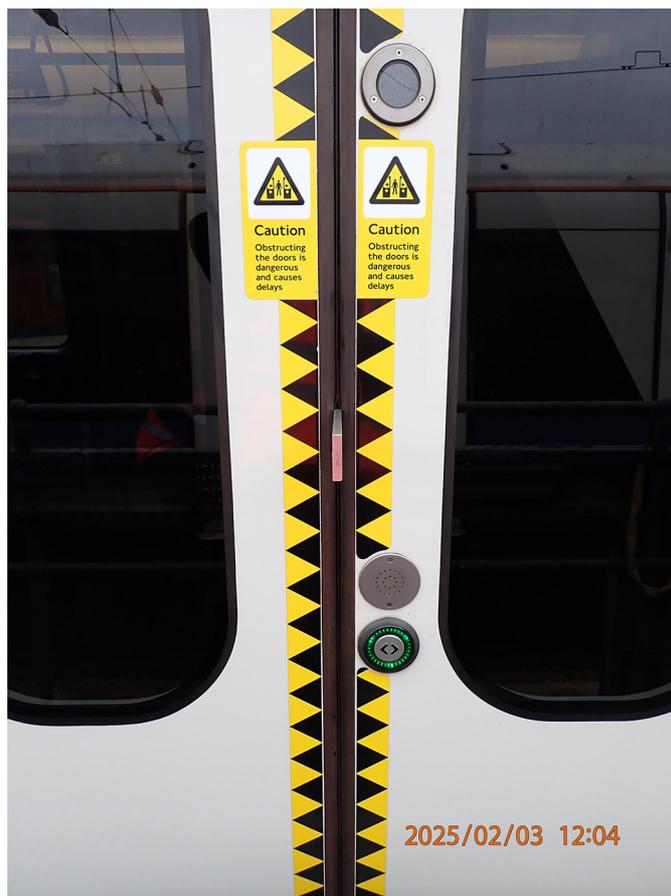
- 102 The doors on class 345 trains remain compliant with the requirements of BS EN 14752:2005 to detect obstructions greater than 30 mm in thickness and 60 mm in height. When an obstruction of this size is detected while the doors are closing, the doors will open, pause and then try to close up to another three times (recycling). After this, if the doors remain obstructed and traction interlock cannot be achieved, then the doors will 'fault' and remain open. The driver will receive a notification on a display in the cab (figure 13) with the relevant door illuminated, showing that there is an obstruction. Although traction power can only be applied once the traction interlock circuit is complete (that is, when all doors are closed and locked) smaller diameter items may not be detected by the system if they become trapped in doors. Traction power will still be available in these circumstances.

Figure 12: An undetected obstruction in the train doors.

103 The average dimension of a small adult hand<sup>3</sup> is 75 mm in height, with a finger thickness of 18 mm. These dimensions are not within the detection parameters of the obstacle detection system on class 345 trains. It is, therefore, likely that the dimension of the passenger's hand involved in the trap and drag accident was too small to be detected, resulting in doors not recycling and the interlock circuit being made.

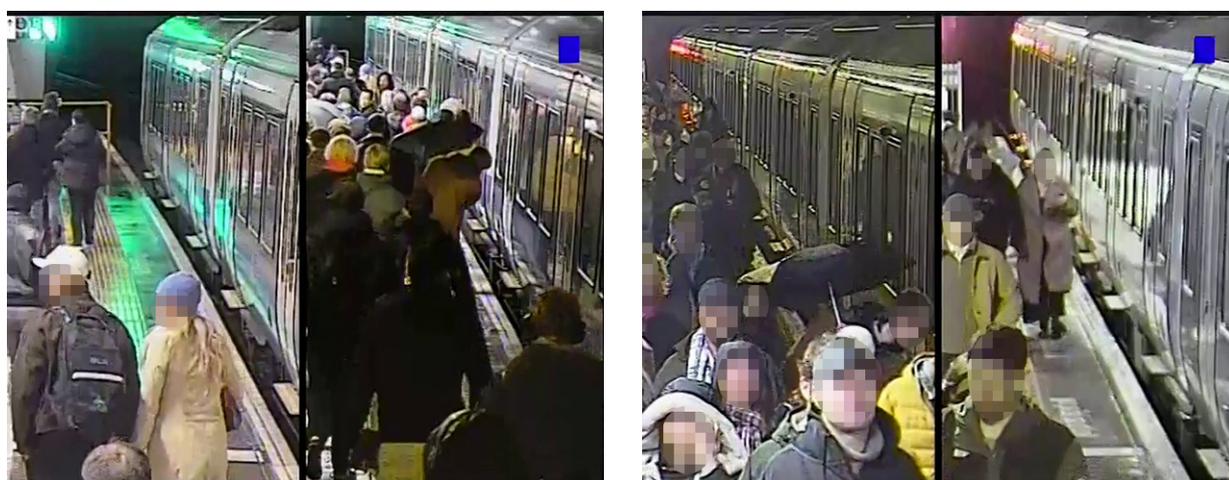
- 114 The area along the platform, particularly by the rear of car 3, remained congested during the train safety check (figure 14). This may explain why the driver did not identify that a passenger's hand had become trapped in the doors.

Figure 14: The view of the platform from the DOO CCTV as the train started to depart at 00:09 (courtesy of MTREL).

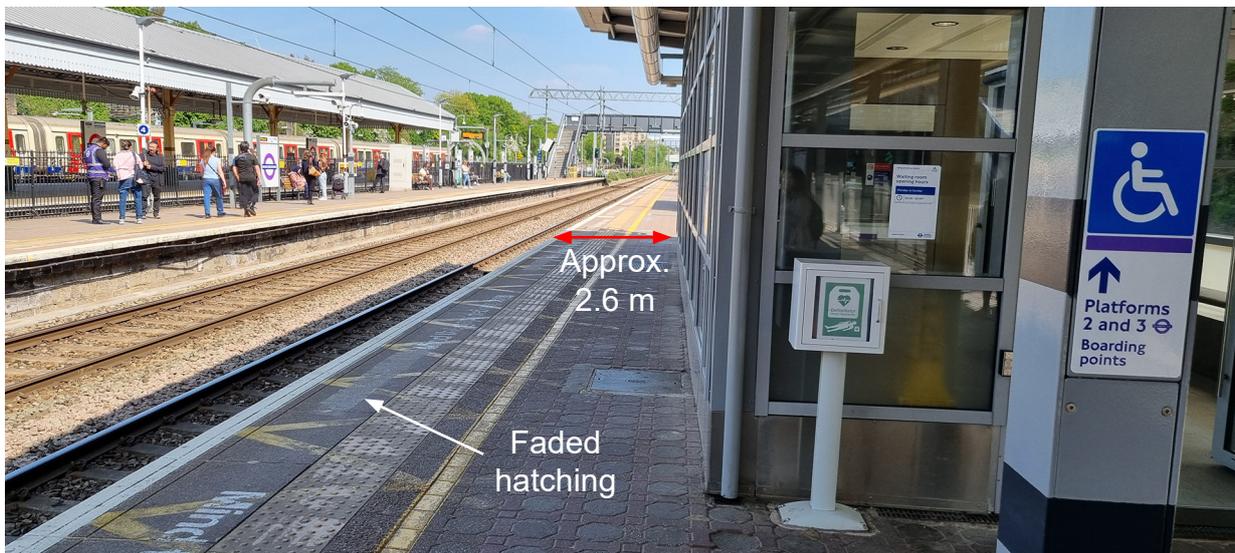
- 131 The risk assessment did not identify the positioning of the yellow line, other markings or safety signage to encourage passengers not to walk or wait in the narrowed area by the waiting room. Platform markings had been applied on the platform at some point by the previous station facility owner, probably to deter passengers from waiting in the narrowed area, but this had worn away and was not clearly visible (figure 15). In addition, the risk assessment did not identify a need to effectively manage, monitor or report issues with the DOO cameras to ensure that images being provided to drivers were optimal.

Figure 15: The waiting room and narrowest point close to where the trap occurred.

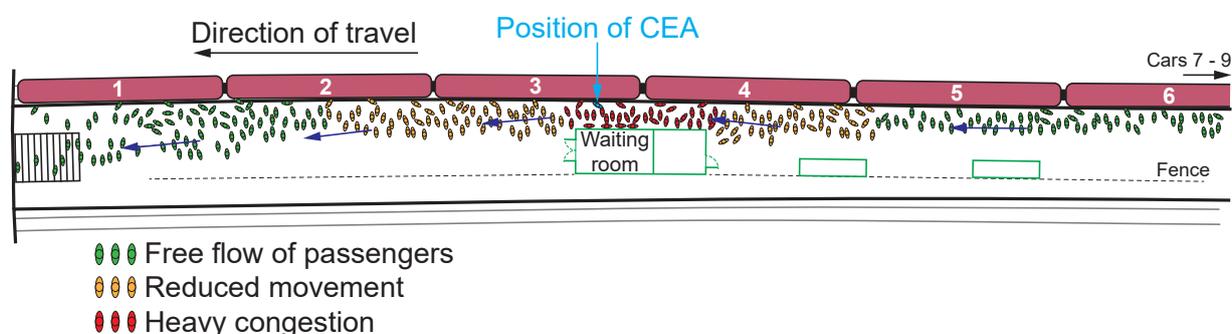
- 134 The new waiting room building was relocated and built before MTREL undertook its dispatch risk assessment. However, the narrowed area was not identified as posing any additional risks, even though the width of the platform was very close to the minimum requirements (paragraph 35) and congestion in the area was not uncommon at peak times (paragraph 132).

Figure 16: Passenger flow from the train and movement of passengers towards the station exit.

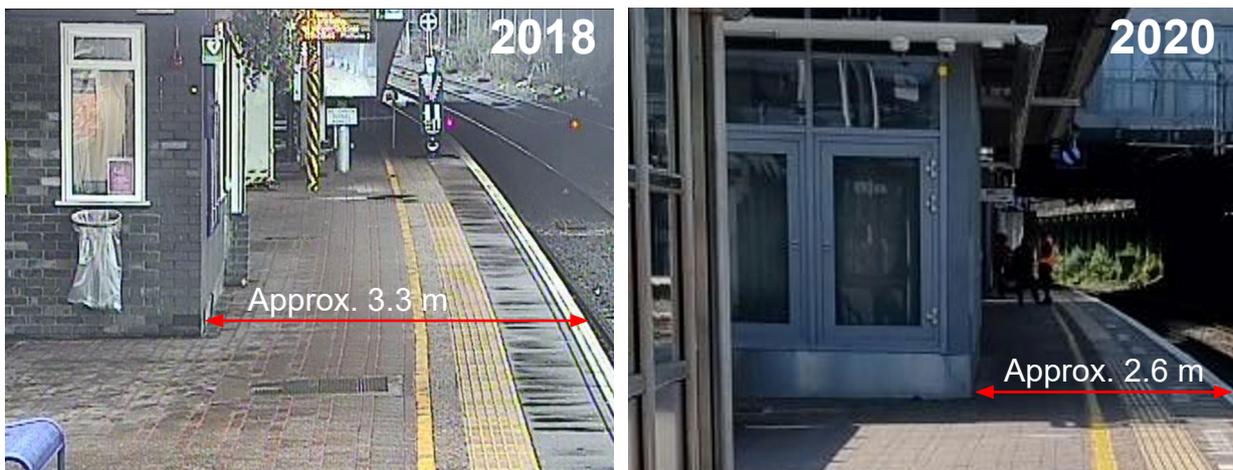
- 140 Network Rail was unable to confirm the dimension differences between the old and new buildings or provide a suitable risk assessment for the impact of the change. However, analysis of the images and measurements taken by RAIB shows the location of the new waiting room building is at least 0.7 metres closer to the platform edge than the old one.

- 141 There is no documentary evidence to show that Network Rail had undertaken any operational risk assessment in relocating the new waiting room building, or if any consideration had been given to potential changes in passenger flows and subsequent risk to platform-train interface. It is, therefore, not possible to determine how the risks associated with a narrowed platform adjacent to the revised waiting room were understood (paragraph 80).

Figure 17: Old waiting area building (taken in 2018) and the new building (taken in 2020) (courtesy of Network Rail).

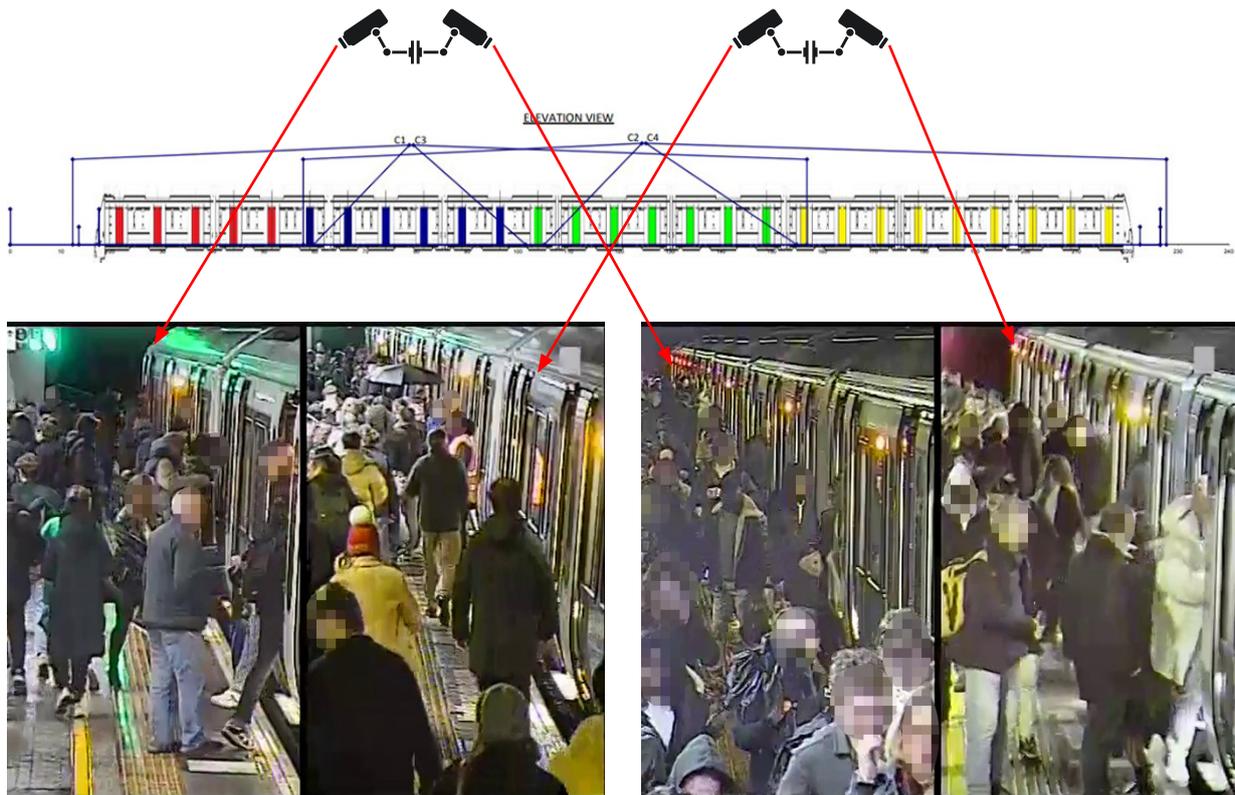
- 164 While the use of the Rotakin test target can provide some assurance on visibility and image quality, it does not in itself consider the practical and realistic passenger/train environment (such as congested platforms) and the effect that this may have on a train driver's view to support the final safety check. The view provided to the driver on their in-cab monitors of platform 3 just before the accident occurred (figure 19), shows the impact a busy platform can have.

Figure 19: DOO camera positioning on platform 3 and actual view available to driver at 00:09 (images courtesy of MTRREL).
