# Rail Accident Report

## Passenger trapped and dragged at Ealing Broadway 24 November 2024

Report 01/2026  
March 2026

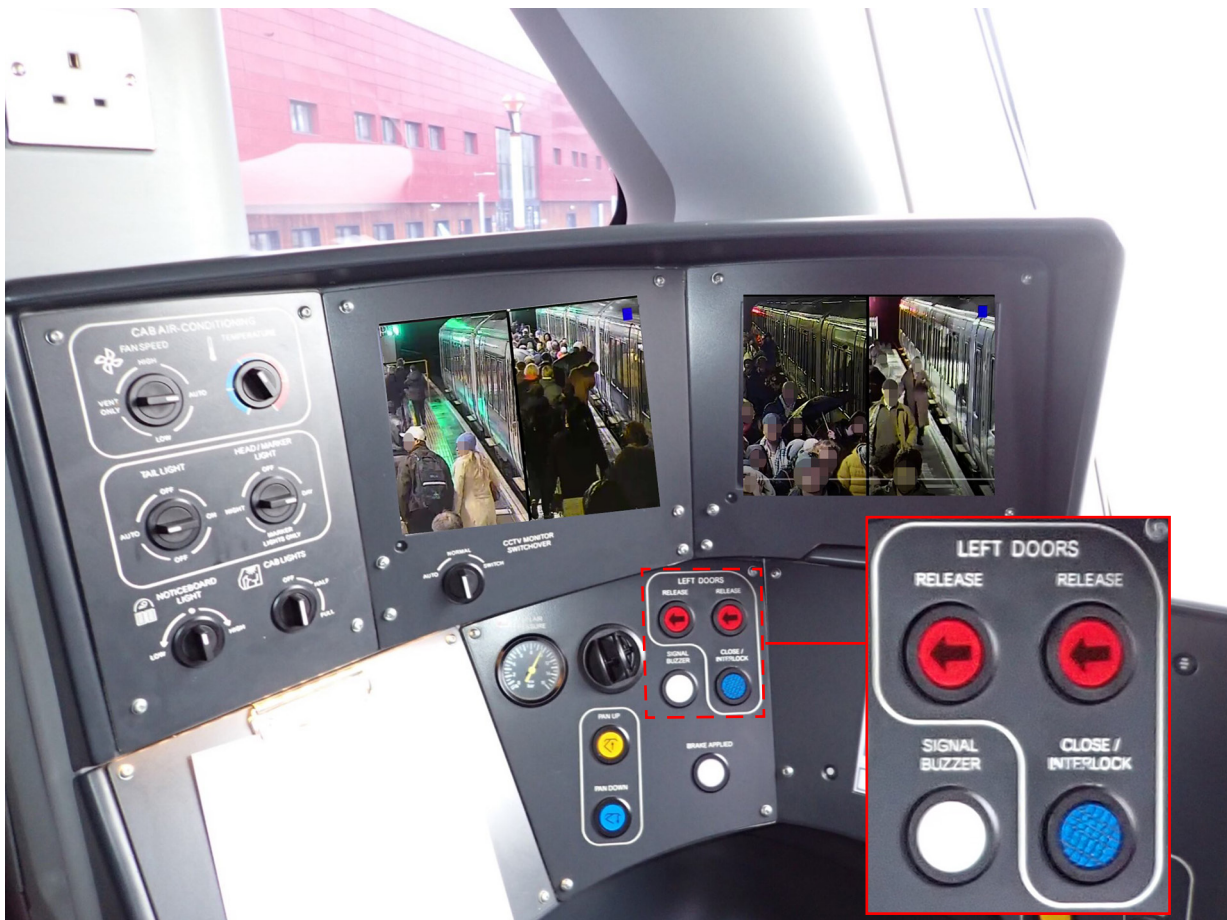
Figure 9: Still taken from the DOO CCTV recordings, superimposed by RAIB onto a photograph of the monitors in the driver's cab (photo taken during daylight hours).

- 77 In the driver's cab, a maximum of eight camera images may be displayed to show the entire length of the train while it is in the platform. The monitors become active once the driver operates the doors open controls and remain enabled until the train has departed and moved 10 metres or exceeded a speed of 3 mph (5 km/h). The actual number of camera images provided to the driver is dependent on the DOO CCTV assessment for each platform.
- 78 At platform 3 at Ealing Broadway station, four images are provided to the driver on the monitors (figure 9), compared to the eight images provided to the driver on platform 4. The additional cameras on platform 4 were provided as a result of the CCTV assessment identifying an additional risk due the curvature of that platform.

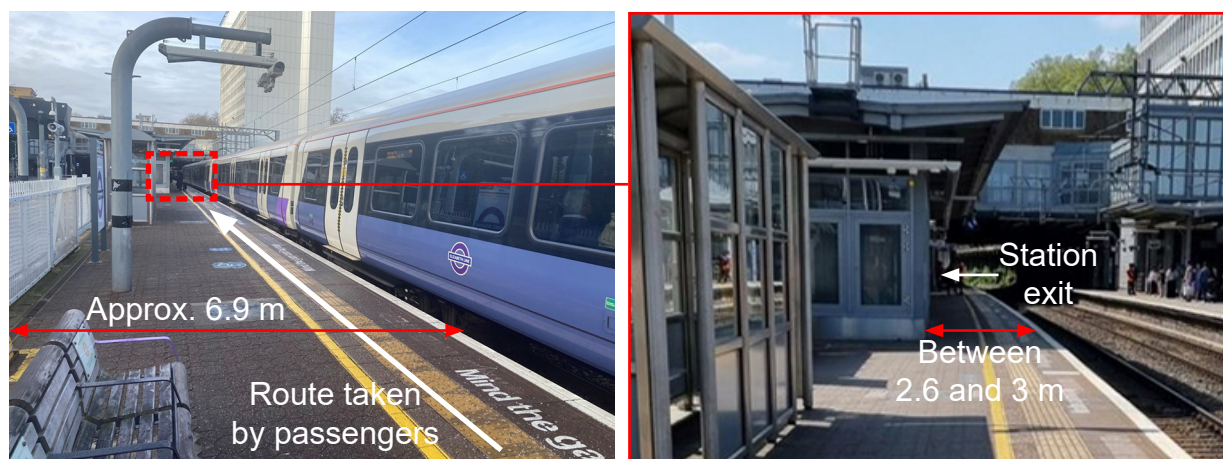
Figure 10: The route taken by passengers and the changes in platform width.

- 80 Passengers who had alighted from other cars also started to make their way along the platform, with a constant flow coming from the middle and rear portions of the train towards the exit. As they moved down the platform, the reduced width in the area around the waiting room created a 'pinch point', and the platform at the rear of car 3 became heavily congested with passengers (figure 10). As well as increasing congestion, the flow of passengers moving towards and through the narrower section (figure 16) made it difficult for passengers at the rear of car 3 to join the flow of passengers leaving the station, and for some passengers on the platform to board the train.

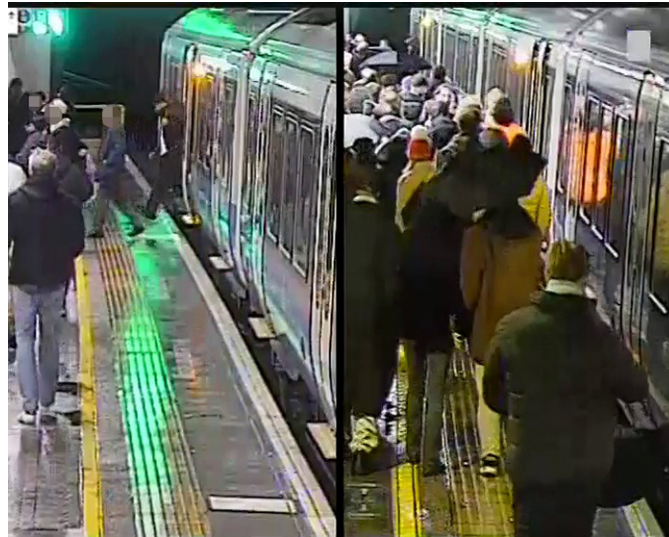
- The heavily congested section of the platform adjacent to the waiting area partially obscured the driver's view of the rear doors of car 3 and affected their ability to distinguish which passengers were moving to leave the station and which passengers were waiting to board this car.

*Figure 11: Images from DOO CCTV showing passengers leaving car 1 (left image) and congestion around car 3 (right image) (courtesy of MTREL).*

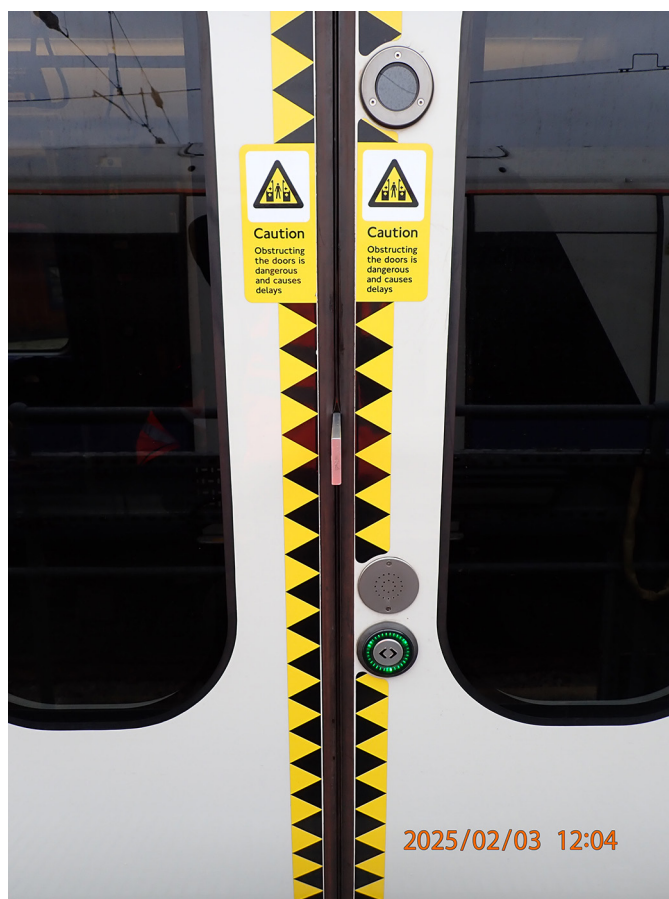
- 102 The doors on class 345 trains remain compliant with the requirements of BS EN 14752:2005 to detect obstructions greater than 30 mm in thickness and 60 mm in height. When an obstruction of this size is detected while the doors are closing, the doors will open, pause and then try to close up to another three times (recycling). After this, if the doors remain obstructed and traction interlock cannot be achieved, then the doors will 'fault' and remain open. The driver will receive a notification on a display in the cab (figure 13) with the relevant door illuminated, showing that there is an obstruction. Although traction power can only be applied once the traction interlock circuit is complete (that is, when all doors are closed and locked) smaller diameter items may not be detected by the system if they become trapped in doors. Traction power will still be available in these circumstances.

Figure 12: An undetected obstruction in the train doors.

- 103 The average dimension of a small adult hand<sup>3</sup> is 75 mm in height, with a finger thickness of 18 mm. These dimensions are not within the detection parameters of the obstacle detection system on class 345 trains. It is, therefore, likely that the dimension of the passenger's hand involved in the trap and drag accident was too small to be detected, resulting in doors not recycling and the interlock circuit being made.

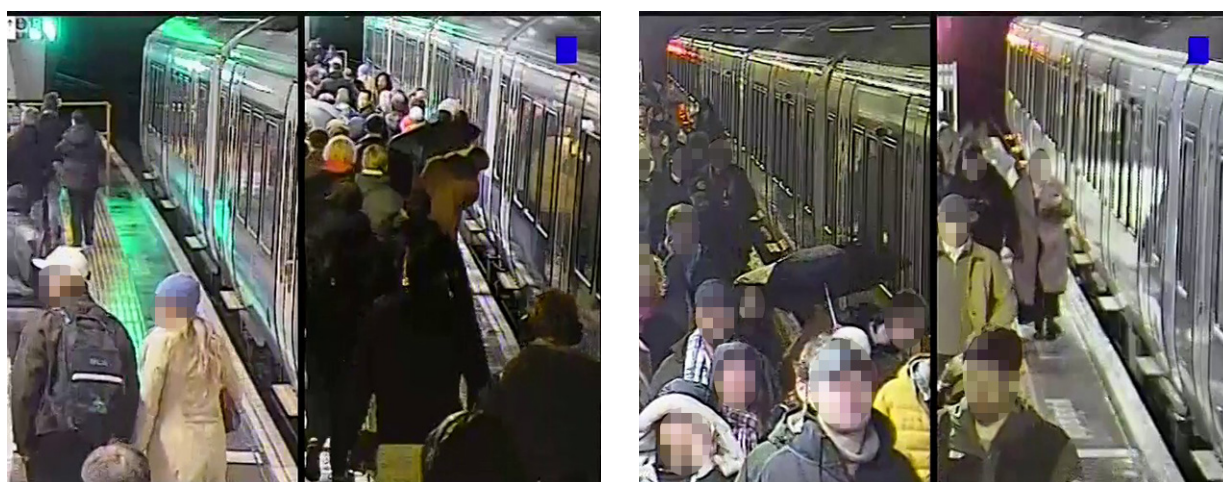
- 114 The area along the platform, particularly by the rear of car 3, remained congested during the train safety check (figure 14). This may explain why the driver did not identify that a passenger's hand had become trapped in the doors.

Figure 14: The view of the platform from the DOO CCTV as the train started to depart at 00:09 (courtesy of MTREL).

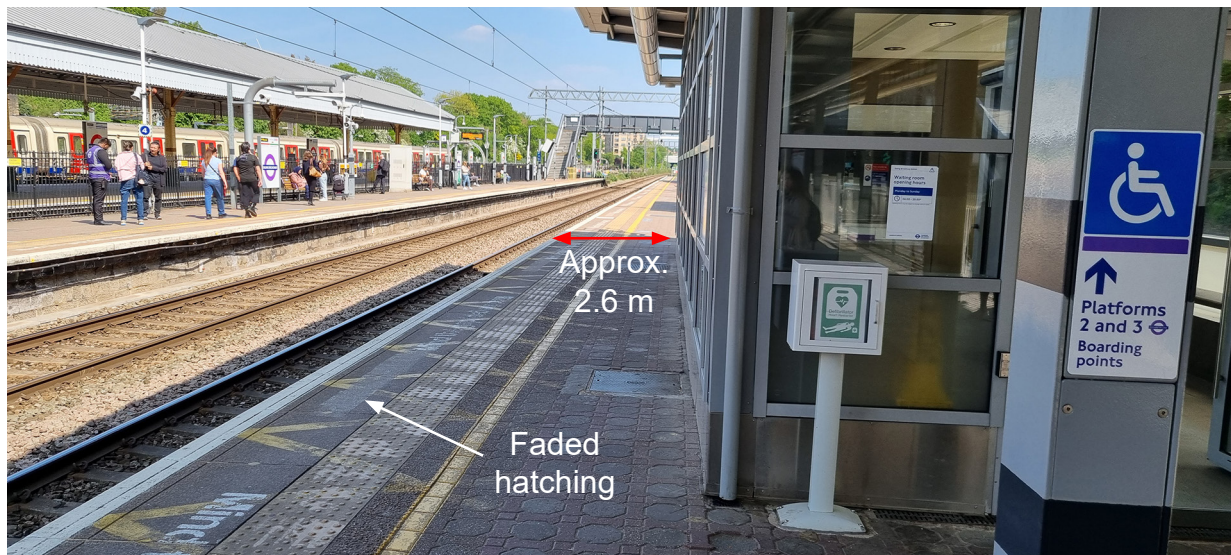
- 131 The risk assessment did not identify the positioning of the yellow line, other markings or safety signage to encourage passengers not to walk or wait in the narrowed area by the waiting room. Platform markings had been applied on the platform at some point by the previous station facility owner, probably to deter passengers from waiting in the narrowed area, but this had worn away and was not clearly visible (figure 15). In addition, the risk assessment did not identify a need to effectively manage, monitor or report issues with the DOO cameras to ensure that images being provided to drivers were optimal.

Figure 15: The waiting room and narrowest point close to where the trap occurred.

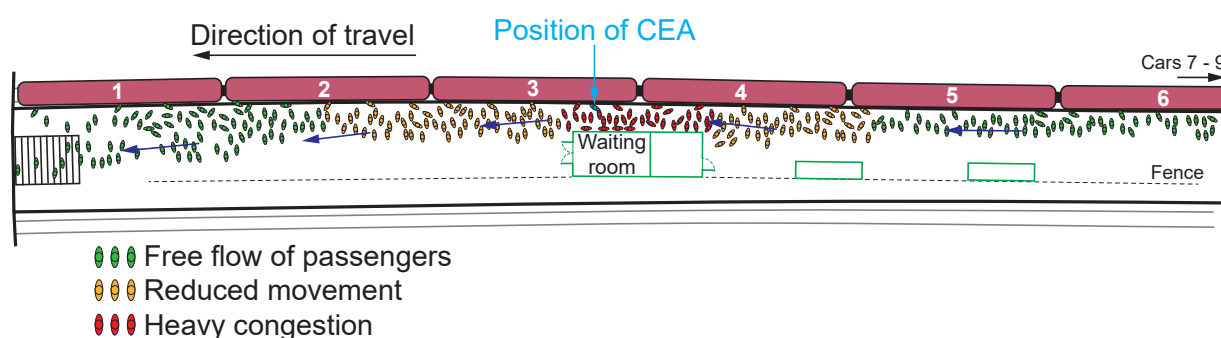
- 134 The new waiting room building was relocated and built before MTREL undertook its dispatch risk assessment. However, the narrowed area was not identified as posing any additional risks, even though the width of the platform was very close to the minimum requirements (paragraph 35) and congestion in the area was not uncommon at peak times (paragraph 132).

Figure 16: Passenger flow from the train and movement of passengers towards the station exit.

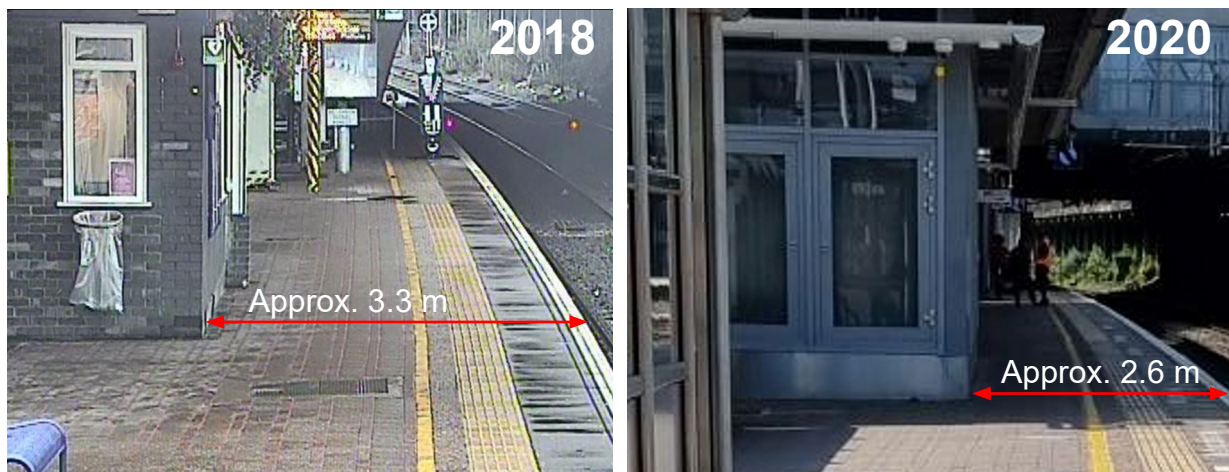
- 140 Network Rail was unable to confirm the dimension differences between the old and new buildings or provide a suitable risk assessment for the impact of the change. However, analysis of the images and measurements taken by RAIB shows the location of the new waiting room building is at least 0.7 metres closer to the platform edge than the old one.

- 141 There is no documentary evidence to show that Network Rail had undertaken any operational risk assessment in relocating the new waiting room building, or if any consideration had been given to potential changes in passenger flows and subsequent risk to platform-train interface. It is, therefore, not possible to determine how the risks associated with a narrowed platform adjacent to the revised waiting room were understood (paragraph 80).

Figure 17: Old waiting area building (taken in 2018) and the new building (taken in 2020) (courtesy of Network Rail).

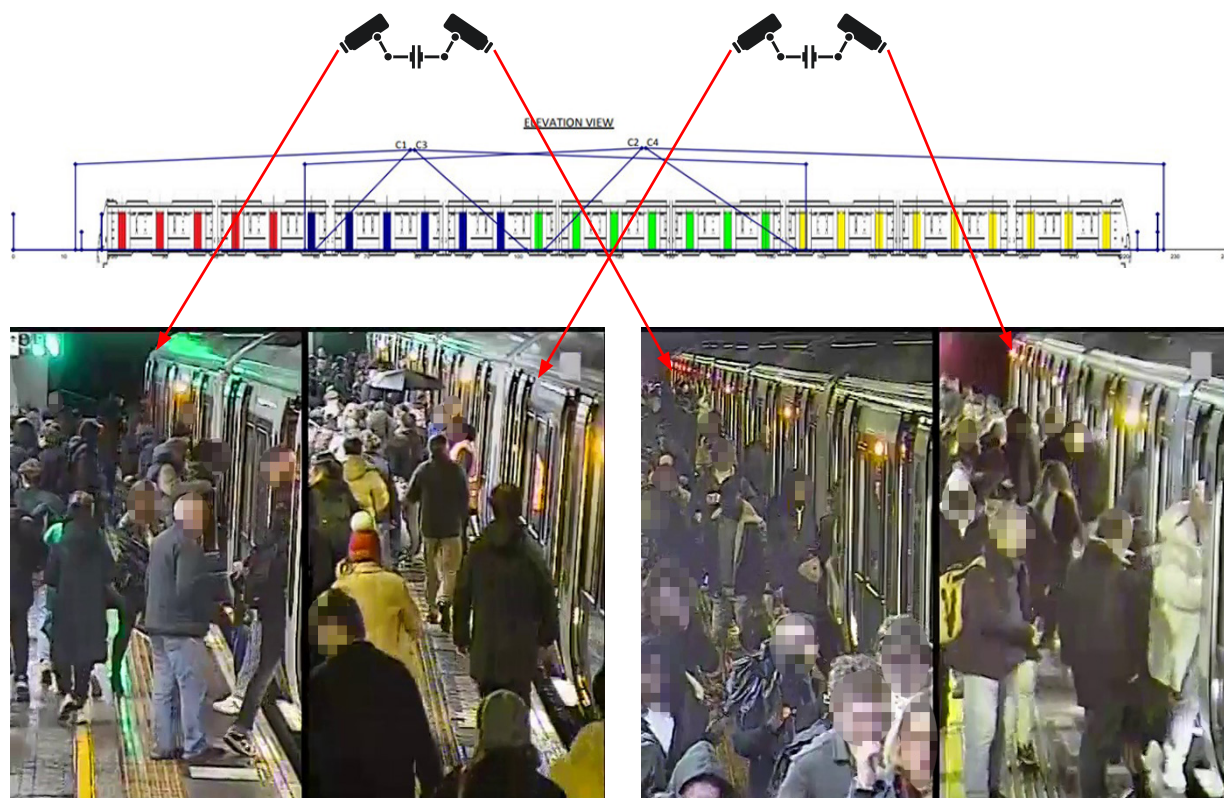
- 164 While the use of the Rotakin test target can provide some assurance on visibility and image quality, it does not in itself consider the practical and realistic passenger/train environment (such as congested platforms) and the effect that this may have on a train driver's view to support the final safety check. The view provided to the driver on their in-cab monitors of platform 3 just before the accident occurred (figure 19), shows the impact a busy platform can have.

Figure 19: DOO camera positioning on platform 3 and actual view available to driver at 00:09 (images courtesy of MTREL).
