Rail Accident Investigation Branch

Rail Accident Report

Fatal accident at Ickenham London Underground station 28 March 2025

Report 02/2026
March 2026

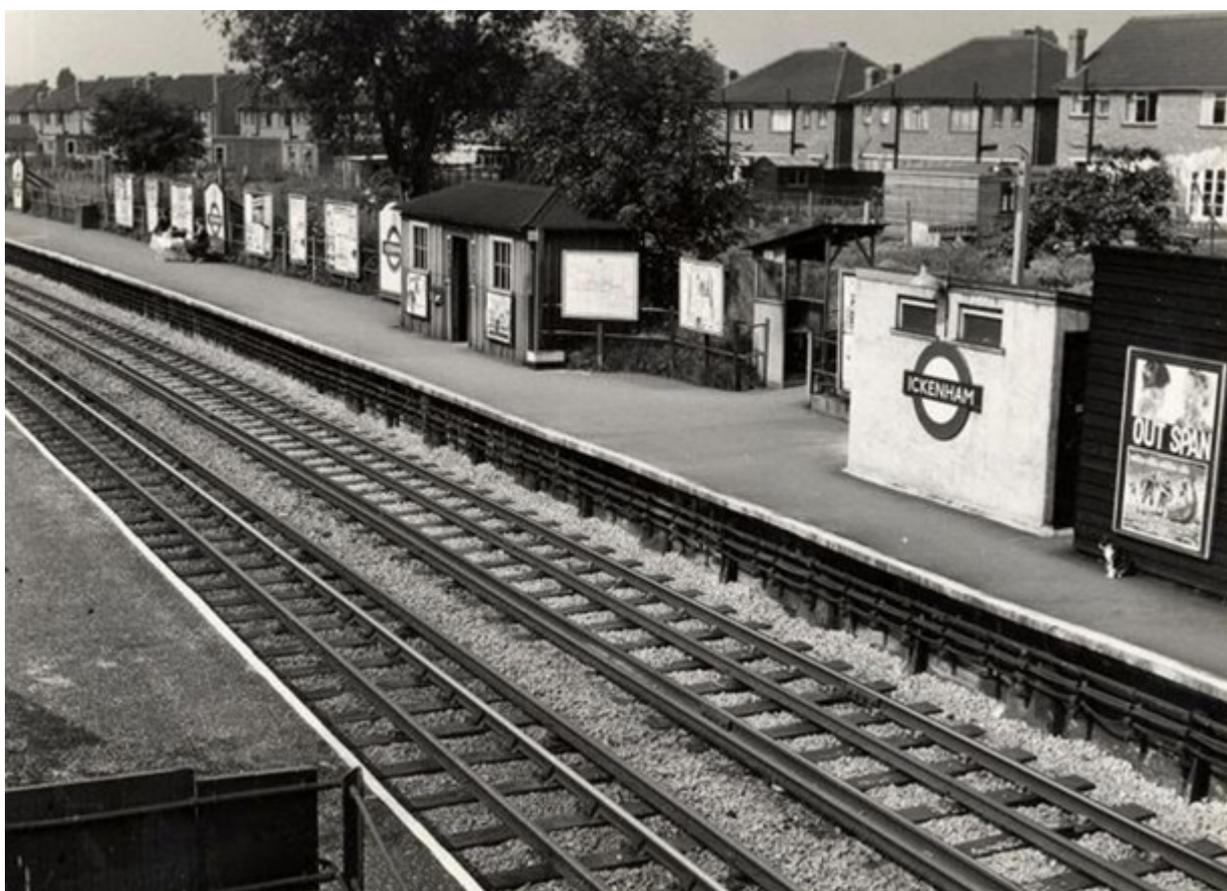
- 53 By July 1958, a photograph of the station (figure 11) shows a substantial cable run had been installed in the under-platform recess of platform 2. Cable runs of a similar appearance can also be seen in a photograph from 2001 (figure 12). This is representative of the current status of the recess.

Figure 11: Ickenham station platforms in 1958 (courtesy of the London Transport Museum).

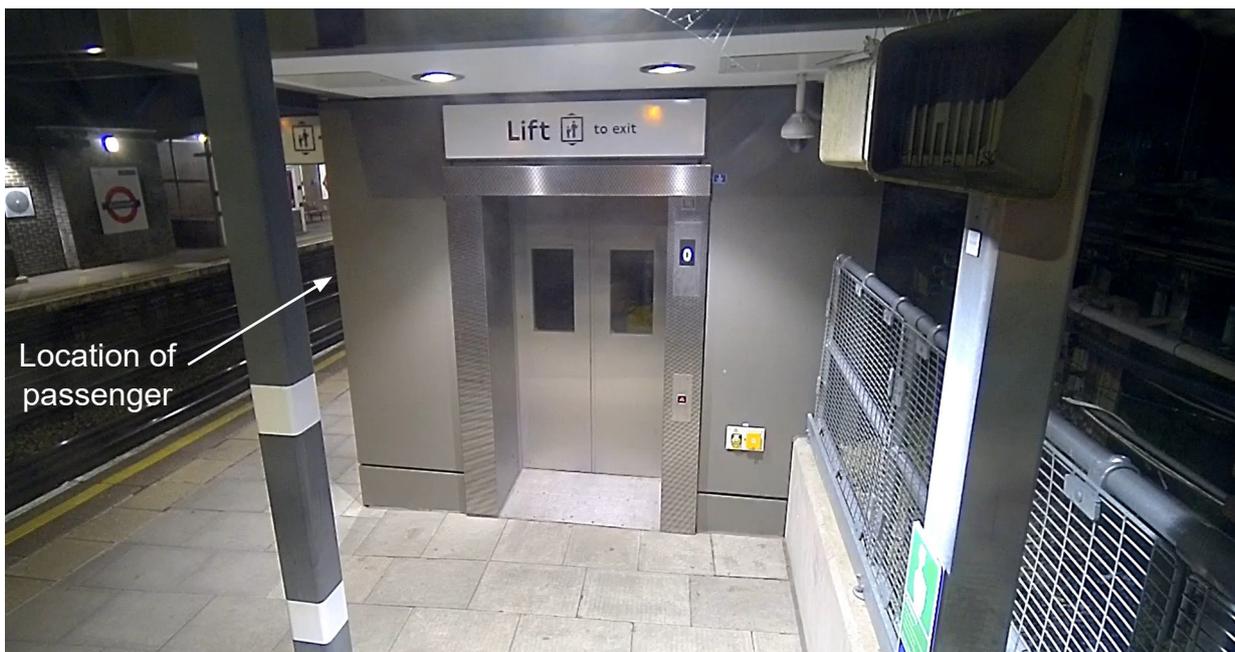
Figure 16: CCTV image showing the lift tower obstructing the view towards the area of the track where the passenger fell (courtesy of TfL with RAIB annotation).

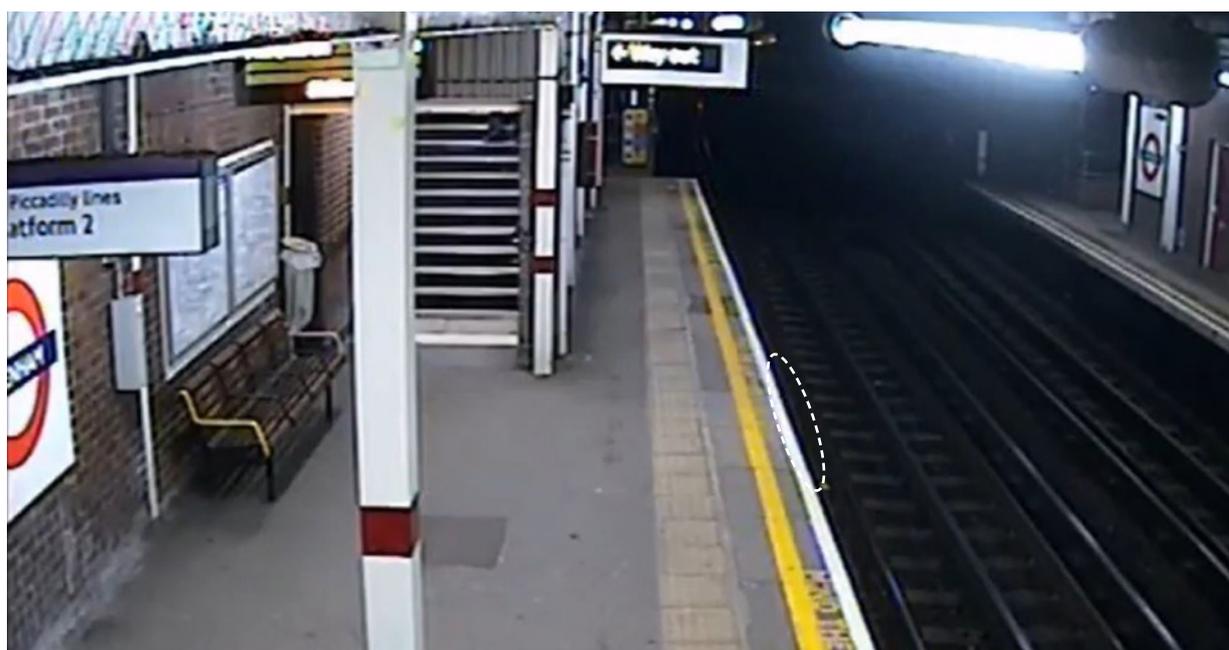
- 86 When the passenger was at track level they would have been difficult to see on the CCTV images. This was because they were wearing dark clothes and were against the dark background of the track, both of which were also partly in shadow from platform area lighting. This meant the passenger on the track may not have contrasted sufficiently to draw the late shift CSS's attention to them on the CCTV monitor had the CSS been looking at the monitor at that time (figure 17).

Figure 17: The better of the two camera views showing the track adjacent to the platform 2 staircase. Location of where the passenger fell marked by dotted white circle (courtesy of TfL with RAIB annotation).

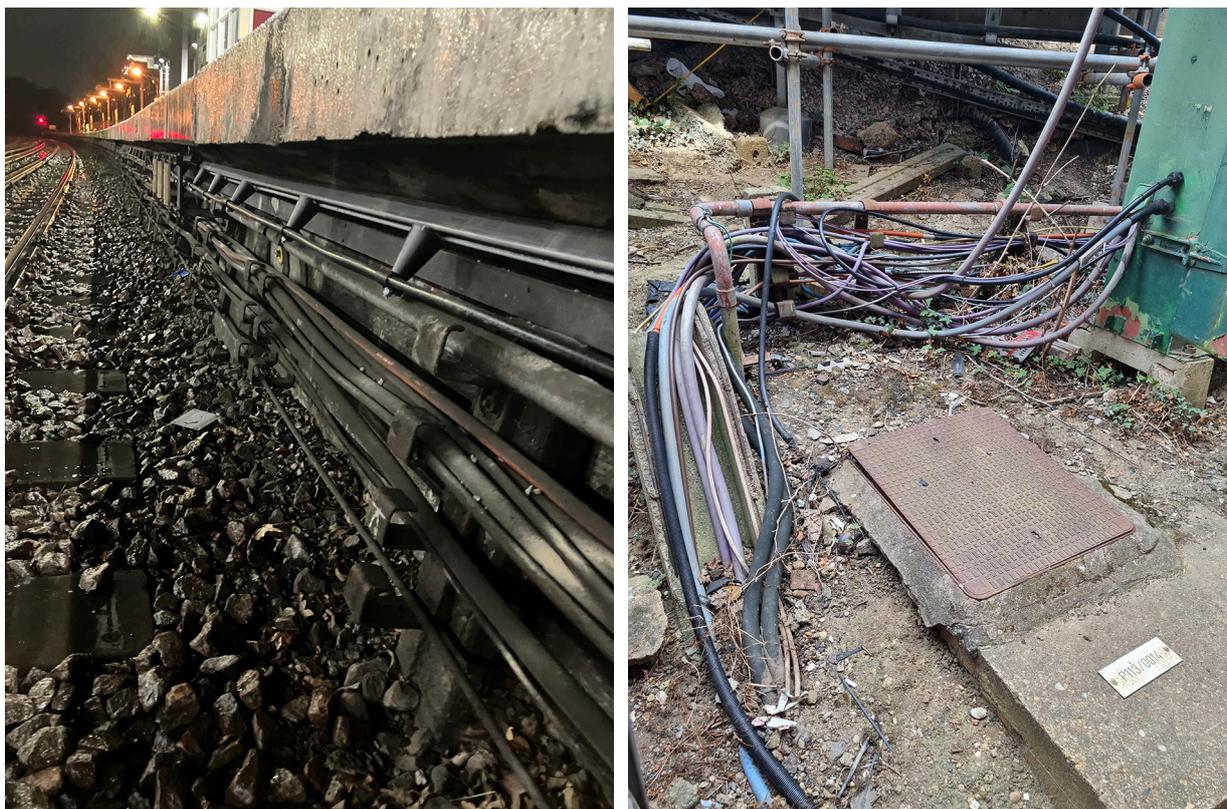
96 There are multiple cables running in the recess under platform 2 which modelling indicates would have prevented the passenger from moving sufficiently far away from the track to avoid being struck by the approaching train (see paragraph 101). These cables run the length of the recess and then up and onto the platform close to signal MUX 743 (figure 18). Witness and site evidence obtained by RAIB indicates that all these cables are still in use and are predominantly phone lines and radio communication cables. There are some cables which need to be in the under-platform recess for other safety features to be effective (see paragraph 121), but this is not the case for the majority of the installed cables.

Figure 18: The cable run in the recess of platform 2 (left). The communications cabinet at the north end of platform 2 (right).

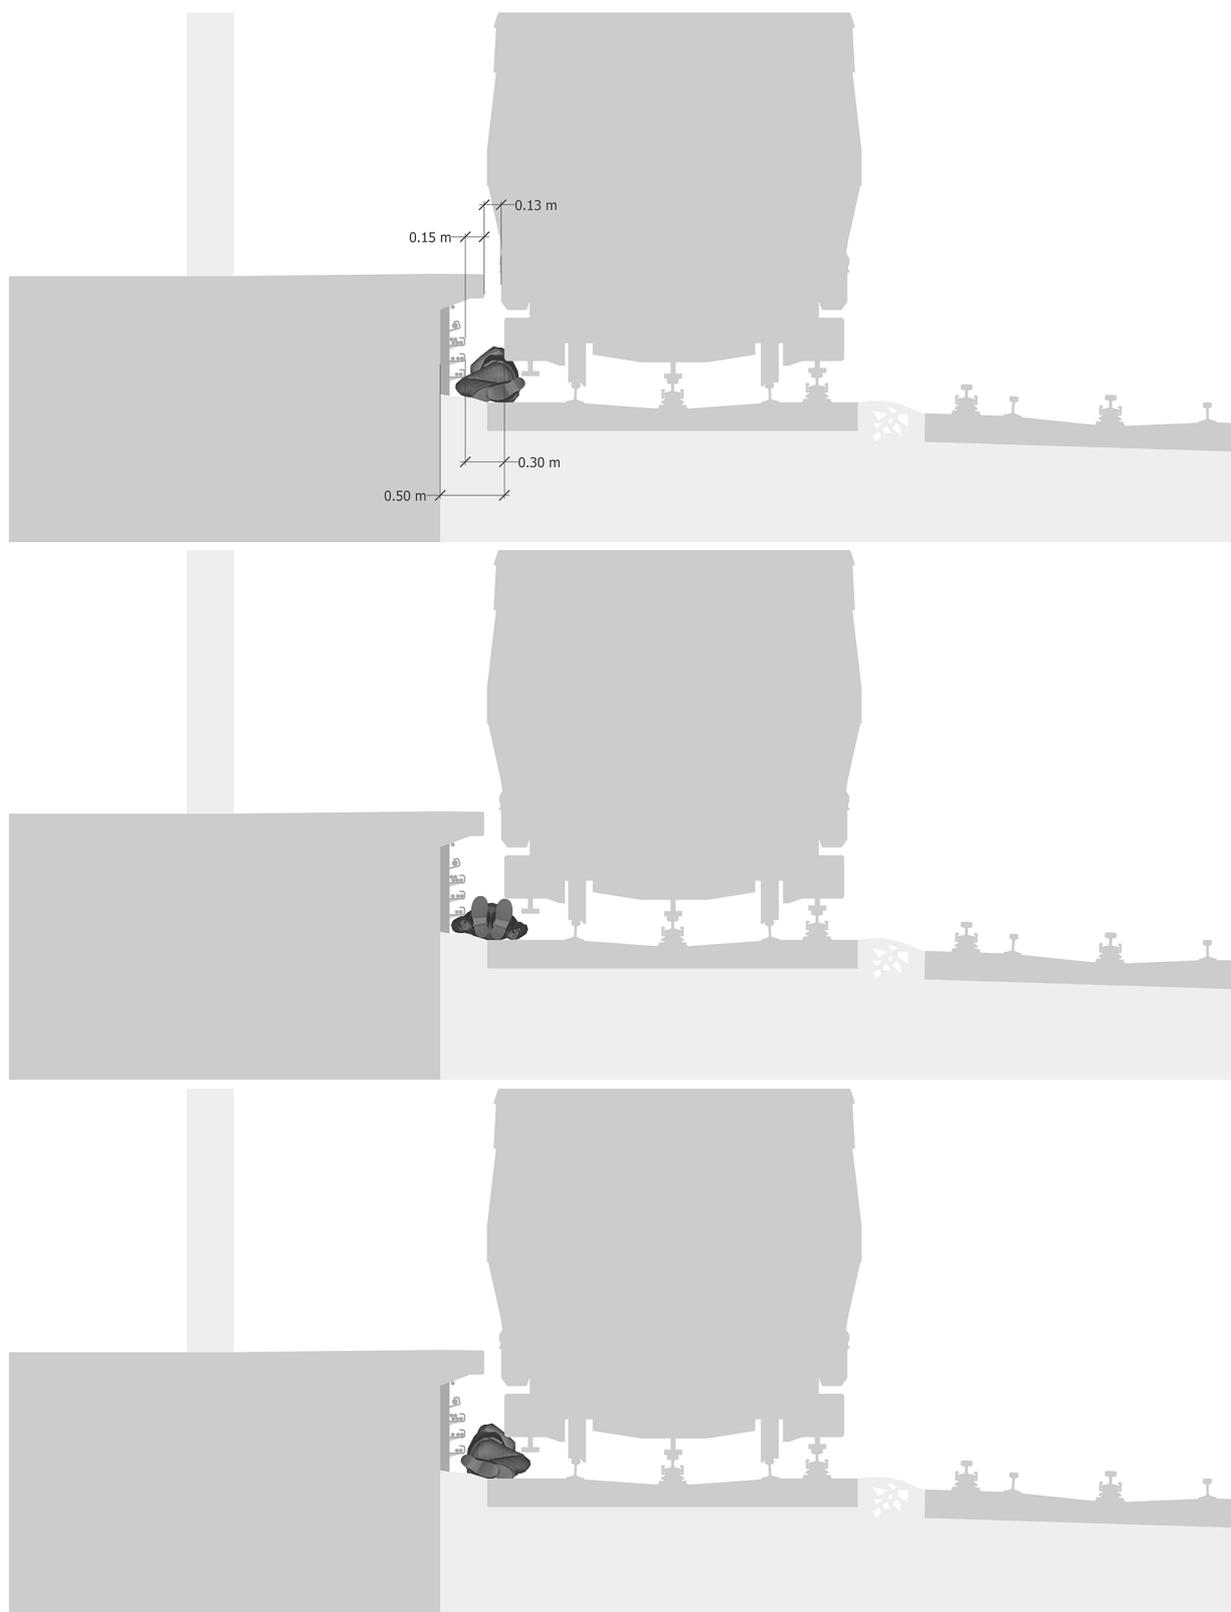
- 103 RAIB cannot say with certainty if the absence of cables would have prevented the passenger from being struck, as the exact position of the passenger and their bag is not visible on CCTV at the time of impact, and there is a chance that loose clothing or their belongings might have been snagged. However, the presence of the cables significantly reduced the available space in the under-platform recess and removed the opportunity for the passenger to avoid being struck. Had the cables not been installed then the recess would have been 370 mm deep, greater than the minimum required by the standard, but the presence of the cables reduced the available recess to 150 mm (figures 19 and 20).

Figure 19: RAIB’s digital representation of the impact of the cables on the available survival space in the under-platform recess.

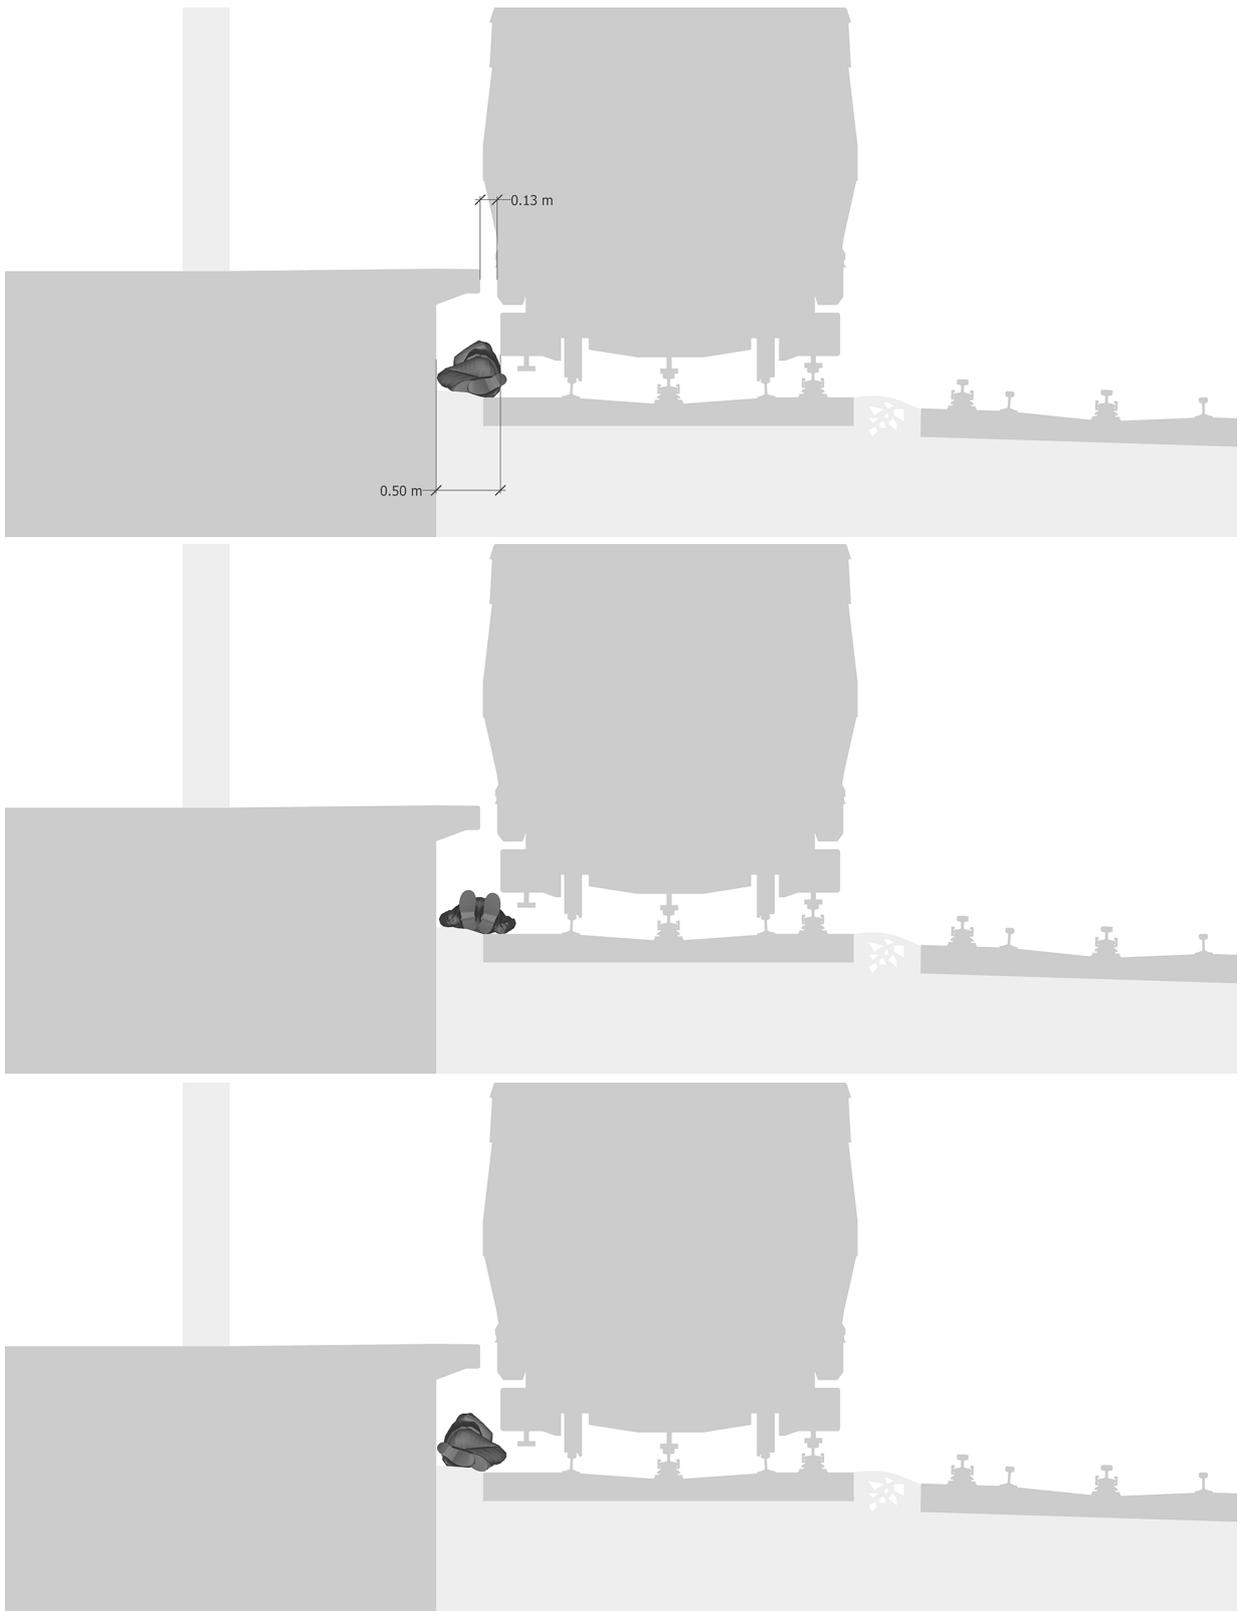
Figure 20: The same model as figure 19 but with the cable run digitally removed.

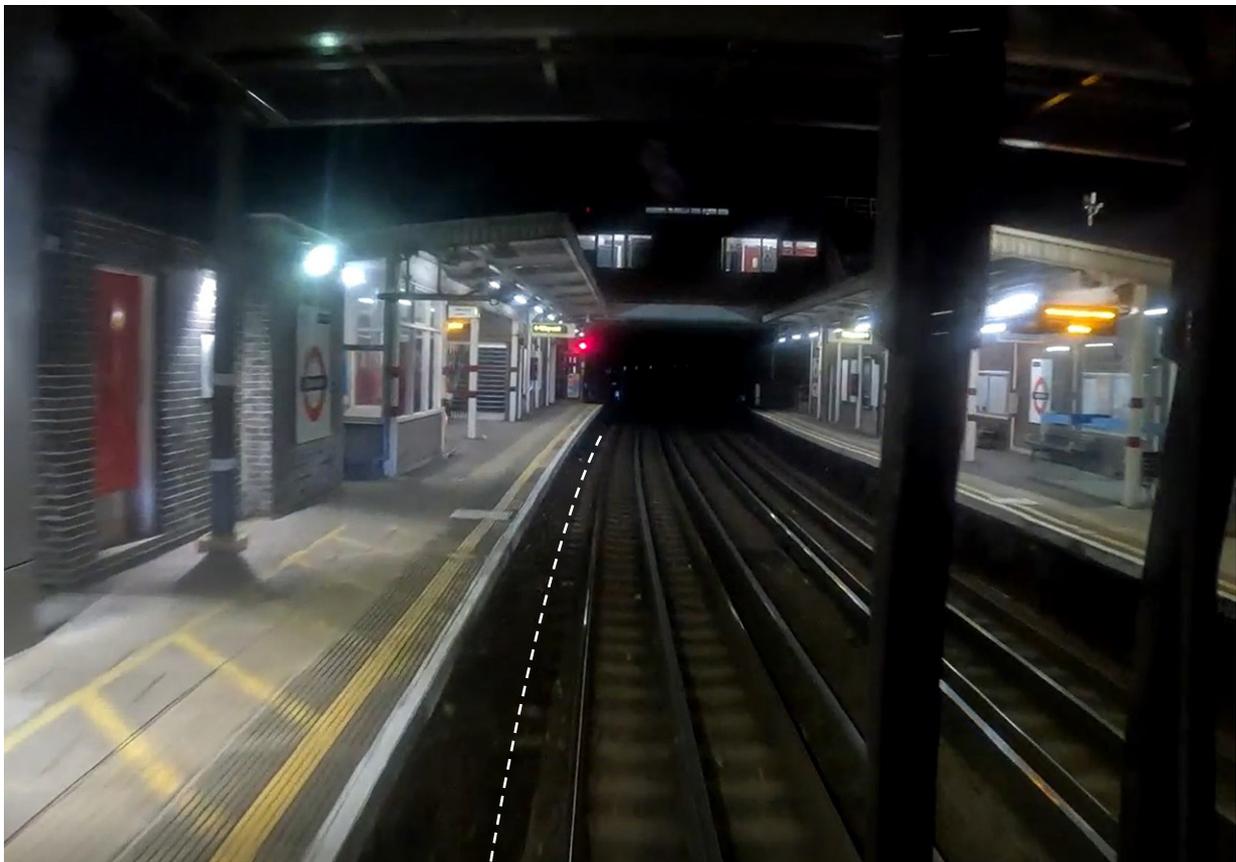
112 Environmental factors may also have contributed towards the train operator not detecting the passenger on the track. The track bed is dark in colour and not well lit in comparison to the surrounding environment, such as the platform. The brightly lit platform, combined with an unlit track bed, also causes a shadow to be cast around the area of the under-platform recess (figure 21). This may have combined with the passenger's dark clothing and their proximity to the platform face to reduce how conspicuous they were.

Figure 21: Image captured from the cab of the reconstruction train showing the edge of the shadow cast by the platform onto the track highlighted with a dashed white line.
