Near miss at Helpston manually controlled barrier level crossing, 21 October 2025

At 08:16 on Tuesday 21 October 2025, a near miss occurred at Helpston manually controlled barrier (MCB) level crossing, situated near Peterborough.

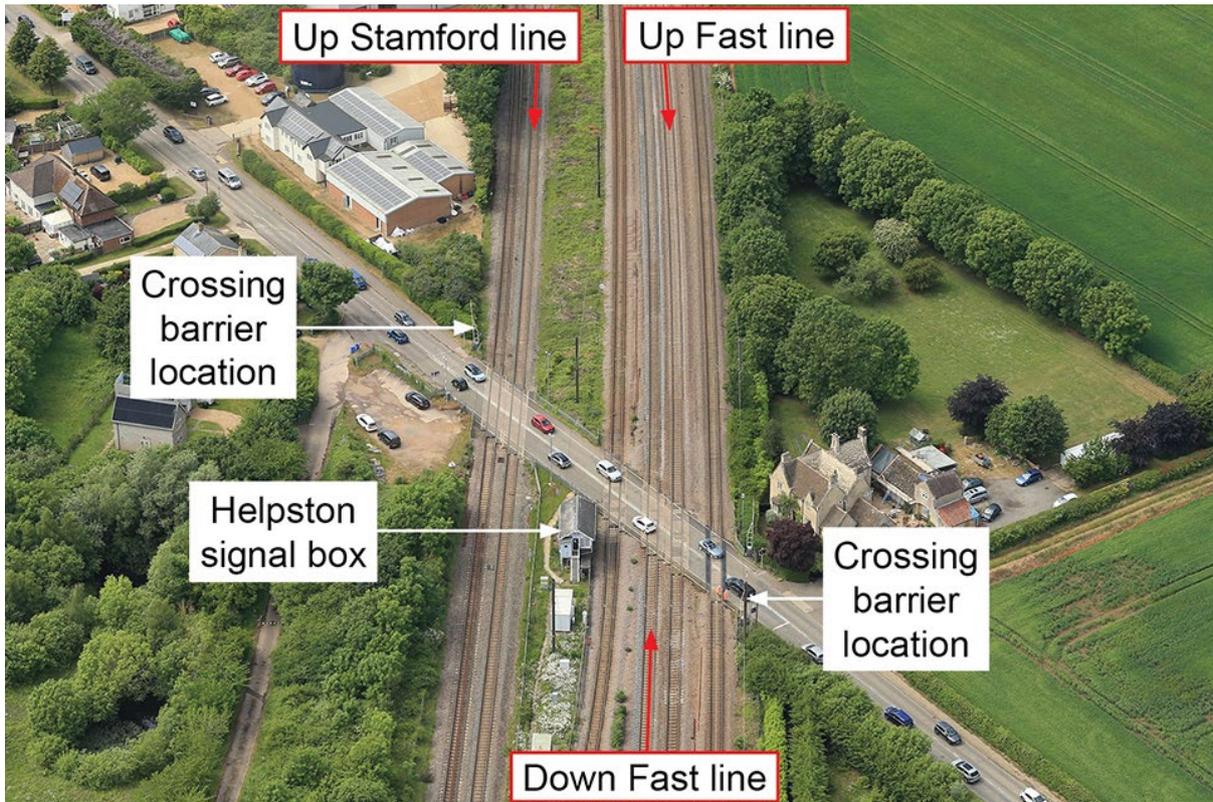
Helpston MCB level crossing spans six railway lines on a skew. These are the Up and Down Fast and Up and Down Slow lines of the East Coast Main Line, and the Up and Down Stamford lines. The crossing is controlled by Helpston signal box which also controls a further four level crossing which are sited remotely and which are monitored using CCTV. The signal box is located between the East Coast Main Line and the Stamford lines.

Helpston MCB level crossing with the directions of approach of the trains involved (courtesy of Network Rail with RAIB annotations).

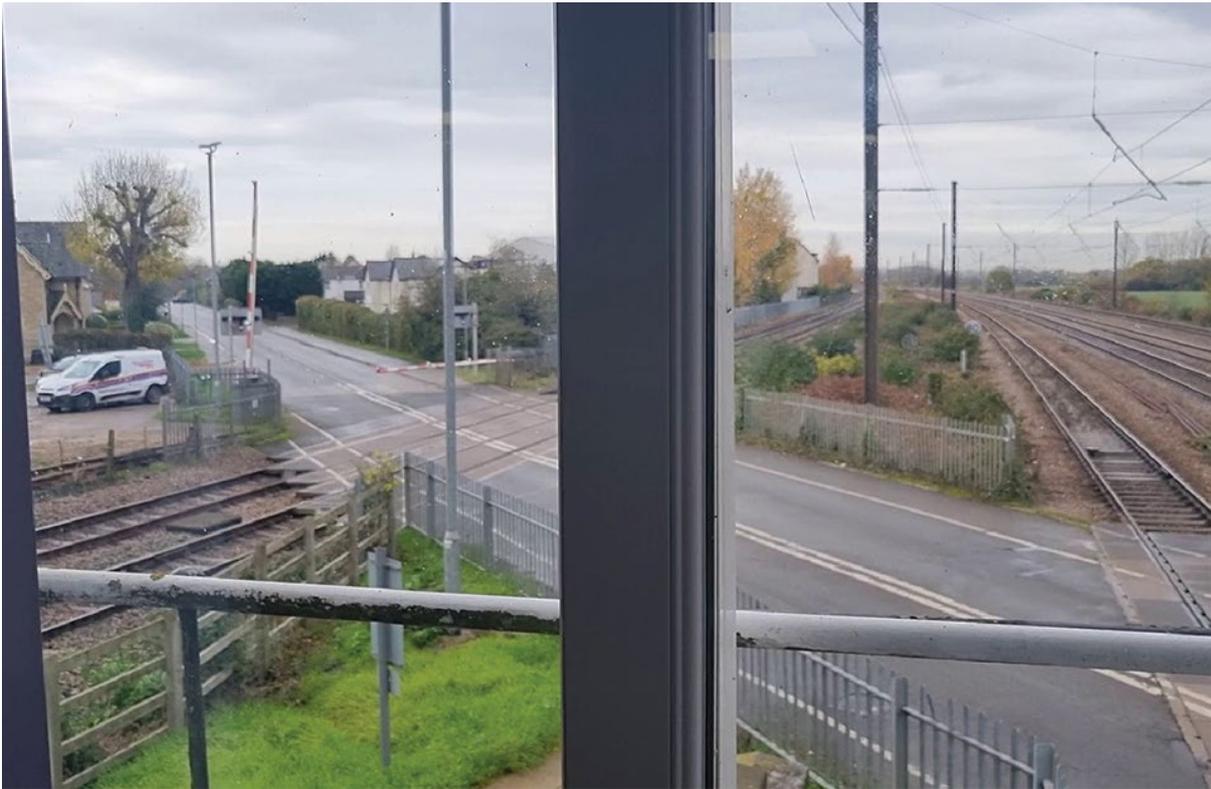
View of the Stamford lines from Helpston signal box. The East Coast Main Line is to the right of the picture.

After the second passenger train had passed over the crossing, witness evidence is that the signaller tried to manually raise the barriers. Signalling data recorded this as happening at 08:16:04, about 11 seconds after the second train had passed over the crossing. As they did this, the signaller looked out of the crossing windows to the right and towards the Up and Down Fast and Up and Down Slow lines. They did not look towards the Stamford lines.

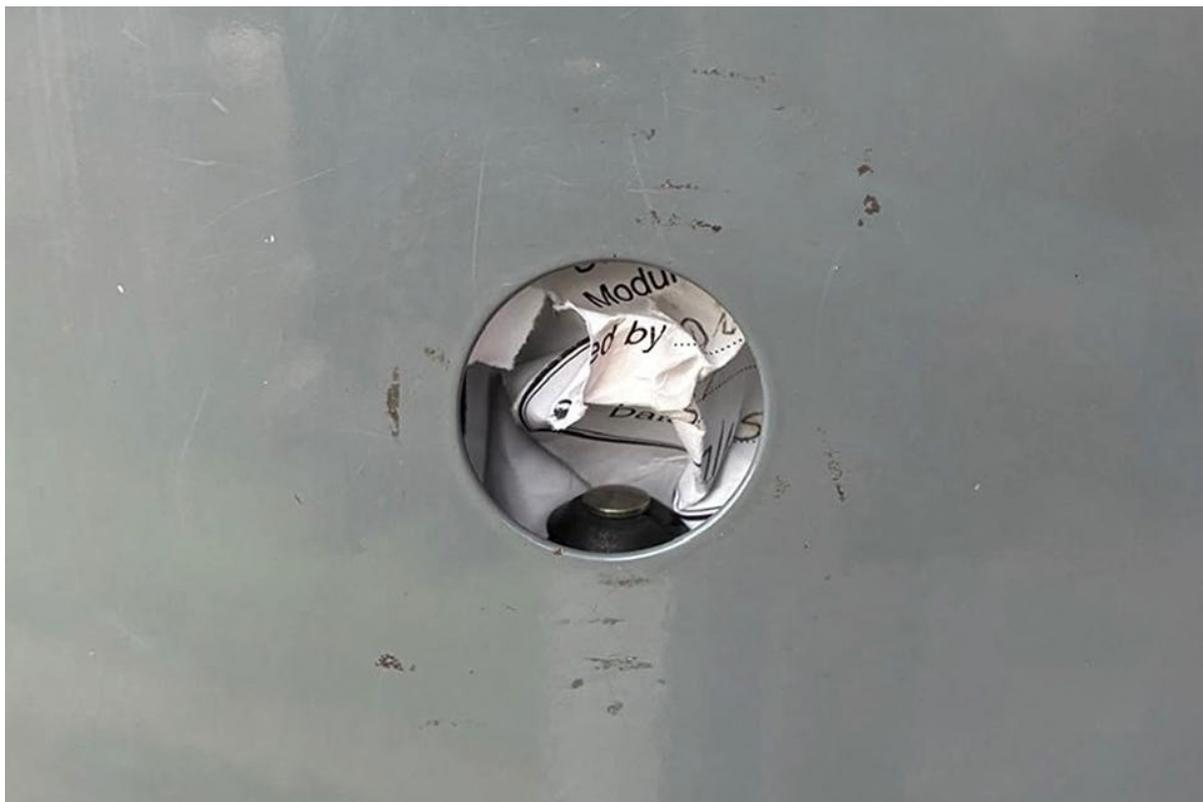
The remains of the paper seal inside the hole which allows access to the sealed release plunger.

Believing that they were dealing with an equipment failure, the signaller decided to use the sealed release plunger to raise the barriers. The paper seal which should have covered the plunger was already broken and had been left inside the plunger access hole. Documentary evidence shows that this seal had been broken on 4 July 2025 and that, while this had been logged by the signaller on duty, it had not been reported for repair.

The 4-month period when the seal over the plunger was broken and not replaced also suggests that there was an acceptance of a non-compliant local practice regarding sealed release use by staff in this signal box.
