Accident

Aircraft Type and Registration:	Bristell NG5 Speed Wing, G-STEL	
No & Type of Engines:	1 Jabiru 3300A piston engine	
Year of Manufacture:	2013 (Serial no: LAA 385-15235)	
Date & Time (UTC):	20 May 2025 at 0842 hrs	
Location:	Near Gordon, Berwickshire	
Type of Flight:	Private	
Persons on Board:	Crew - 1	Passengers - None
Injuries:	Crew - 1 (Fatal)	Passengers - N/A
Nature of Damage:	Aircraft destroyed	
Commander's Licence:	Private Pilot's Licence (Aeroplanes) (Microlights Only)	
Commander's Age:	59 Years	
Commander's Flying Experience:	795 hours (of which 32 were on type) Last 90 days - 17 hours Last 28 days - 6 hours	
Information Source:	AAIB Field Investigation

Synopsis

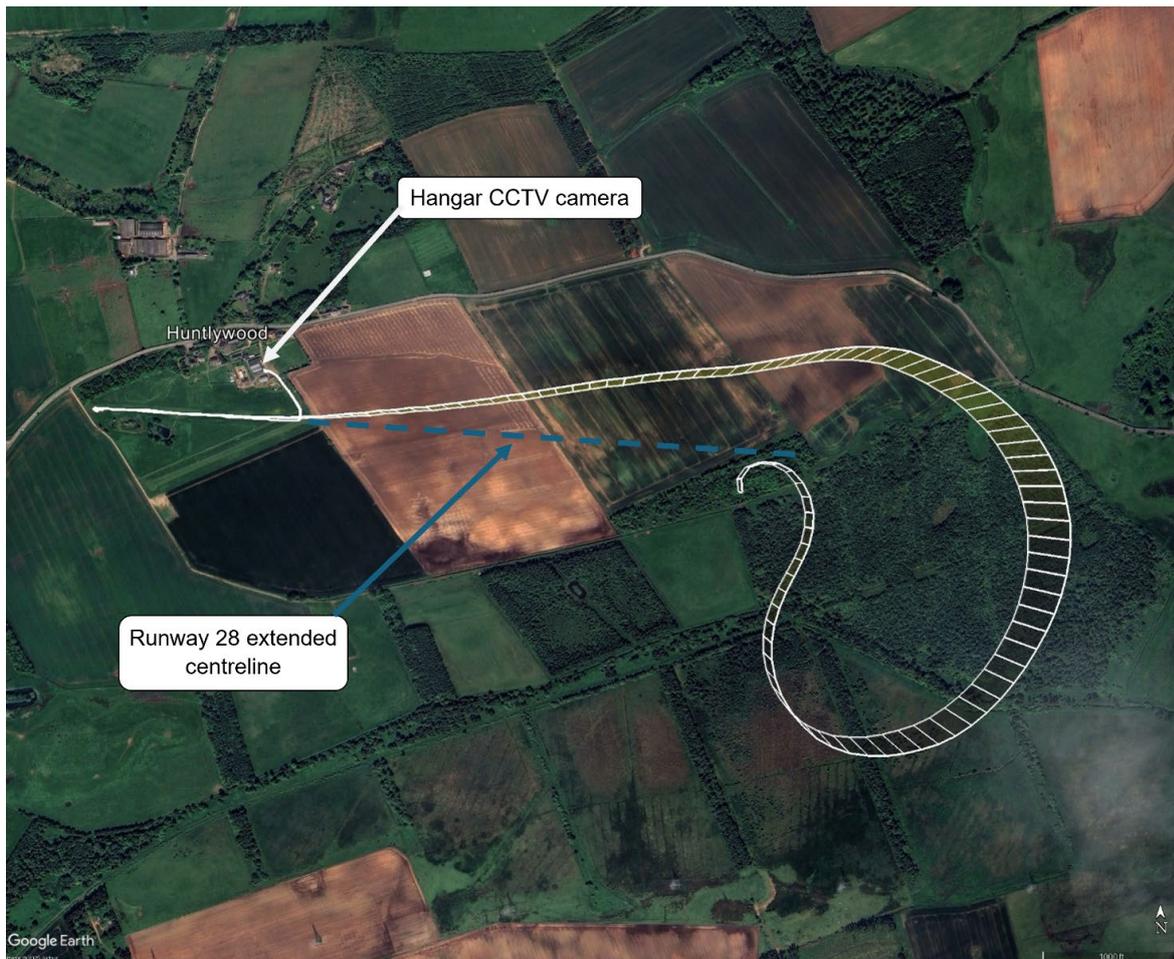
Figure 1

G-STEL flight path from GNSS data

The aircraft took off at 0840 hrs and reached a height of 610 ft aal before entering a right turn and reducing power. The right turn continued along with a descent for, what appeared to be, a landing on to the reciprocal Runway 28.

A return to land on a runway reciprocal to the runway used for takeoff requires continuous manoeuvring, as shown in Figure 1. Whilst starting the left turn to align with Runway 28, the pilot appeared to enter cloud, and at the point that the aircraft re-appeared on CCTV it had a high bank angle and steep nose-down attitude consistent with a spiral descent following a loss of control. It is likely, therefore, that the pilot became spatially disorientated very rapidly after entering cloud and when emerging from the cloud had insufficient height to understand and correct the flightpath.

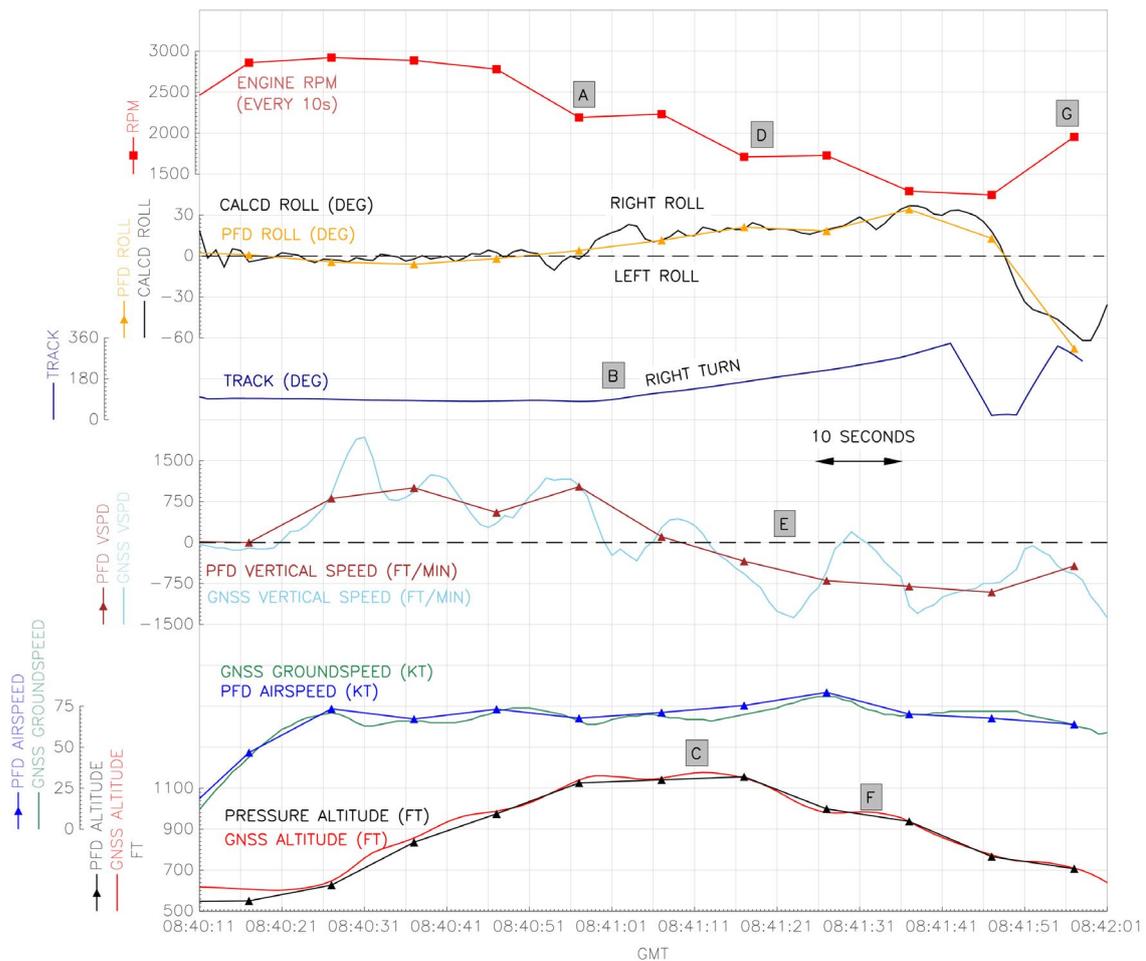
Figure 4

The CCTV and GNSS data confirmed the aircraft taxiing from the hangar at 0834 hrs, entering and backtracking Runway 10. One camera captured the airfield windsock which was flaccid and showed that there was no wind. Takeoff commenced at 0840:10 hrs with recorded engine rpm increasing to 2,920 rpm and the aircraft climbed straight ahead to a GNSS altitude of 1,160 ft³ amsl (610 ft aal). The aircraft levelled, engine rpm reduced to approximately 2,190 rpm (Figure 4, Point A) and a right turn commenced (Point B).

G-STEL flight data from GNSS, PFD and EMS recordings

Maximum GNSS altitude achieved was 1,177 ft amsl (627 ft aal) at 0841:12 hrs (Point C), after which the aircraft started to descend. Recorded rpm reduced again (Point D) and the initial part of the descent reached up to 1,377 ft/min (Point E)⁴. An estimate of bank angle was calculated which showed the bank angle increasing slowly during the turn up to approximately 30° to the right.

The recorded GNSS data confirmed the CCTV footage with a steepening and descending left turn until the end of the recording. Recorded rpm showed an increase from 1,244 rpm to 1,954 rpm in the final 10 seconds of recording, indicating that engine power increased (Figure 4, Point G). The final recorded GNSS position was four seconds later, at 0842:01 hrs, at 639 ft amsl (89 ft aal) with the aircraft descending at approximately 1,400 ft/min.

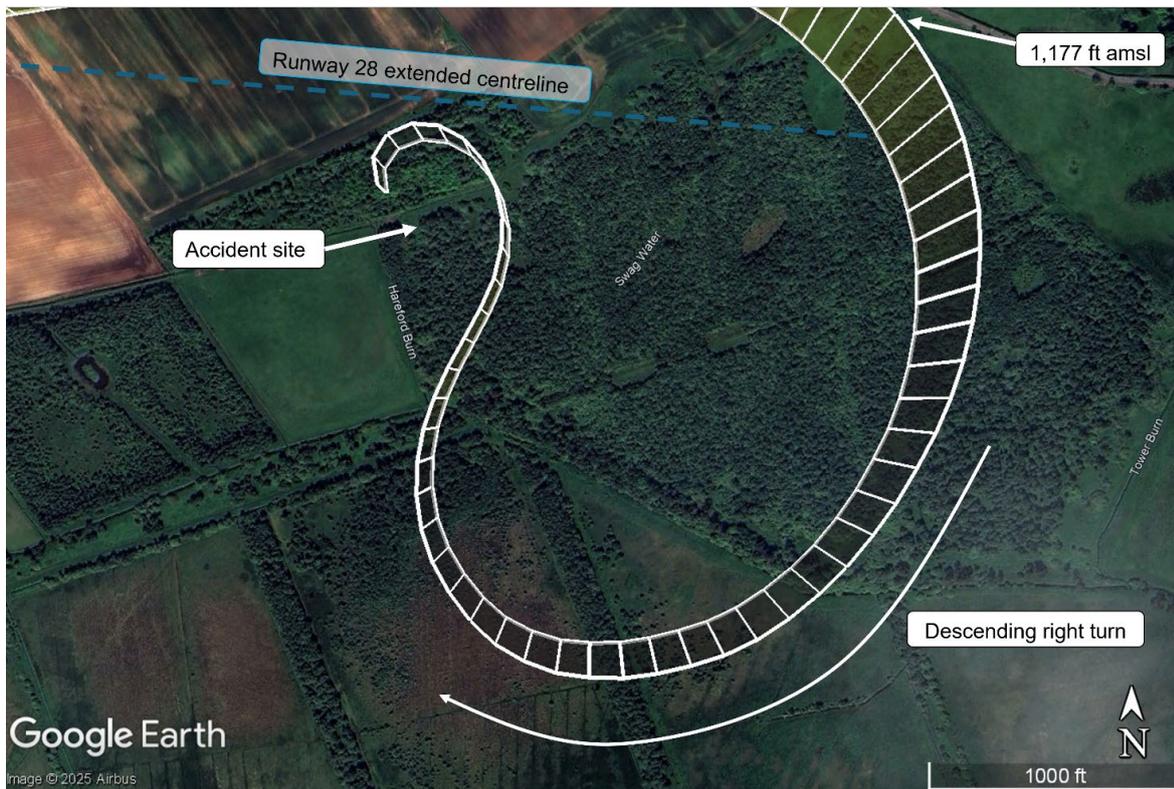
Figure 5

The aircraft continued to descend and turn to the right, briefly levelling for a few seconds at 980 ft amsl (430 ft aal) having turned through 180° (Point F). The descent and right turn continued until 0841:49 hrs when the right turn was reversed into a left turn. At this point the aircraft was 0.6 nm from the Runway 28 threshold at 753 ft amsl (203 ft aal). At this distance and altitude, it was close to being on a 3° slope to the runway threshold (Figure 5).

G-STEL aircraft track from recorded GNSS data

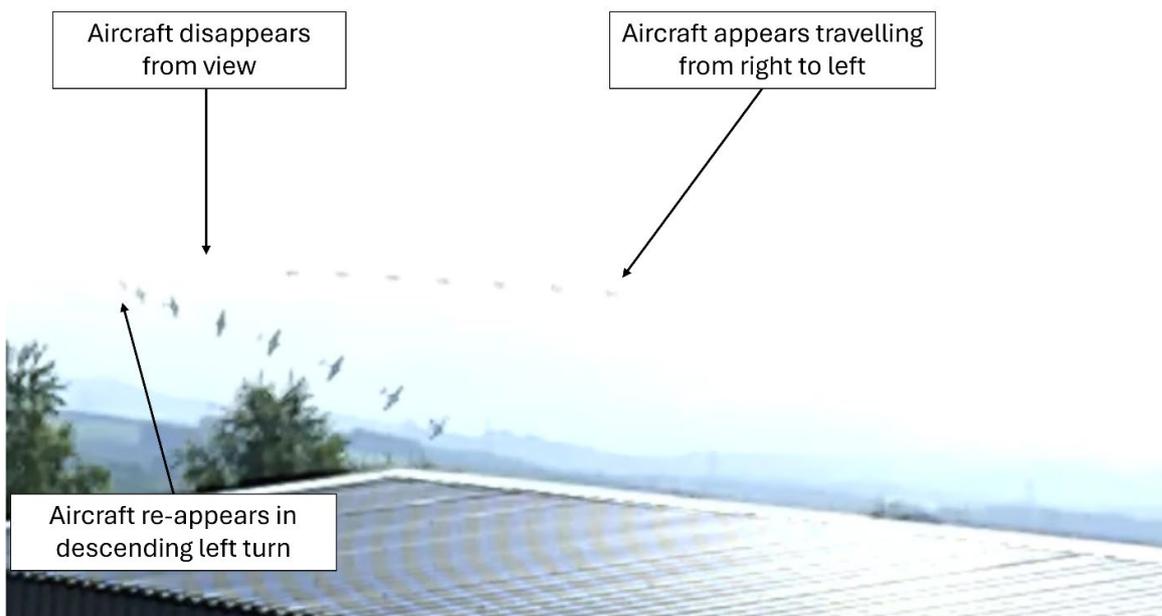
As the left turn commenced, CCTV recording from the airfield captured the aircraft on a camera mounted to the airfield hangar. This camera was approximately 0.6 nm from the accident site and the aircraft appeared in the top right corner. The footage showed the aircraft moving from right-to-left for around three seconds before disappearing from view. It re-appeared around three seconds later in a steeper descending left turn which continued until out of sight. Figure 6 shows a portion of the CCTV footage as a compound view of frames approximately every 0.5 seconds.

Figure 6
G-STEL CCTV image

The period when the aircraft disappeared from the CCTV view suggested that there were pockets of poor visibility and/or cloud.

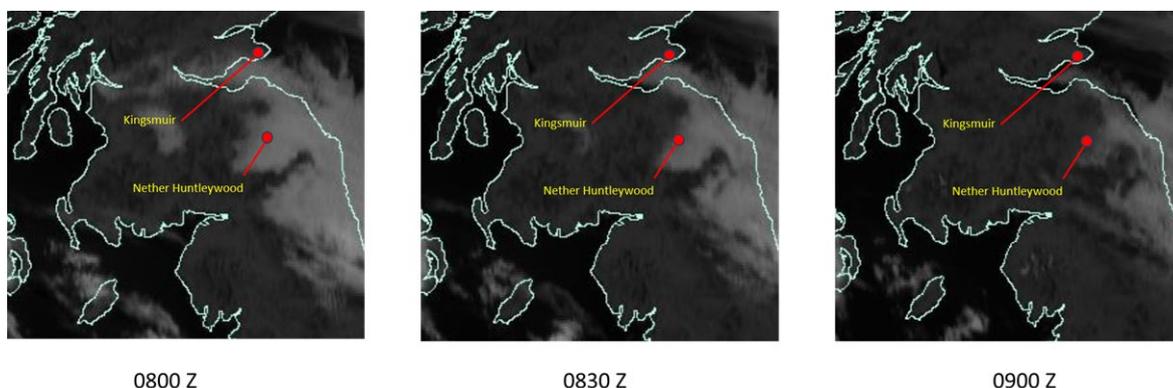
Figure 7

settled with a bank of cloud affecting the east coast from the Firth of Forth southwards. This cloud penetrated inland and affected the Huntlywood area during the morning but cleared by 0900 hrs. Some low cloud would also have affected the Kingsmuir area during the early part of the morning, but this appears to have cleared by 0830 hrs. From the observations, surface visibility remained above 10 km throughout the period of interest.

Met Office Aftercast cloud cover

The Met Office aftercast showed that the haar was clearing from the area of the airfield when the aircraft took off, but it had not completely dissipated. The decision to abandon the flight and return to Nether Huntlywood might, therefore, be attributed to significant cloud remaining on the intended route to Kingsmuir, which was discovered after departure. Although this appeared likely, it was not positively determined and it is possible that there was another reason for the decision to return.

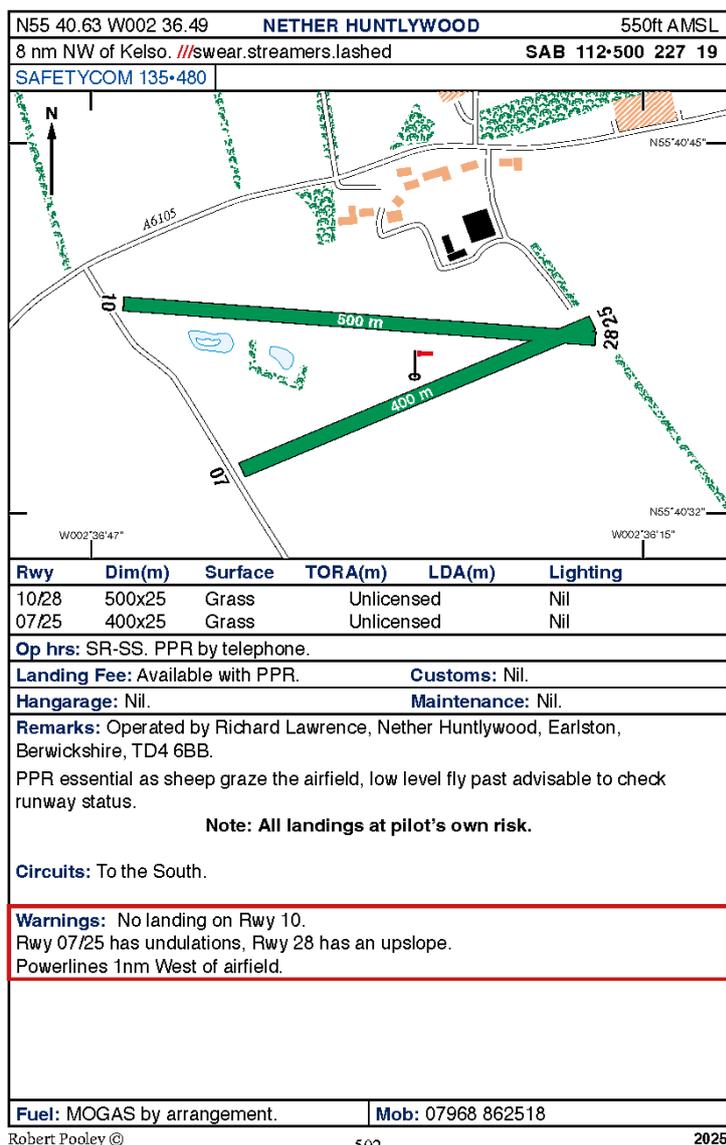
Figure 8

The airfield sits at an elevation of 550 ft amsl, with sheep commonly grazing on the runways. In the *'Warnings'* section of the Pooley's guide to the airfield it states: *'No landing on Rwy 10'*.

Pooley's Nether Huntlywood airfield plate

Having decided to return to the airfield, the weather probably favoured a landing on Runway 10, with better visibility to the west and no significant cloud. However, the Pooley's airfield chart contains a warning that does not allow landing on Runway 10, which would explain why the pilot positioned himself for a landing on Runway 28. The fact that the accident occurred as the aircraft was intercepting a 3° slope to the runway threshold, ie a normal approach path, also supported a conclusion that the pilot was attempting to land on Runway 28.
