Report on the investigation into
the loss of propulsion in heavy weather experienced by
the passenger vessel
Spirit of Discovery
while crossing the Bay of Biscay, leading to over
100 injuries and one fatality
on 4 November 2023

Shortly after 1230 on 4 November 2023, the passenger vessel *Spirit of Discovery* lost propulsion in heavy weather while crossing the Bay of Biscay. This led to the vessel moving violently while the crew restarted the vessel's propulsion. The propulsion issues, storm force conditions and vessel motion continued until the vessel was able to resume its passage the following morning. Over 100 passengers were injured during this period. Eight of the seriously injured passengers were taken directly to hospital on arrival at Portsmouth, England. One of these passengers, Trevor Gilks, later died from his injuries.

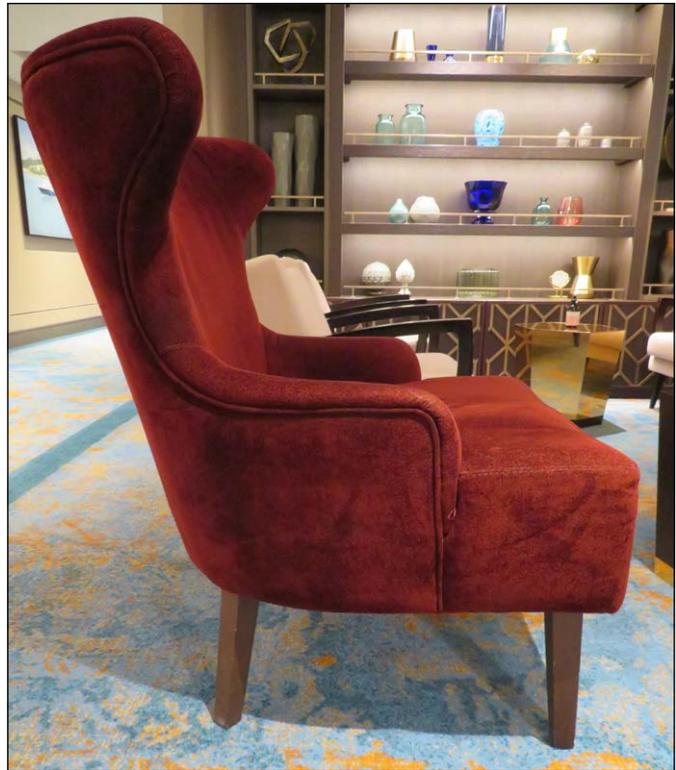
Figure 4: Example of the high-backed chair used by passenger 1

At about 1710, *Spirit of Discovery* rolled violently to approximately 10° to 13°. Passenger 1's chair toppled backwards, and he rolled backwards onto the deck. The main impact of the fall and subsequent roll was to his neck. Nearby crew saw passenger 1's fall from the chair and raised the alarm.

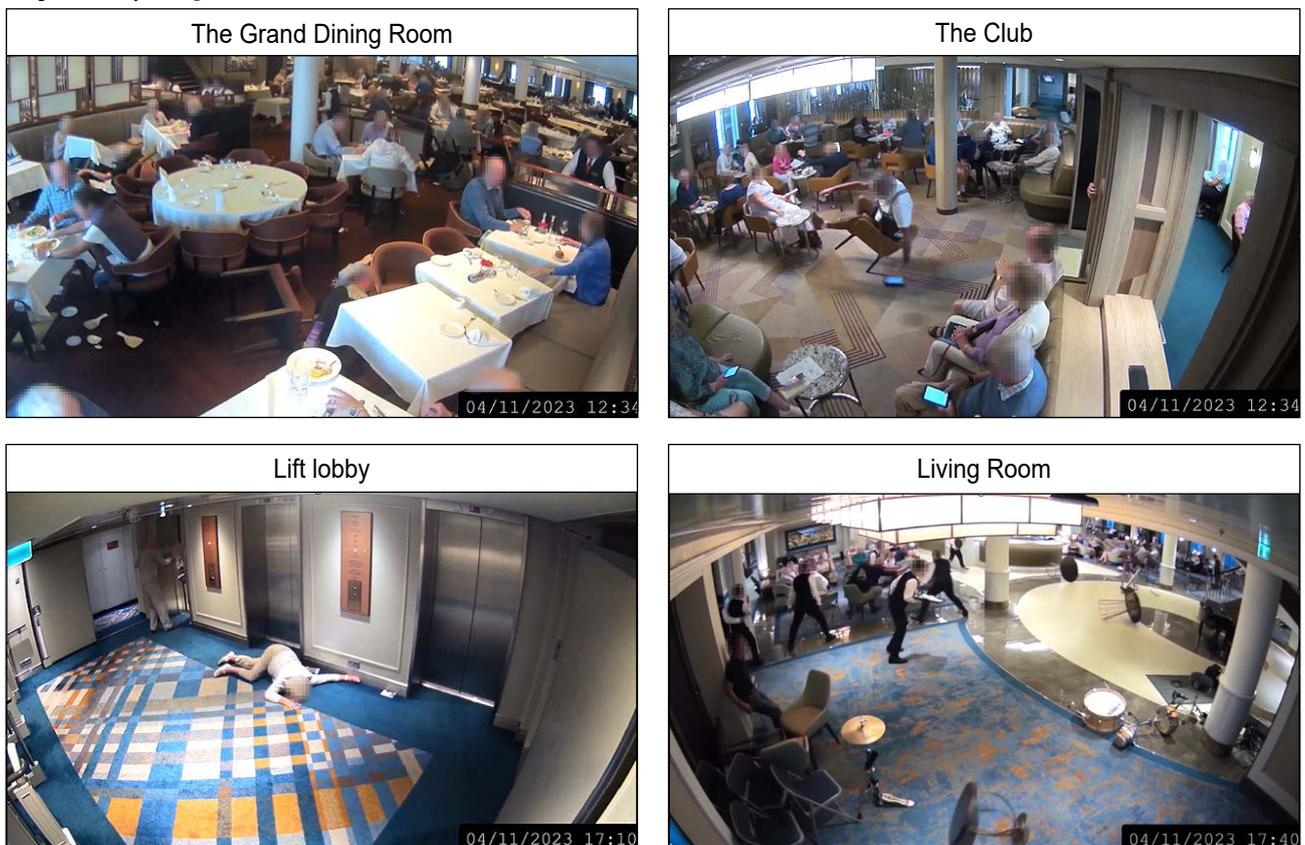
Figure 6: CCTV images of public spaces after propulsion was lost

A review of the vessel's closed-circuit television (CCTV) images showed that many passengers fell and were injured by unsecured tables, chairs and crockery in the public spaces. Not all the furniture was observed to be equally affected by the vessel's violent motion. Lighter café style tables and chairs appeared the most vulnerable and were observed to cause some chair occupants to fall to the deck or, having toppled over, slide across the deck, occasionally striking passengers. Heavier, more stable tables and chairs with a broad base and low centre of gravity appeared less affected. One passenger was injured in a lift lobby when they were unable to hold onto anything to prevent themselves falling (**Figure 6**). Of those who were injured in their cabins, 52% fell while standing; 36% fell while sitting; 10% were struck by furniture or other items; and 2% fell from their mobility aids.

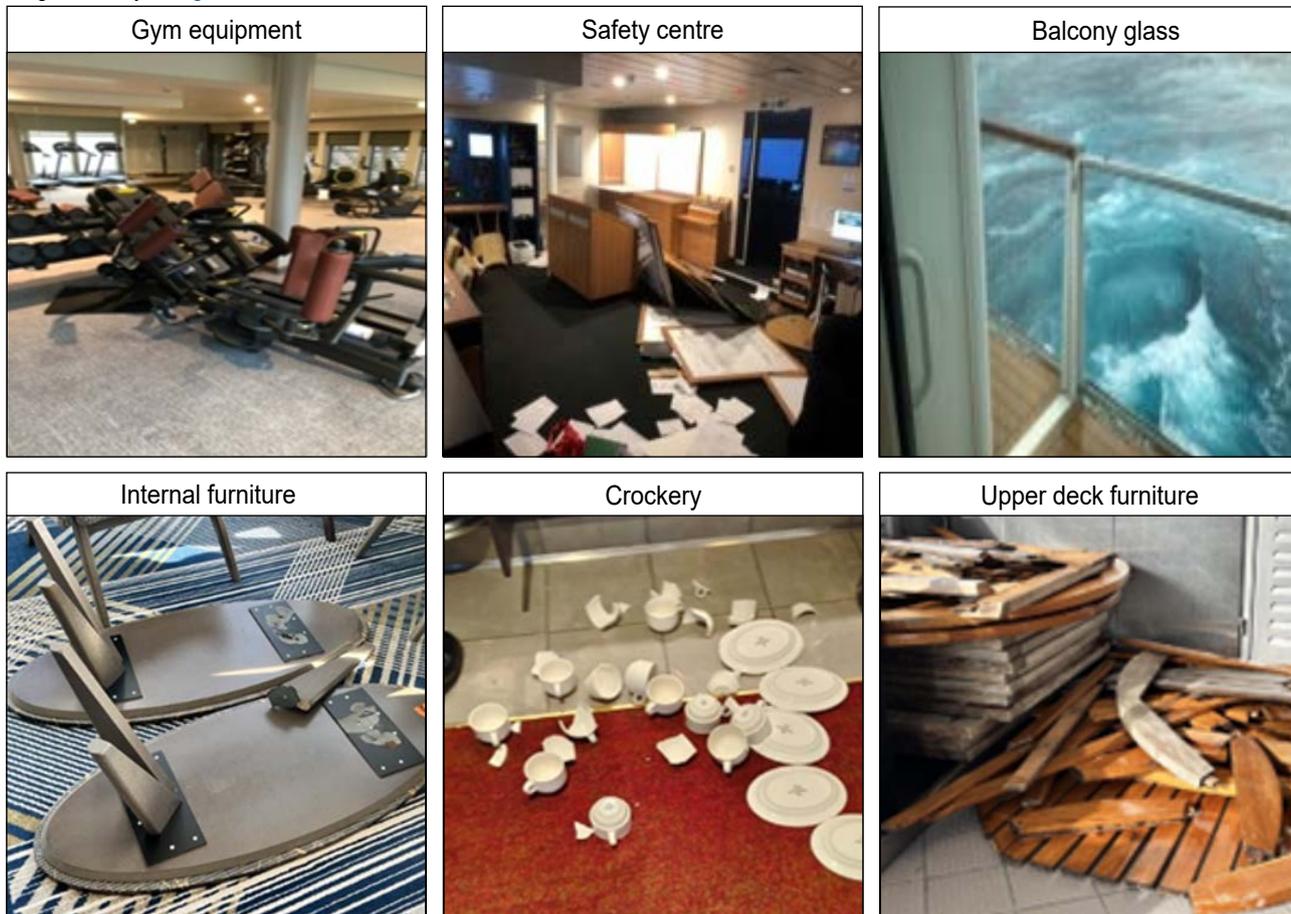
Figure 7: Examples of the damage

Spirit of Discovery sustained damage to some of its balcony glass panels, gym equipment, and furniture as well as crockery and glassware. The vessel's watertight integrity remained intact and there was no structural damage (**Figure 7**).

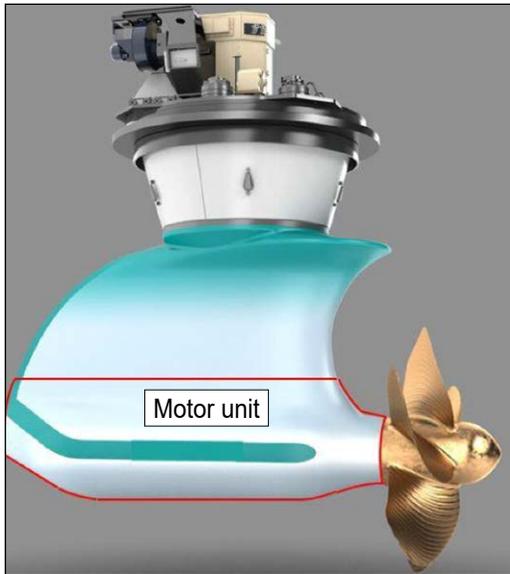
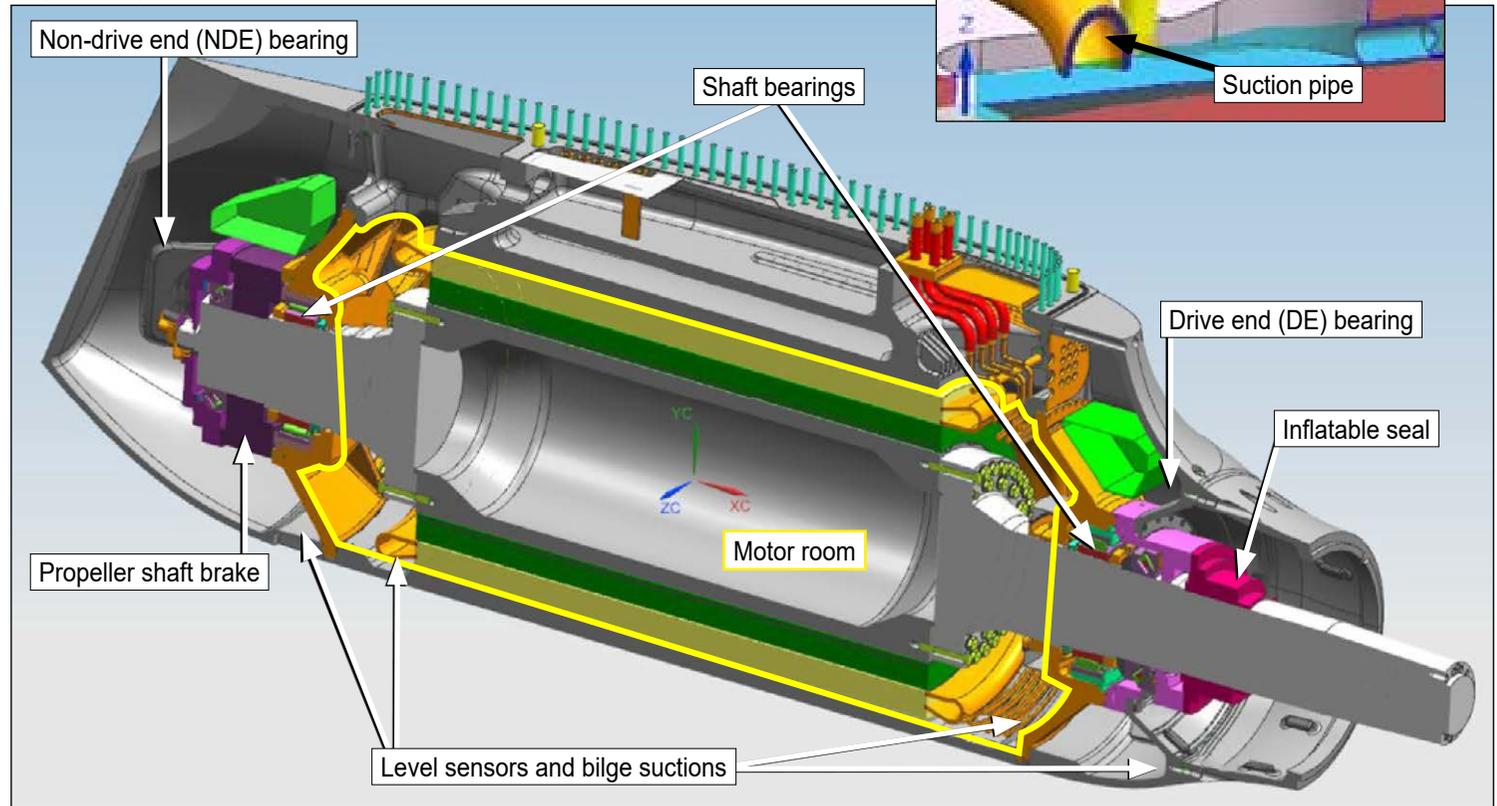
Figure 8: Cross-section of a Siemens SISHlp eSiPOD motor unit and bilge arrangements

Spirit of Discovery's propulsion motors' maximum rated speed was 120 revolutions per minute (rpm). To prevent mechanical damage due to motor overspeed, the PCS automatically shut the pod motor down if it reached 132 rpm, which was 110% of the maximum rated speed. The vessel's engine management records indicated that this pod overspeed protection led to each loss of propulsion.

Given the weather conditions at the time, it is almost certain that *Spirit of Discovery's* pitching caused the propellers to come out of the water. This caused a sudden reduction in torque on the propulsion motor and led to a very rapid increase in the motors' rpm. The engine alarm and monitoring system recorded that, immediately before their shutdown, the rpm of each pod's propulsion motor very rapidly increased and exceeded the preset overspeed limitation. The pod's PCS therefore automatically tripped the power to its motor to prevent it being damaged.
